North Dam Weekly Walkover Survey Report

Date:	June 28/2014
Inspected By:	Brenden Greenley
Conditions:	(ie. snow on ground, clear) Clear/Rain

Date:	July 6/14
Inspected By:	Jill and Sarah
Conditions:	(ie. snow on ground, clear) no snow, all ground clear, cold and windy

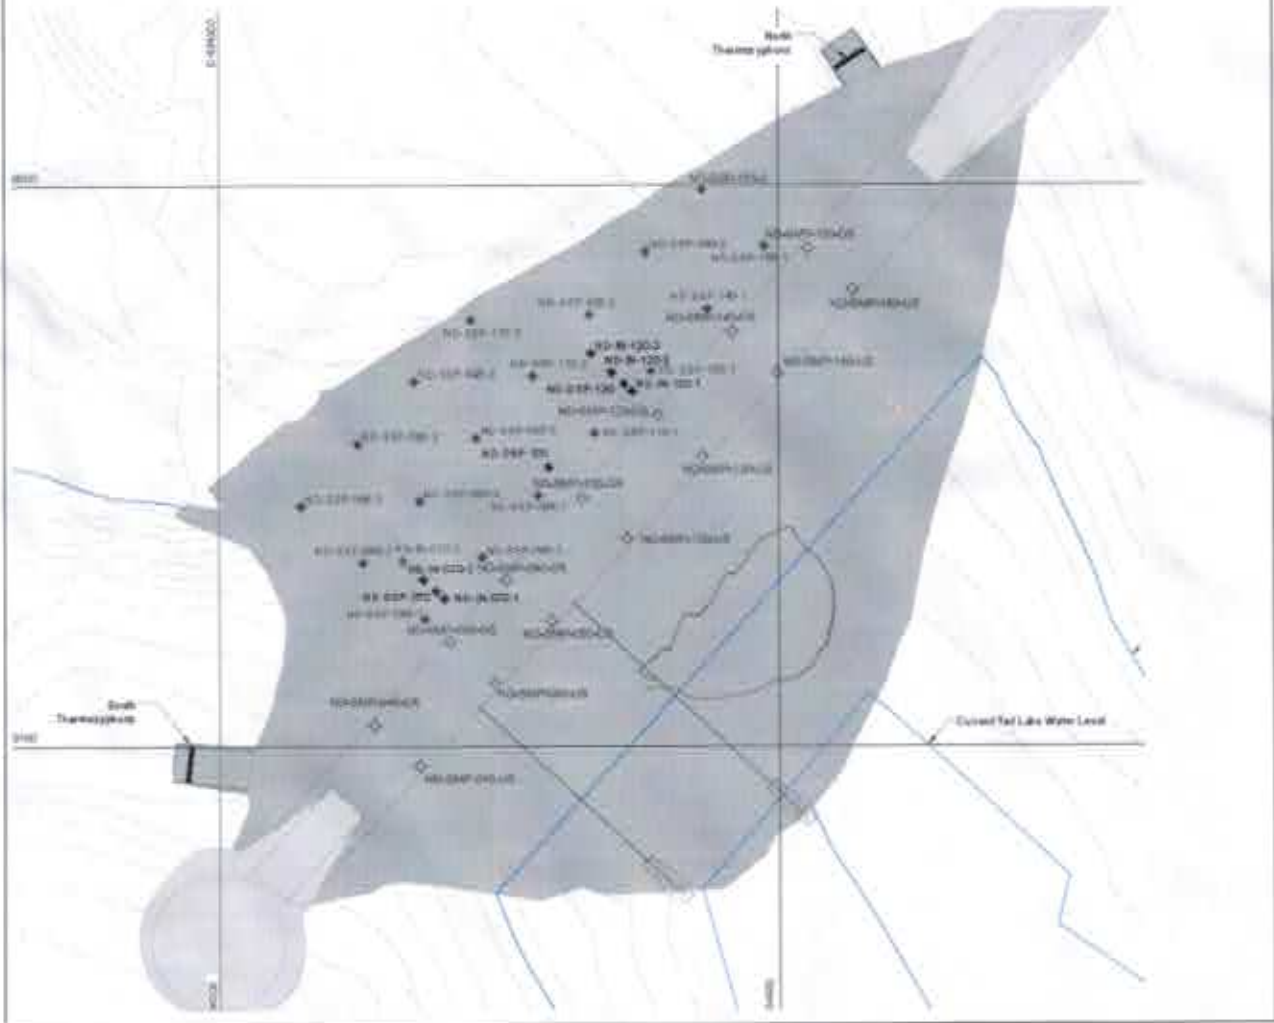
1) depression upst ream of Dam
2) Two days of Rain No signs of erosion

check for suspended sediment @ TIA:

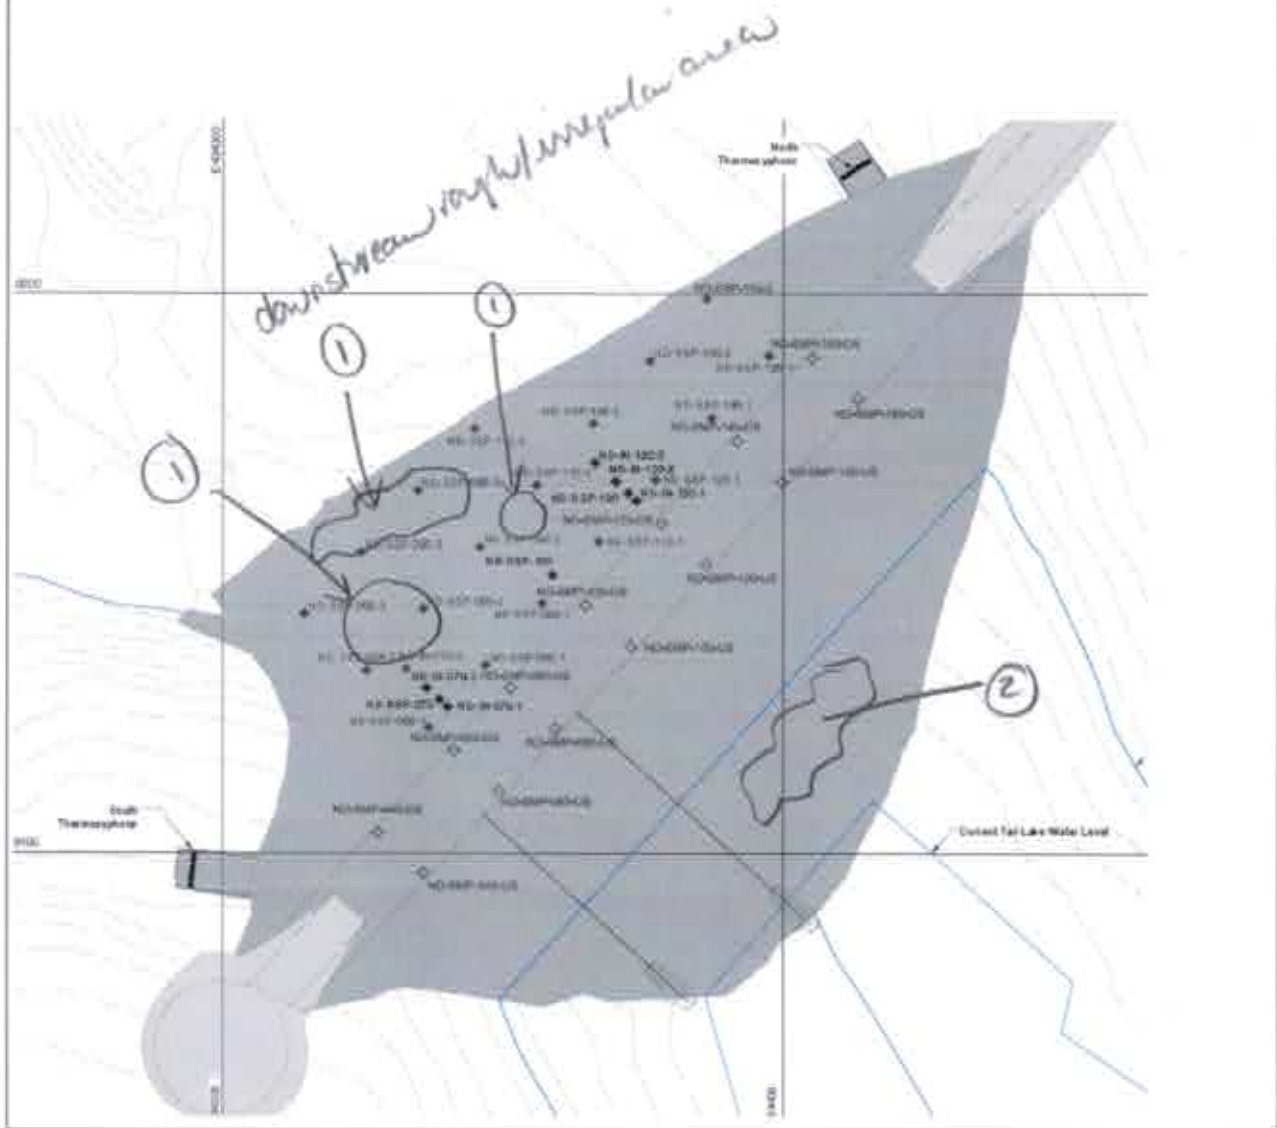
- ① Should check during next Geotechnical inspection, all "depressions". (see picture - downstream)
- ② Upstream, there are also very rough + crude depressions in the surface. Hard to tell if these are irregular

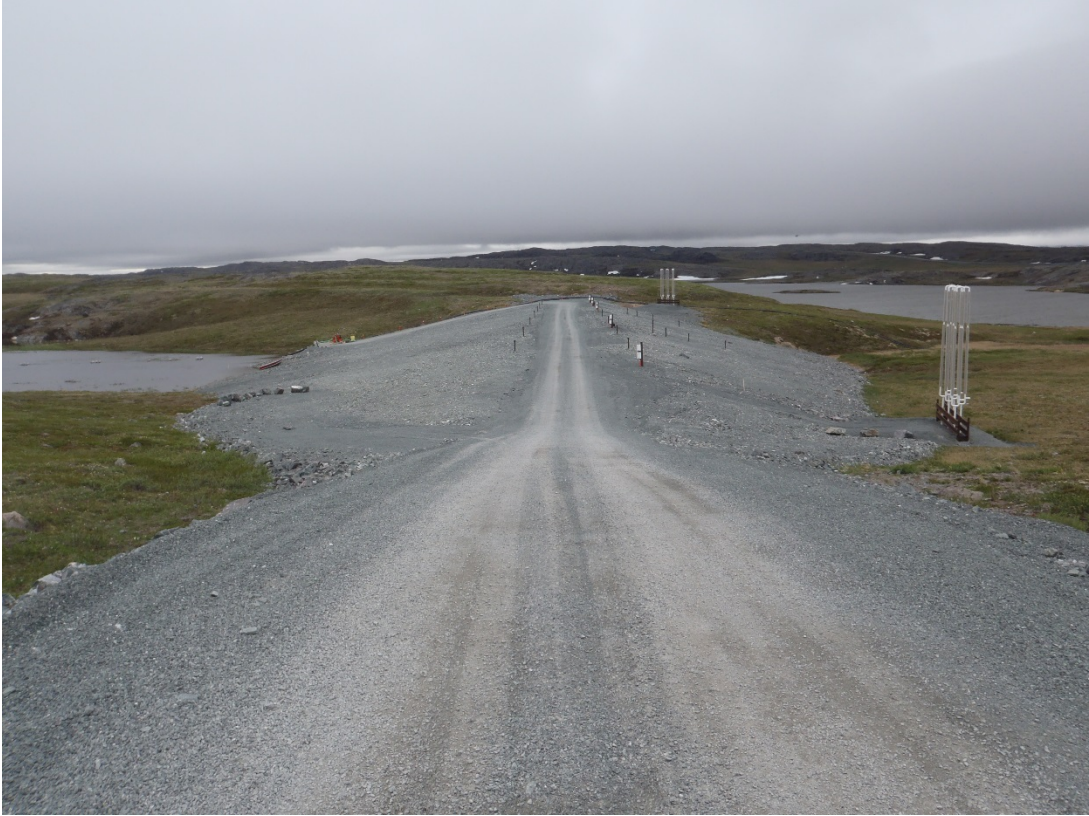
Rough area downstream
