## North Dam Weekly Walkover Survey Report

Date:	July 12/14
Inspected By:	SARAH WARNOCK
Conditions:	(ie. snow on ground, clear) clear, sunny, 10°C

Date:	July 27, 2014 ~ 2:30pm
Inspected By:	Jill Turk and Claire Brown
Conditions:	(ie. snow on ground, clear) Overcast, but no rain in the last 4 days. No snow or ice.

Date:	AUGUST 02, 2014
Inspected By:	CLAIRE BROWN
Conditions:	(ie. snow on ground, clear) Clear. Heavy rain 2 days prior.

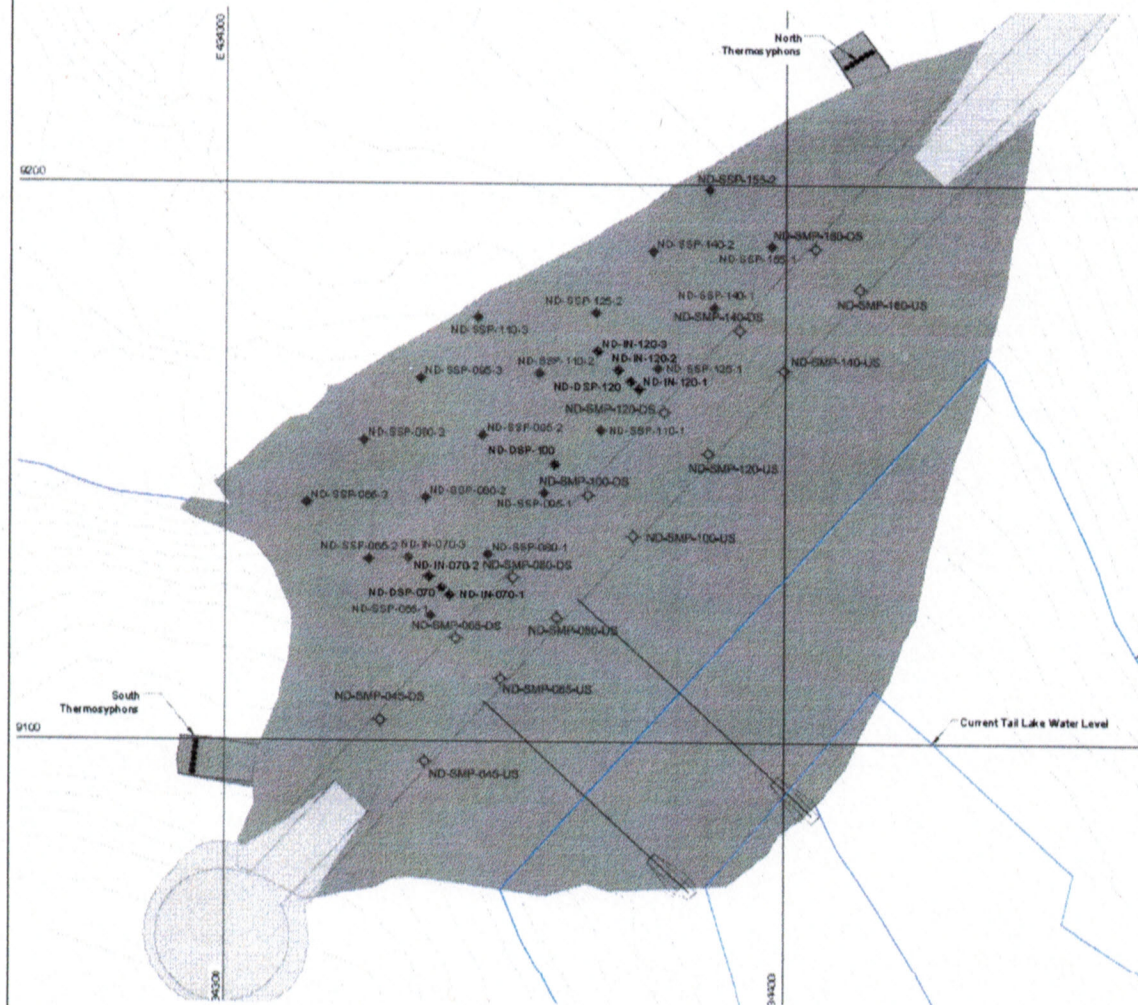
<b>Thermistors and Dataloggers</b>		
Any visible concerns? (frayed or cut cables, damaged boxes, etc.)	<input type="radio"/> Yes	<input checked="" type="radio"/> No
If you answered yes to any of the questions above please provide details and photos. Observations can be sketched on the figure provided on the next page. If seepage has been noted please estimate the flow.		
Check for suspended sediment @ T1A: None, water clear		
Depressions on upstream side of dam - noted in previous inspections.		
Animal burrow on Downstream Side of Dam		
Depressions on Downstream side of dam noted in previous inspection - marked - do not appear to have grown in size

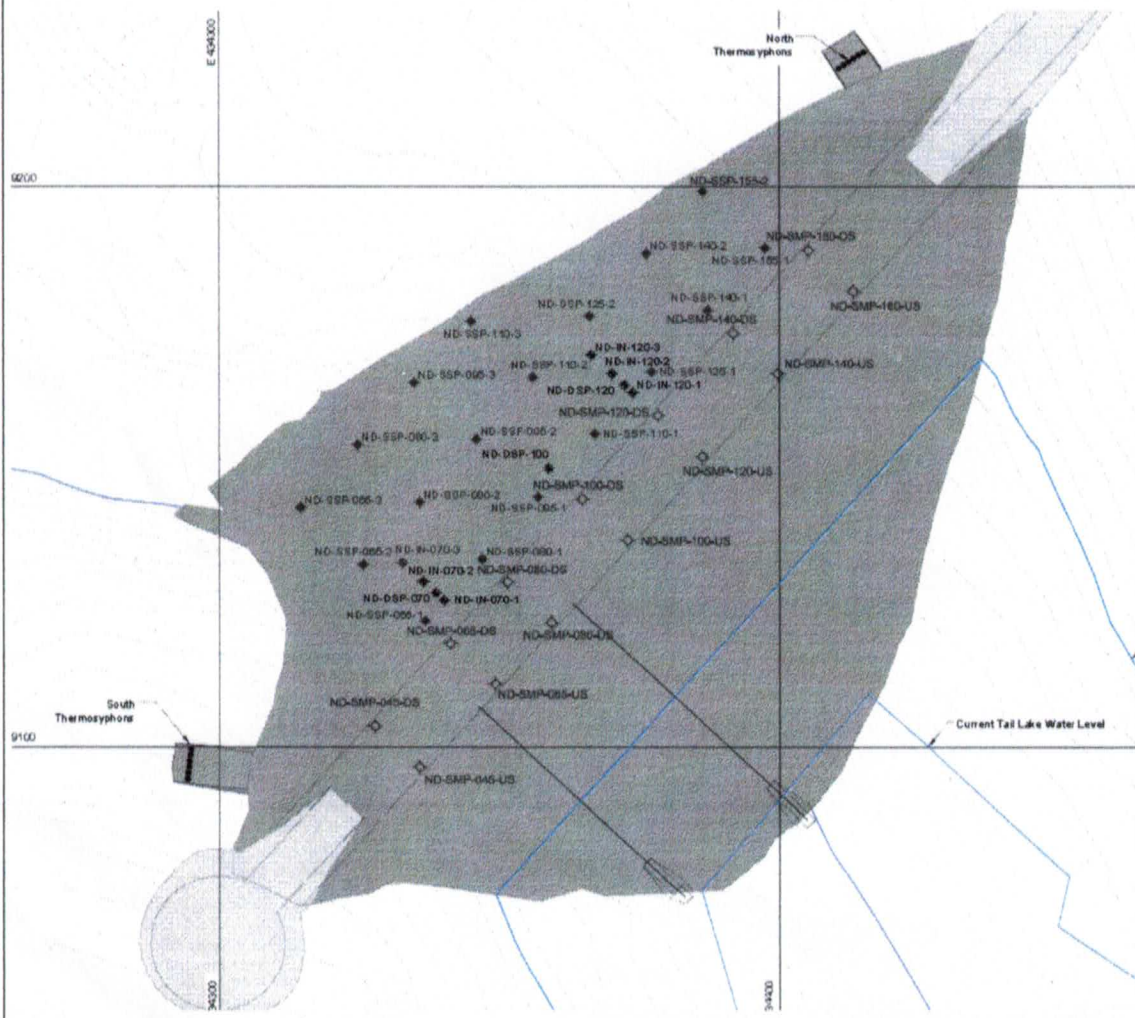
- Lowell Wade at site in previous week. Spray painted new boundaries of depressions: U1, U2, U3, D1, D2, D3

① Appear consistent w demarkations (U1, U2, U3). No cracking or erosion

② D1, D2, D3 appear consistent. D3, D2 inhabited by unknown animal. Possible seepage at toe?

→ Consistent w demarkations made by Lowell Wade in the previous week.

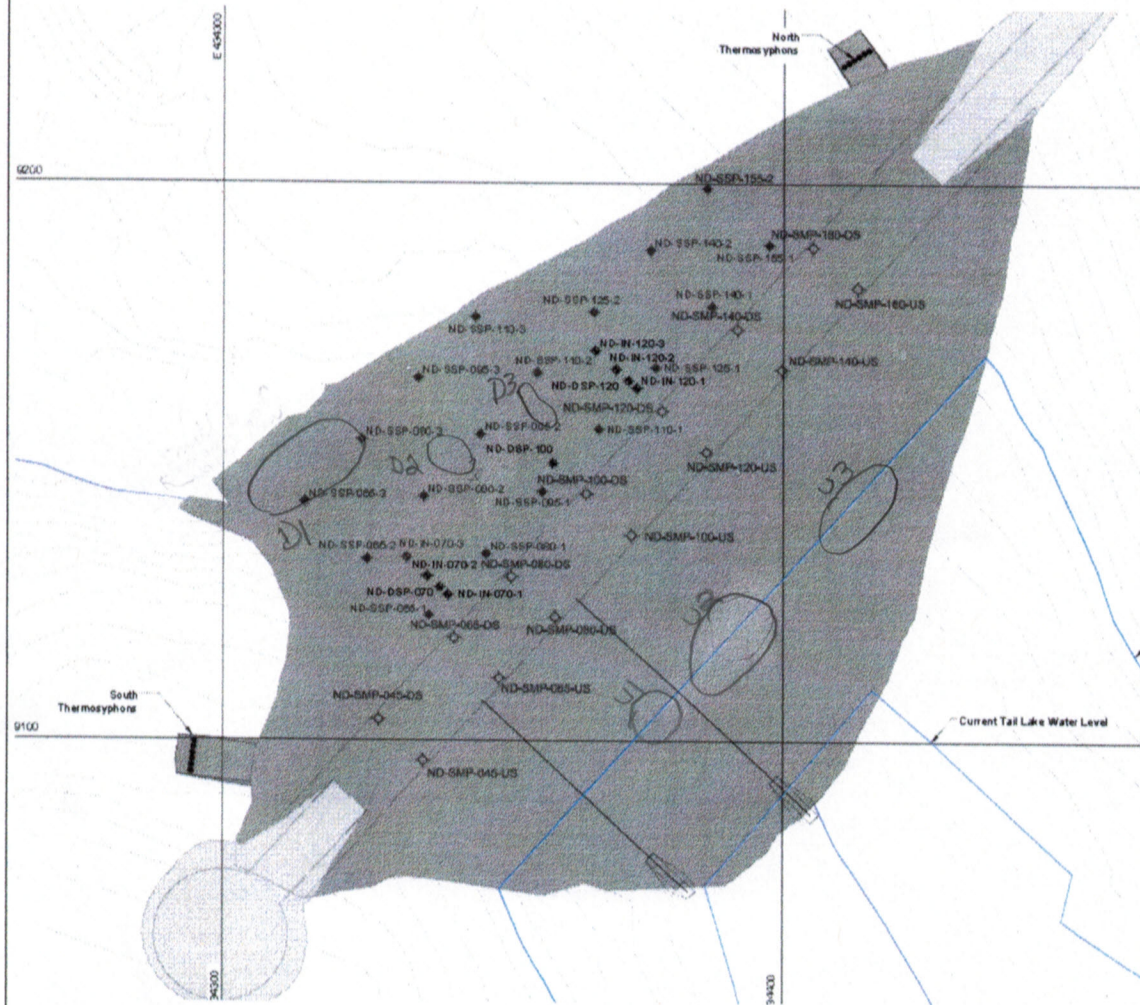
Check for suspended sediment @ T1A: No.			
① Depressions appear consistent w previous inspections (U1, U2, U3). No cracks or seepages observed.			
② Depressions appear consistent w previous inspections (D1, D2, D3). No cracks or erosion observed, but small volume of water at toe
