North Dam Weekly Walkover Survey Report

Date:	Aug 25/14
Inspected By:	Sarah Warnock, Anneli Jokela
Conditions:	(ie. snow on ground, clear) Overcast, Rain in am.

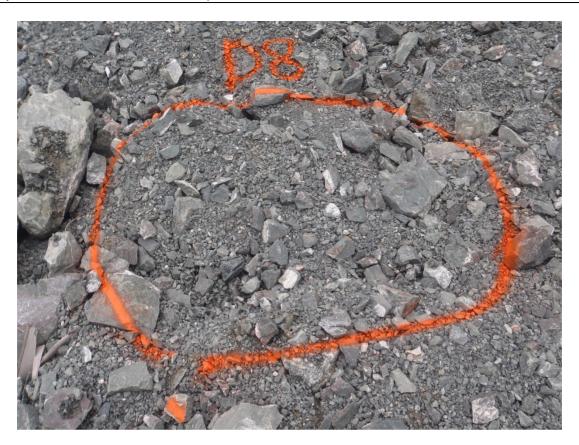
Upstream Side of Dam Any visible concerns? (cracks, depressions, erosion, etc.)	()(Yes)	No
Downstream Side of Dam	(163)	140
Any visible concerns? (cracks, depressions, erosion, seepage, etc.)	(Yes)	No
Crest of Dam	(9/	73.9
Any visible concerns? (cracks, depressions, erosion, etc.)	Yes	(No)
Thermosyphons North Side	AND THE RESERVE TO TH	
Any visible concerns? (cracks, punctures, peeling paint, birds nests, etc.)	Yes	(No)
Thermosyphons South Side		
Any visible concerns? (cracks, punctures, peeling paint, birds nests, etc.)	Yes	(No)
Instrumentation (on crest and downstream side)		
Any visible concerns? (bent, rusted, cracked, etc.)	Yes	(No)
Thermistors and Dataloggers		~
Any visible concerns? (frayed or cut cables, damaged boxes, etc.)	Yes	(No)
f you answered yes to any of the questions above please provide details and photo	os. Observations can be sket	ched on the figure
provided on the next page. If seepage has been noted please estimate the flow.

Dreviously marked depressions UI, U2, U3 - no 2) No change to previously noted rust 3) Some signs of erosion at the of dam DI expanding towards south, remarked orang		
Offerviously marked depressions U1, U2, U3 - no 2) No change to previously noted rust 3) Some signs of prosion of the of days		
Offerviously marked depressions U1, U2, U3 - no 2) No change to previously noted rust 3) Some signs of prosion of the of days

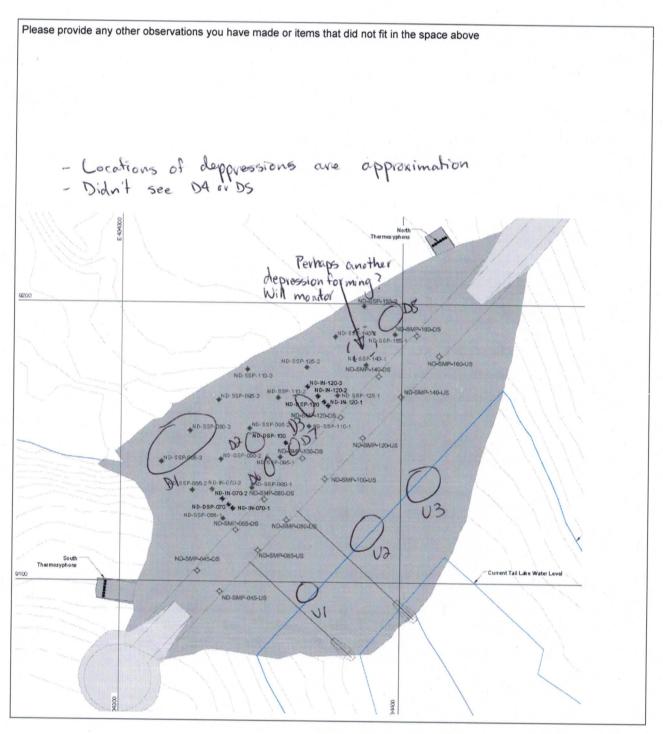
ny visible concerns? (cracks, depre	.)	(Yes)	No
ownstream Side of Dam (2)			
ny visible concerns? (cracks, depre	page, etc.)	Yes	No
est of Dam			
y visible concerns? (cracks, depre	.)	Yes	No
ermosyphons North Side			
y visible concerns? (cracks, punc	birds nests, etc.)	Yes	No
ermosyphons South Side			
y visible concerns? (cracks, punct	pirds nests, etc.)	Yes	No
strumentation (on crest and d	e)		
y visible concerns? (bent, rusted,		Yes	No
ermistors and Dataloggers			
y visible concerns? (frayed or cut of	xes, etc.)	Yes	No
ou answered yes to any of the question yided on the next page. If seepage has	ide details and photos. Observatio	ons can be ske	tched on the figure
Three depressions mark is noted. No cracks, a	ous inspections, the		
Show incremental slow Flowing water at to Vain (Snow). Another	(perhaps by SM) mal). No notable of more than previous cression near 08,	Da avracts or week	erosion, exs. Crecent monitored

vain (Snow). Another	ression near 08.	to to	be
