North Dam Weekly Walkover Survey Report

Date:	Sept 19, 2014
Inspected By:	Claire Brown, Andy Topalak
Conditions:	(ie. snow on ground, clear) Sub zero (-5 to 0°C) and no precipitation today. Light snow previous 3 days.

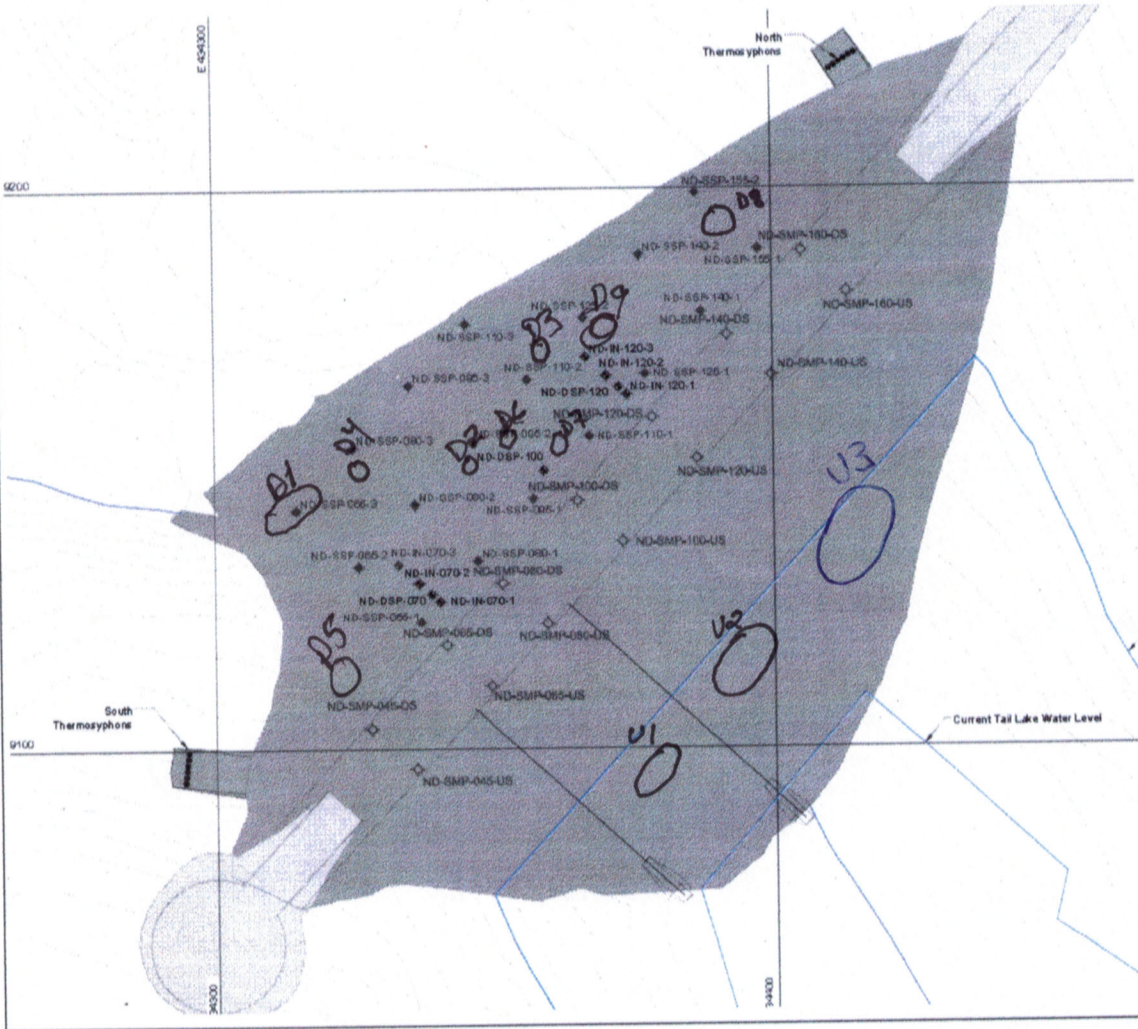
D9 - New depression noted @ survey anchor.
13W 0434375 - 7559187
