Appendix H: Depression Monitoring

2014 North Dam Geotechnical Inspection		
		Depression Tracking U1		
Job No: 1CT022.001 Filename: Ndam_DepressionTracking.pptx	HOPE BAY MINING LTD.	Date: Oct. 2014	Approved: MMM	Figure: H.2

2014 North Dam Geotechnical Inspection

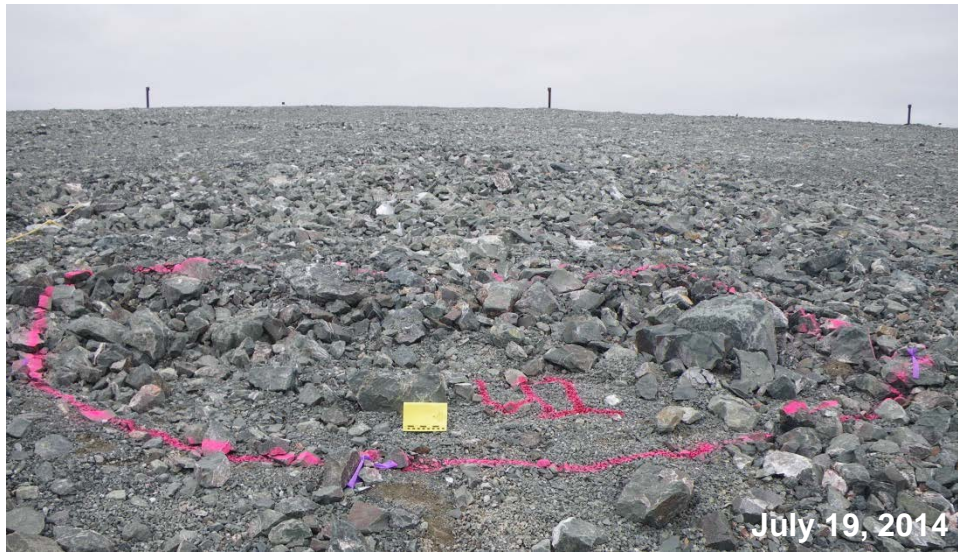
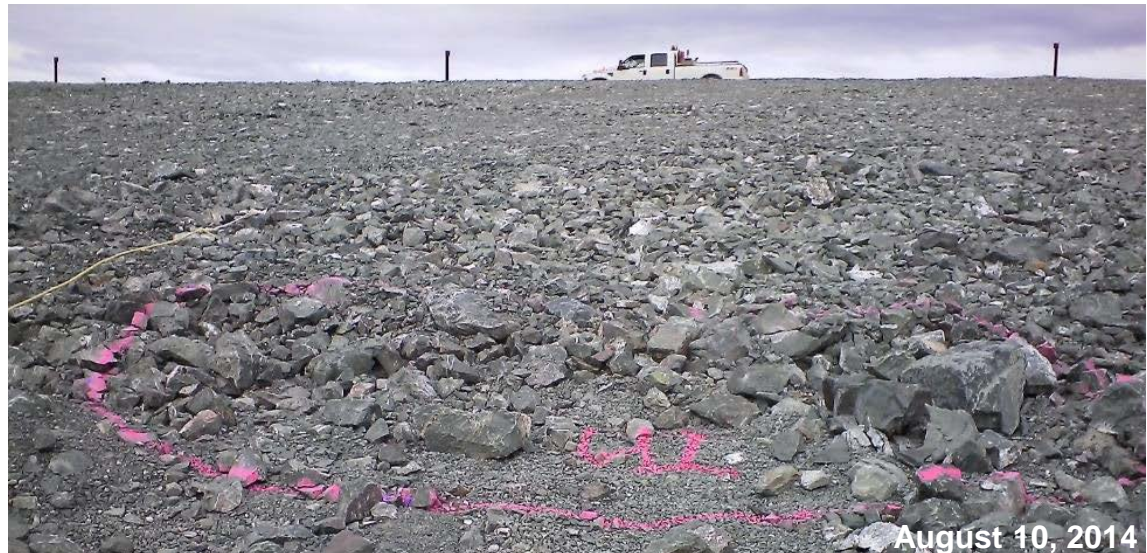
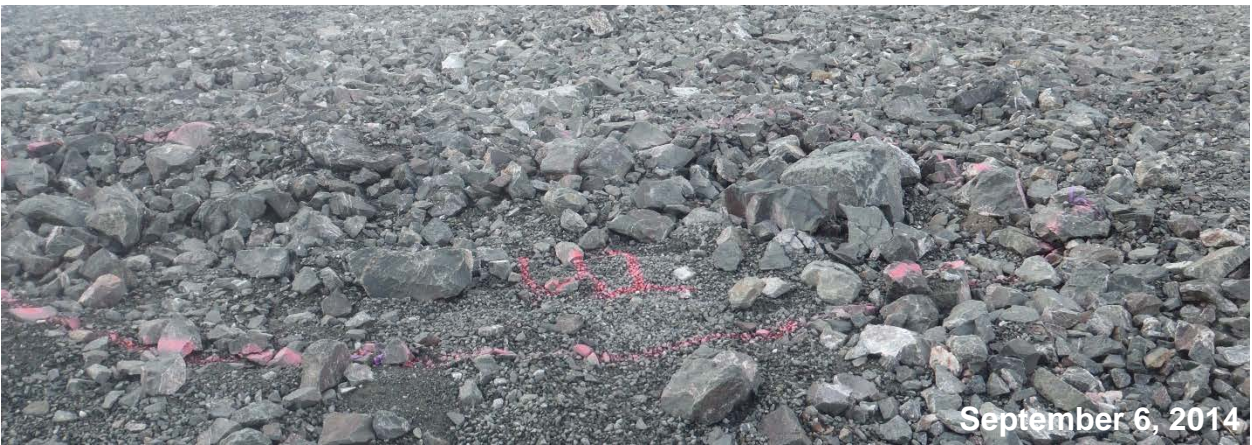
ID	Location	Comments
U1	Upstream	Boundaries spray painted and ID given July 2014, was previously identified.
U2	Upstream	Boundaries spray painted and ID given July 2014, was previously identified.
U3	Upstream	Boundaries spray painted and ID given July 2014, was previously identified.
D1	Downstream	First noted in 2013 Annual Geotechnical Inspection
		September 1, 2014 - expanded towards the south
		September 20, 2014 - TMAC ESR noted the depression looks to have expanded, paint mark updated.
D2	Downstream	First noted in 2013 Annual Geotechnical Inspection
		September 14, 2014 - TMAC ESR noted that the depression may have expanded slightly
D3	Downstream	Identified during 2014 annual geotechnical inspection, spray painted and given ID.
		August 10, 2014 - larger area marked
D4	Downstream	First noted August 16, 2014 in weekly report prepared by TMAC ESR. Roughly 0.5x0.5 m area
D5	Downstream	First noted August 16, 2014 in weekly report prepared by TMAC ESR.

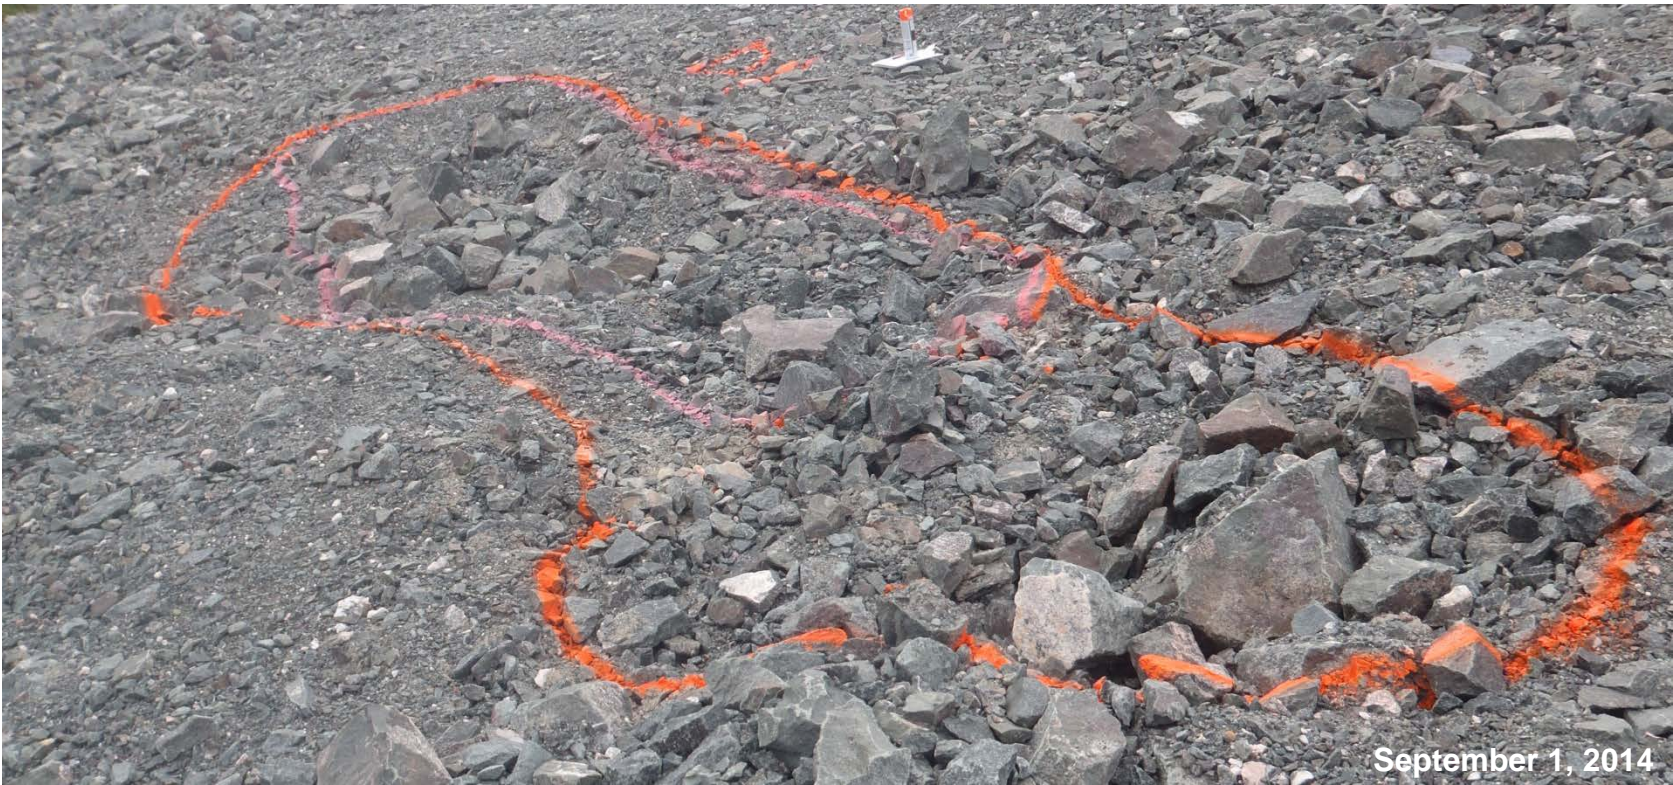
Expanded to the south, note the faded pink paint mark in the center

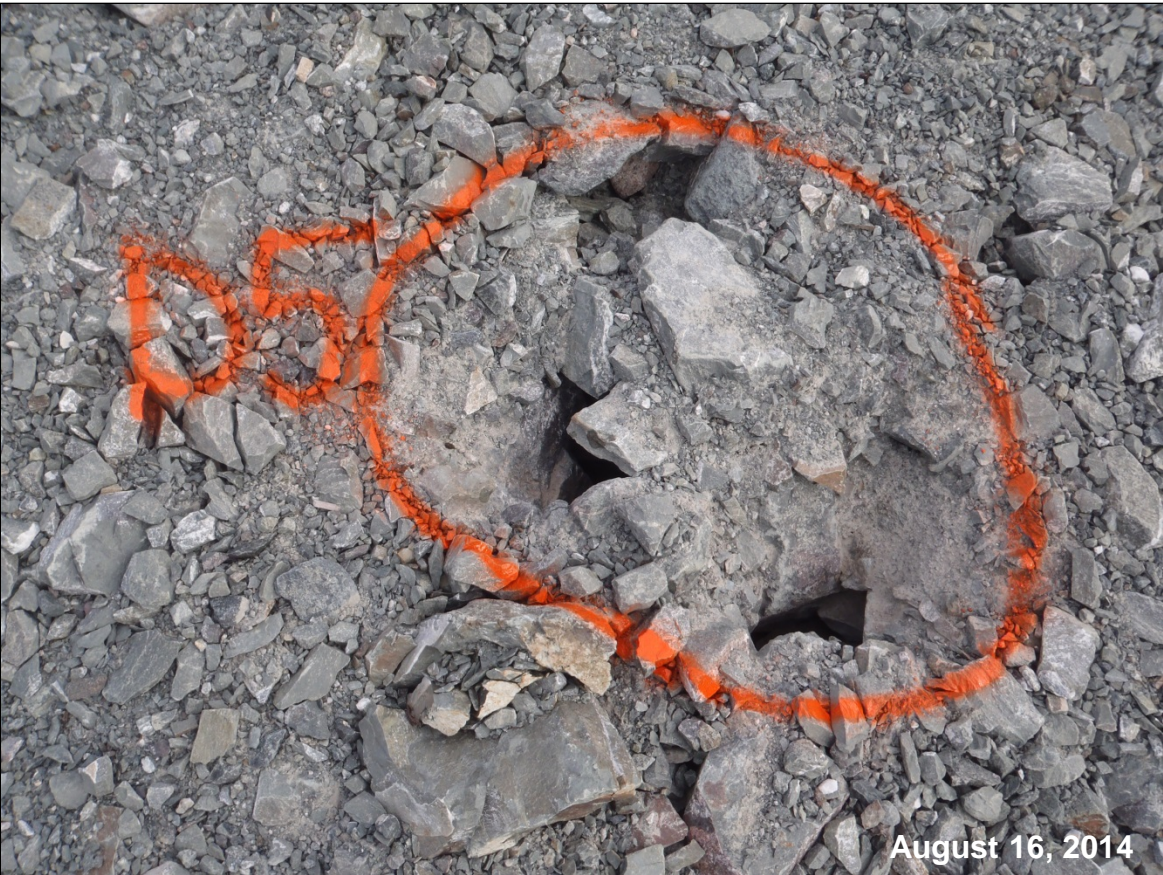
2014 North Dam Geotechnical Inspection		
		Depression Tracking D5		
Job No: 1CT022.001 Filename: Ndam_DepressionTracking.pptx	HOPE BAY MINING LTD.	Date: Oct. 2014	Approved: MMM	Figure: H.9

TMAC ESR notes it could be animal burrows ~1x1 m wide disturbed area (August 2014)
D6	Downstream	First noted August 25, 2014 in weekly report prepared by TMAC ESR. 1.5x1.5 m area
		September 6, 2014 - Possible incremental sloughing (minimal)
D7	Downstream	First noted August 25, 2014 in weekly report prepared by TMAC ESR
D8	Downstream	First noted August 25, 2014 in weekly report prepared by TMAC ESR. Area with signs of erosion.
		September 20, 2014 - TMAC ESR noted depression looks to have expanded on top right. Difficult to tell from photos, due to snow (and unlabeled photos).
D9	Downstream	First noted September 14, 2014 in weekly report prepared by TMAC ESR
