North Dam Weekly Walkover Survey Report

Date:	September 27, 2014 9:00am
Inspected By:	Key Evalic & Andy Topilak
Conditions:	(ie. snow on ground, clear) Snow on ground, mostly cloudy, wind from North.

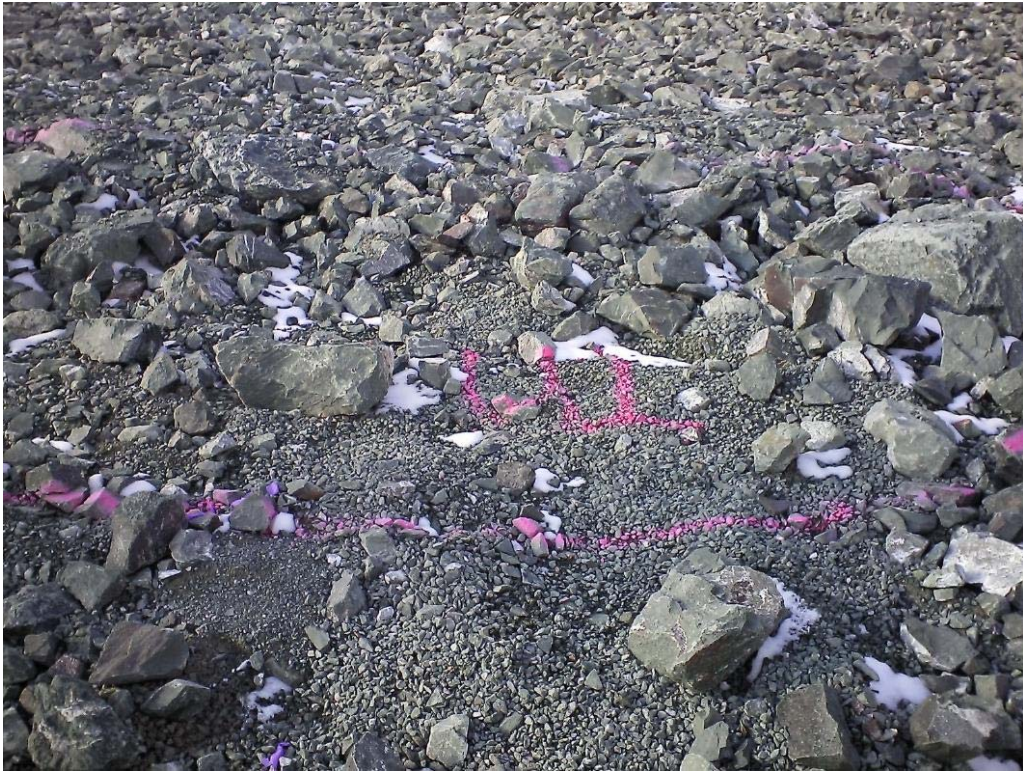
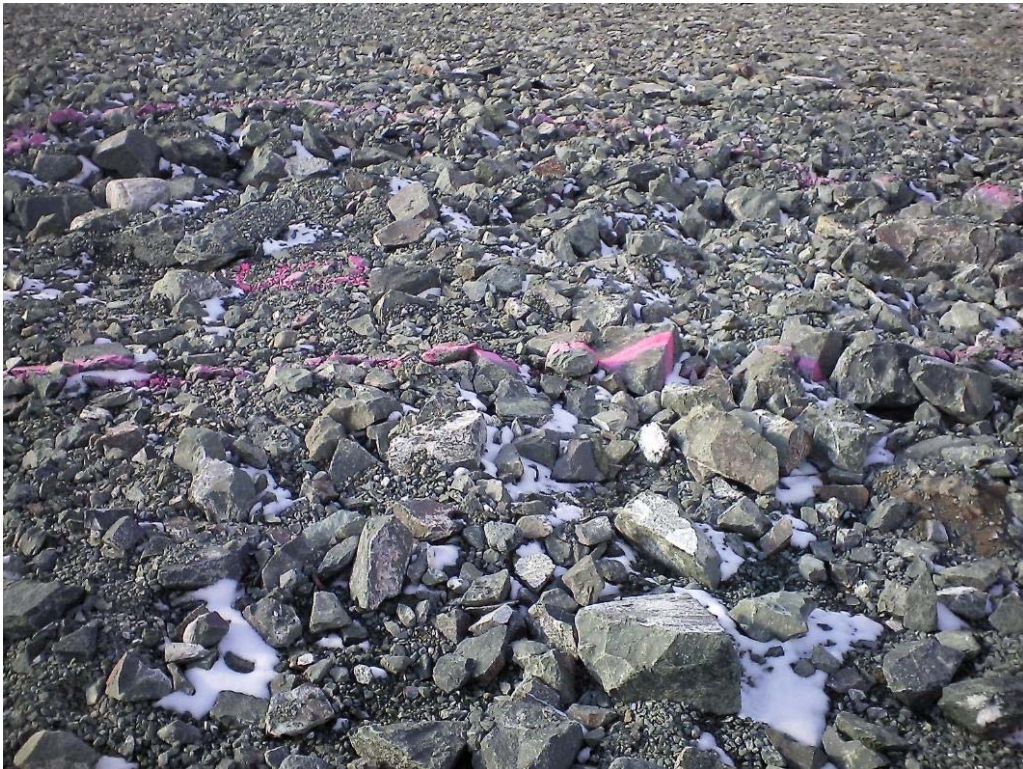
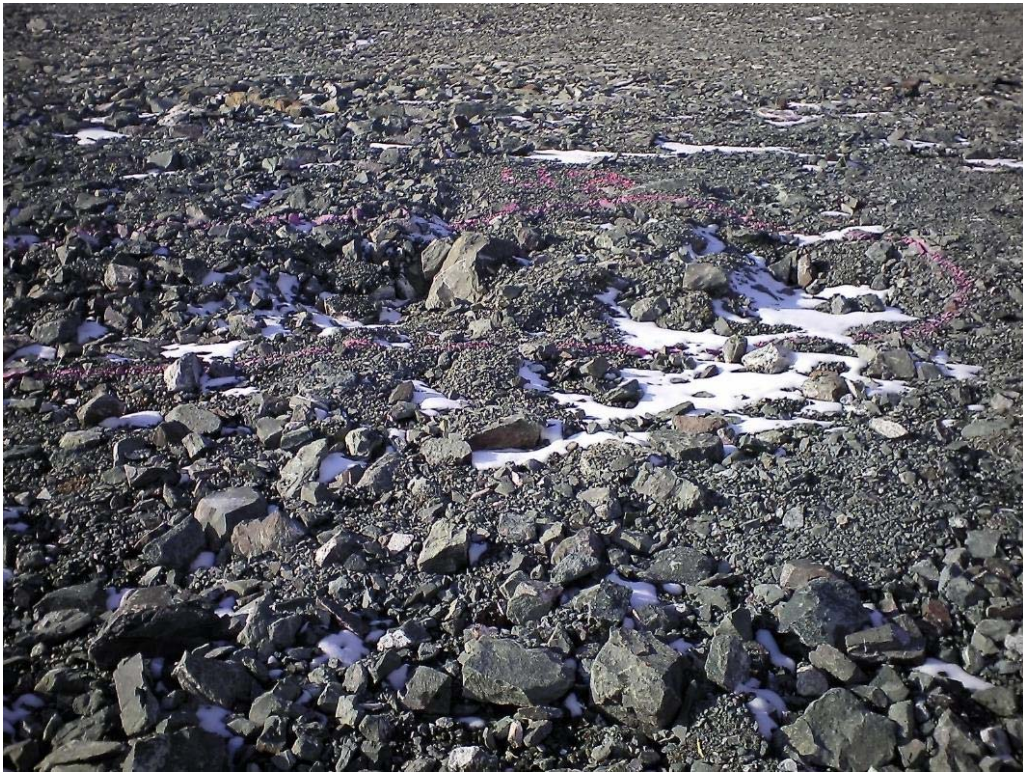
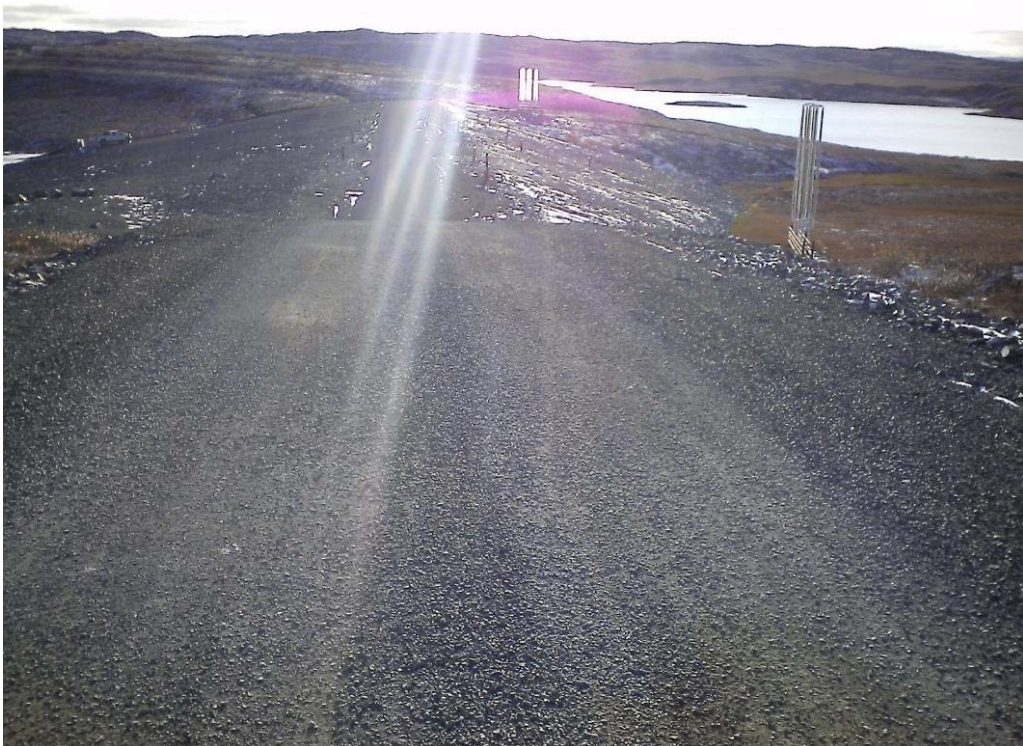
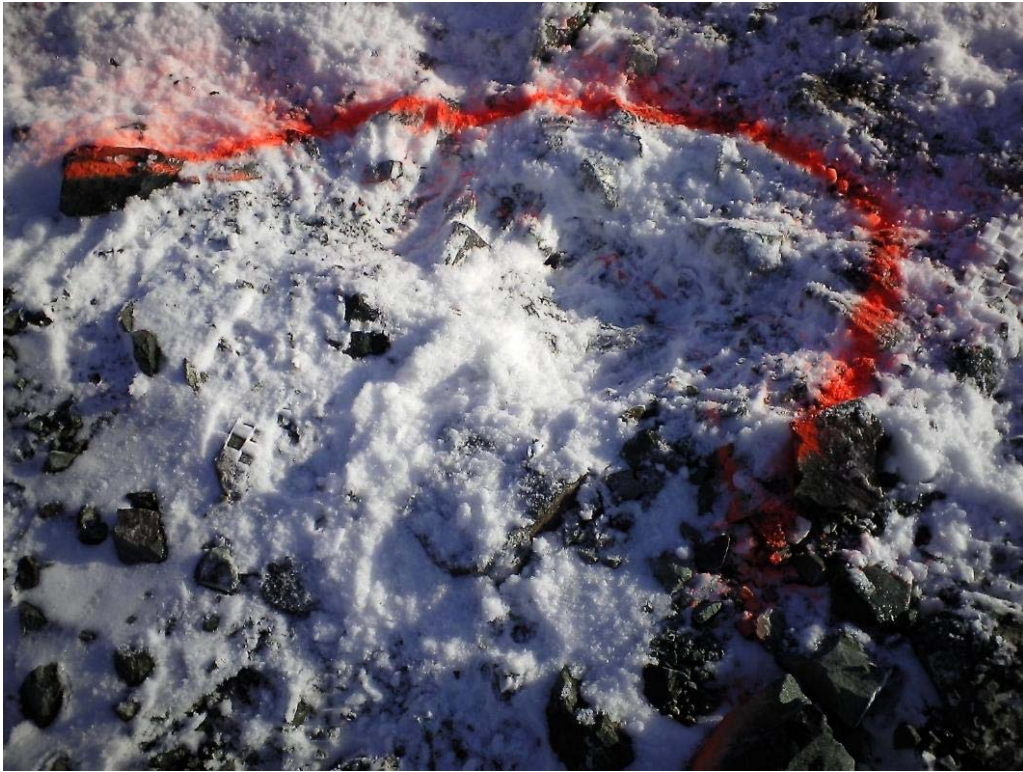
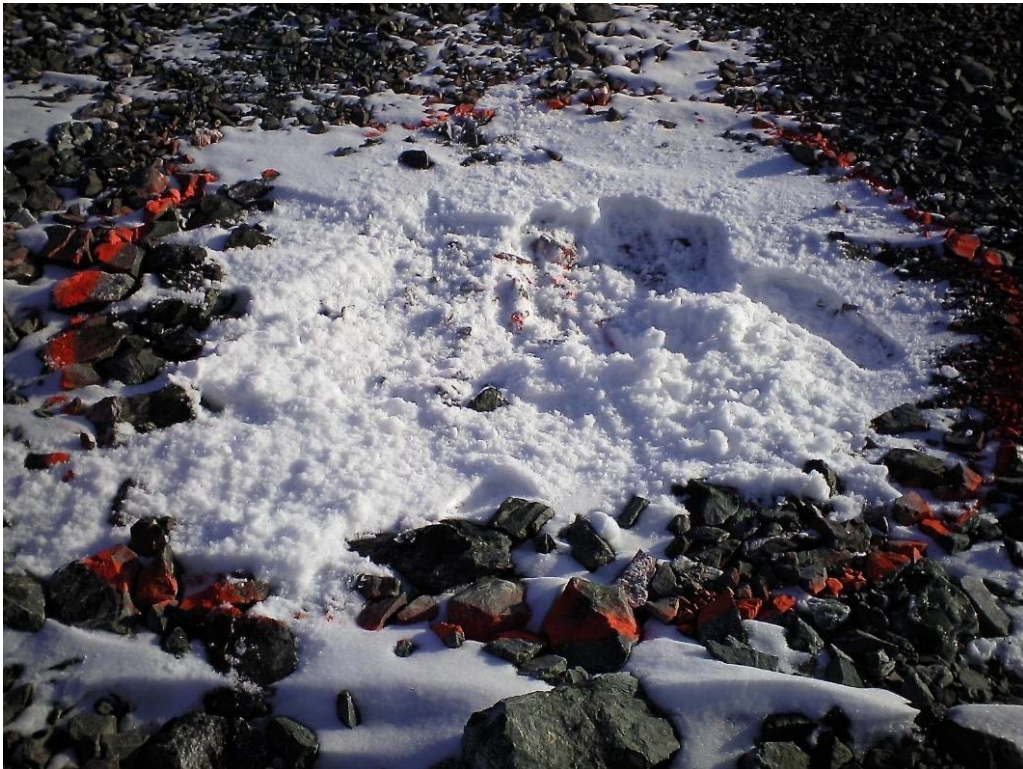
<p>Check for suspended sediment @ TIA:</p> <p>① No changes to depressions - photos taken anyway</p> <p>② Snow built upon most of downstream side of dam. No visible changes to depressions that aren't covered in snow.</p> <p>③ Rust previously recorded, no changes</p> <p>④</p>
