## Appendix F: Weekly Monitoring Reports

# North Dam Weekly Walkover Survey Report

Date:	September 20, 2014
Inspected By:	Andy Toplak & Key Evalik
Conditions:	(ie. snow on ground, clear) little amount of snow on ground, cloudy, -6 wind N

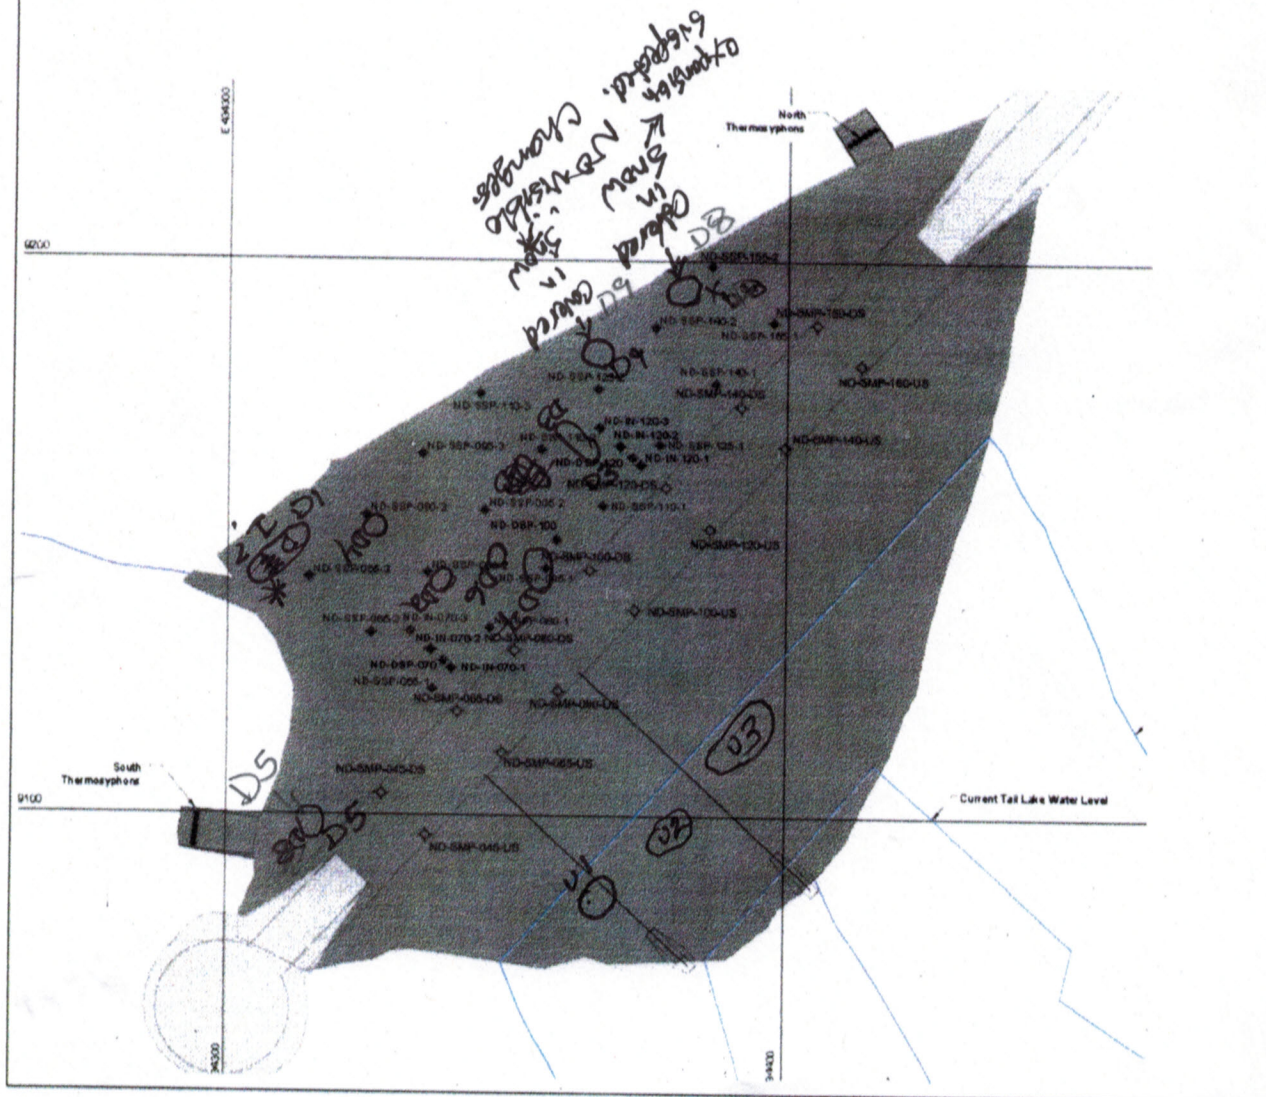
<p>Check for suspended sediment @ T1A: <sup>visible</sup></p> <p>① No new depressions spotted. ice forming on lake. No changes to old depressions.</p> <p>② still the same issue as last week - rust building up/paint peeling (small amount)</p> <p>③ Changes observed to 2 of the depressions, marked new outline at locations. will need to be monitored closely. 1'-2" snow coverage in most areas of downstream side of dam. Depressions need to be marked on higher areas to be identified. (Changes)</p>

\*D1 - looks to have expanded - marked & photo'd.  
 XD8 - expansion suspected @ top right.

- Mark areas (D1, D2, D3, ...) on areas where it won't get too buried in snow to identify.

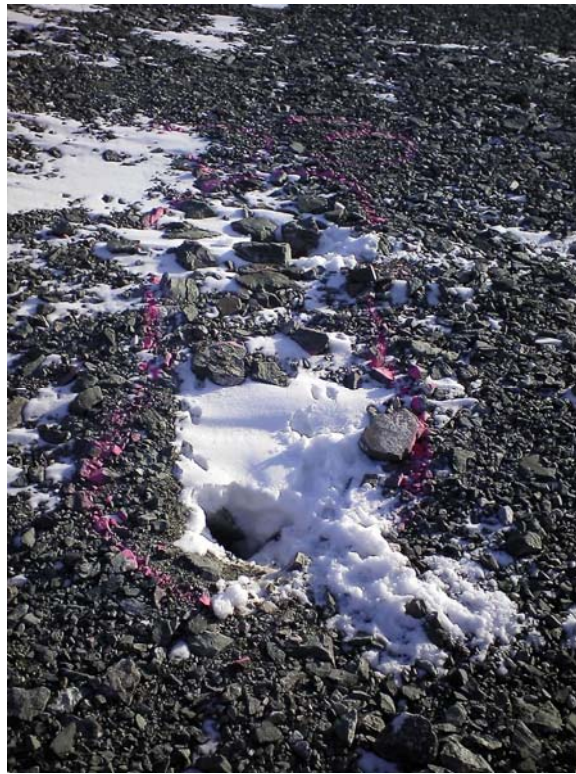
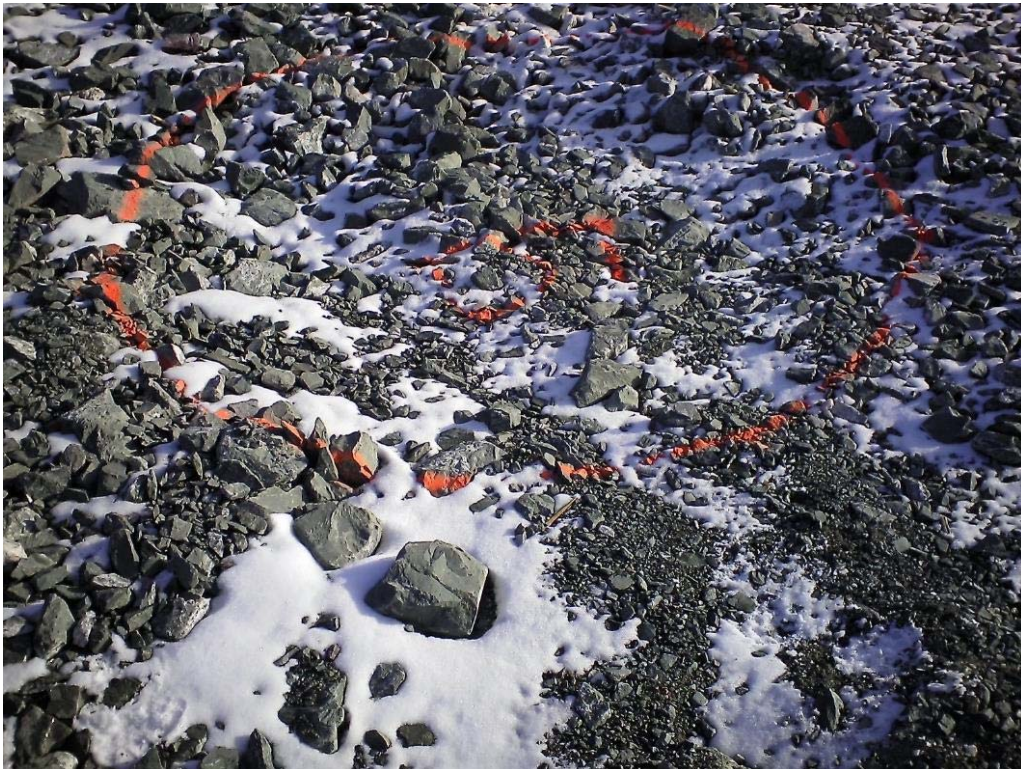
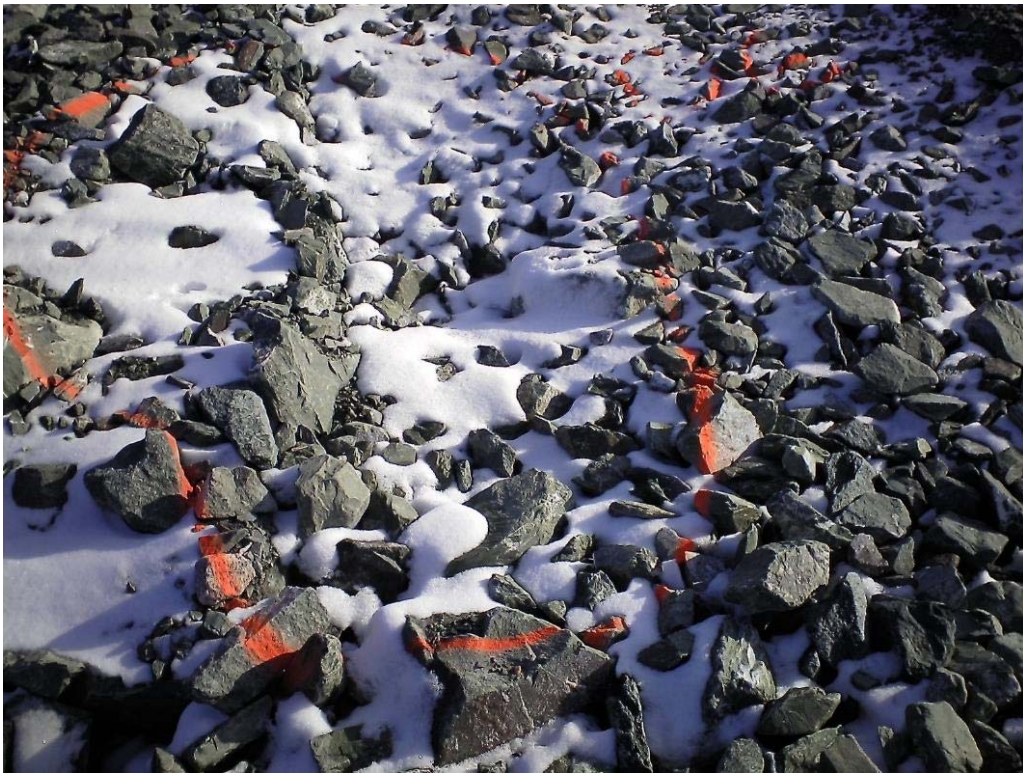
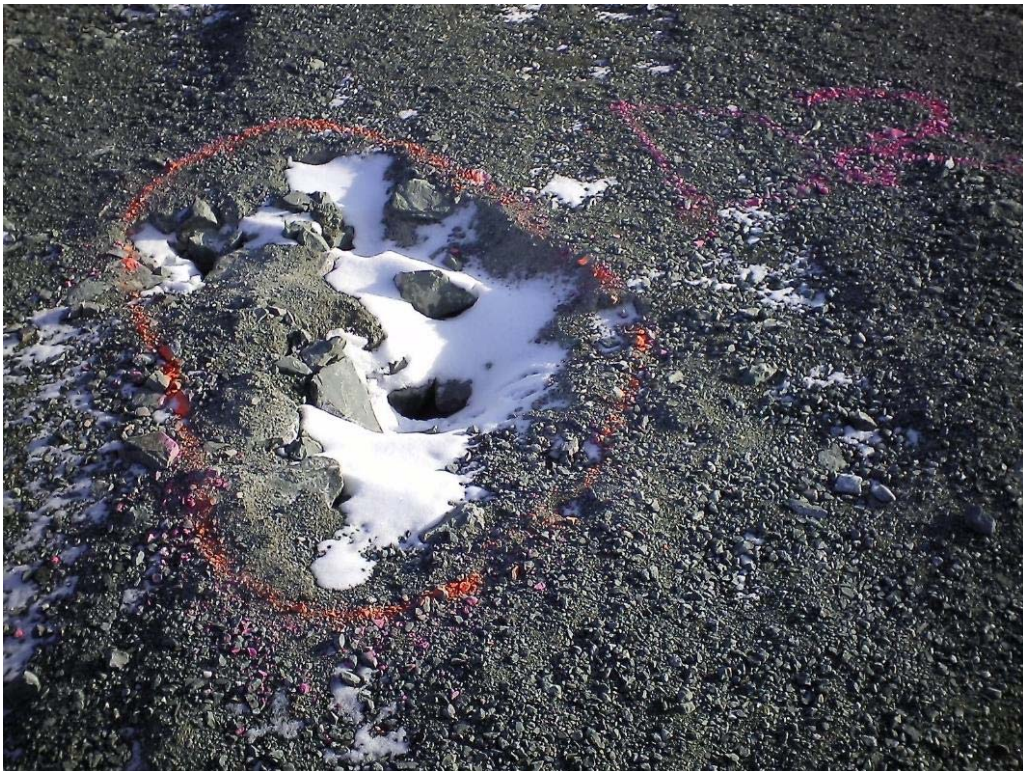
Other photos, please describe suspected changes to D1 & D8.

D1 - \*D1: looks like it expanded slightly. outlined with marking paint & will monitor.  
 XD8: expansion suspected slightly at top right.
