North Dam Weekly Walkover Survey Report

Date:	FEB 15, 2015
Inspected By:	SCOTT GOLDSBOROUGH
Conditions:	(ie. snow on ground, clear) SNOW ON GROUND & BLOWING.

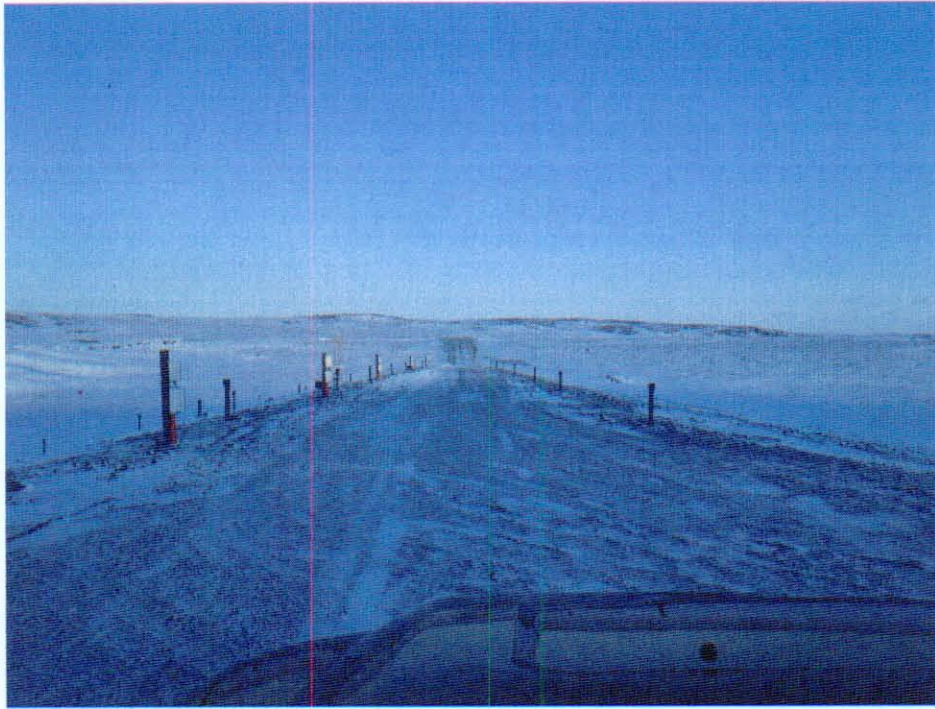
Figure 1 North Dam looking north, Feb 6, 2015

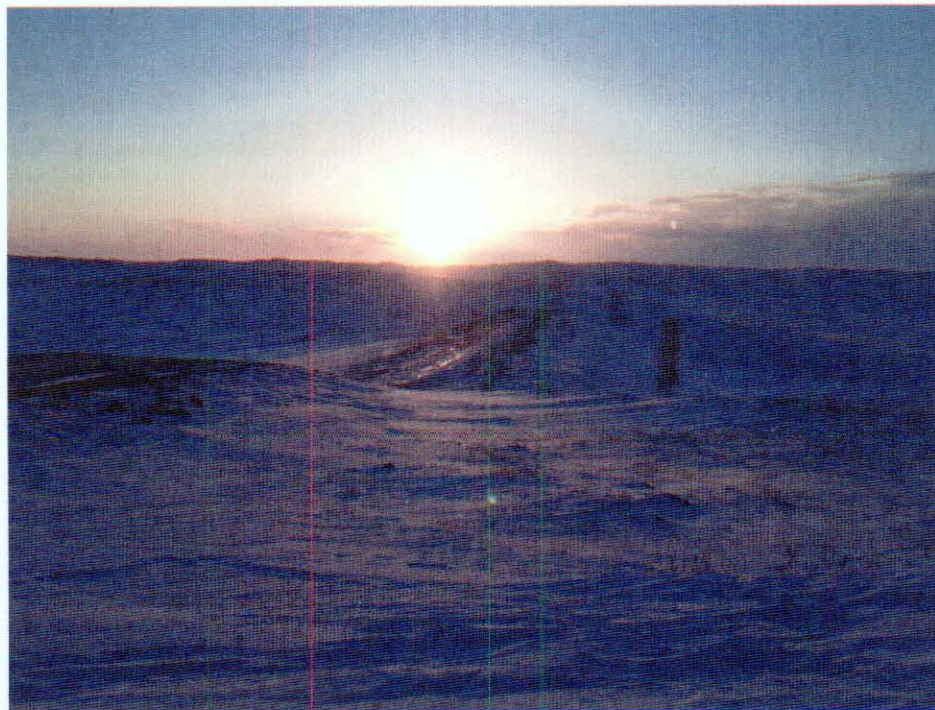
Figure 2 North Dam looking south, Feb 6, 2015

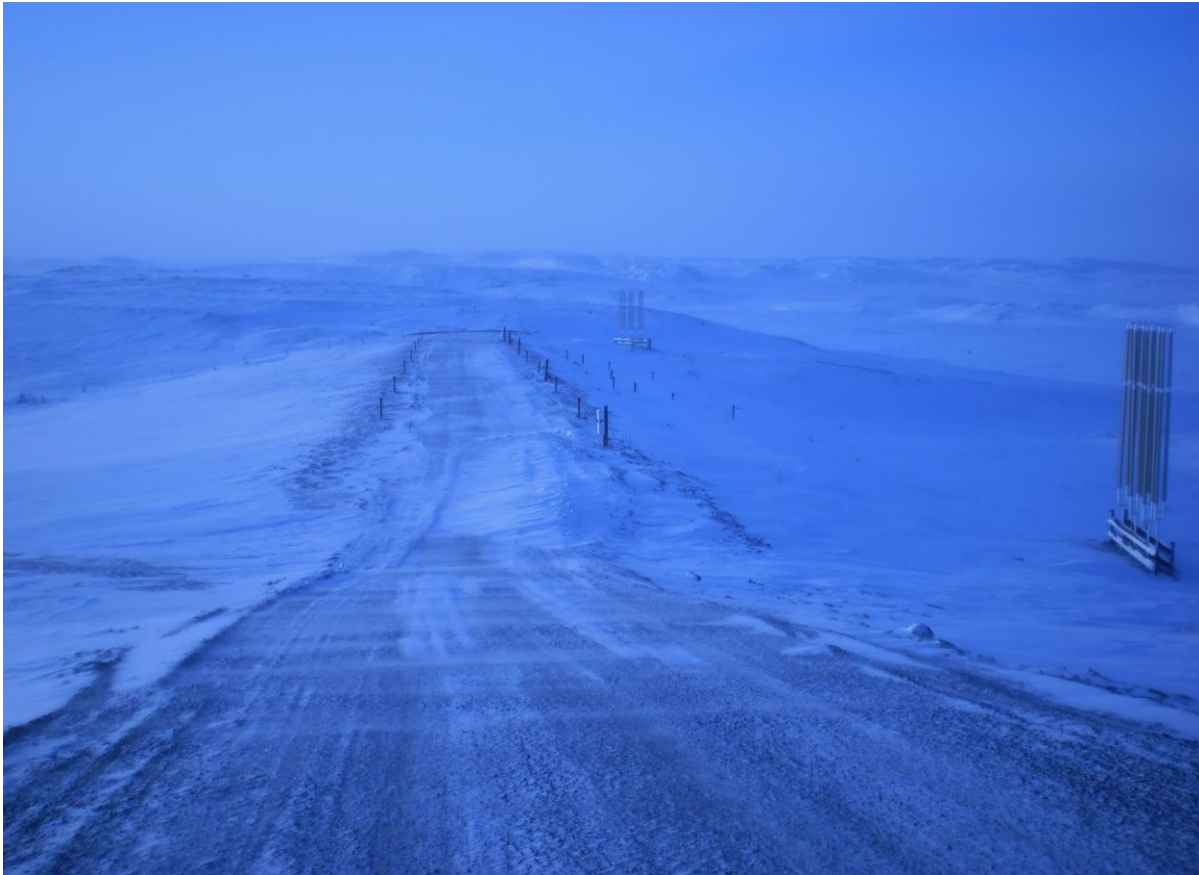
North Dam looking south

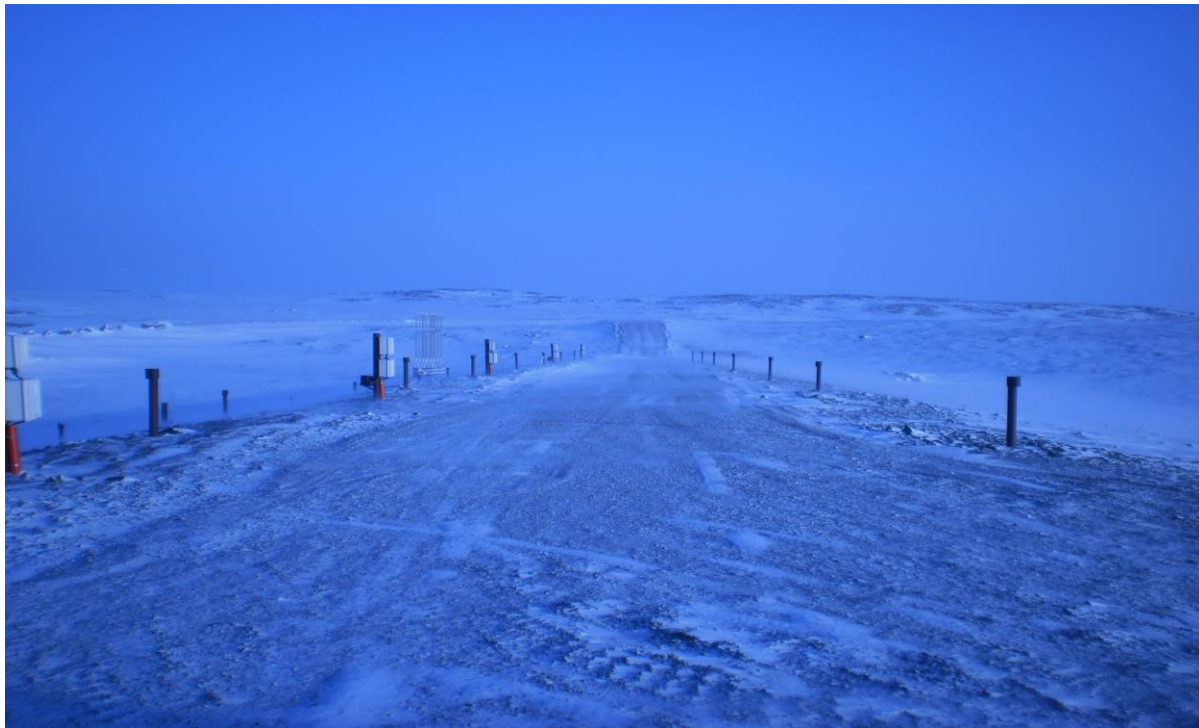
North Dam looking North

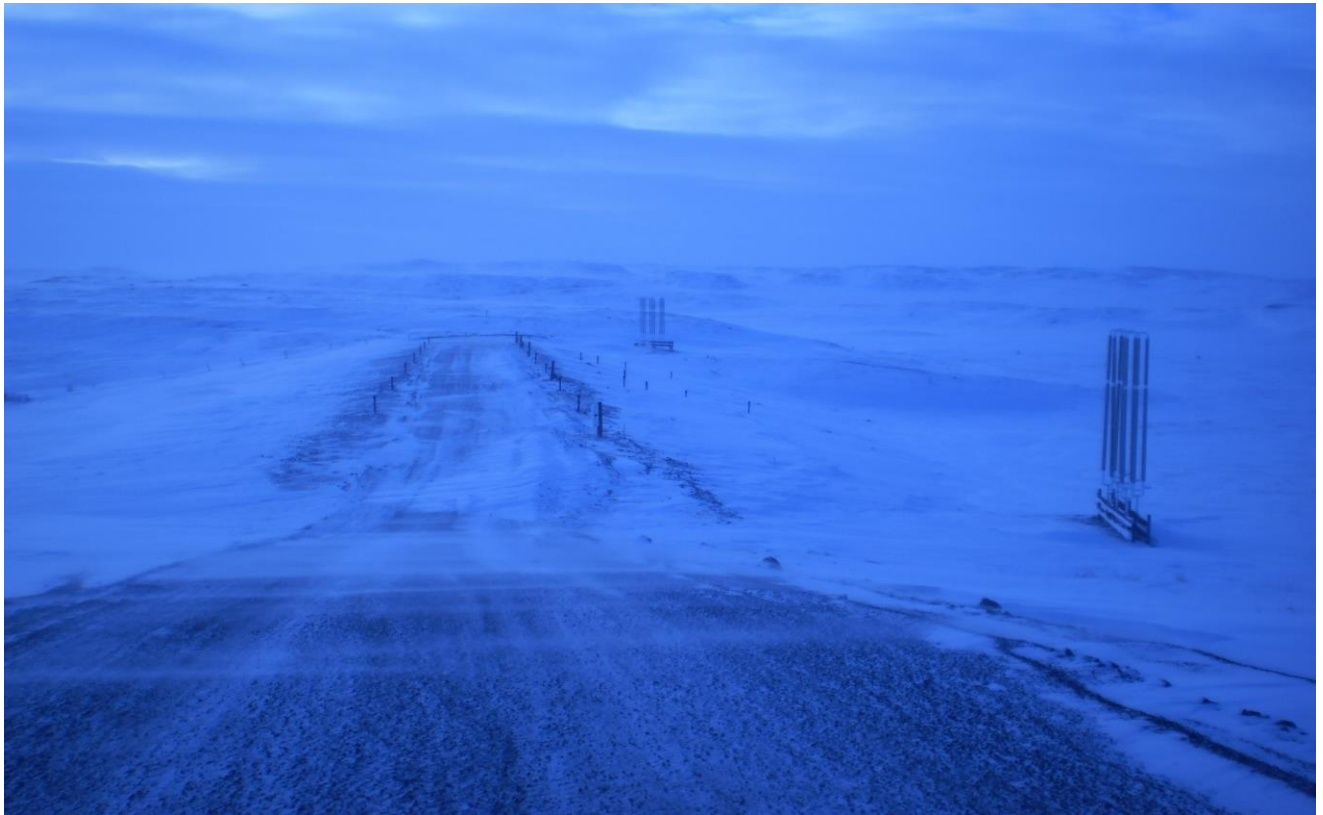
North Dam: Looking South

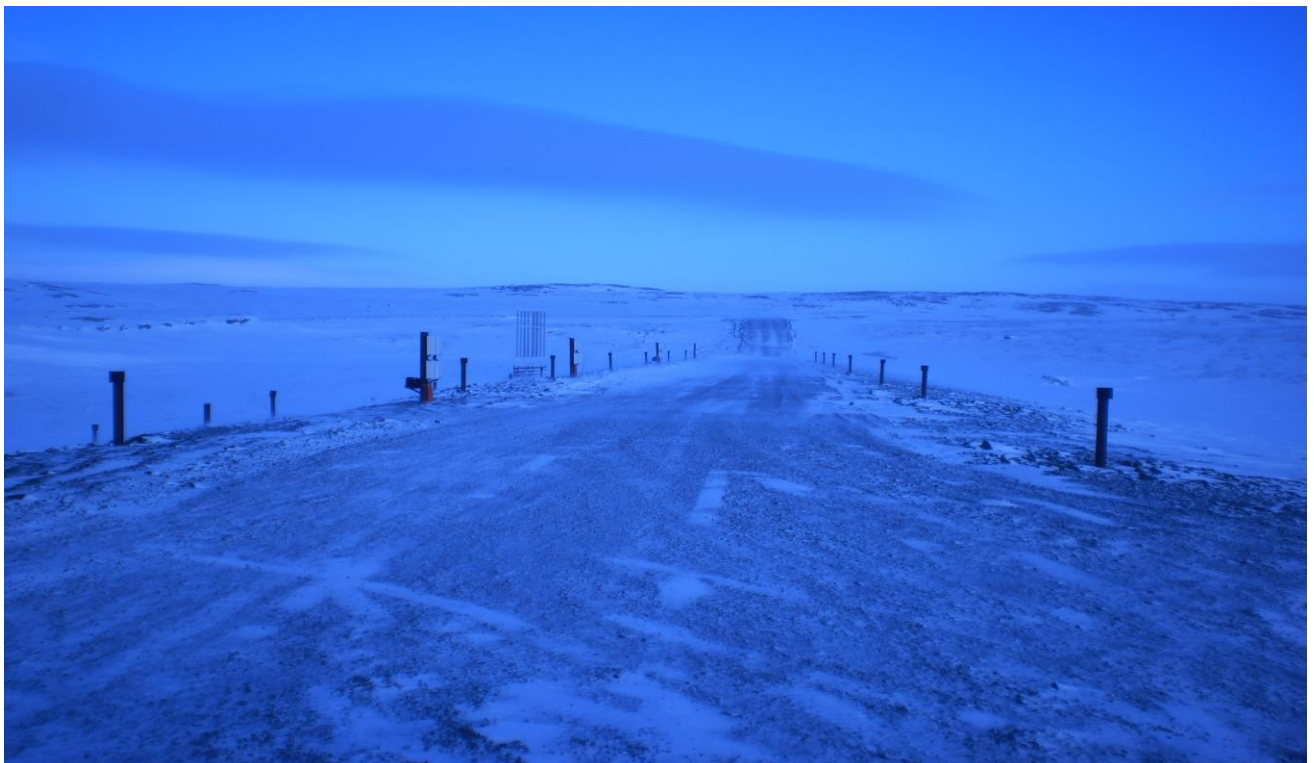
North Dam: Looking North
