North Dam Weekly Walkover Survey Report

Date:	April 4/2015
Inspected By:	SARAH WARNOCK
Conditions:	(ie: snow on ground, clear) snow on ground, high winds

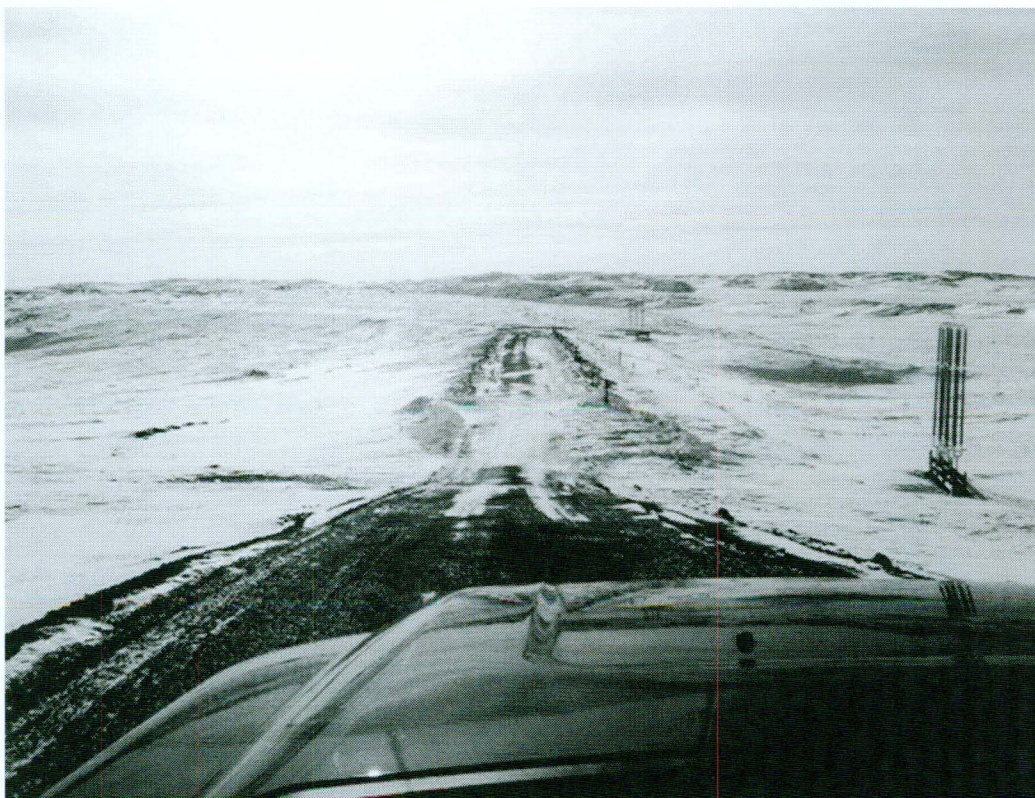
Figure 1 North Dam looking south, March 27, 2015

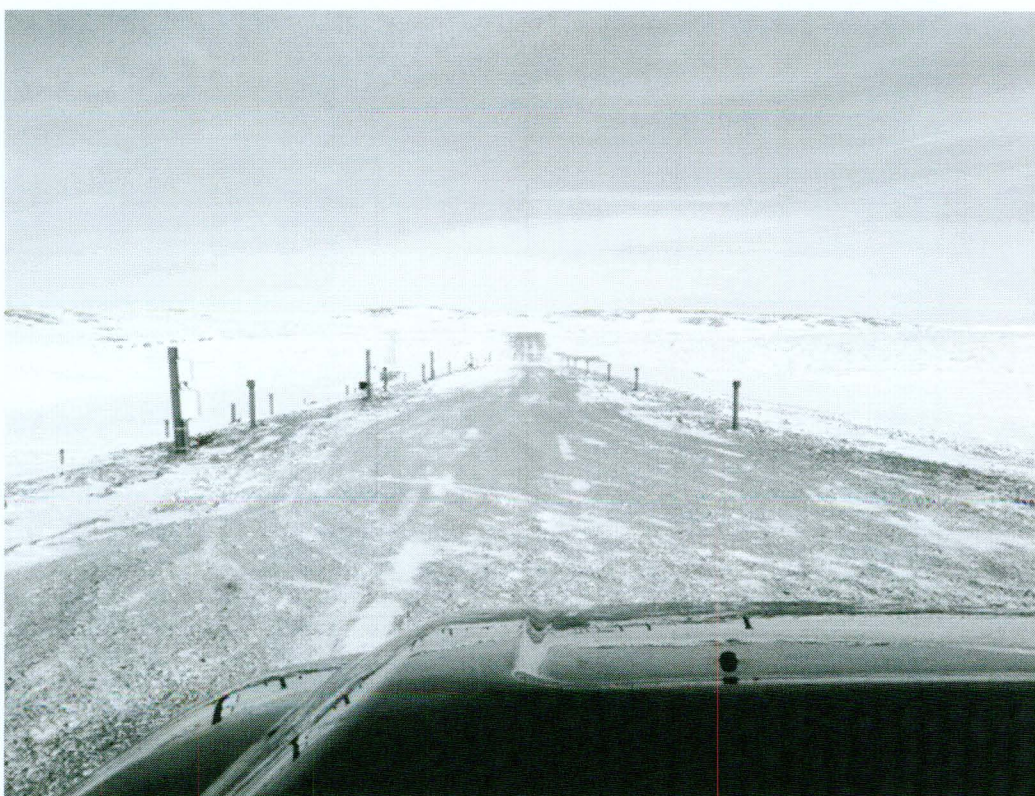
Figure 2 North Dam looking north, March 27, 2015
