HOPE BAY MINING LTD.

2015 Geotechnical Inspection

Station 0+85 Horizontal Ground  
Temperature Cable Readings  
by Location

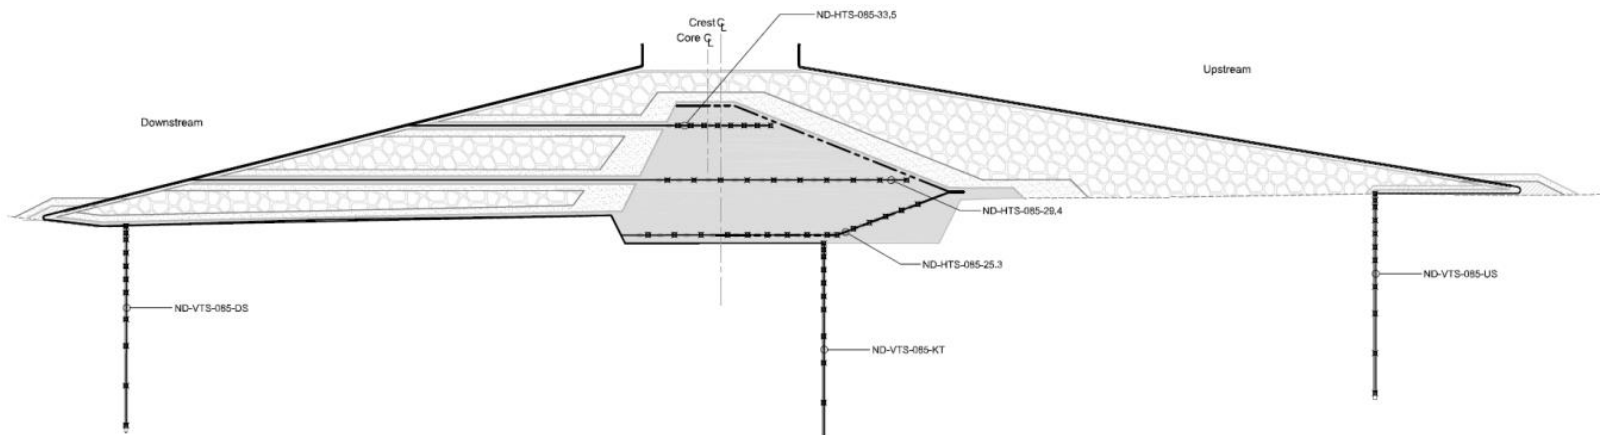
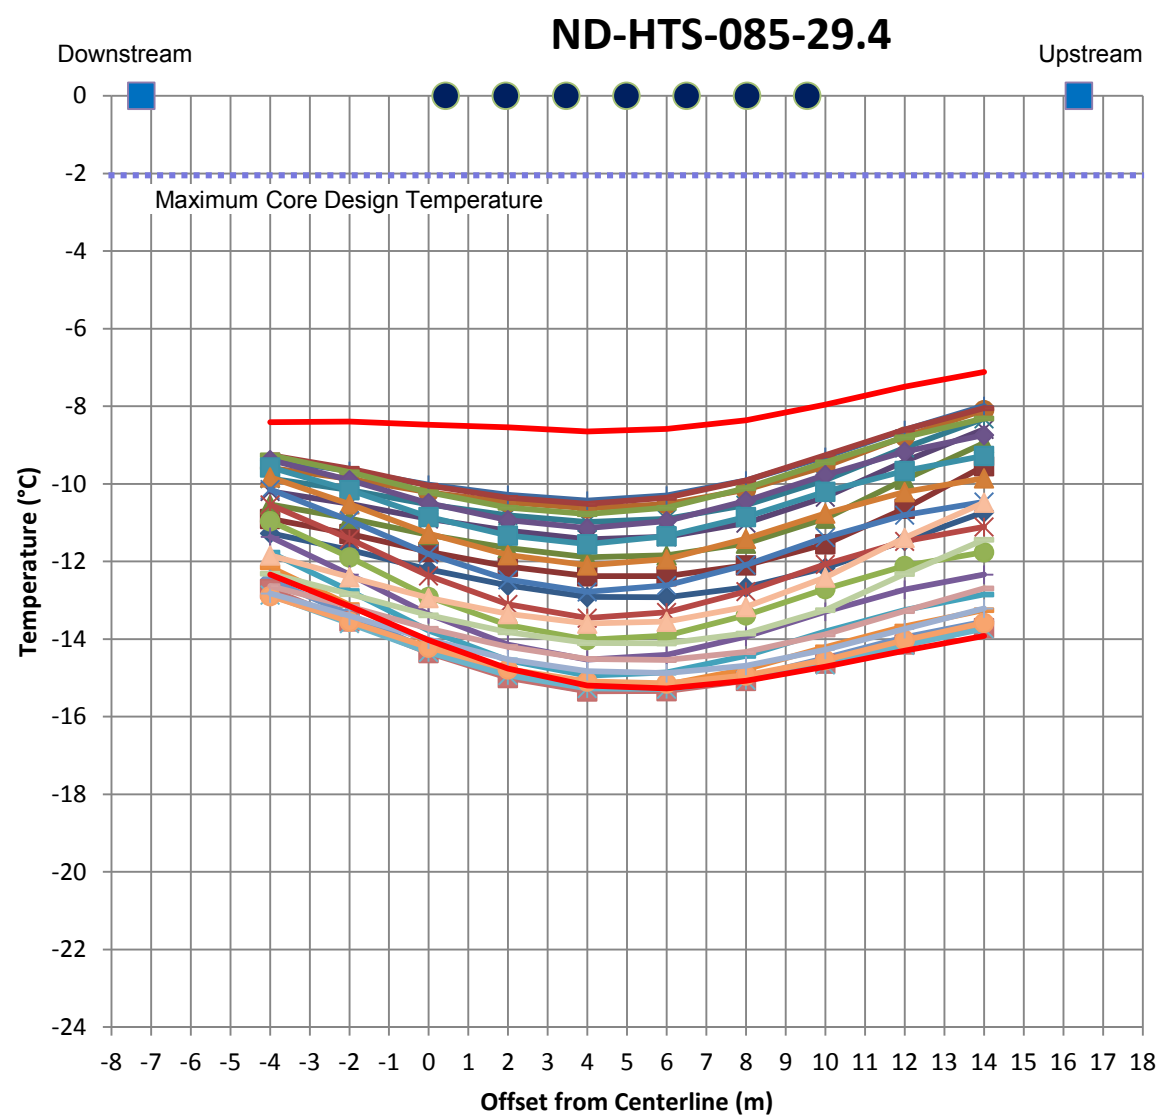
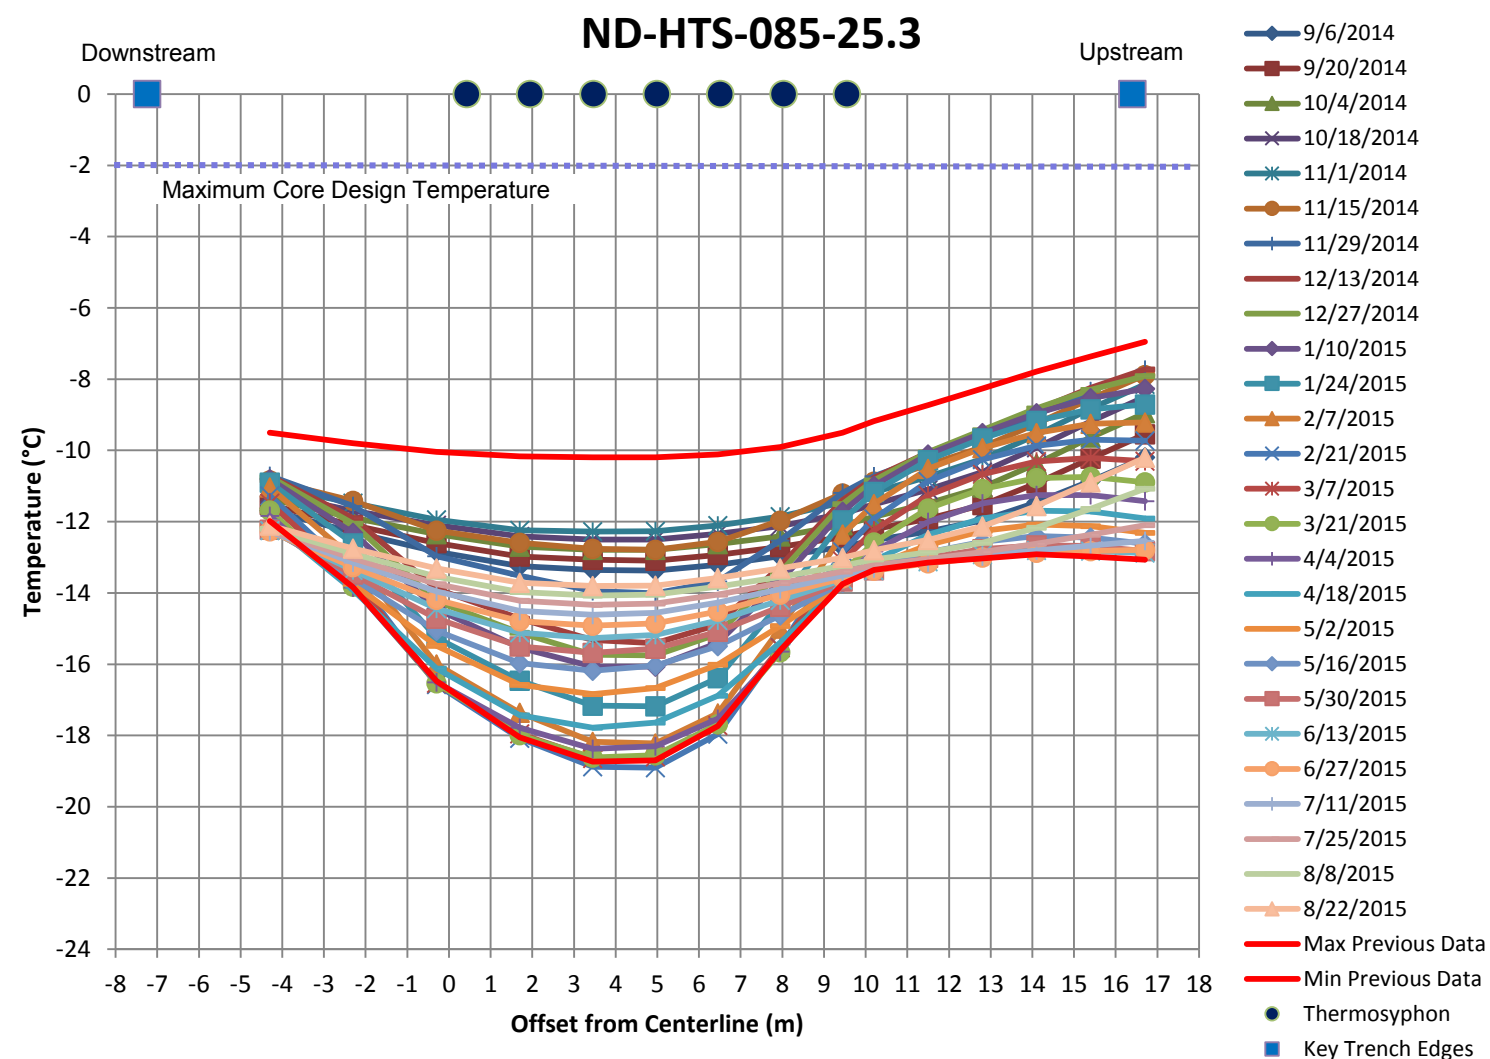
Figure:  
**A.8**

- ND-HTS-085-33.5 was irreparably damaged during construction
- Previous Data was recorded between August 2012 and September 2014

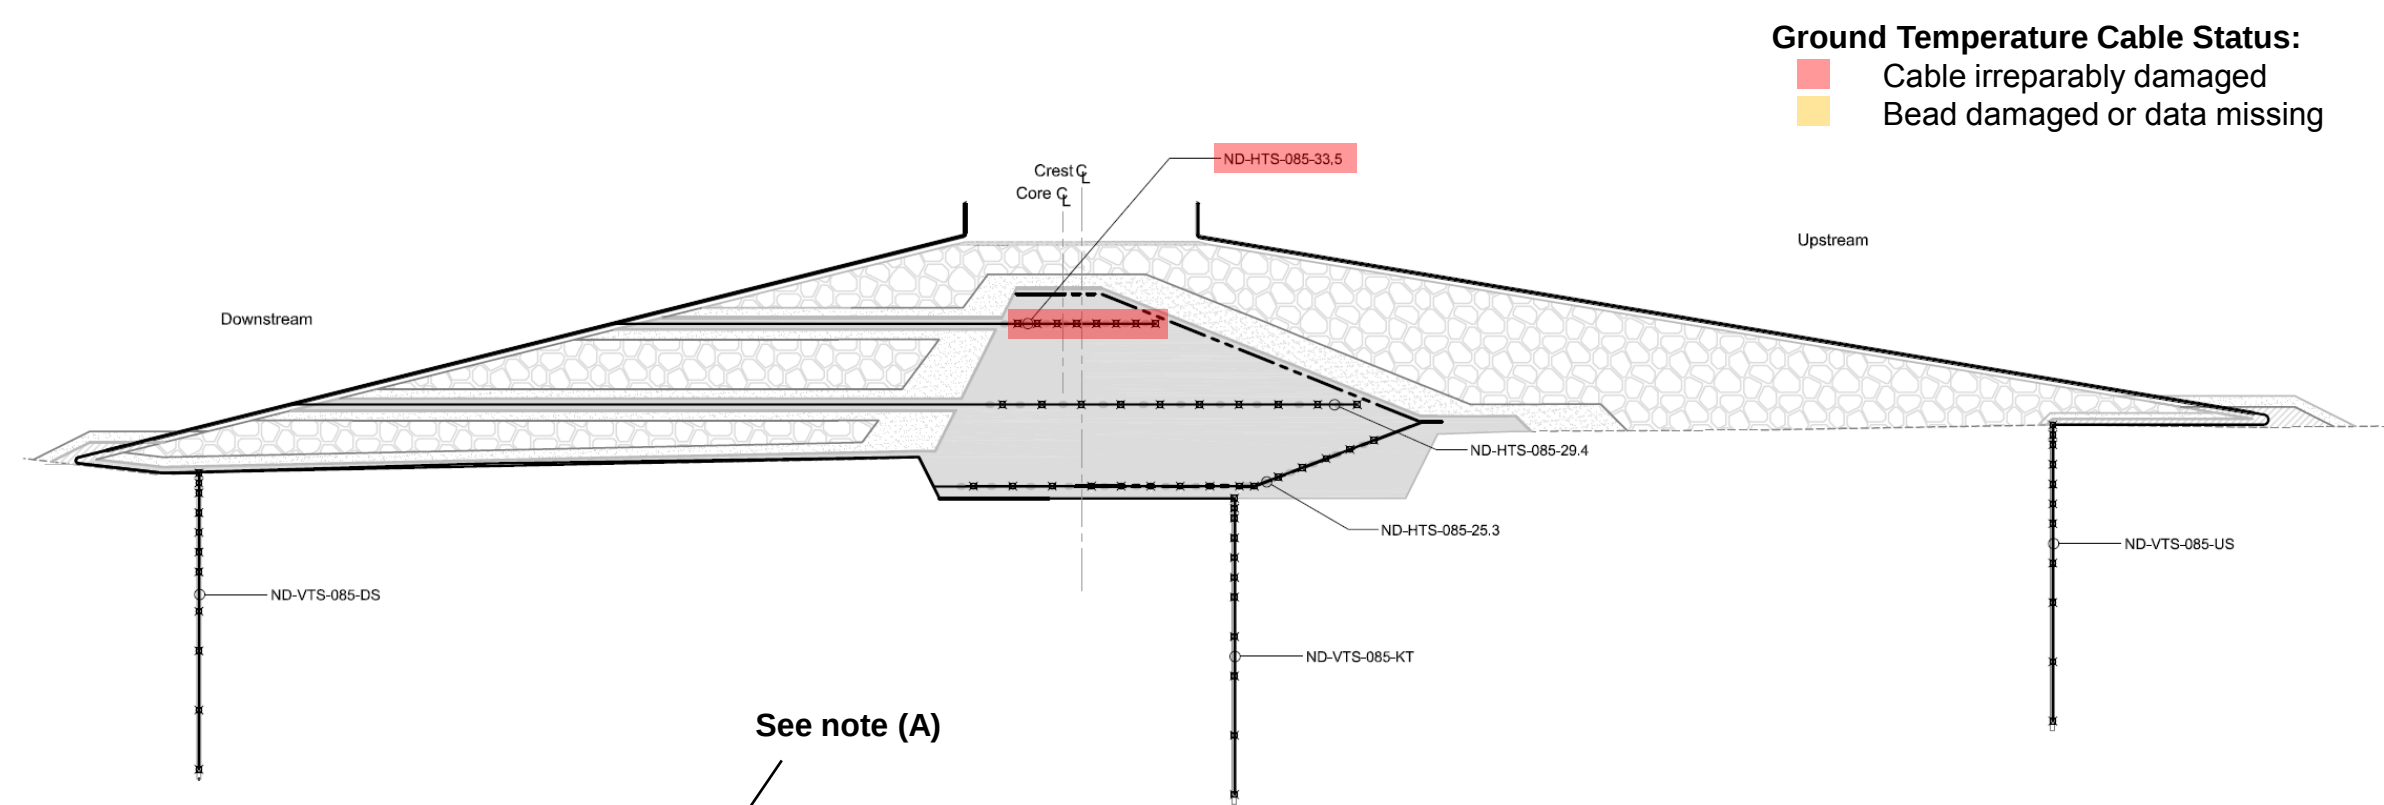
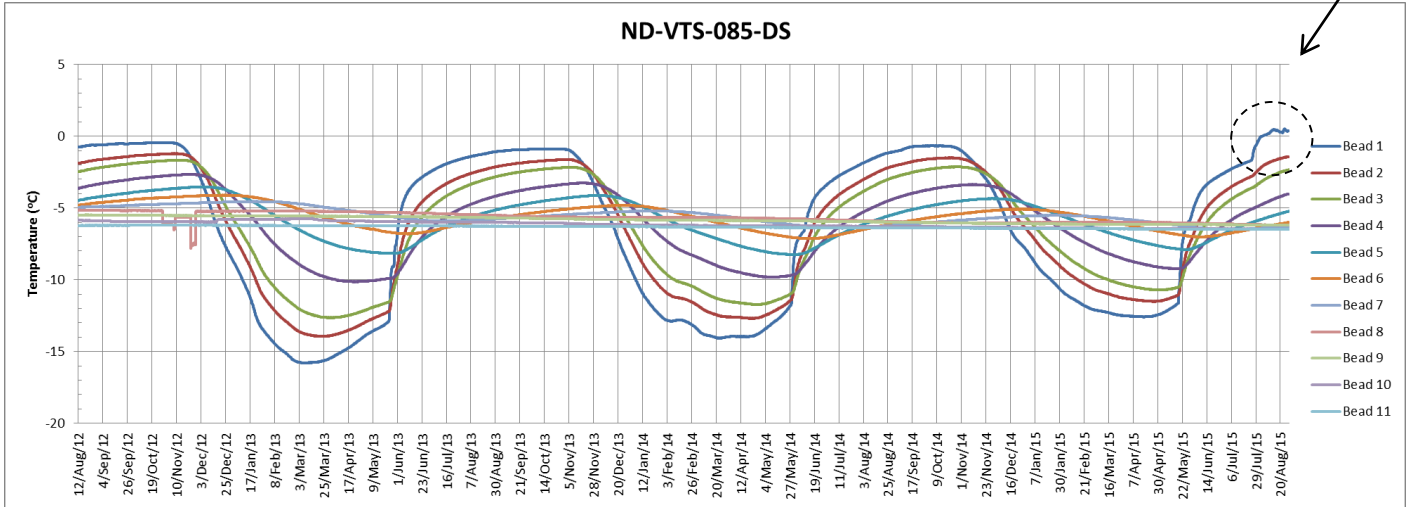
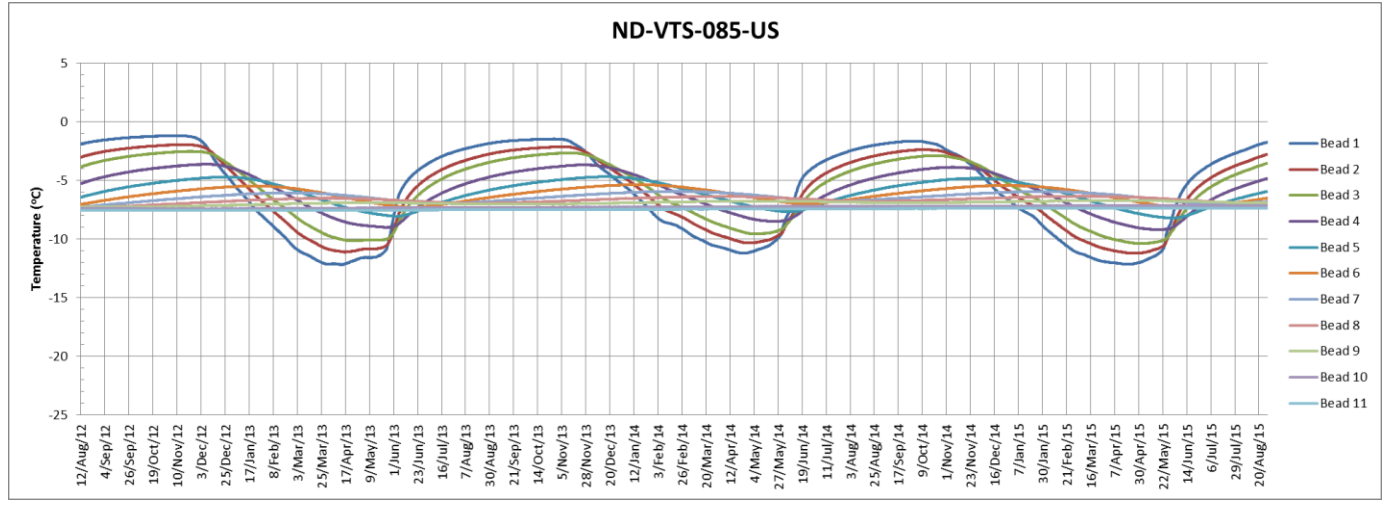
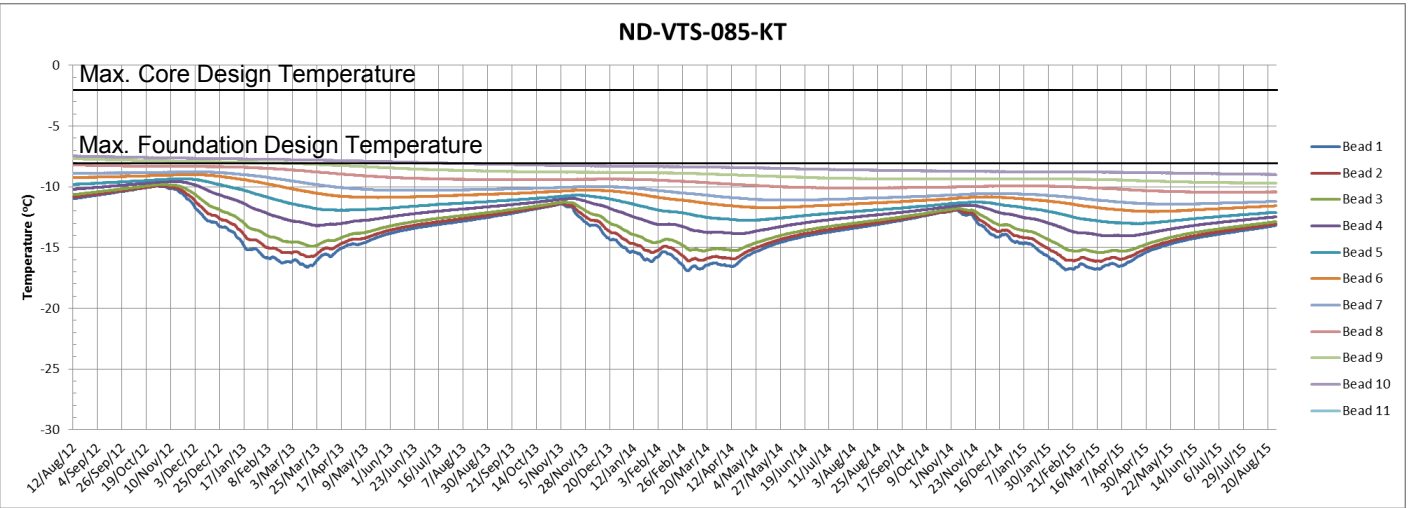
See note (A)

- Notes:
- Bead numbers increase from downstream to upstream (horizontal) and top to bottom (vertical)
  - (A) Temperature in Bead 1 rose at the shallowest bead near the end of the monitoring period and will continue to be monitored.

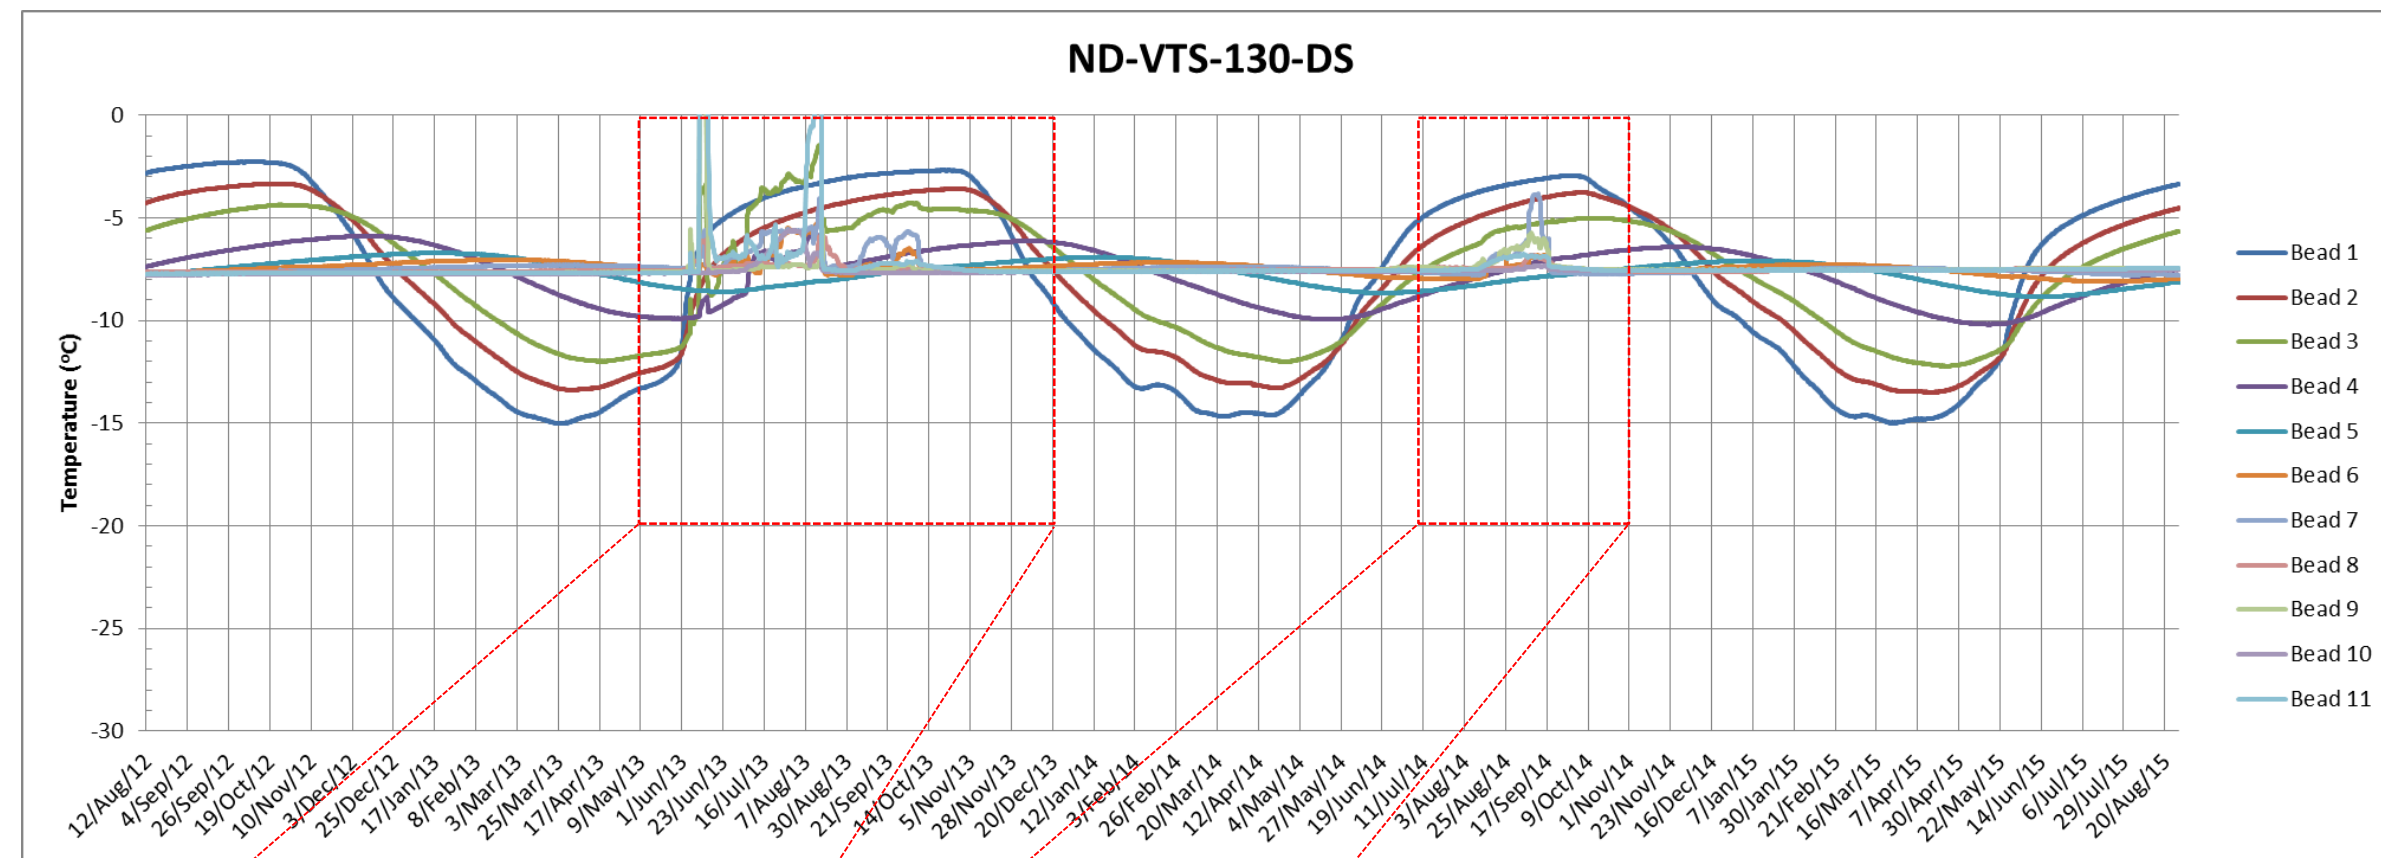
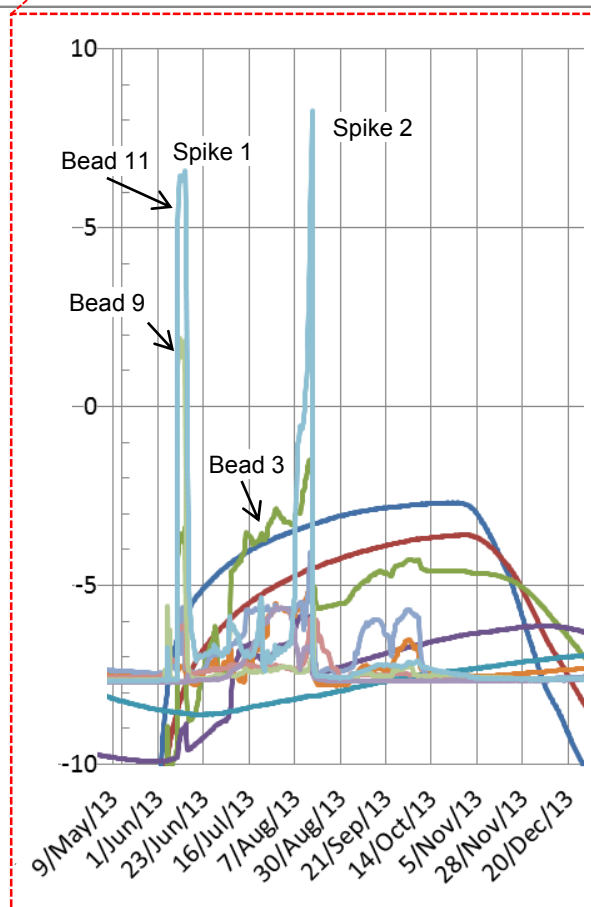
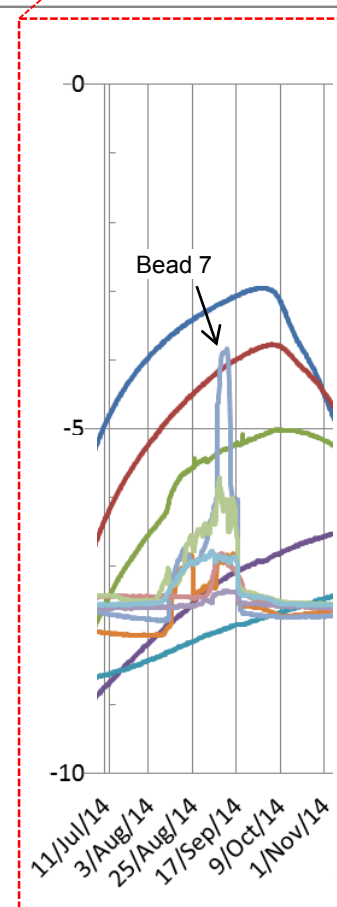
- Temperature spikes were noted in the 2014 North Dam Annual Geotechnical Inspection. No spikes have been noted since September 2014.
