North Dam Weekly Walkover Survey Report

Date:	Nov 8/14
Inspected By:	SHARAH / IKEY
Conditions:	(ie. snow on ground, clear) MOSTLY CLOUDY

Date:	Nov 15/14
Inspected By:	Sarah Warnock
Conditions:	(ie. snow on ground, clear) snow on up/down stream sides of dam

Date:	NOV 23, 2014
Inspected By:	SCOTT GOULDSBOROUGH
Conditions:	(ie. snow on ground, clear) SNOW ON GROUND

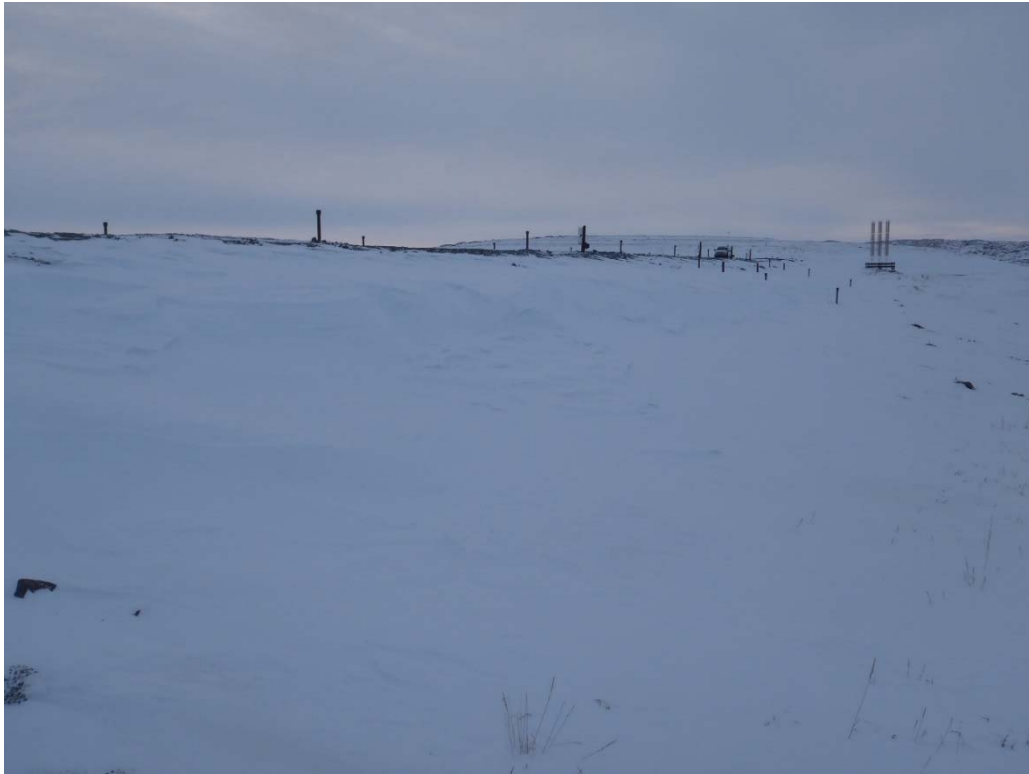
Photo from north end looking south along the dam

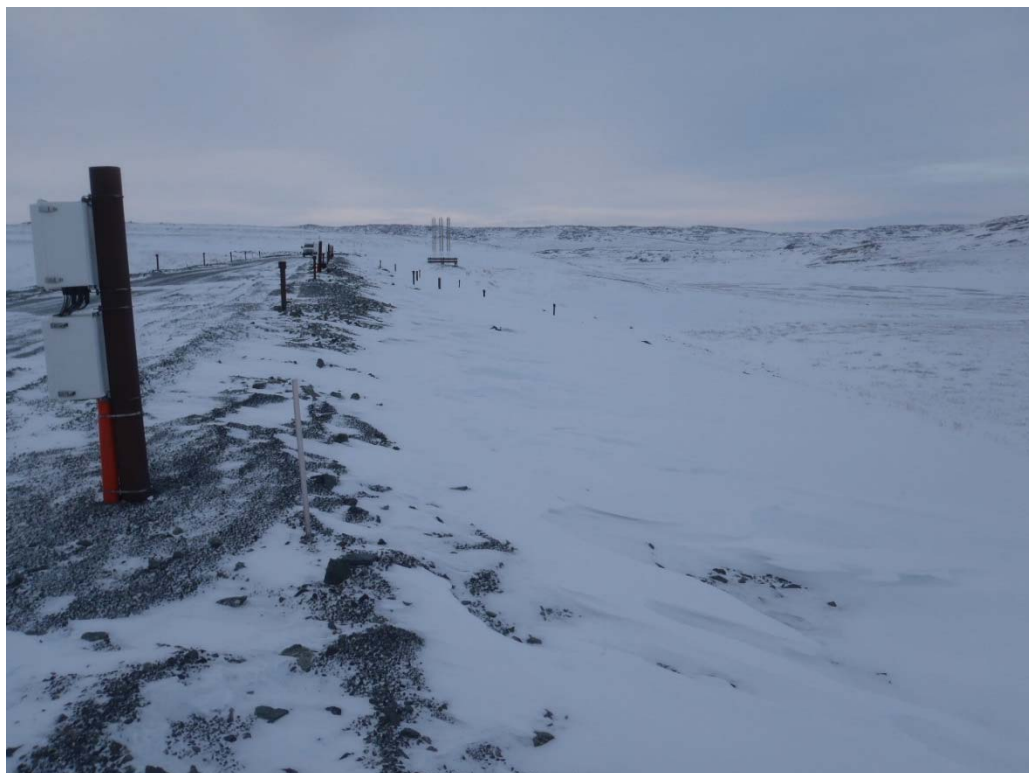
Photo from south end looking north along the dam

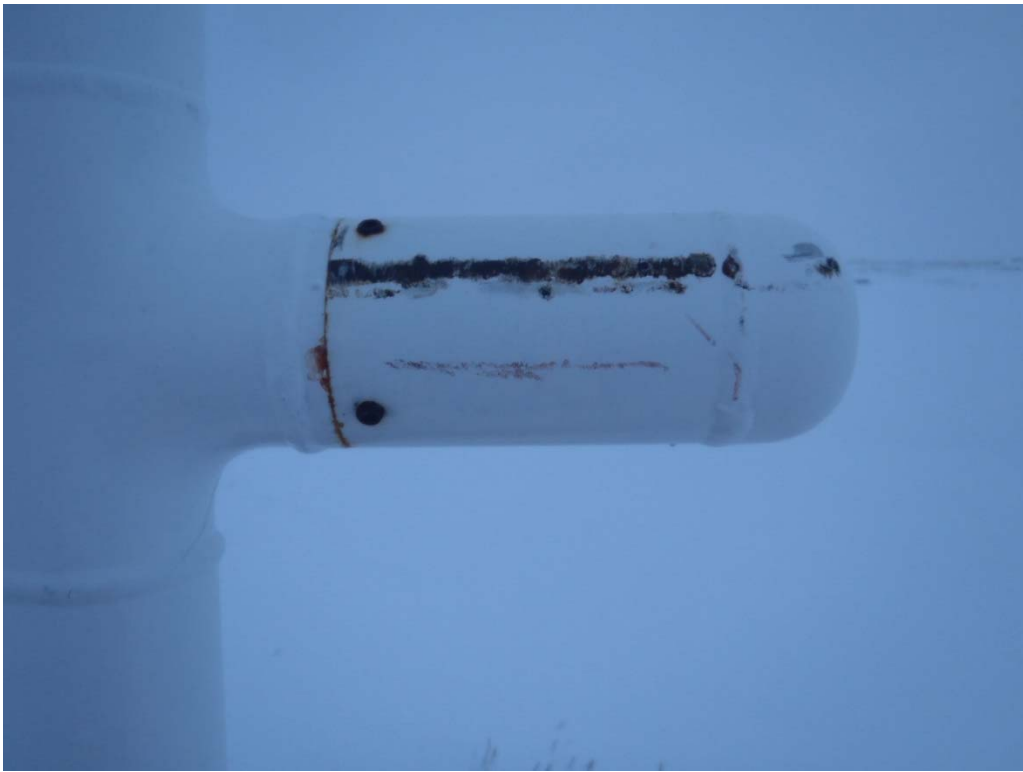
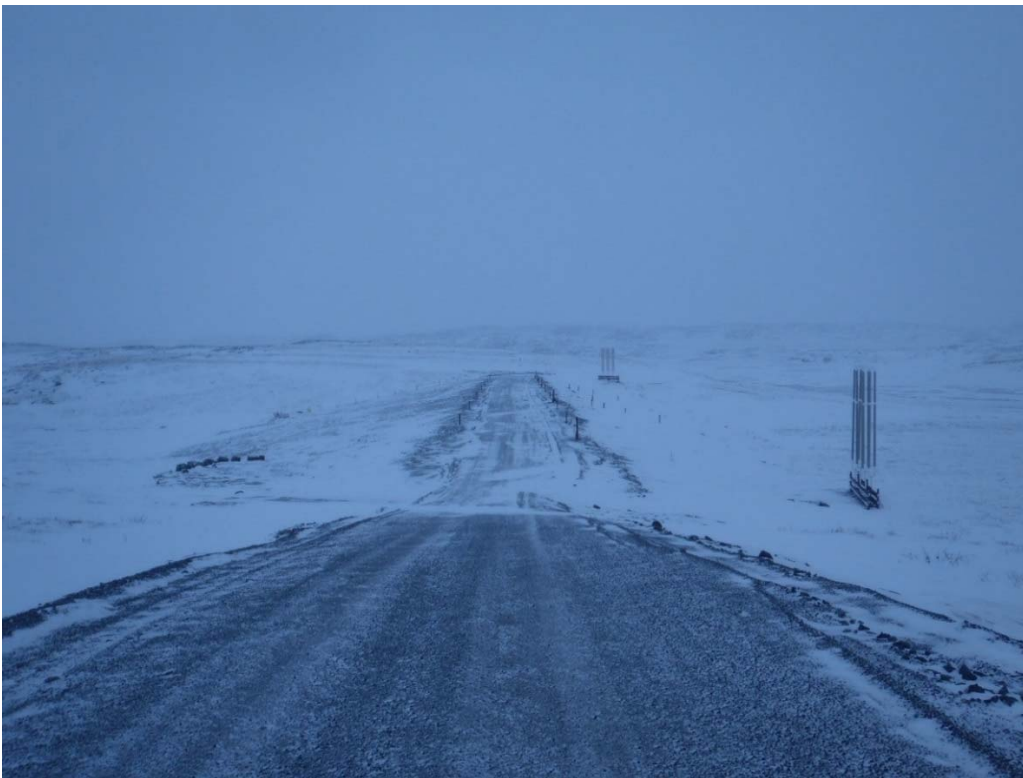
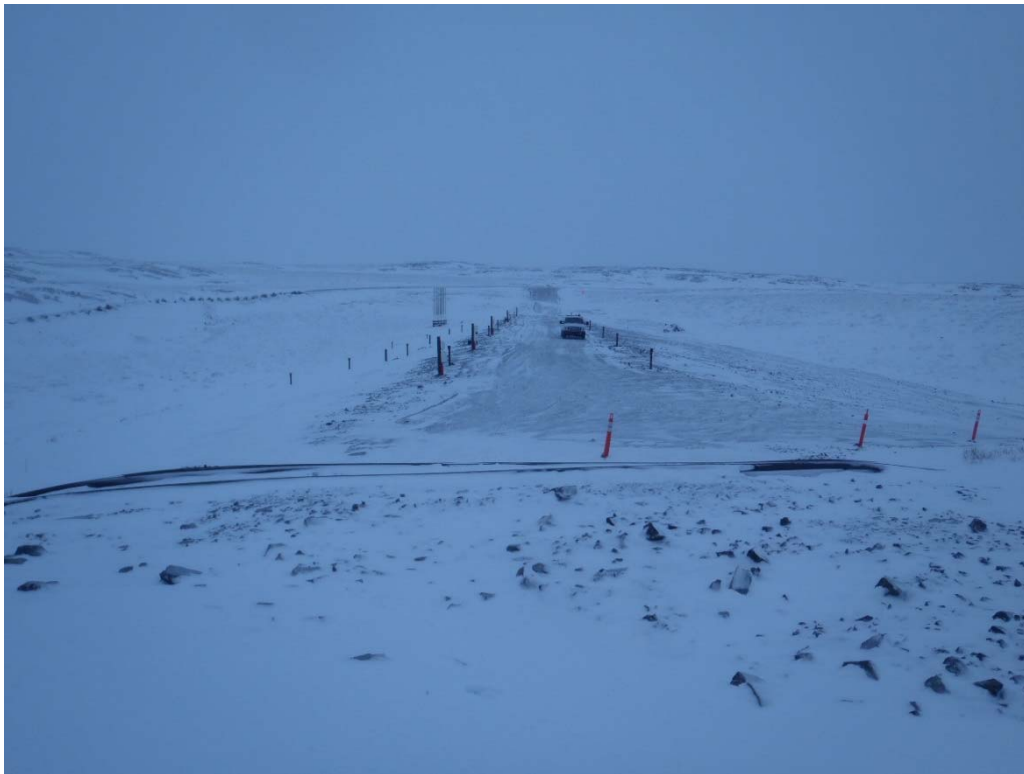
- ① Depressions noted in previous surveys - Snow cover prevented further evaluation
- ② Rust previously noted
- ③ Frozen.
