North Dam Weekly Walkover Survey Report

Date:	Nov 30, 2014
Inspected By:	Scott Gouldsbrough.
Conditions:	(ie. snow on ground, clear) SNOW ON GROUND.

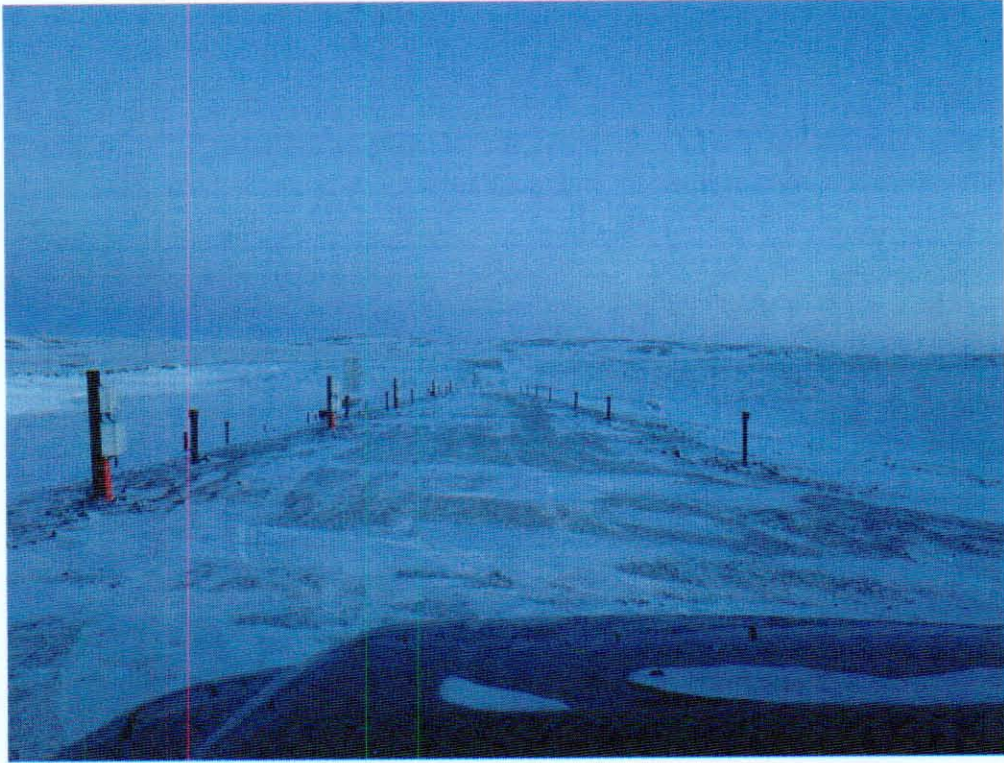
Figure 1 Dec 13, 2014, Looking North

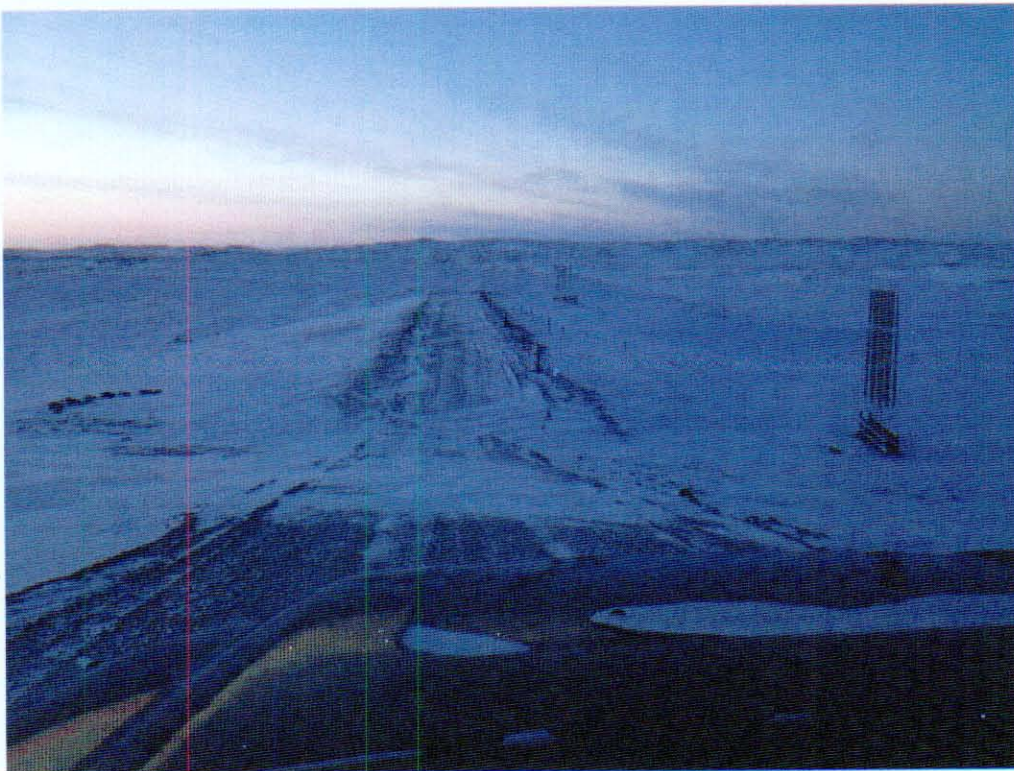
Figure 2 Dec 13, 2014 Looking South

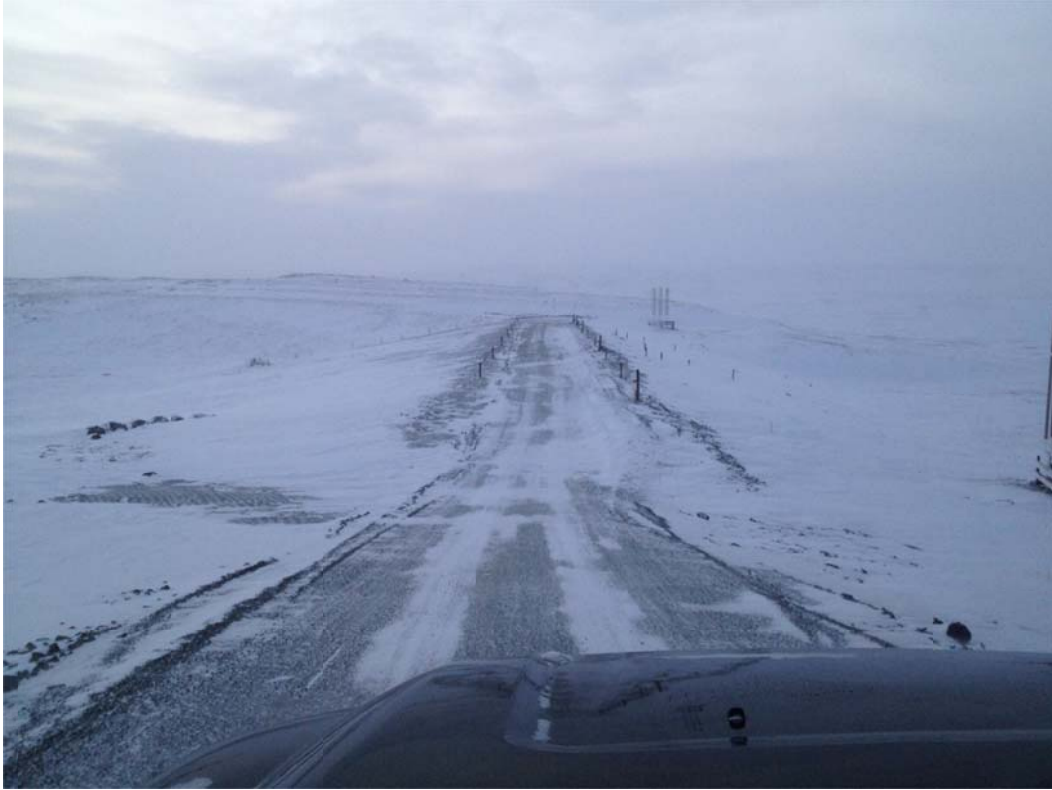
Figure 1 Photo looking south, Jan 3, 2015

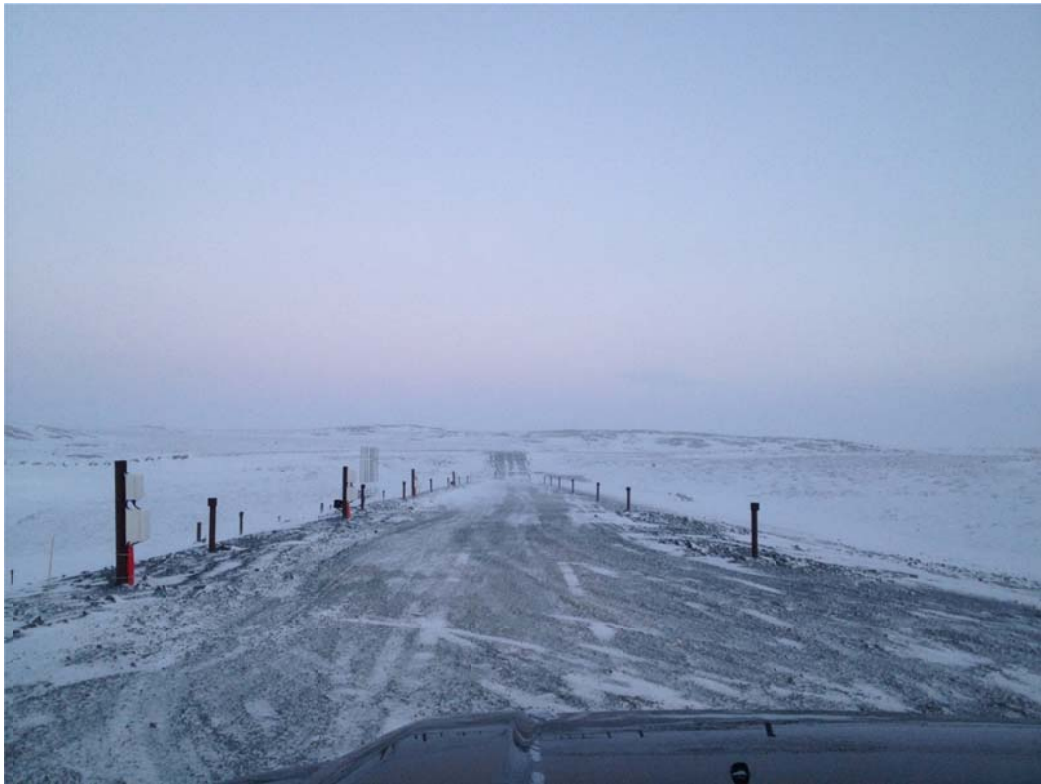
Figure 2 Photo looking north. Jan 3, 2015
