## North Dam Weekly Walkover Survey Report

Date:	JAN 9, 2015
Inspected By:	DAVE SHERLOCK
Conditions:	(ie. snow on ground, clear) SNOW ON GROUND

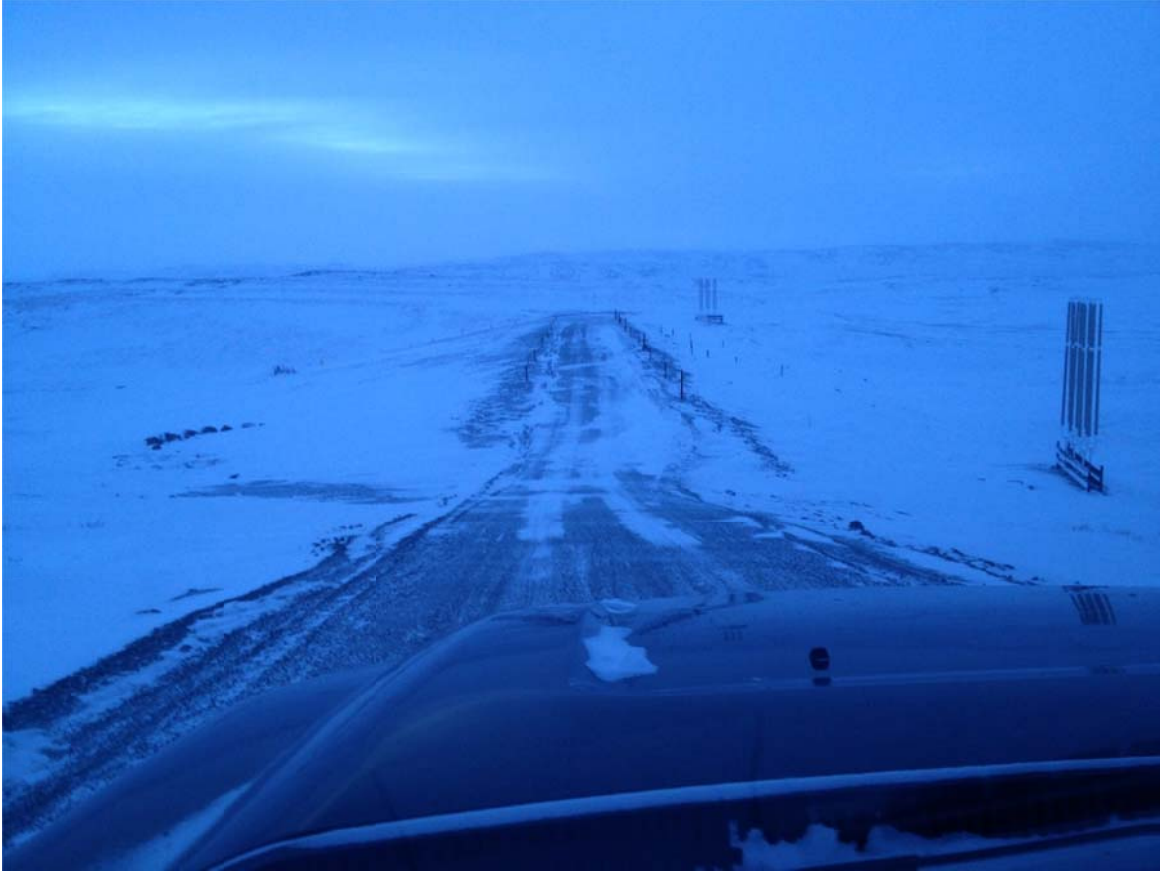
Figure 1 North Dam, Looking South, Jan 9, 2015

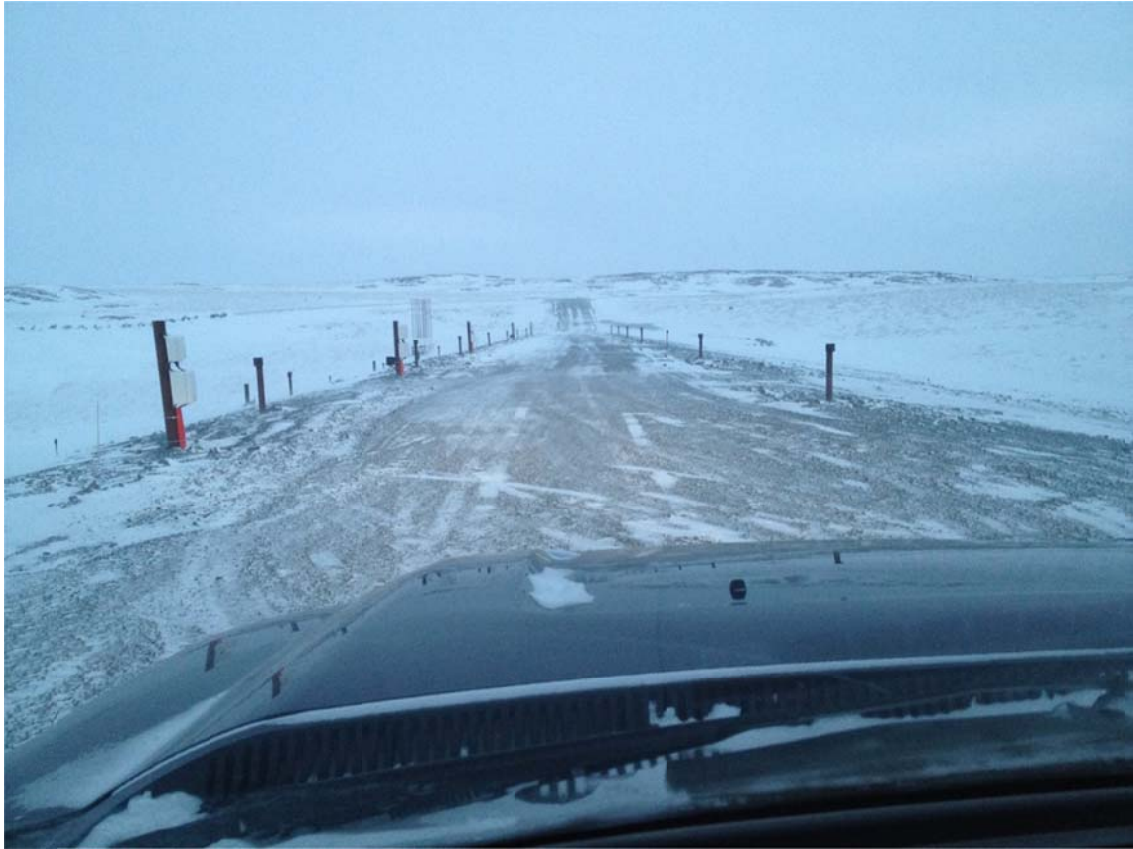
Figure 3North Dam - Looking North, Jan 9, 2015

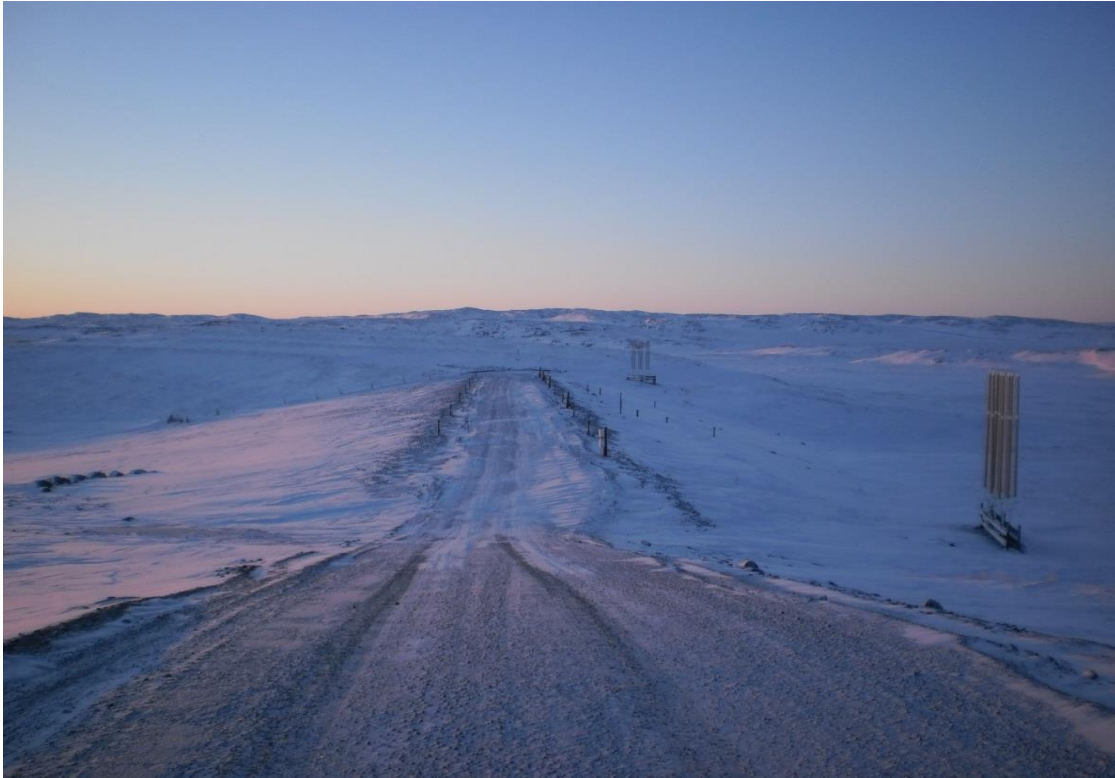
North Dam looking South

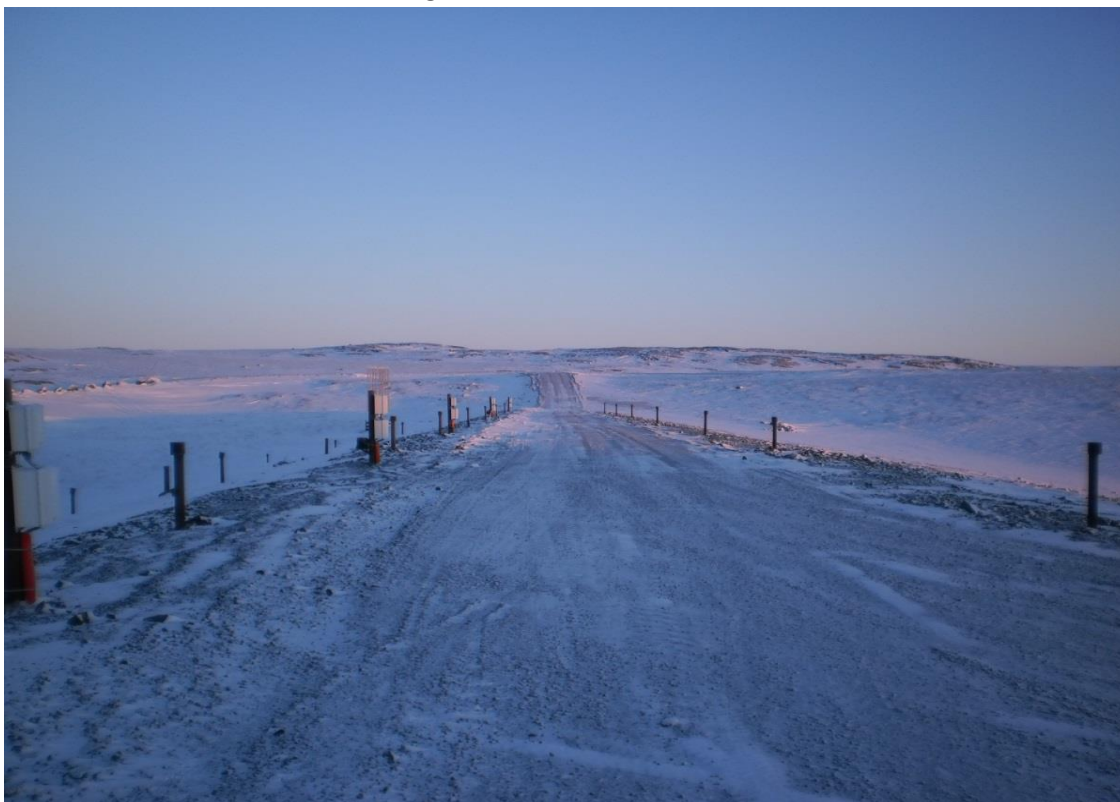
North Dam looking North

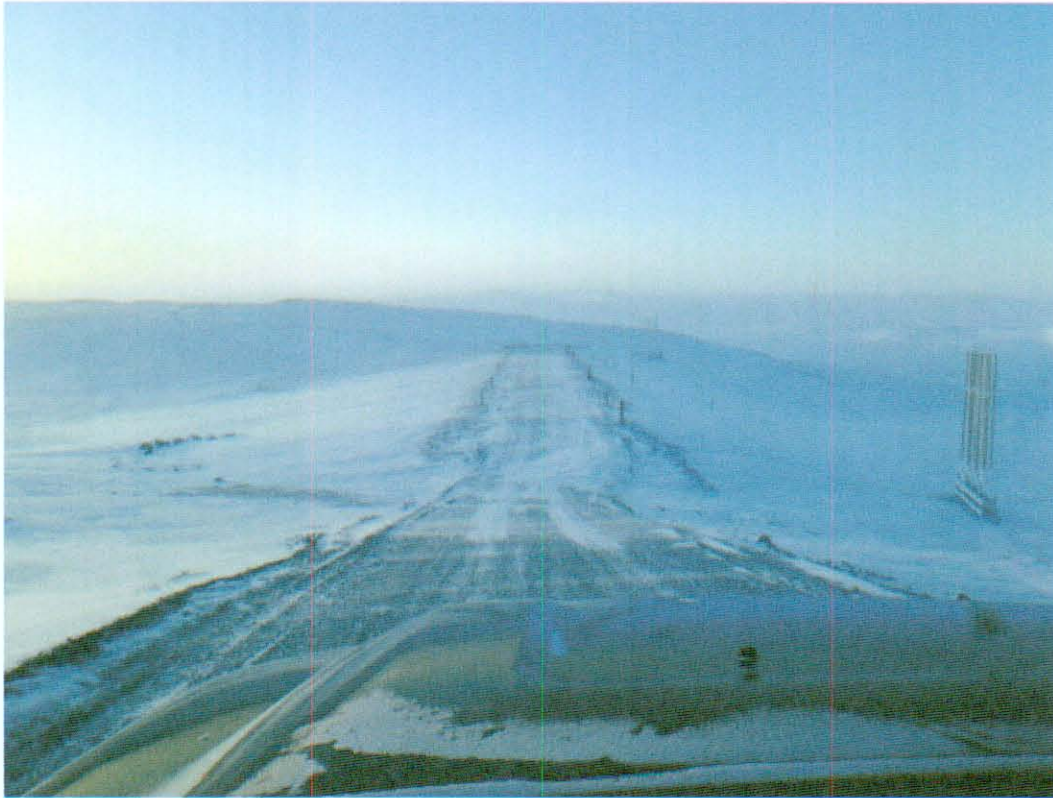
Figure 1 Photo looking to south, Jan 31, 2015

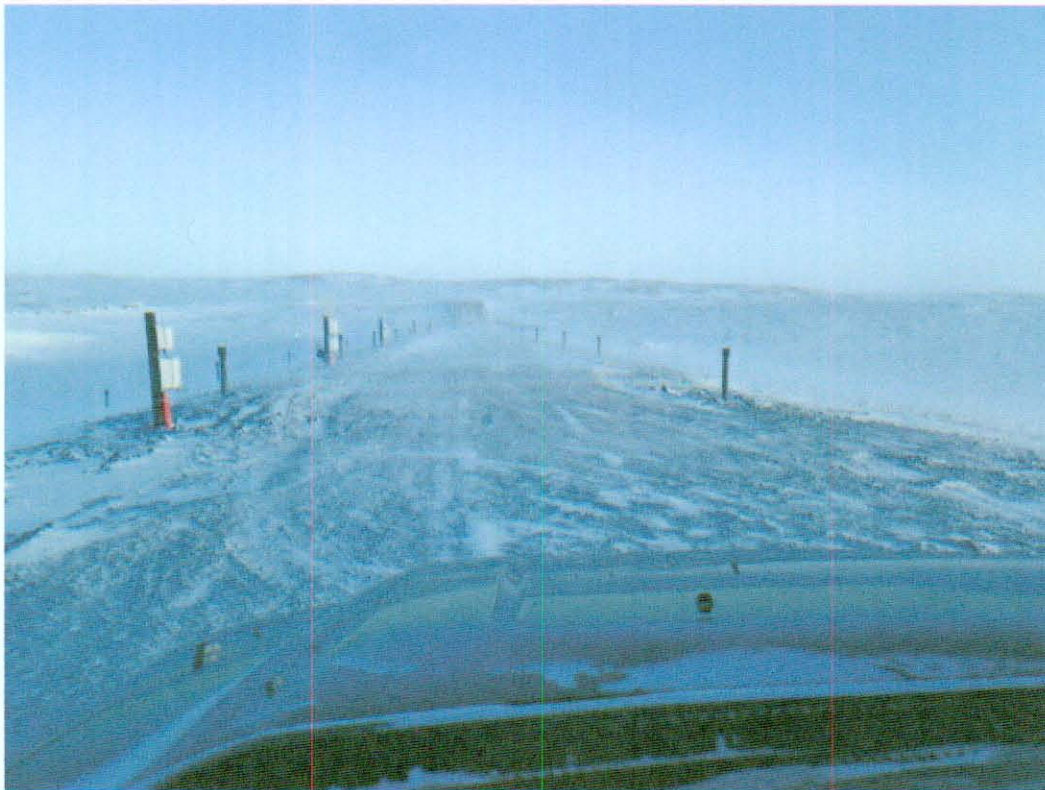
Figure 2 Photo looking to North, Jan 31, 2015
