North Dam Weekly Walkover Survey Report

Date:	Friday, June 19, 2015
Inspected By:	Darcy Kanayok
Conditions:	(ie. snow on ground, clear) Clear, North end still abit of snow on foot of Dam

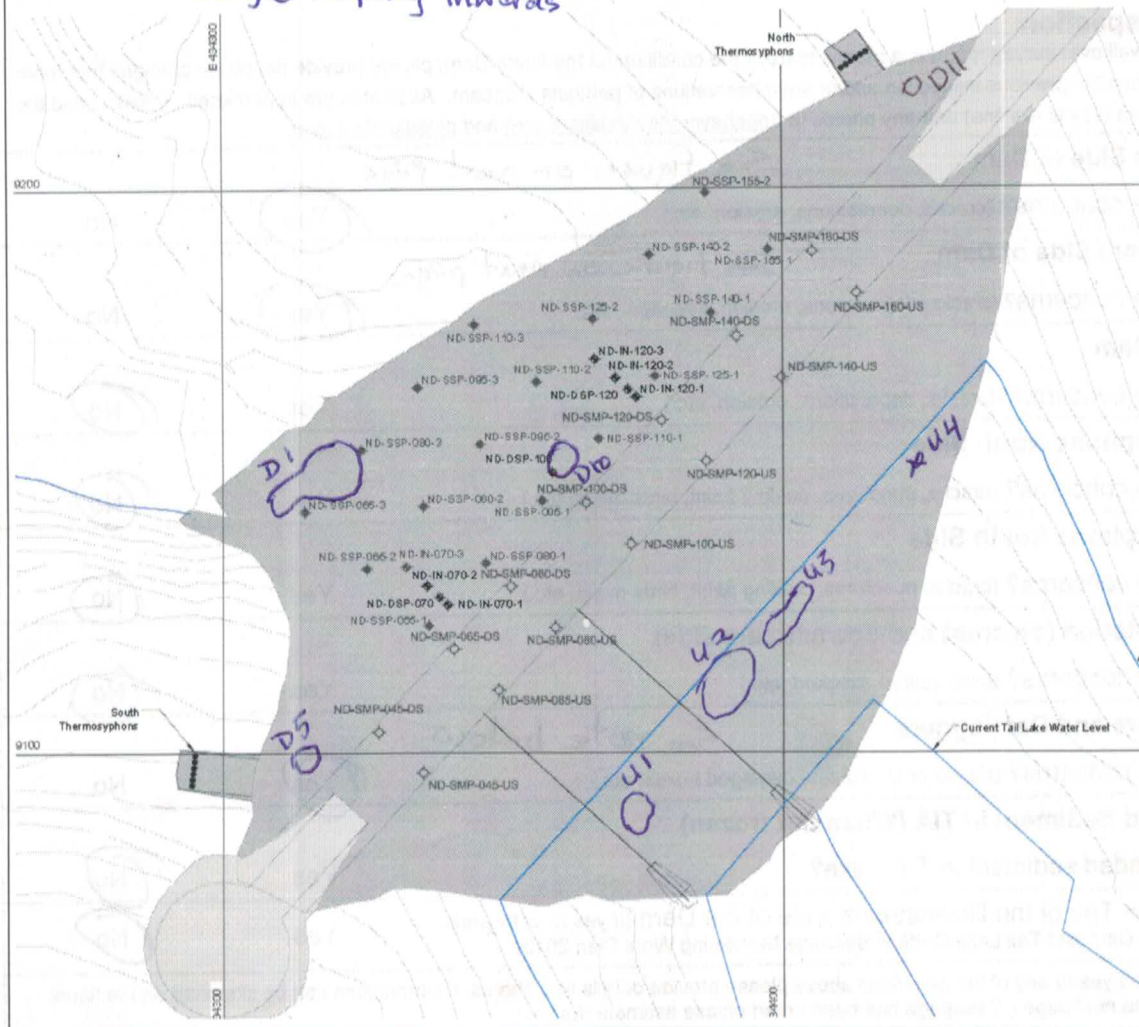
U3 maybe getting bigger

U4 new depression

U2 still looks the same

U1 still looks the same

D5 still looks the same

D1 still looks the same

D2 small change sloping inwards

D6 still looks the same

D7 still looks the same

D3 still looks the same

D9 still looks the same

D8 still looks the same

D10 new depression

D11 new depression
