Date:	MARCH 1, 2015
Inspected By:	DAVE SHERLOCK
Conditions:	(ie. snow on ground, clear) SNOW ON GROUND

# North Dam Weekly Walkover Survey Report

Date:	MARCH 7, 2015
Inspected By:	DAVE SHERLOCK
Conditions:	(ie. snow on ground, clear) SNOW ON GROUND

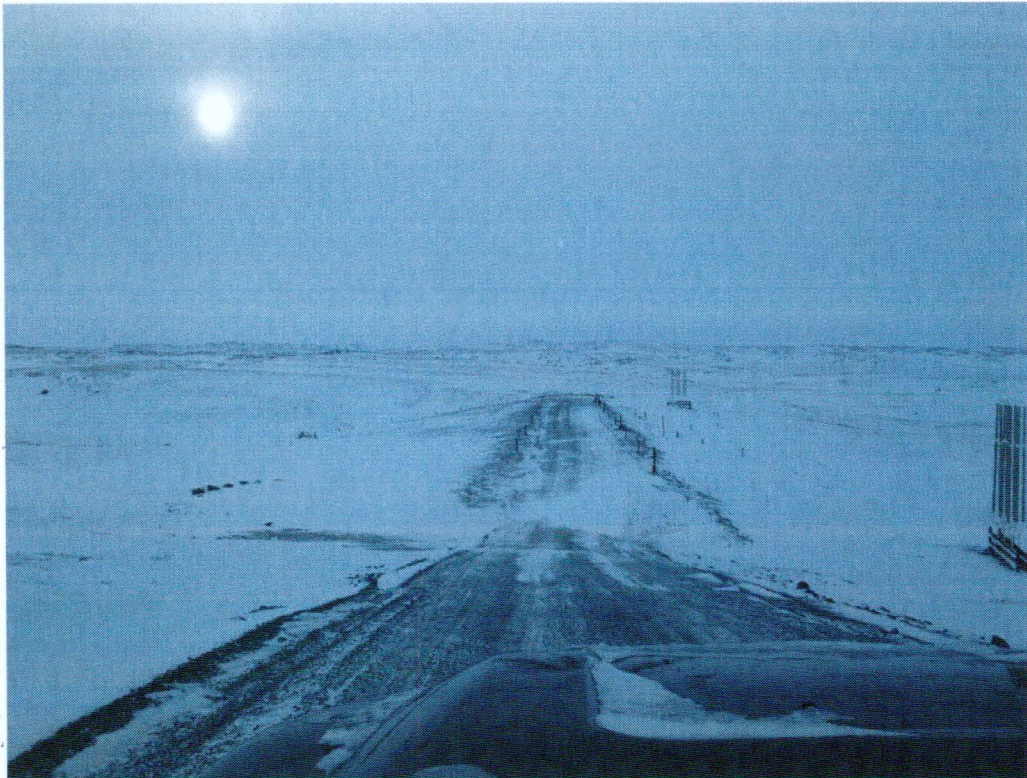
Figure 1 North dam looking south, March 1, 2015

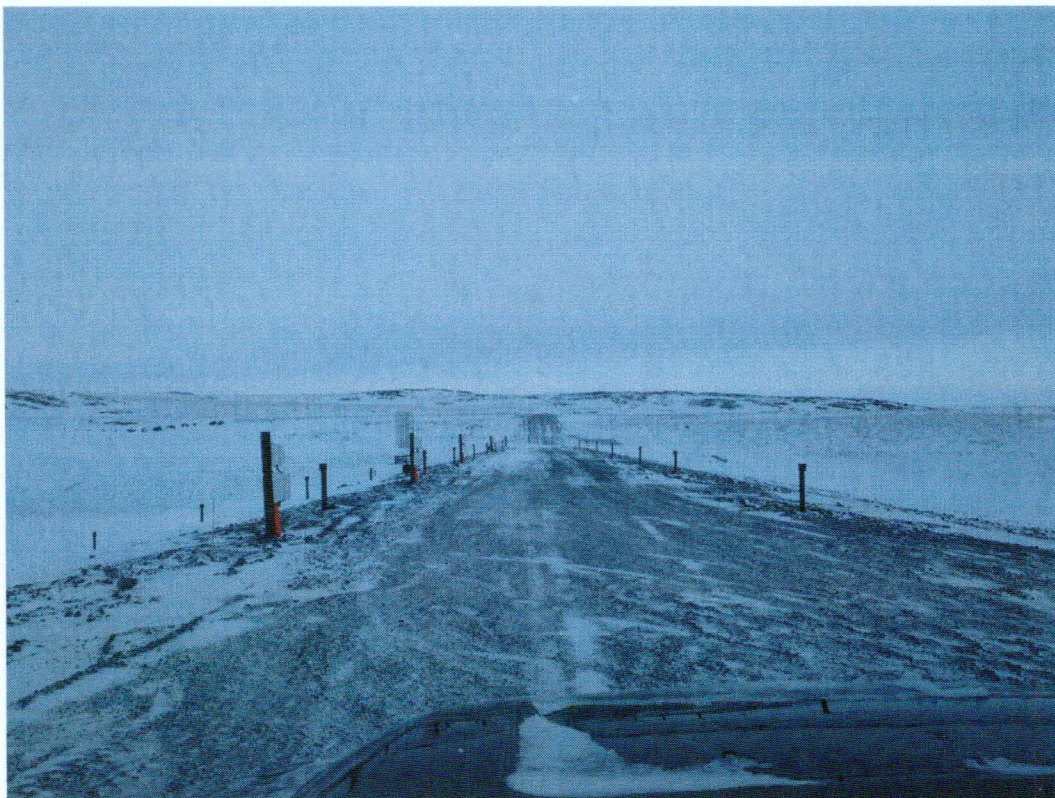
Figure 2 North Dam looking north, March 1, 2015

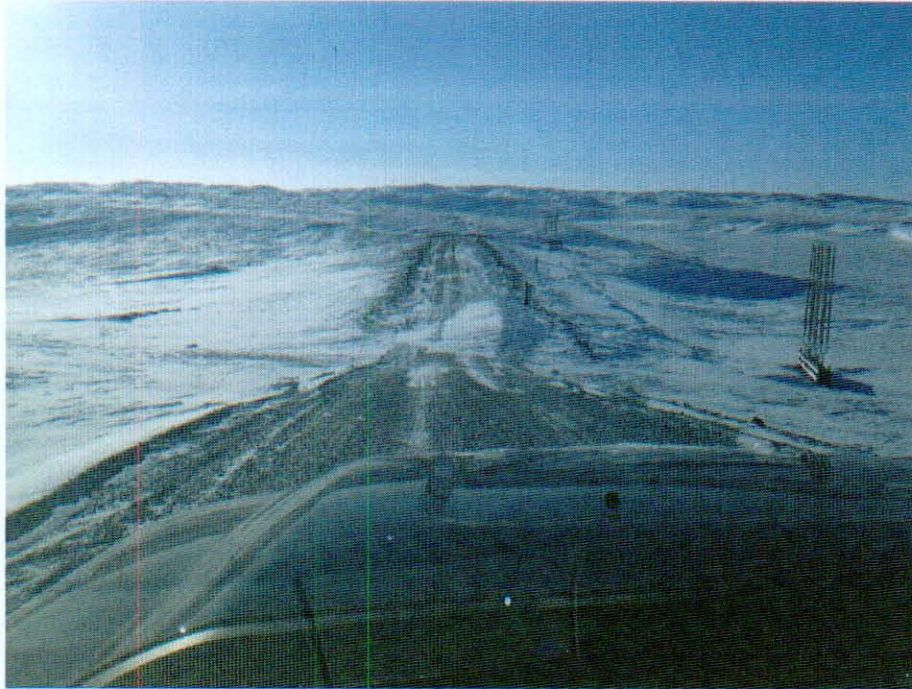
Figure 1 North Dam looking South, March 7, 2015

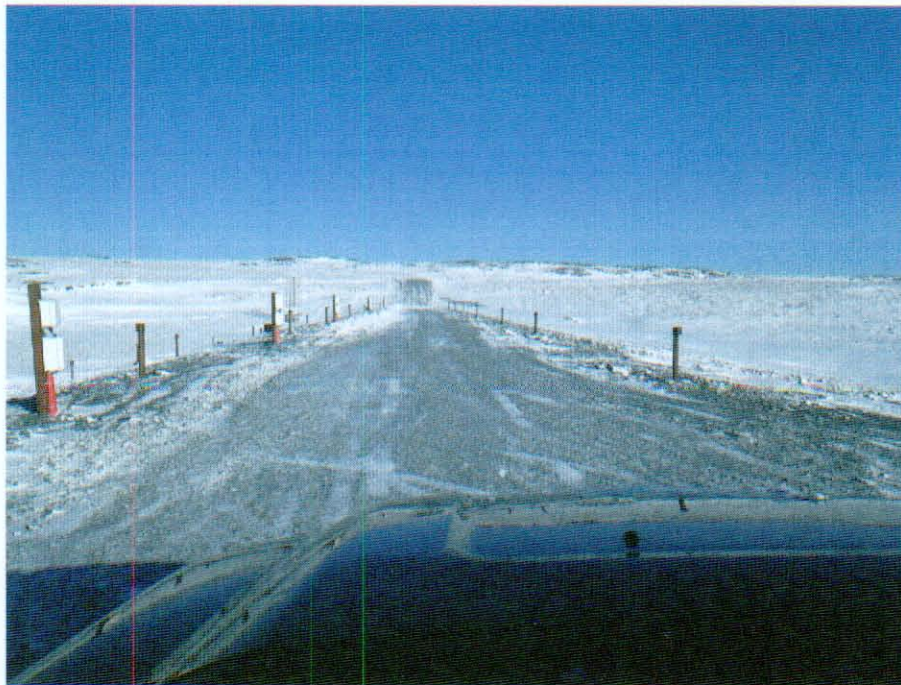
Figure 2 North Dam Looking South, March 7, 2015
