North Dam Weekly Walkover Survey Report

Date:	Oct 5/14
Inspected By:	Sarah Wannock
Conditions:	(ie. snow on ground, clear) Snow on downstream side of dam, overcast, no precip.

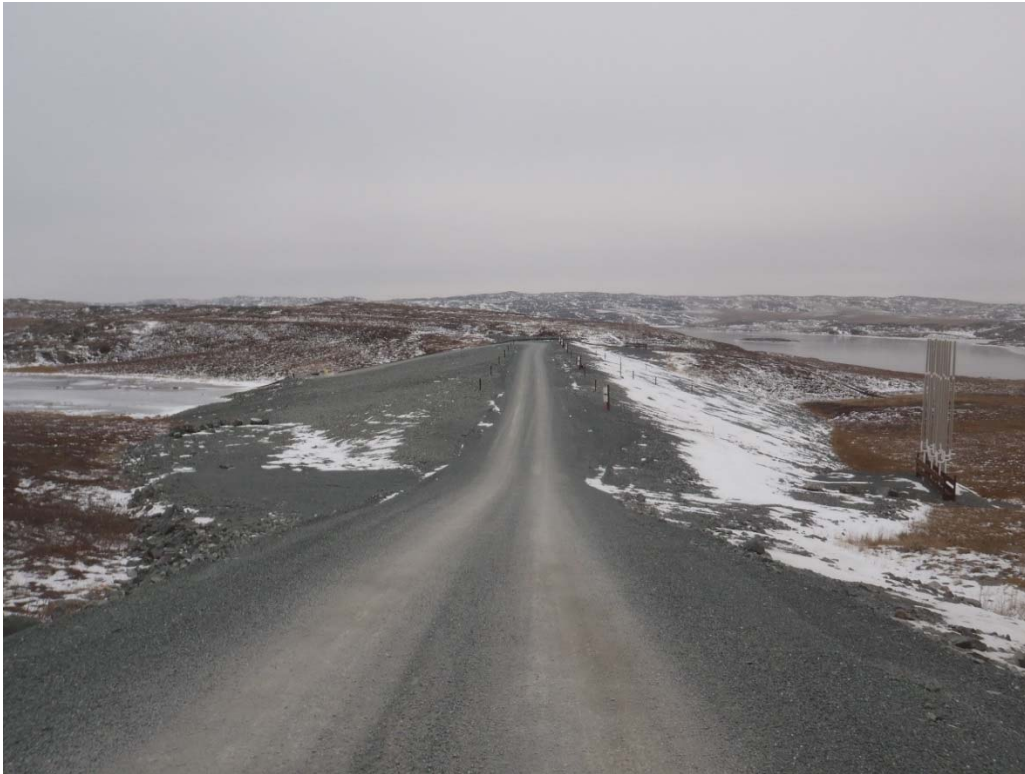
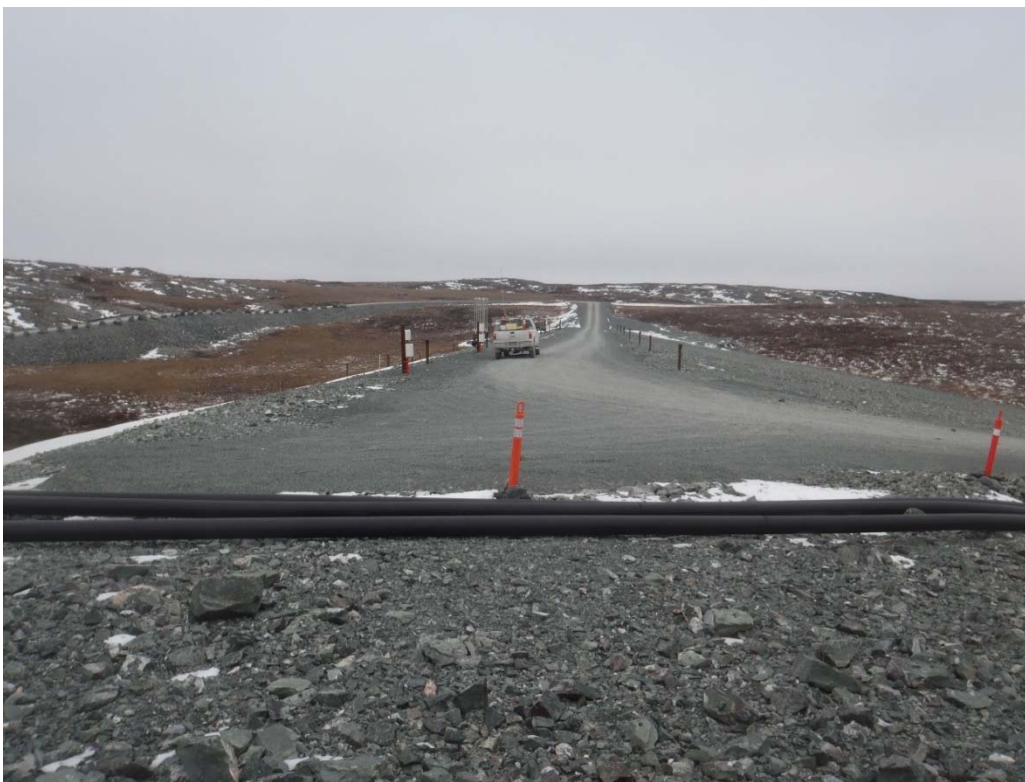
- ① No new depressions noted. No change to V_1 , V_2 , V_3
- ② Some rust - previously noted.
- ③ Snow cover on d/s side of dam. Previously noted depressions D1-D9 covered in snow. Could not evaluate change. No new depressions identified.

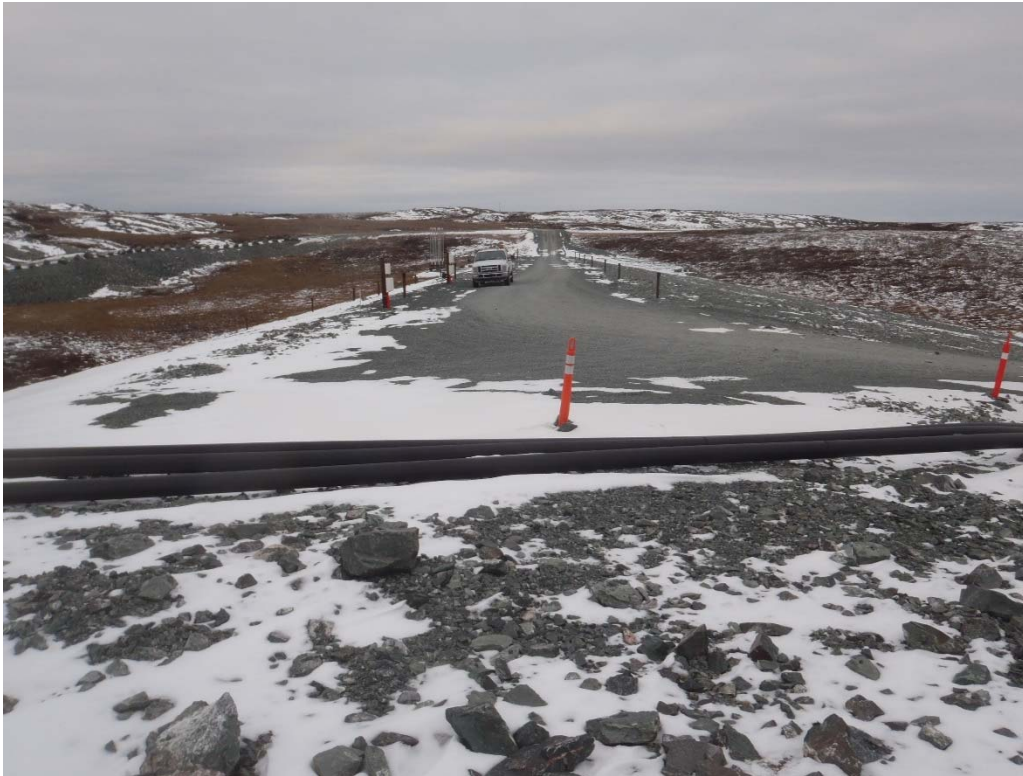
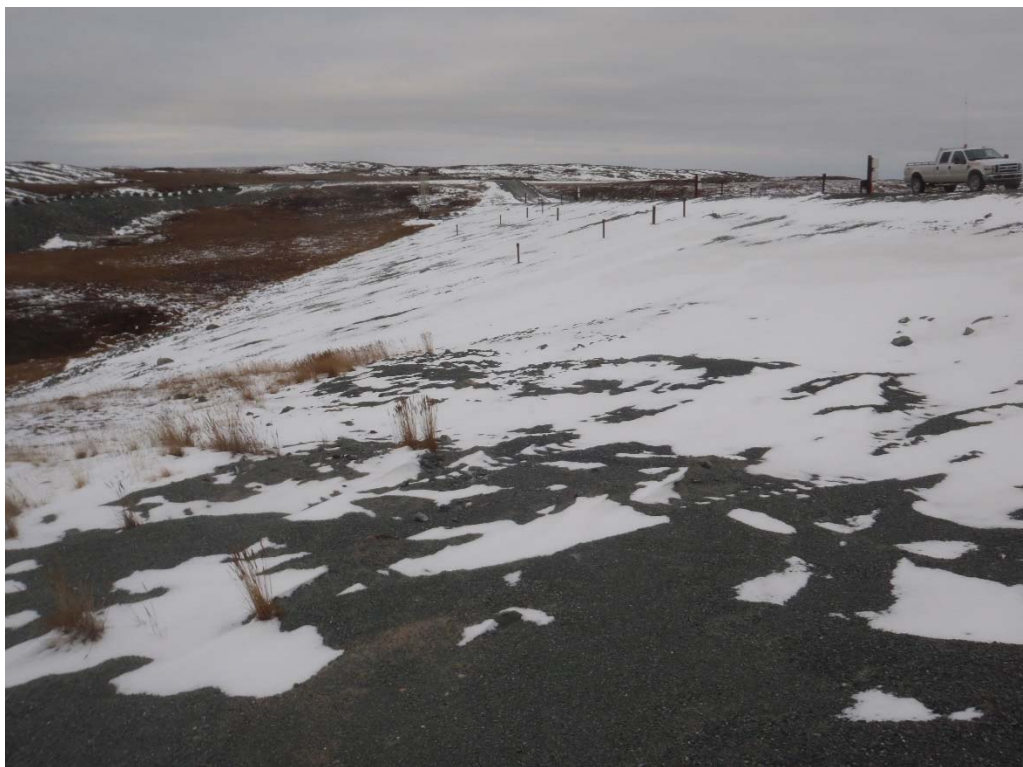
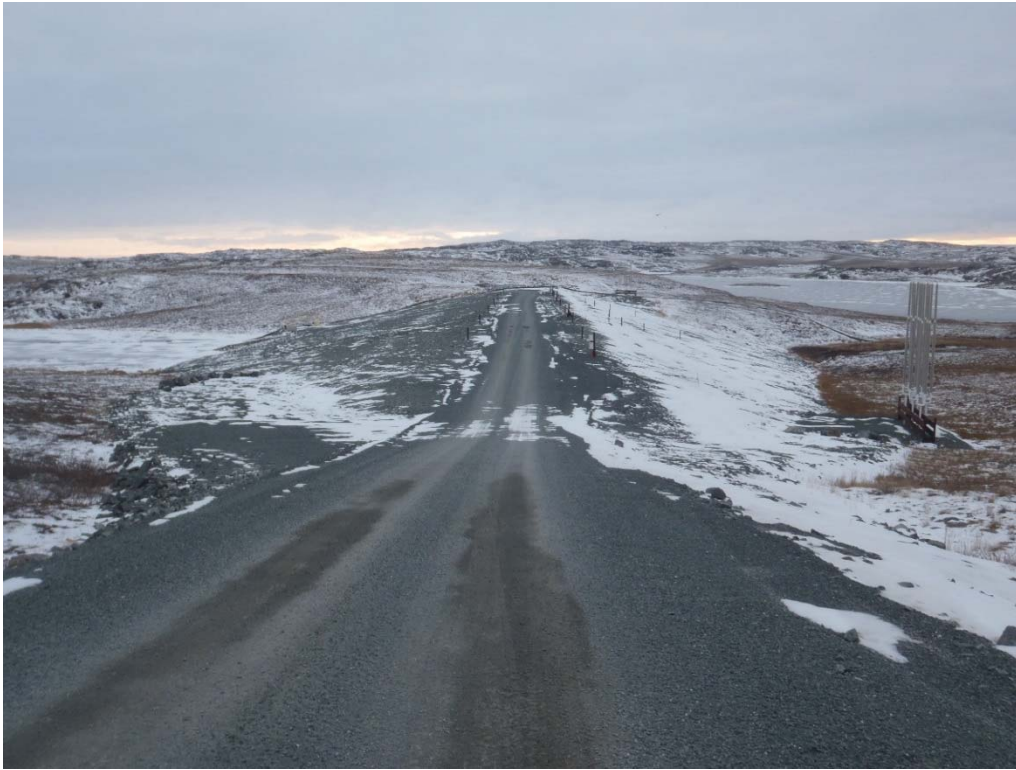
- ① Previously note - U1, U2, U3 partially covered in snow, no visible change to these depressions
- ② Same rust previously noted
- ③ Snow cover preventing assessment of depressions. No visible signs of change

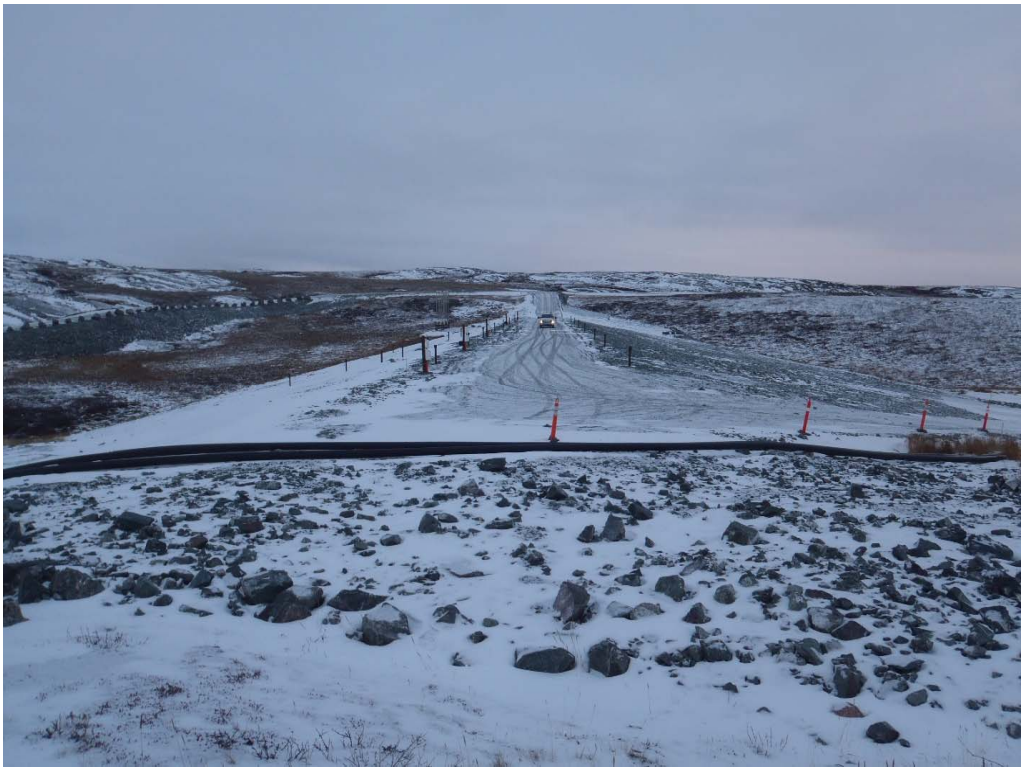
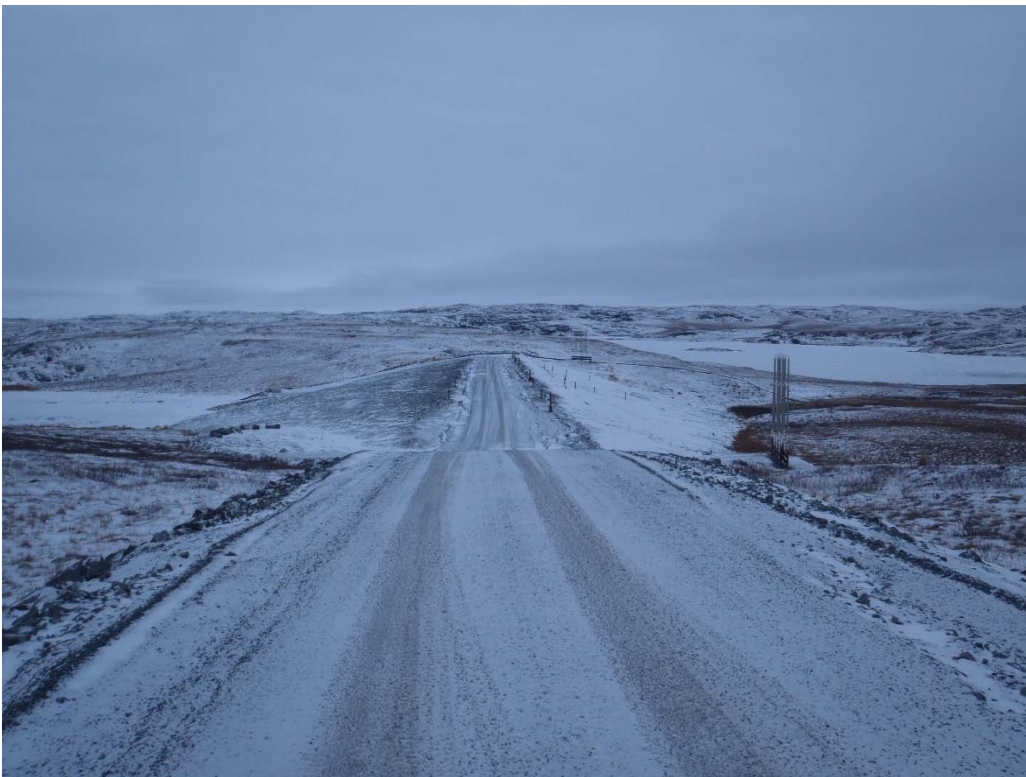
Photo from north end looking south along the dam

Photo from south end looking north along the dam
