North Dam Weekly Walkover Survey Report

Date:	June 13, 2015
Inspected By:	Darcy Kanayok
Conditions:	(ie. snow on ground, clear) No snow, no precipitation in previous days. Clear.

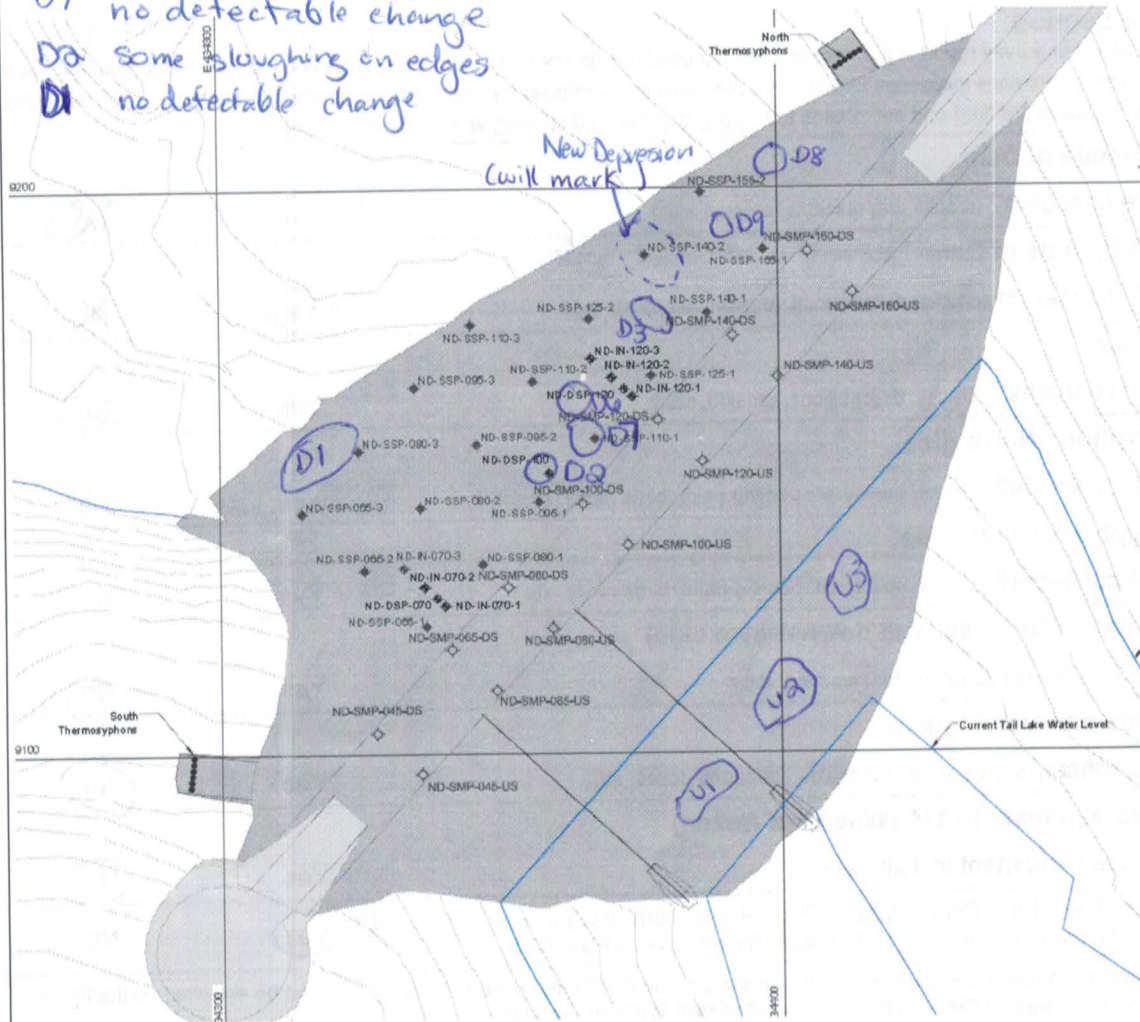
- ① Depressions U1, U2, U3 → previously marked on map.
- ② Rust, as noted earlier
- ③ Snow drift still melting at toe. Small amount of pooling water from snow melt.

U2 may be getting bigger. Small amount of change in paint boundary.
 U3 some sloughing on edges.
 U1 no detectable change
 D8 may be increasing slightly
 D9 no detectable change
 D3 no detectable change
 D6 no detectable change
 D7 no detectable change
 D2 some sloughing on edges
 D1 no detectable change

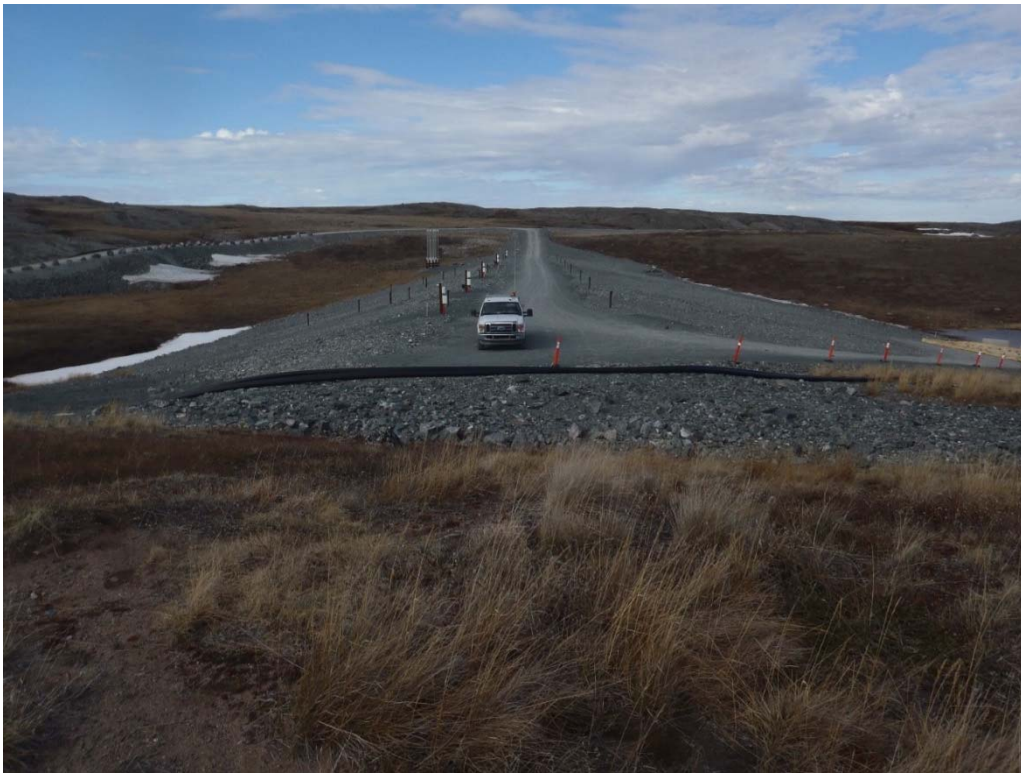
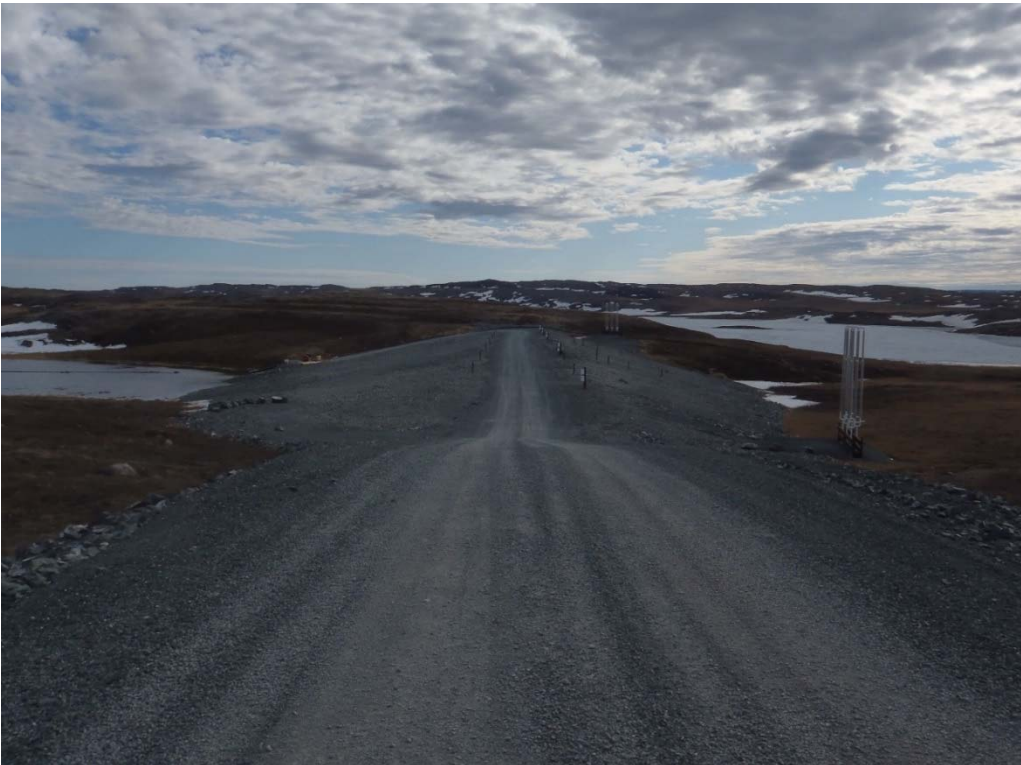
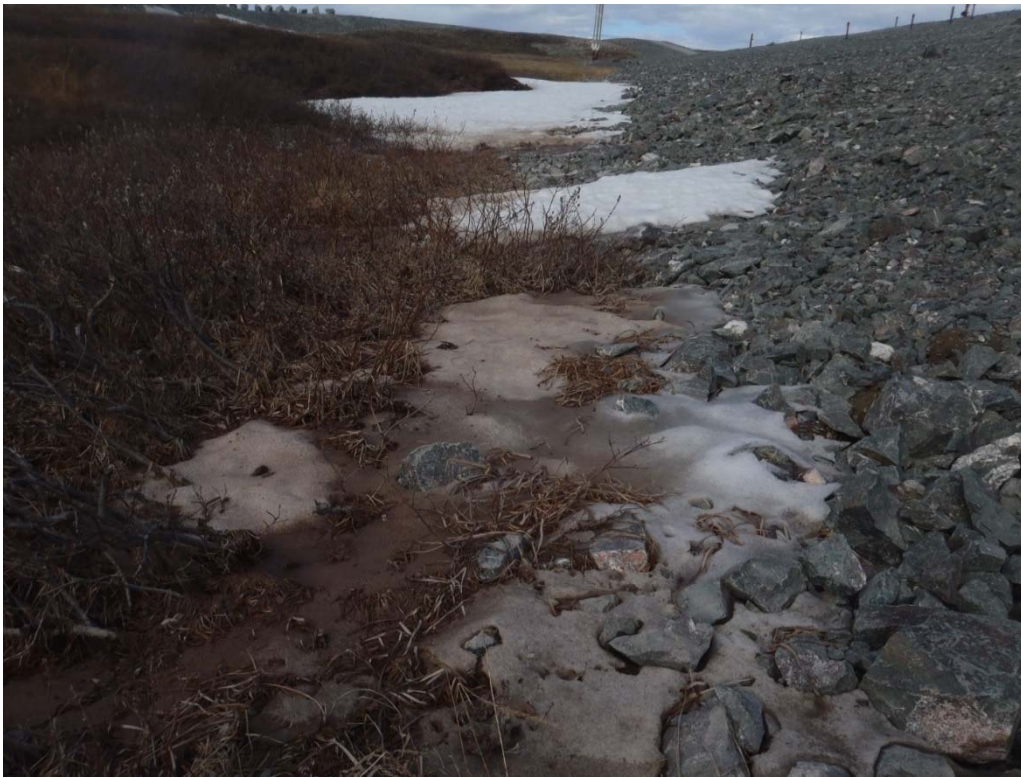
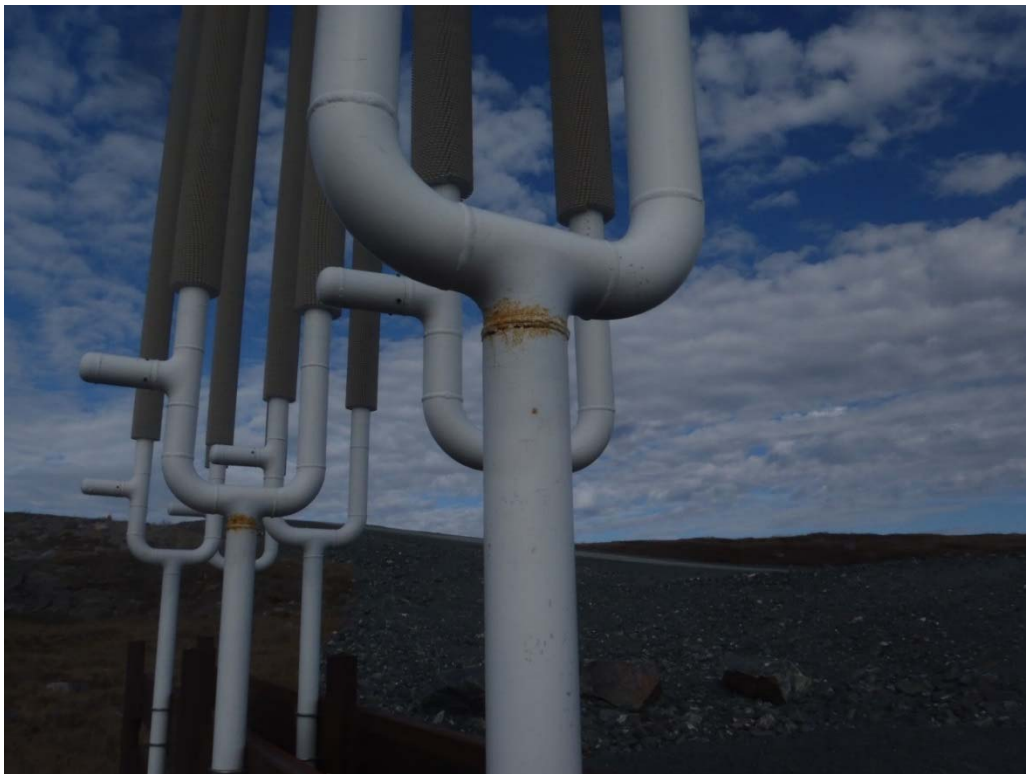
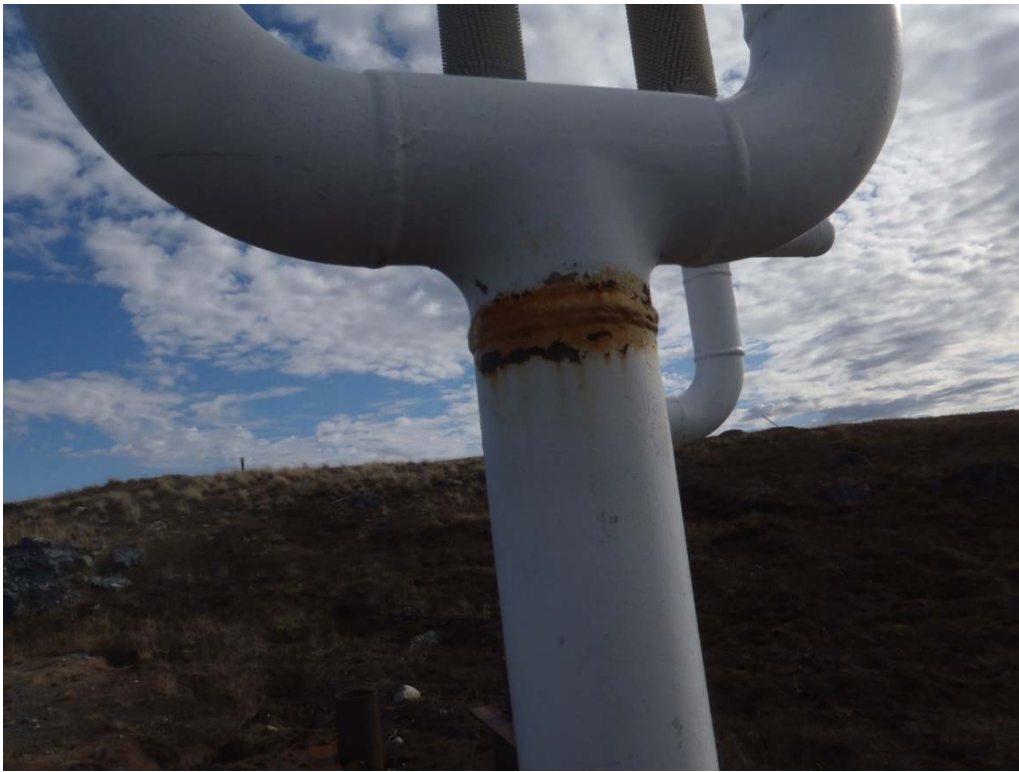
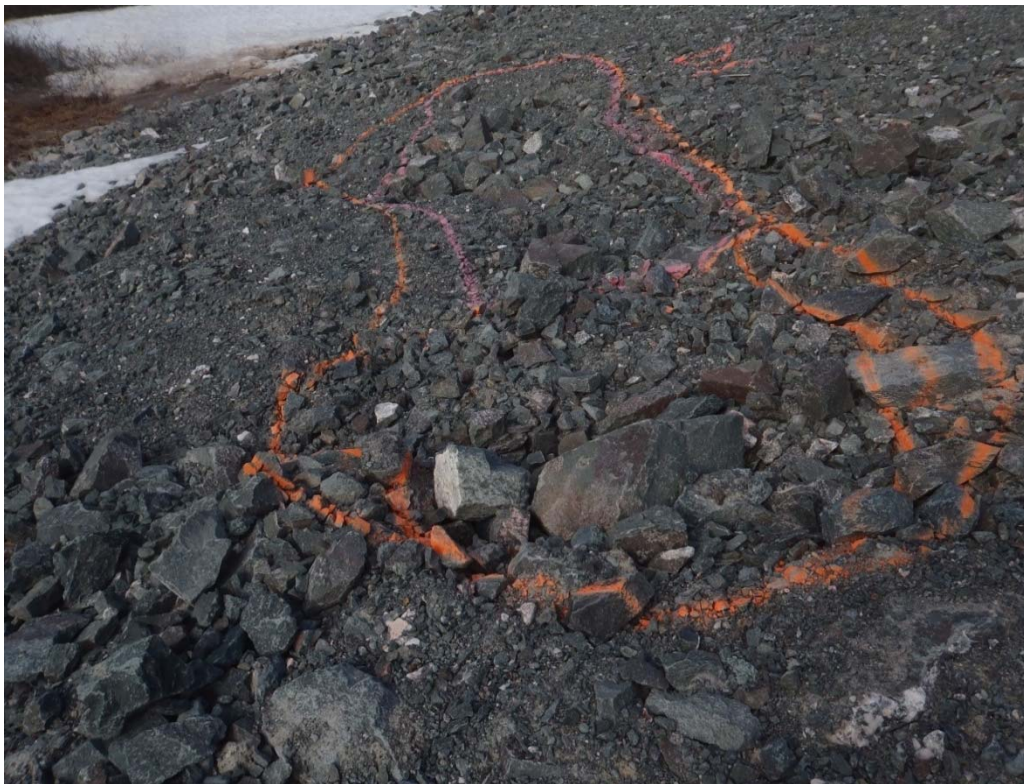
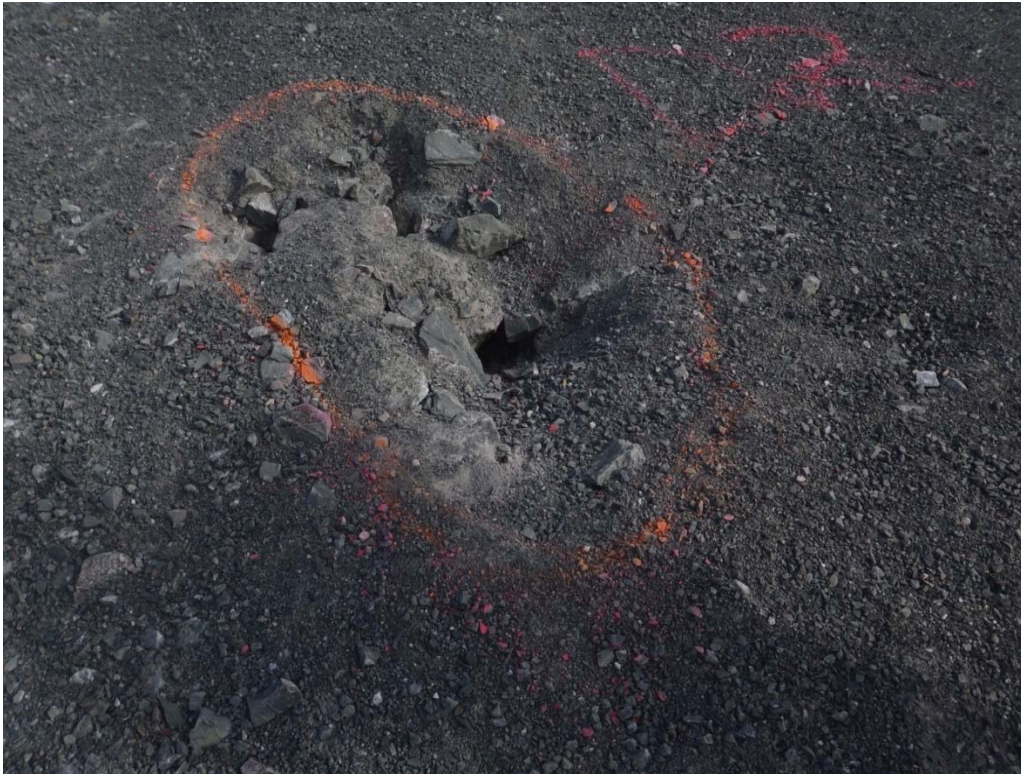
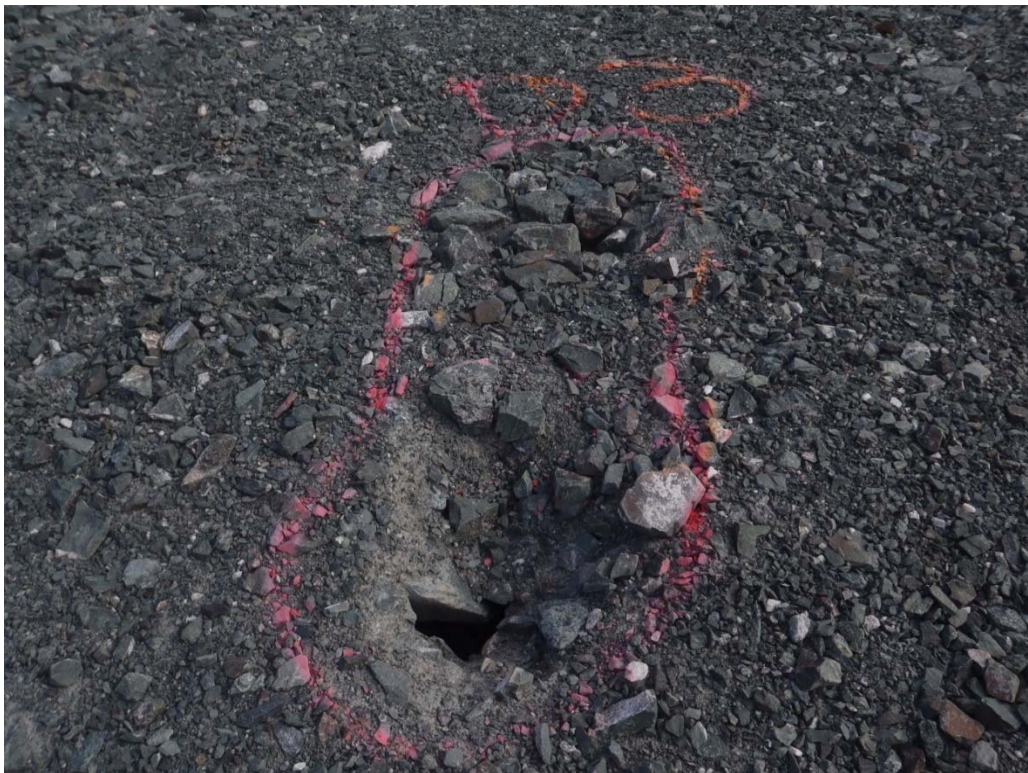
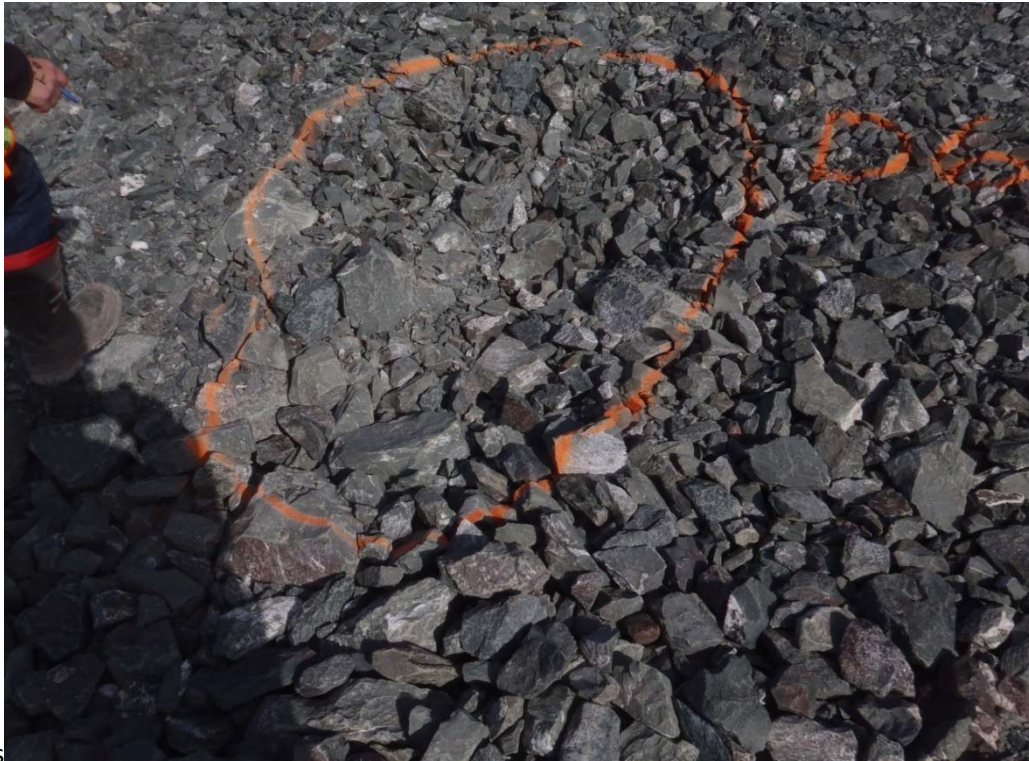
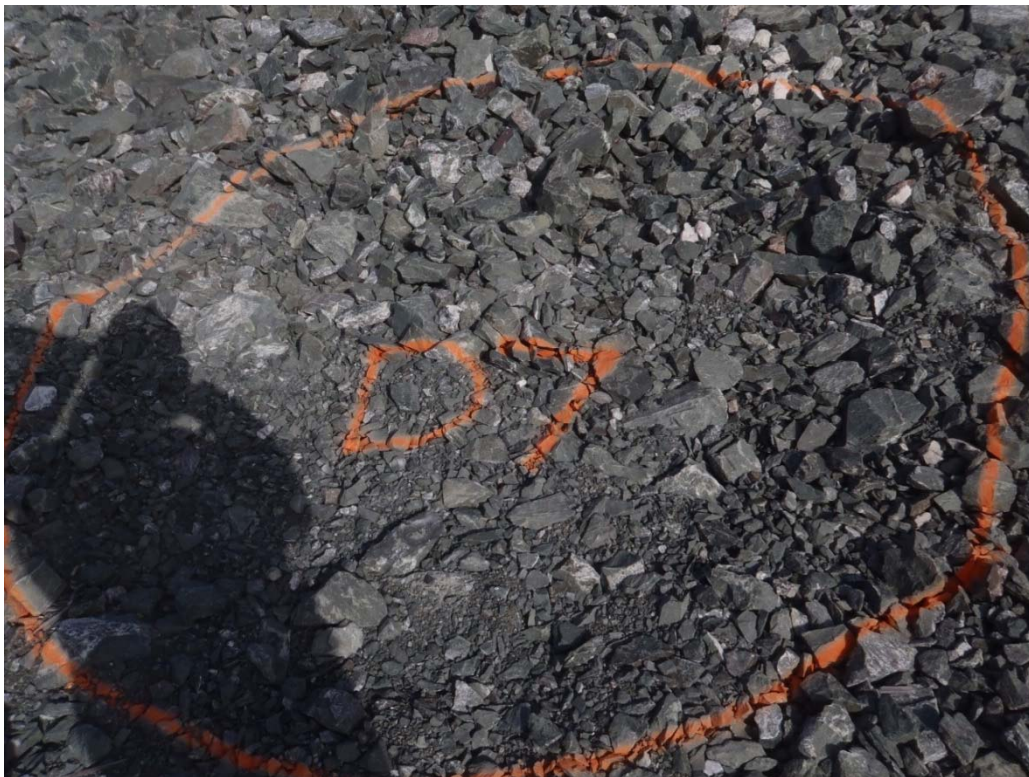
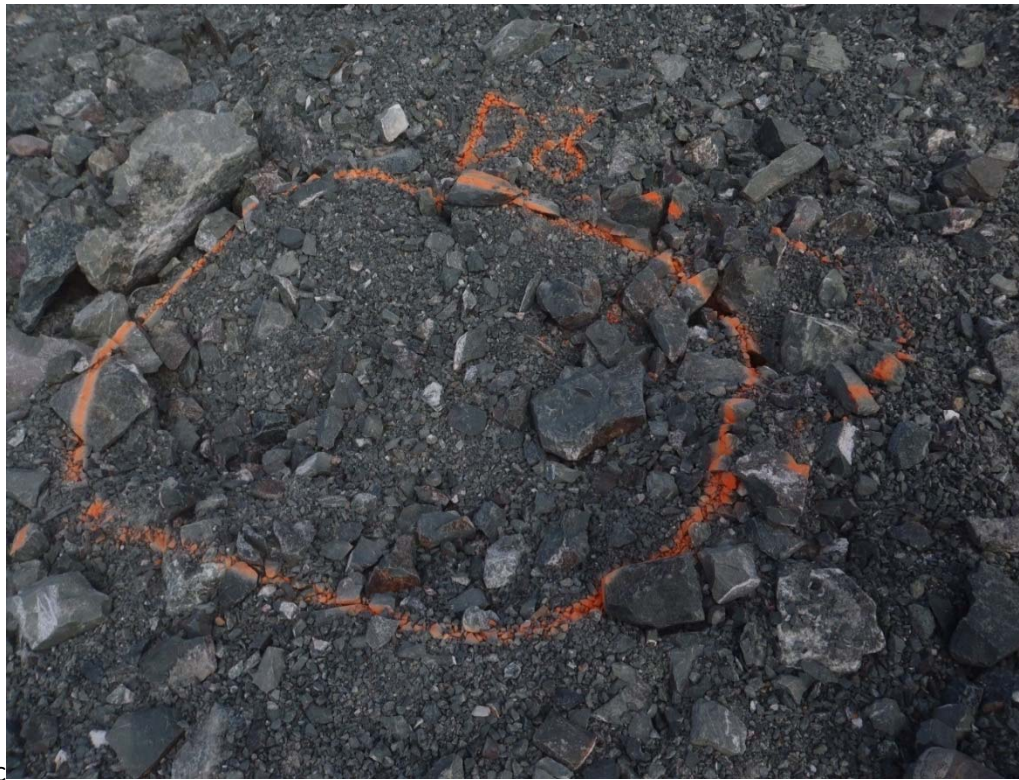
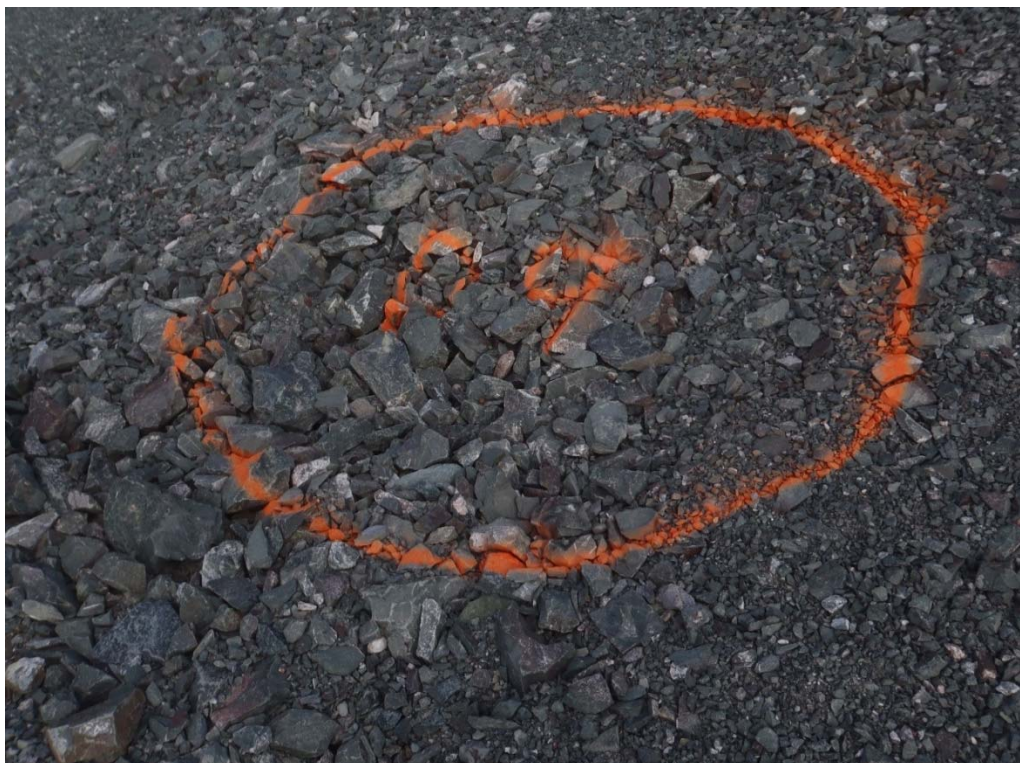
Photos of depressions included.
