North Dam Weekly Walkover Survey Report

Date:	May 9, 2015
Inspected By:	Claire Brown
Conditions:	(ie. snow on ground, clear) Snow covered. Significant drifts.

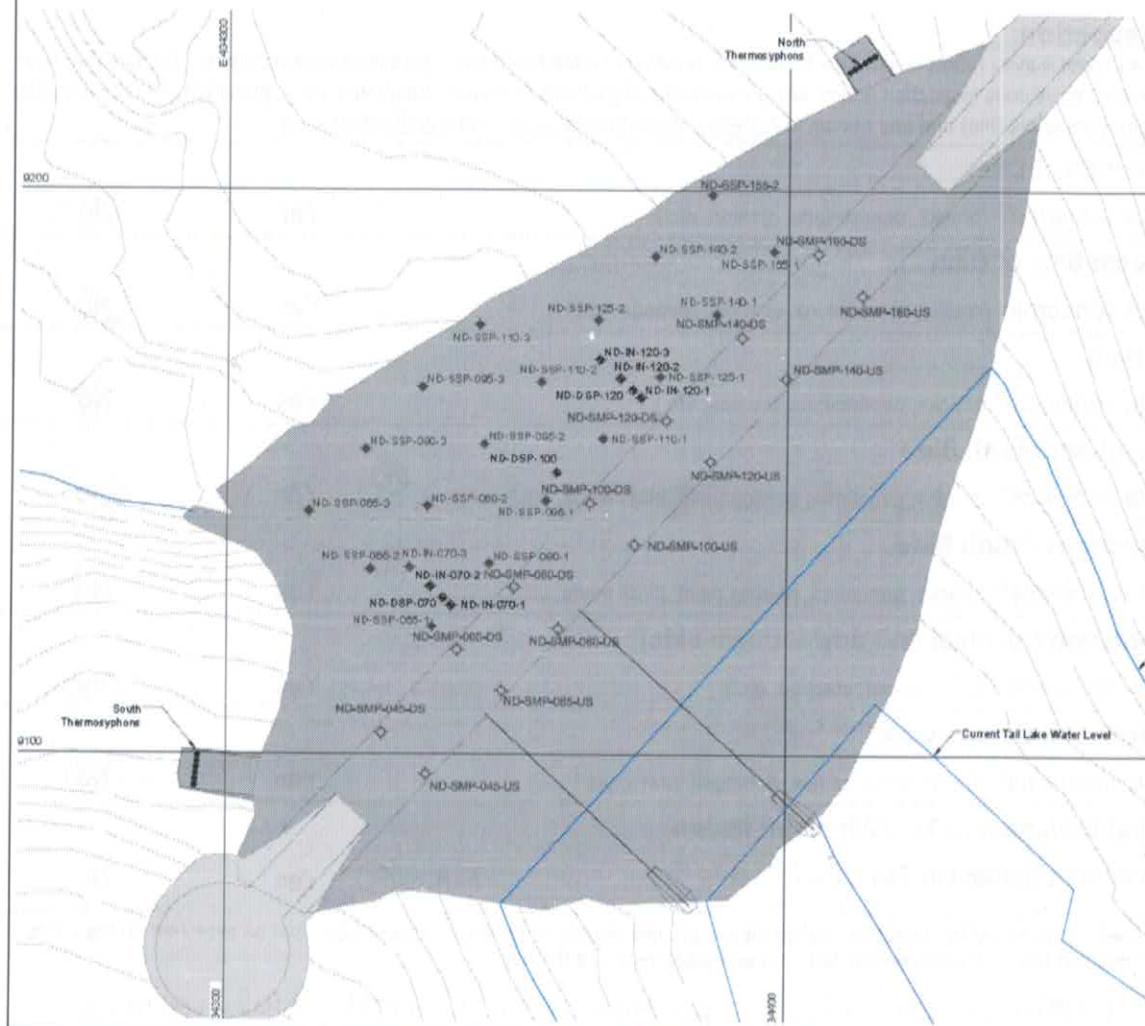
Suspended Sediment in TIA (When not frozen)			
Any suspended sediment in Tail Lake?	NA <input checked="" type="radio"/> B	Yes	No
<p>If you answered yes to any of the questions above please provide details and photos. Observations can be sketched on the figure provided on the next page. If seepage has been noted please estimate the flow.</p> <p><input checked="" type="radio"/> A Snow buildup on the upper portion of several thermistors. Will likely melt during daily temperature highs, but will inspect for additional buildup.</p> <p><input checked="" type="radio"/> B Frozen</p>

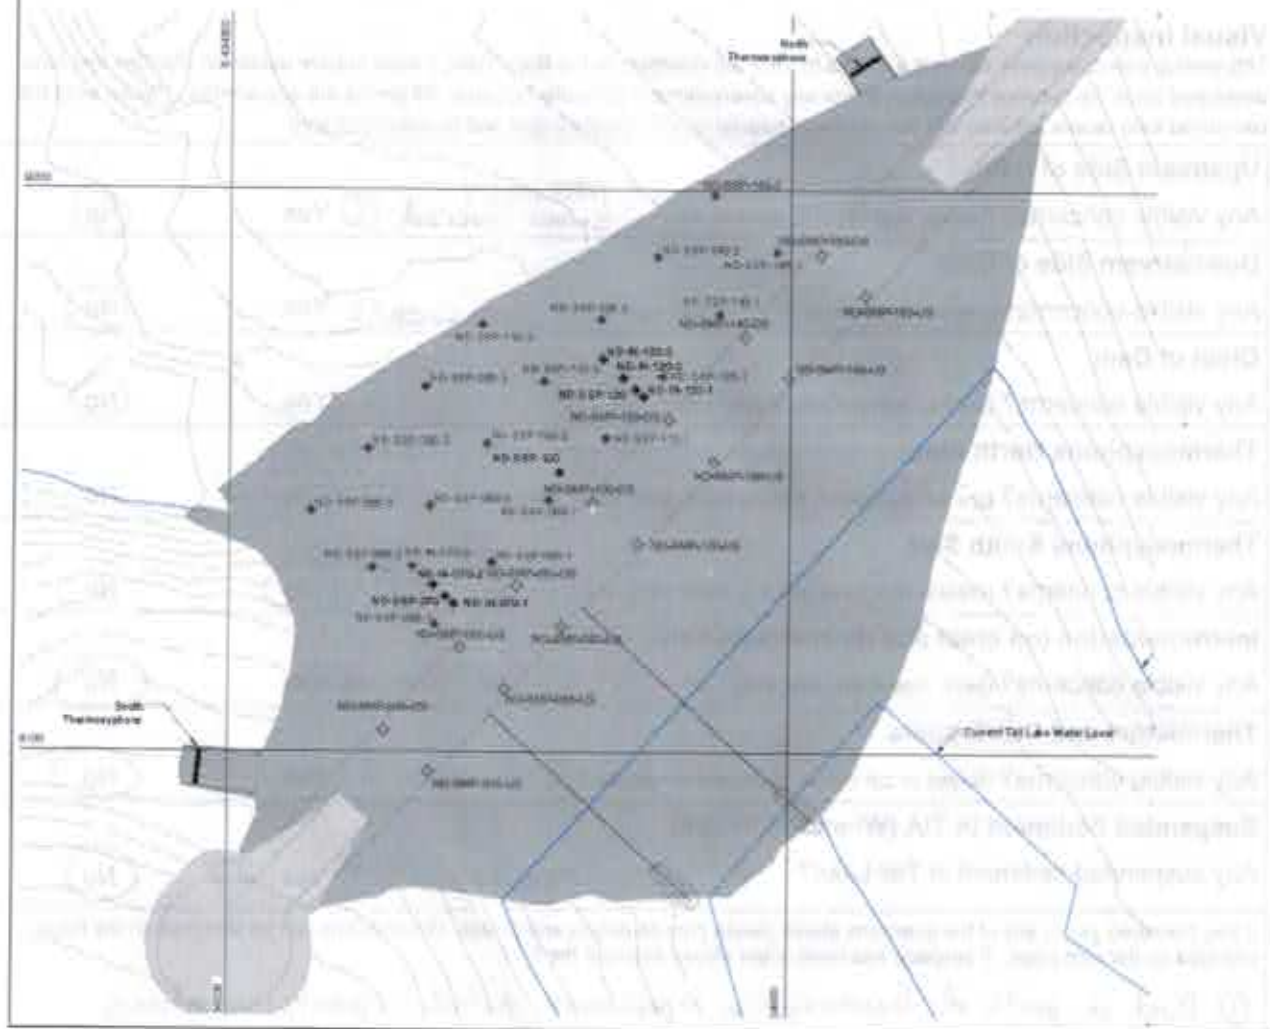
Upstream Side of Dam		
Any visible concerns? (cracks, depressions, erosion, etc.)	PARTIALLY SNOW COVERED ② Yes	No
Downstream Side of Dam		
Any visible concerns? (cracks, depressions, erosion, seepage, etc.)	SNOW COVERED Yes	No
Crest of Dam		
Any visible concerns? (cracks, depressions, erosion, etc.)	Yes	No
Thermosyphons North Side		
Any visible concerns? (cracks, punctures, peeling paint, birds nests, etc.)	① Yes	No
Thermosyphons South Side		
Any visible concerns? (cracks, punctures, peeling paint, birds nests, etc.)	① Yes	No
Instrumentation (on crest and downstream side)		
Any visible concerns? (bent, rusted, cracked, etc.)	Yes	No
Thermistors and Dataloggers		
Any visible concerns? (frayed or cut cables, damaged boxes, etc.)	Yes	No
Suspended Sediment in TIA (When not frozen)		
Any suspended sediment in Tail Lake?	FROZEN Yes	No
<p>If you answered yes to any of the questions above please provide details and photos. Observations can be sketched on the figure provided on the next page. If seepage has been noted please estimate the flow.</p> <p>① Rust on joints of thermosyphon → previously noted in past inspections</p> <p>② Snow cover on u/s side. No visible issues in clean area</p>

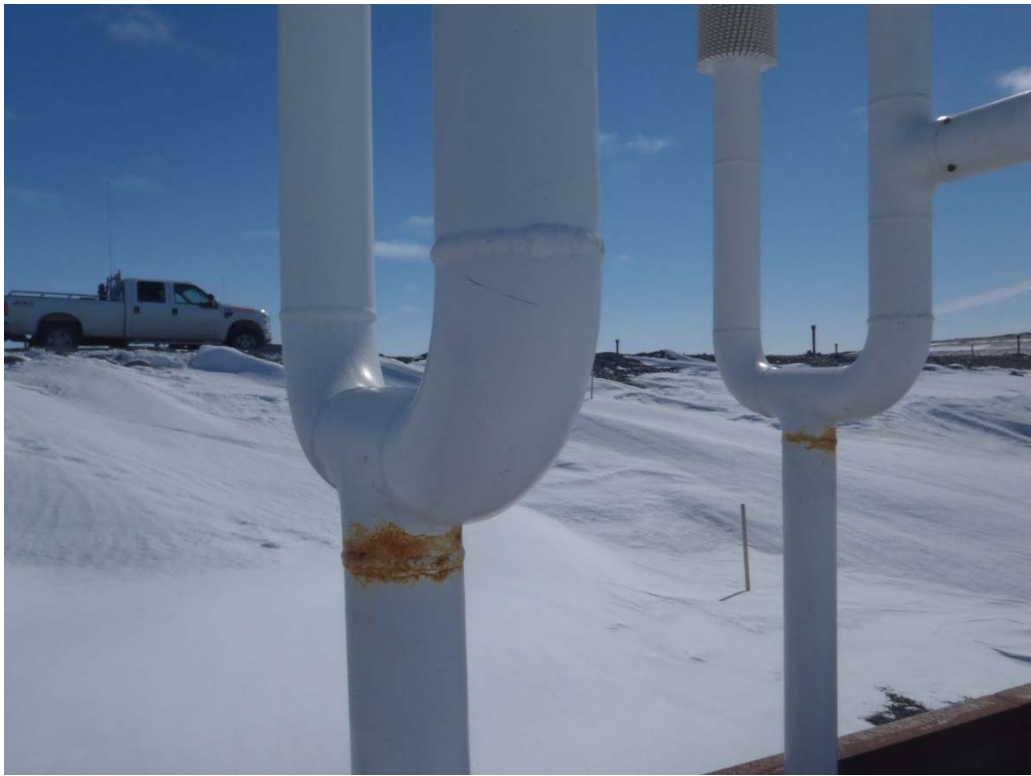
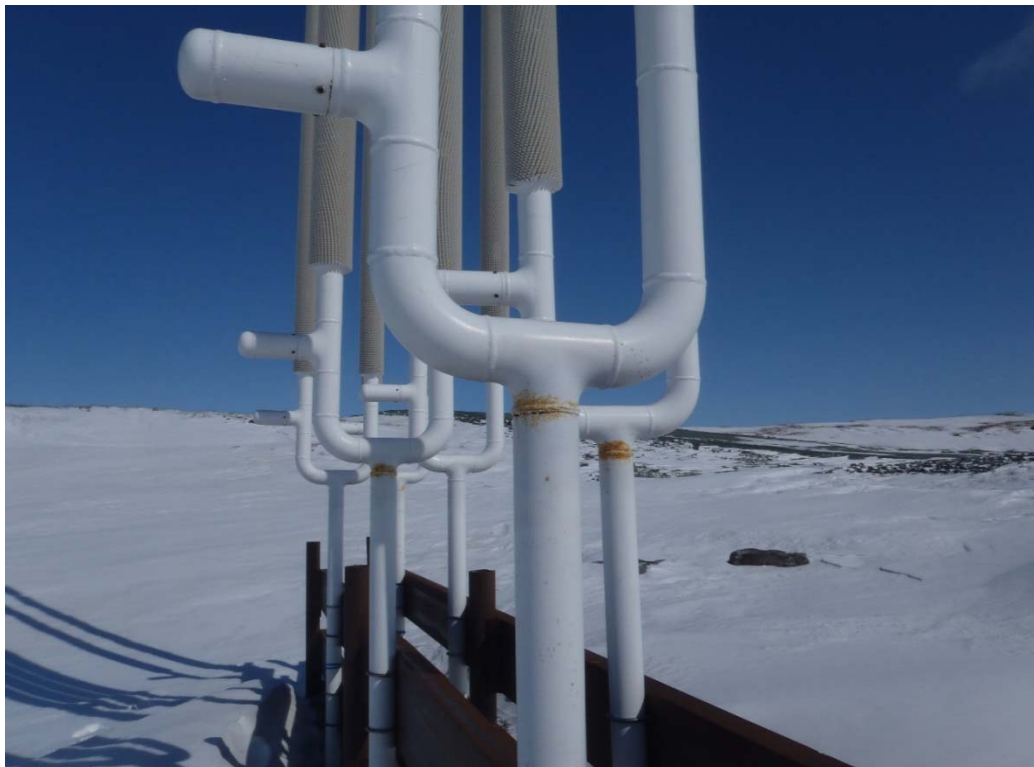
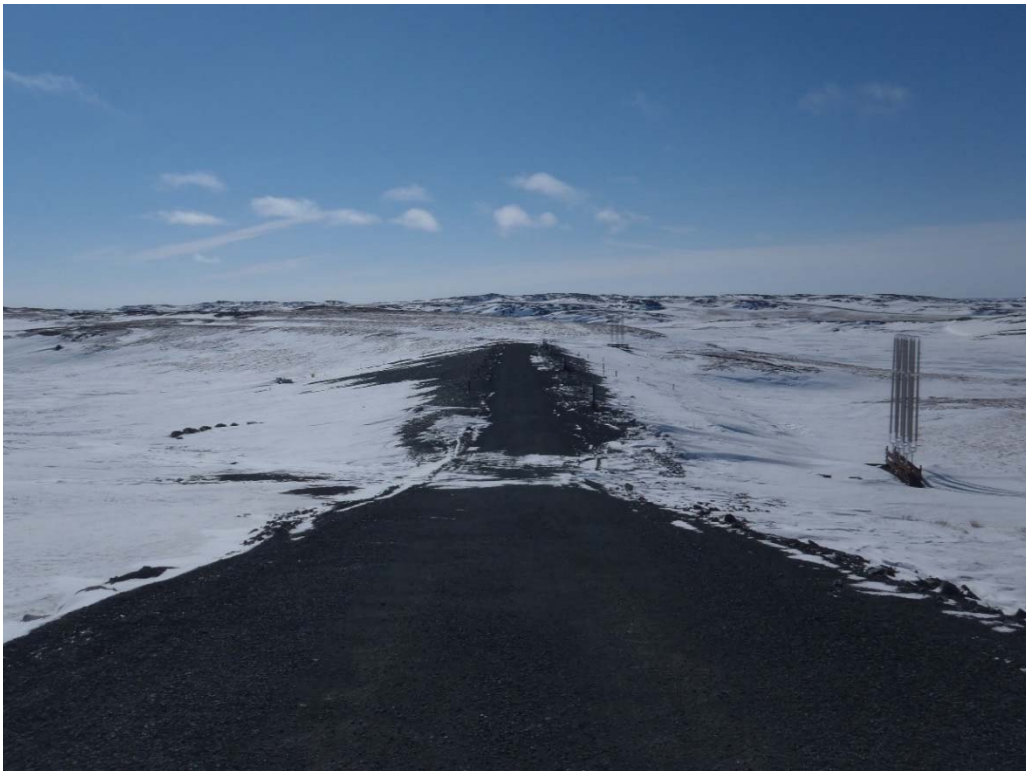
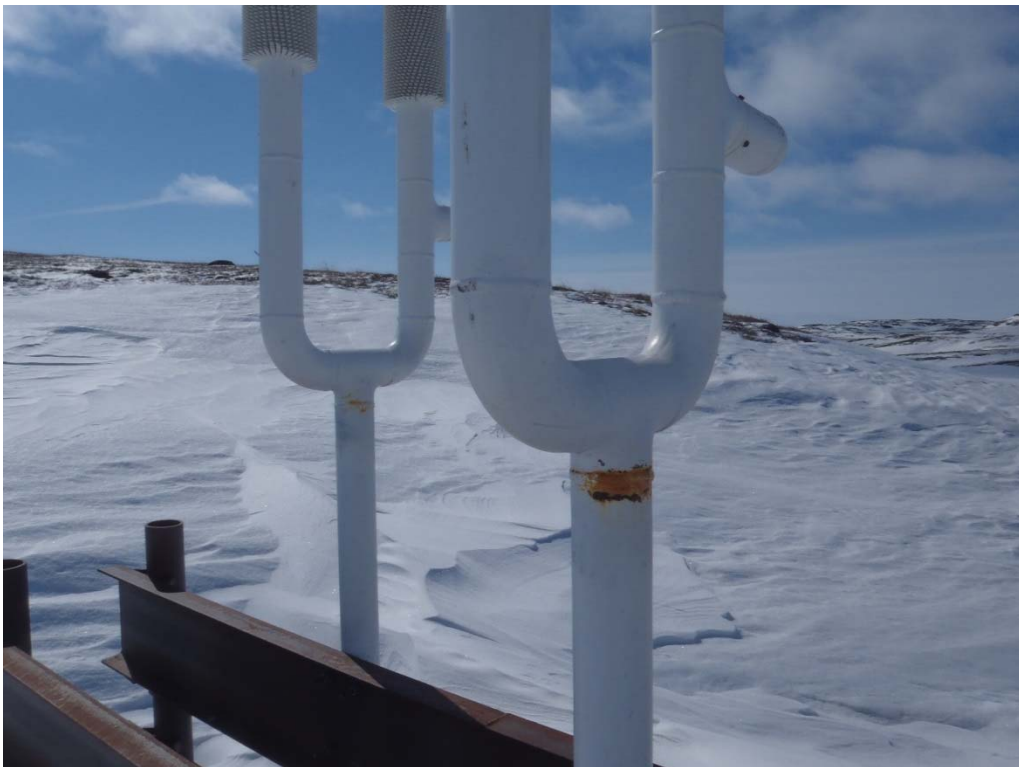
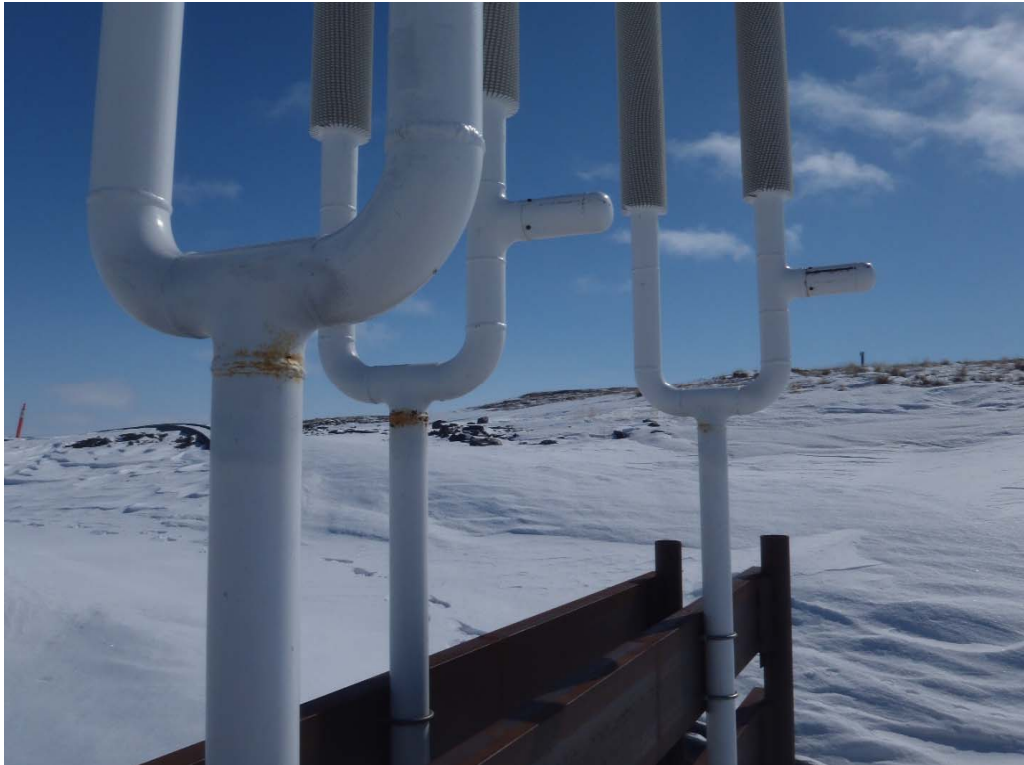
Rust on N4S thermographs.

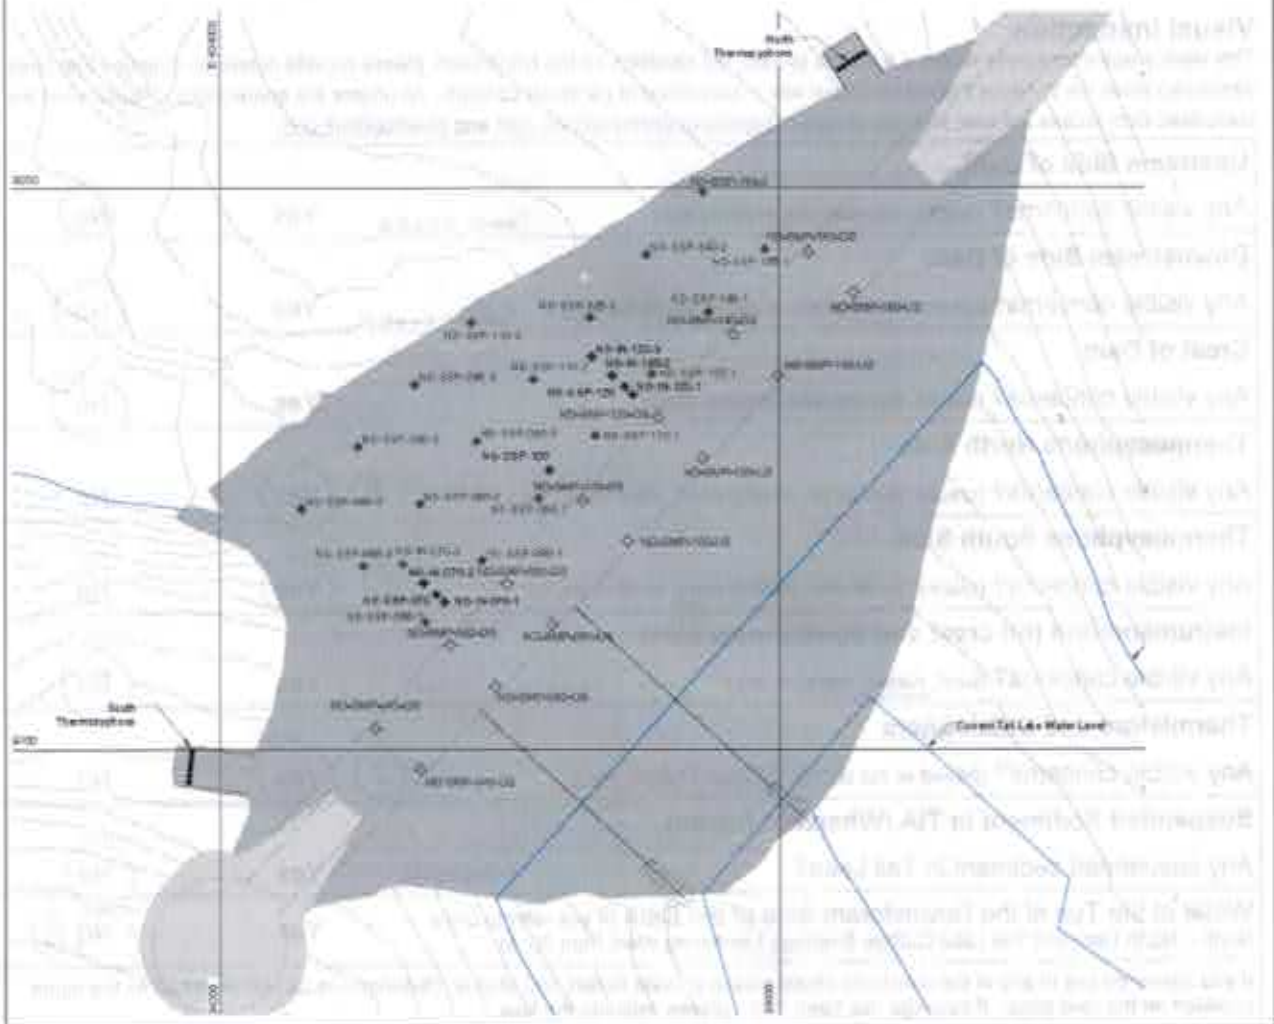
Yes	No ③
If you answered yes to any of the questions above please provide details and photos. Observations can be sketched on the figure provided on the next page. If seepage has been noted please estimate the flow.			
① Rust noted in previous inspections ② Noticed that display light on CR1000 #1 is not orange (is on CR1000 #2 data logger) ③ Snow still accumulated at d/s toe of dam

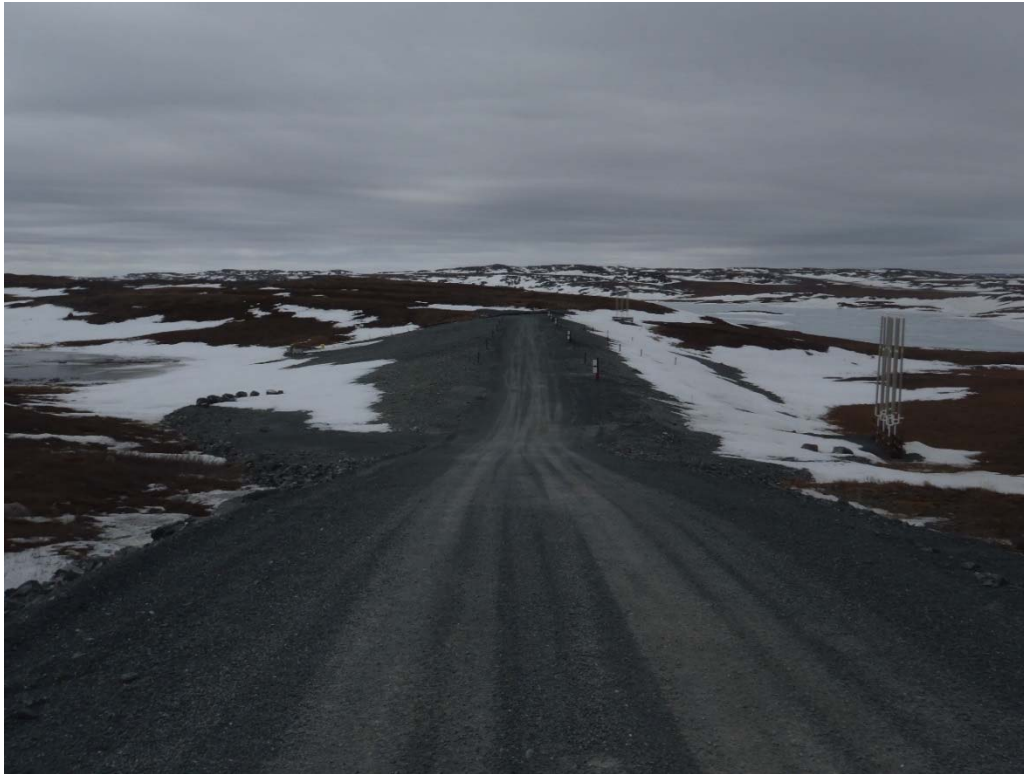
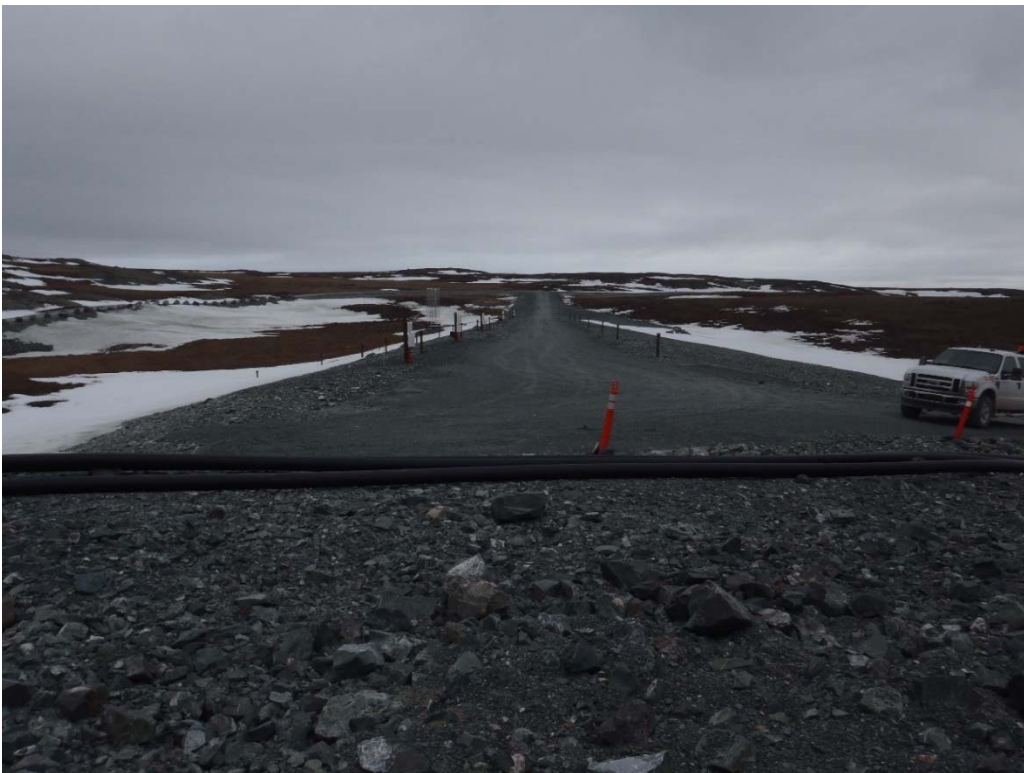
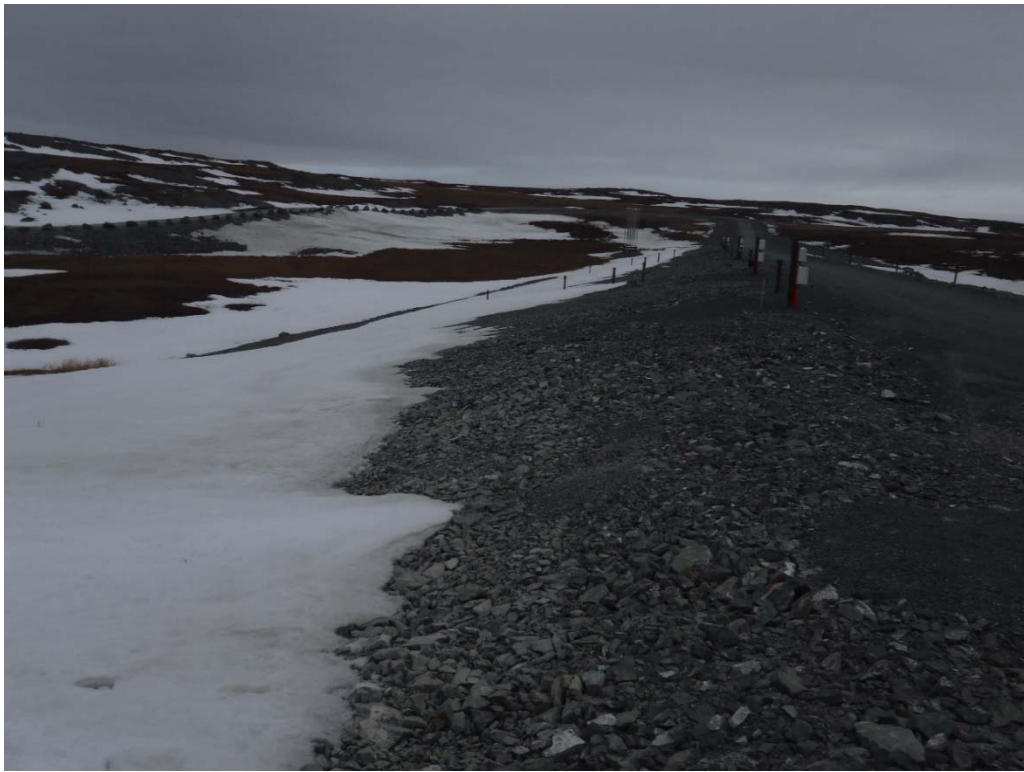
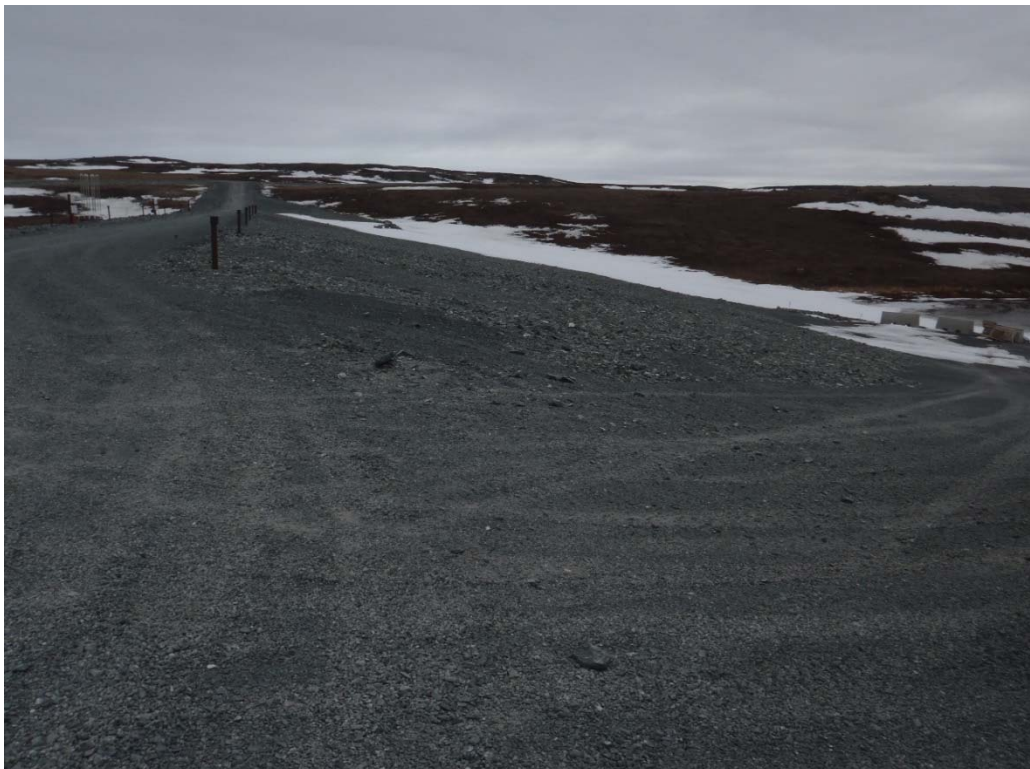
Snow cover on u/s, d/s slopes of dam.

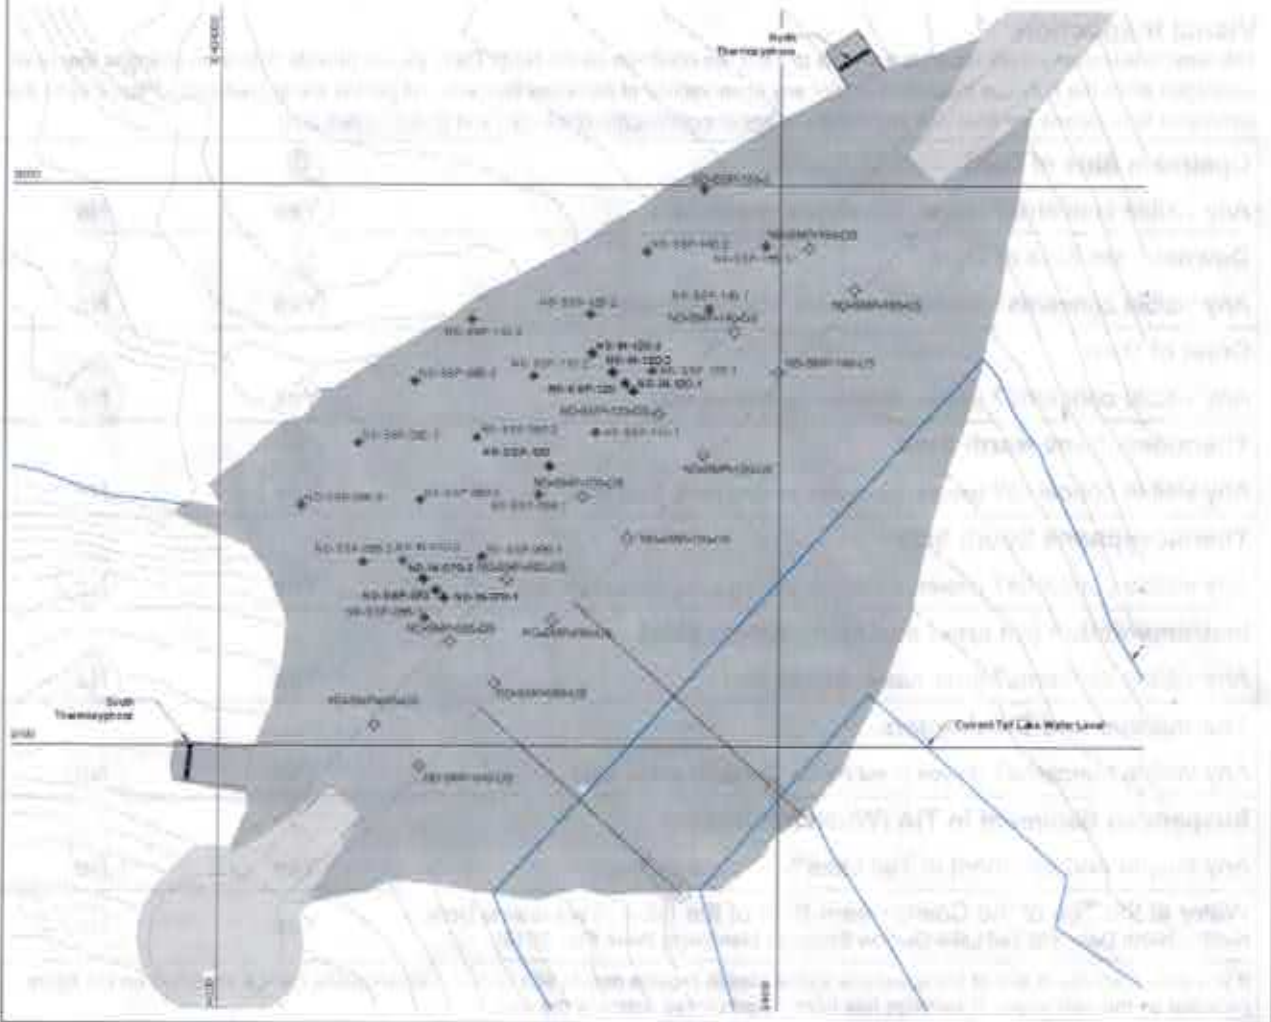
If you answered yes to any of the questions above please provide details and photos. Observations can be sketched on the figure provided on the next page. If seepage has been noted please estimate the flow.		
<p>① Snow accumulation at shore line.</p> <p>② - Depressions marked in 2014 not visible due to snow cover.</p> <p>③ Rust noted in previous inspections.</p> <p>④ Some signs of erosion in area of sloping inclinometer 0702-3, snow cover on the downstream side makes it difficult to identify any depression.</p> <p>⑤ No visible seepage due to snow cover.</p>

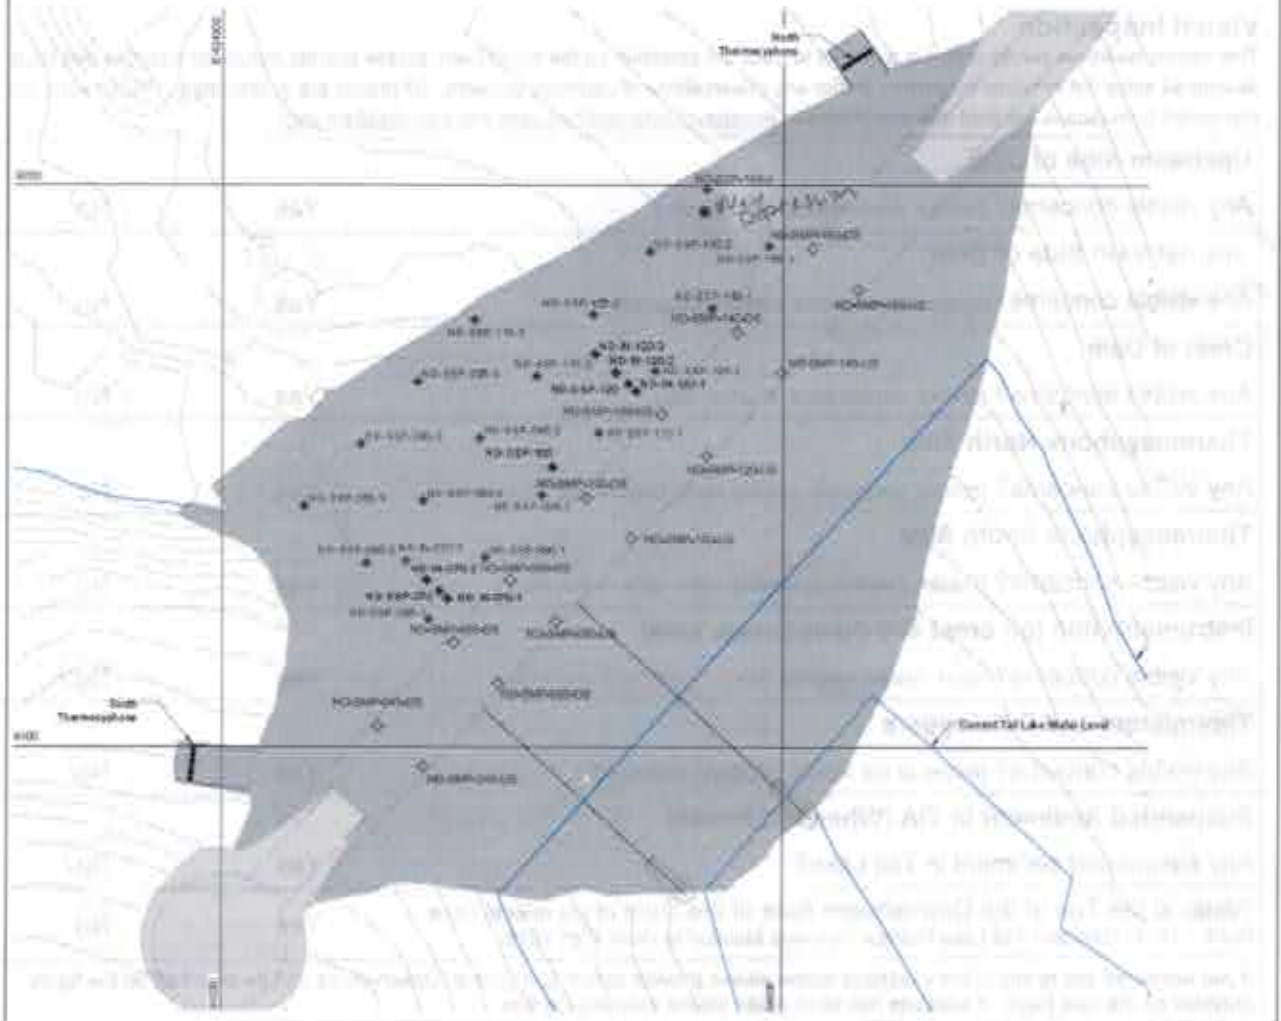
Any visible concerns? (bent, rusted, cracked, etc.)	Yes	No
If you answered yes to any of the questions above please provide details and photos. Observations can be sketched on the figure provided on the next page. If seepage has been noted please estimate the flow.		
<p>① Some rust @ base of Thermosyphons</p> <p>② Questionable Depressions 1m North of already marked Depression, further up North</p> <p>③ D2 - some painted rocks fallen down into Depression</p> <p>④ Some rust to box of Thermosyphon</p>
