North Dam Weekly Walkover Survey Report

Date:	June 27, 2015
Inspected By:	Darcy Kanayok
Conditions:	(ie. snow on ground, clear) Clear

Date:	July 4/2015
Inspected By:	SARAH WARNOCK
Conditions:	(ie. snow on ground, clear) snow all melted, clear → marked new depressions July 4/15. Rain overnight on into day

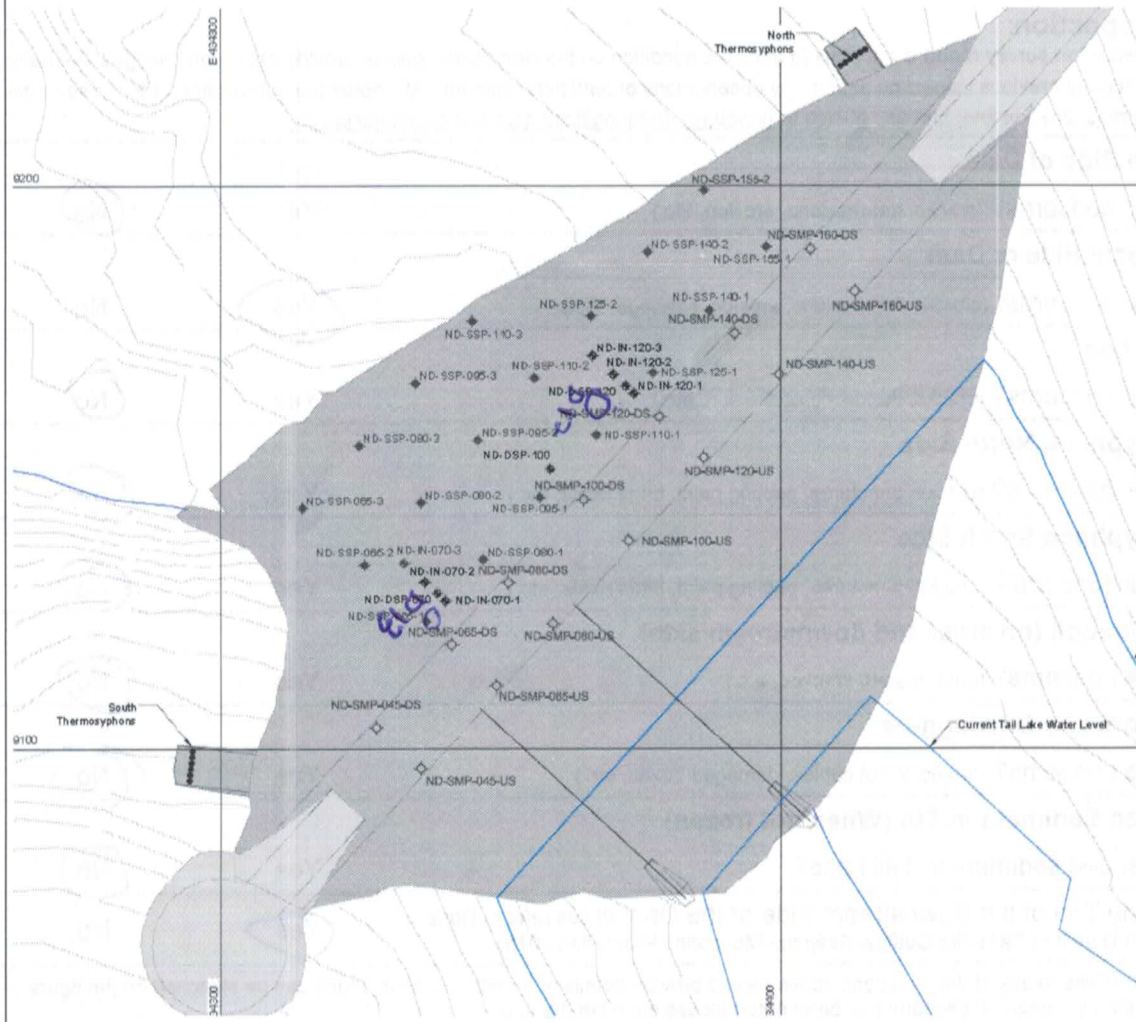
D12 - New depression
D13 - New depression

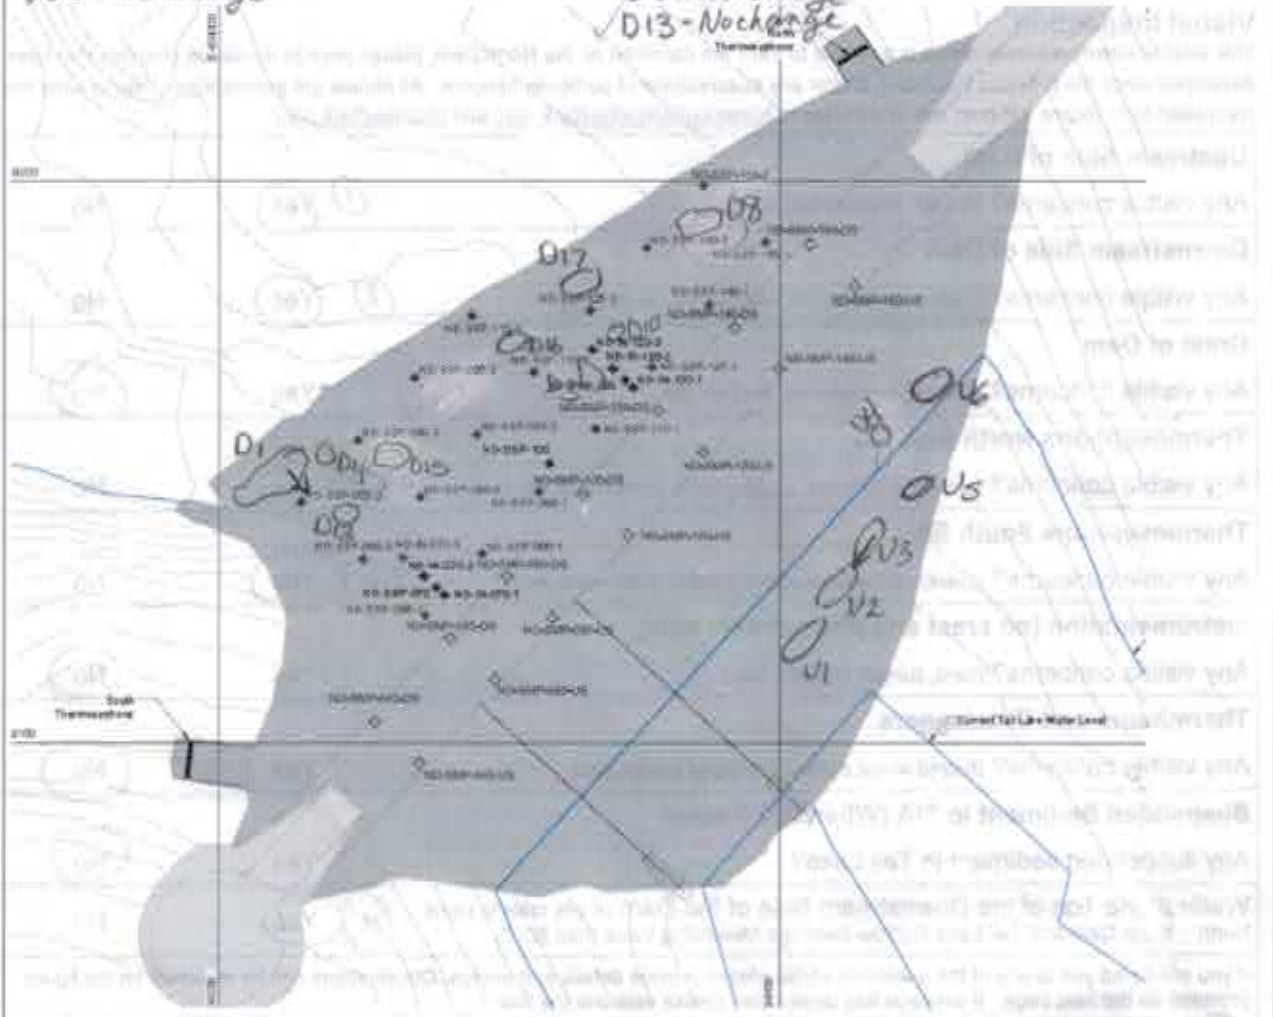
④ Yes	No
If you answered yes to any of the questions above please provide details and photos. Observations can be sketched on the figure provided on the next page. If seepage has been noted please estimate the flow.		
① Two new depressions marked on u/s side of dam. See reverse. ② Four new depressions marked on d/s side. Two depressions appear to have expanded. See reverse. ③ Rust noted in previous inspections. ④ Seep noted at 13W 0434294 7559147. Water Quality sample collected from seep location, Tail Lake and background location on July 6/2015. Sample ID: NOSP-06JUL15, BKGSP-06JUL15, TLI-06JUL15.

- ✓ U1 - No change
- ✓ U2 - No change
- ✓ U3 - Expanding towards U2
- ✓ U4 - No change
- ✓ U5 - New - 13W 0434415 7559130
- ✓ U6 - New - 13W 0434432 7559166
- ✓ D1 - Expanding towards crest of dam
- ✓ D2 - No change
- ✓ D3 - No change

- ✓ D4 - No change
- ✓ D5 - Backfilled
- ✓ D6 - No change
- ✓ D7 - Expanded towards toe
- ✓ D8 - Expanded towards toe
- ✓ D9 - No change
- ✓ D10 - No change
- ✓ D11 - No change
- ✓ D12 - No change
- ✓ D13 - No change
- ✓ D14 - New 13W 0434432 7559144
- ✓ D15 - New 0434434 7559166
- ✓ D16 - New 0434437 7559177
- ✓ D17 - New 04344363 7559188
