North Dam Weekly Walkover Survey Report

2015 Geotechnical Inspection

2015 North Dam Geotechnical Inspection

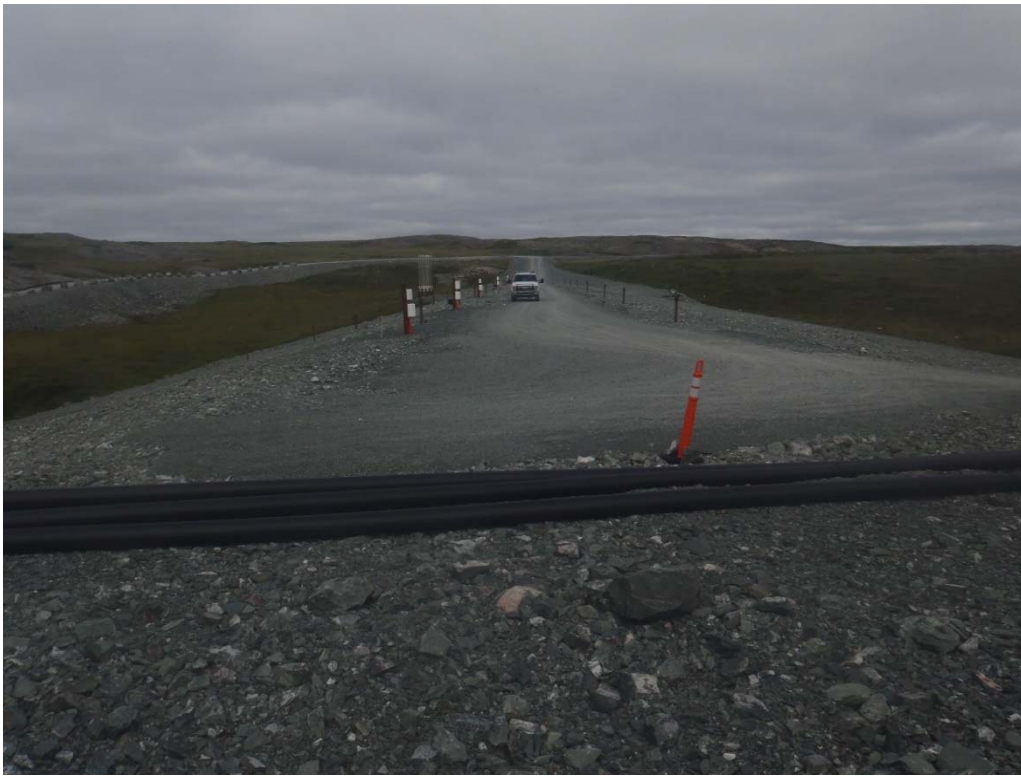
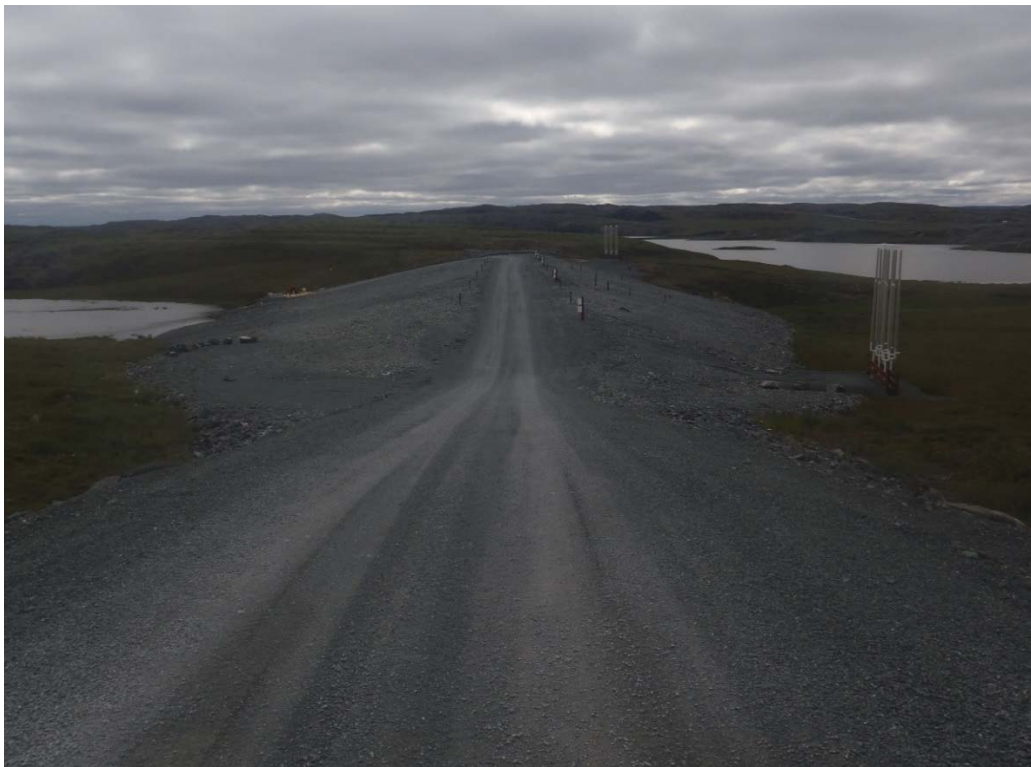
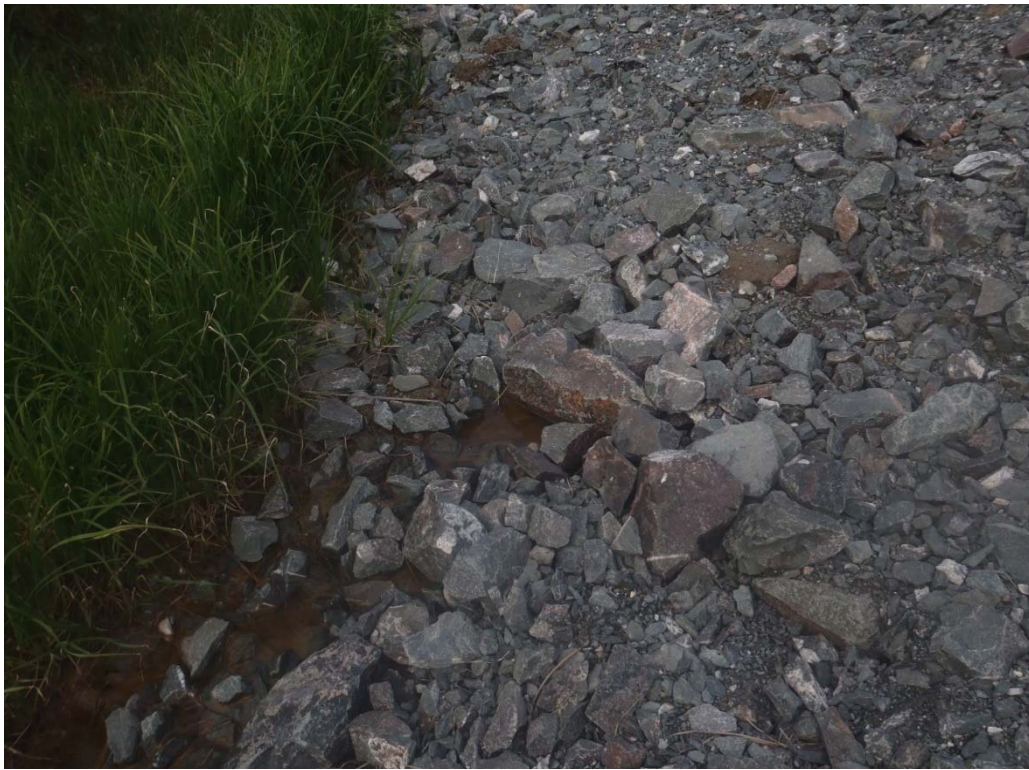
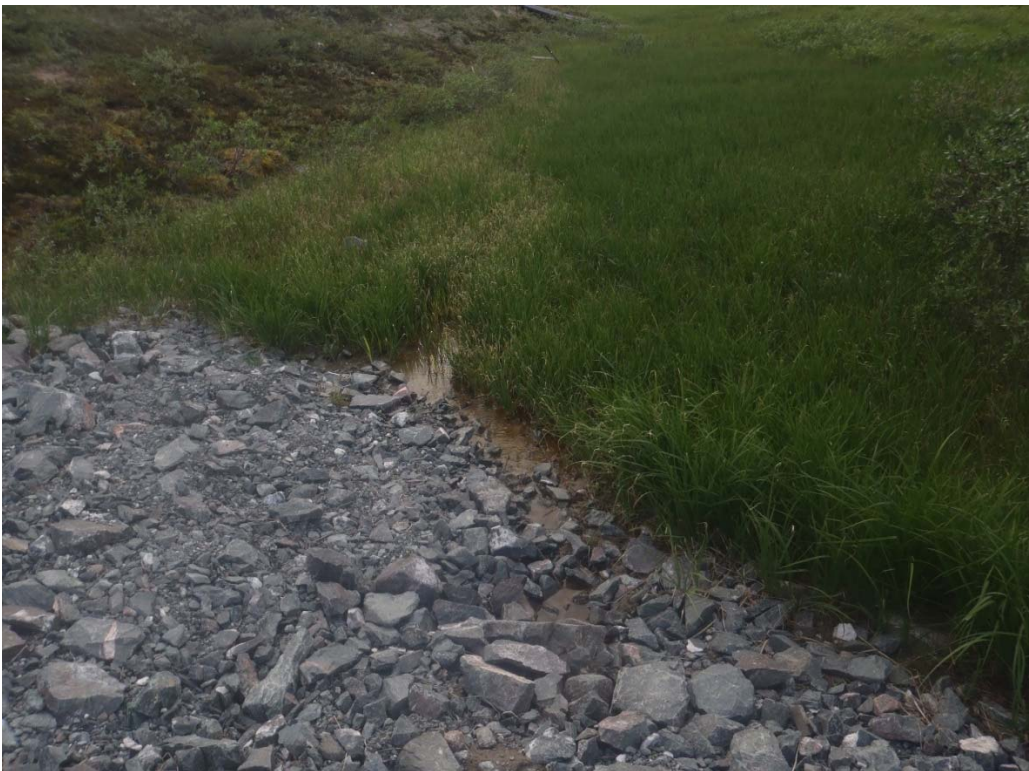
If you answered yes to any of the questions above please provide details and photos. Observations can be sketched on the figure provided on the next page. If seepage has been noted please estimate the flow.		
<p>① No new depressions marked. No change to previously identified depressions.</p> <p>② Rust noted previously - no change</p> <p>③ Water at toe of dam identified in three locations. Thick vegetation along toe made it difficult to identify source location. Appears to run from North end of d/s toe to south end. Field measurements collected for pH, EC, temp, ORP.</p>

Other photos, please describe *South seep location*

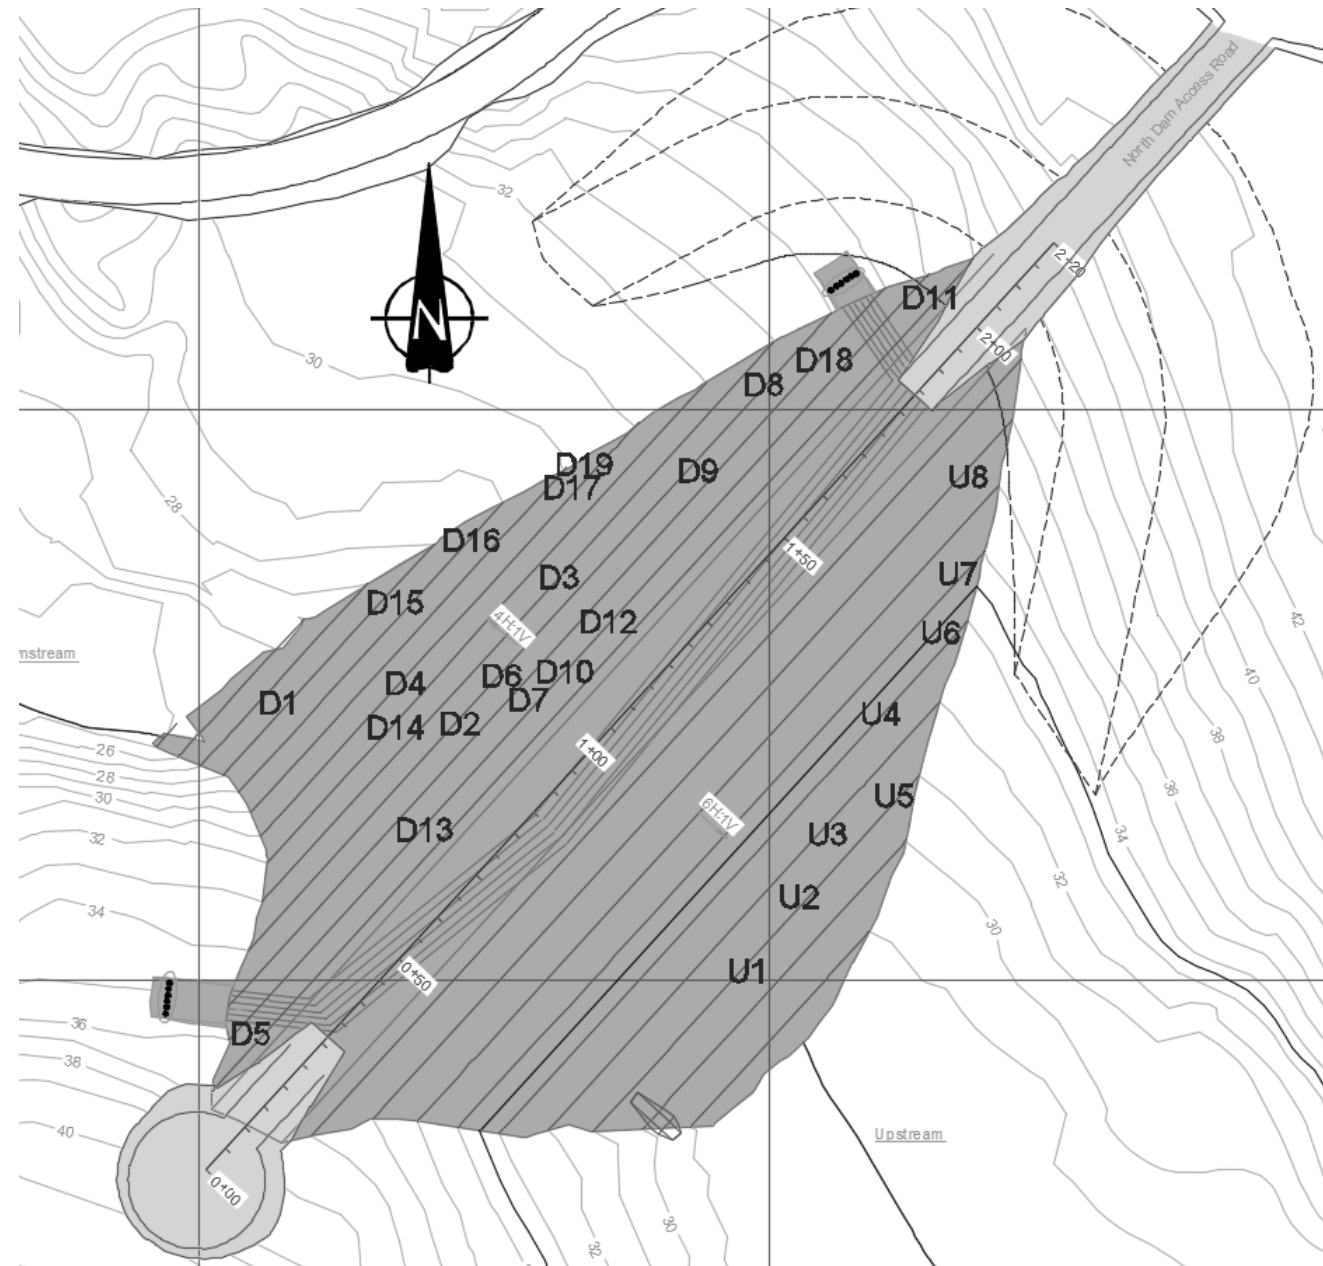
Date: Oct. 2015
Approved: PDL
Figure: H.1

ID	Location	Comments
U1	Upstream	First noted June 2014 Boundaries spray painted and ID given July 2014
U2	Upstream	First noted June 2014 Boundaries spray painted and ID given July 2014
U3	Upstream	First noted June 2014 Boundaries spray painted and ID given July 2014 July 4, 2015 - Expanding toward U2
U4	Upstream	First noted June 19, 2015 in weekly reports - No significant change in 2015
U5	Upstream	First noted July 4, 2015 in weekly reports - No significant change in 2015
U6	Upstream	First noted July 4, 2015 in weekly reports - No significant change in 2015
U7	Upstream	First noted July 11, 2015 in weekly reports - No significant change in 2015
U8	Upstream	First noted July 11, 2015 in weekly reports - No significant change in 2015
D1	Downstream	Identified during 2014 annual geotechnical inspection, spray painted and given ID. September 1, 2014 - expanded towards the south September 20, 2014 - TMAC ESR noted the depression looks to have expanded, paint mark updated. July 4, 2015 - Slight expansion toward the crest was noted in the daily report

D2	Downstream	First noted in 2013 Annual Geotechnical Inspection September 14, 2014 - TMAC ESR noted that the depression may have expanded slightly
D3	Downstream	First noted in 2013 Annual Geotechnical Inspection August 10, 2014 - larger area marked
D4	Downstream	First noted August 16, 2014 in weekly report prepared by TMAC ESR. Roughly 0.5x0.5 m area
D5	Downstream	First noted August 16, 2014 in weekly report prepared by TMAC ESR. TMAC ESR notes it could be animal burrows ~1x1 m wide disturbed area (August 2014) July 4, 2015 - Backfilled
D6	Downstream	First noted August 25, 2014 in weekly report prepared by TMAC ESR. 1.5x1.5 m area September 6, 2014 - Possible incremental sloughing (minimal)
D7	Downstream	First noted August 25, 2014 in weekly report prepared by TMAC ESR July 4, 2015 - Paint outline was expanded toward toe as noted in weekly walkover report
D8	Downstream	First noted August 25, 2014 in weekly report prepared by TMAC ESR. Area with signs of erosion. September 20, 2014 - TMAC ESR noted depression looks to have expanded on top right. Difficult to tell from photos, due to snow (and unlabeled photos). July 4, 2015 - Paint outline was expanded toward toe as noted in weekly walkover report

D9	Downstream	First noted September 14, 2014 in weekly report prepared by TMAC ESR
D10	Downstream	First noted June 19, 2015 in weekly reports - No significant change in 2015
D11	Downstream	First noted June 19, 2015 in weekly reports - No significant change in 2015
D12	Downstream	First noted June 27, 2015 in weekly reports - No significant change in 2015
D13	Downstream	First noted June 27, 2015 in weekly reports - No significant change in 2015
D14	Downstream	First noted July 4, 2015 in weekly reports - No significant change in 2015
D15	Downstream	First noted July 4, 2015 in weekly reports - No significant change in 2015
D16	Downstream	First noted July 4, 2015 in weekly reports - No significant change in 2015
D17	Downstream	First noted July 4, 2015 in weekly reports - No significant change in 2015
D18	Downstream	First noted July 11, 2015 in weekly reports - No significant change in 2015
D19	Downstream	First noted July 11, 2015 in weekly reports - No significant change in 2015
