North Dam Weekly Walkover Survey Report

Date:	July 19, 2015
Inspected By:	Robert Maksagak
Conditions:	(ie. snow on ground, clear) clear

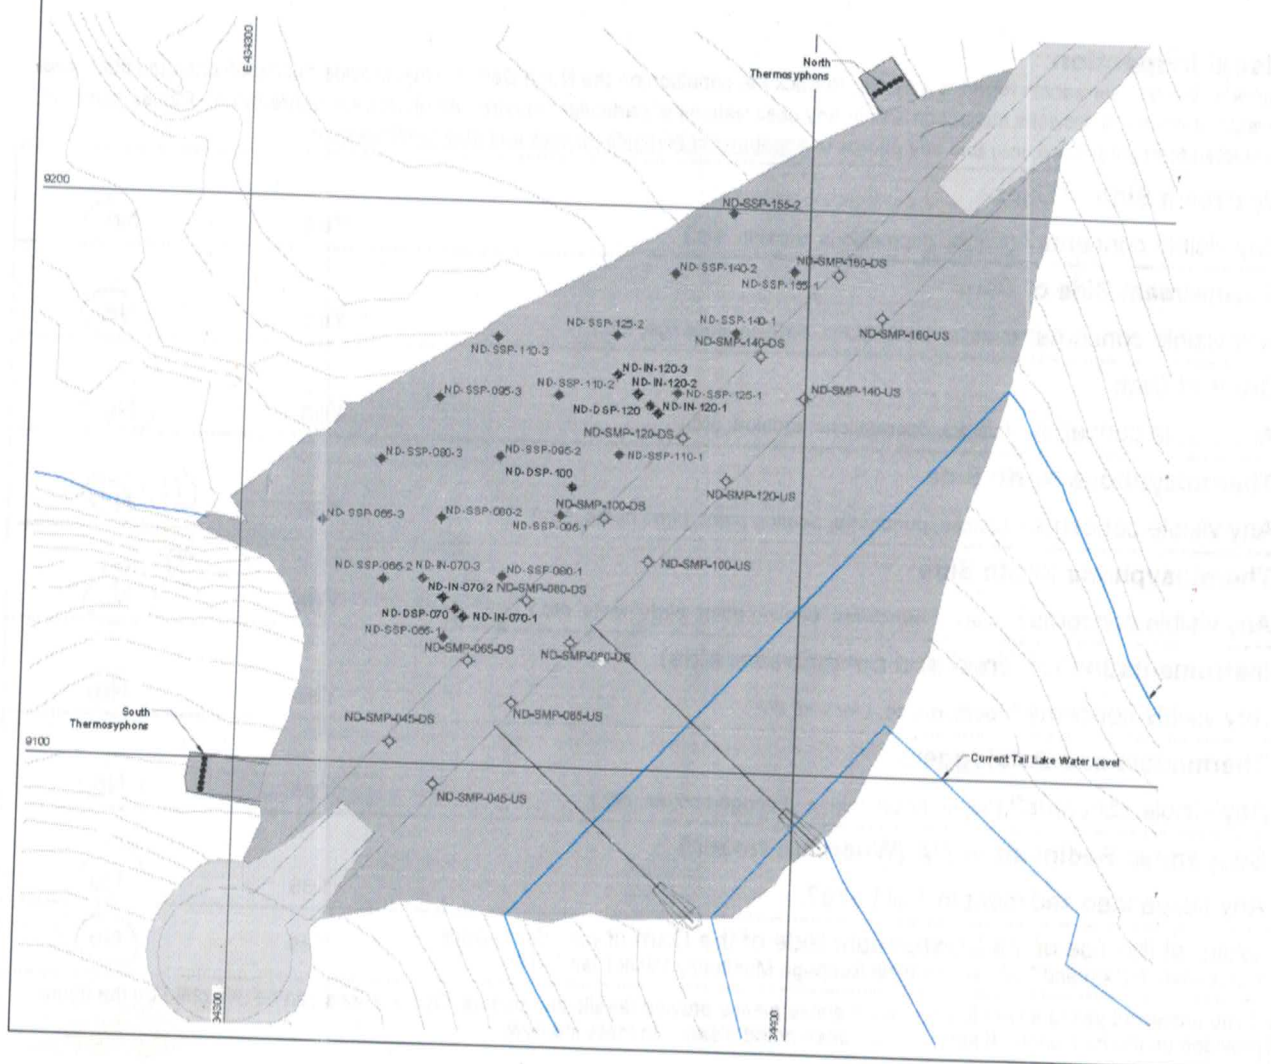
① same rust as previous inspections.

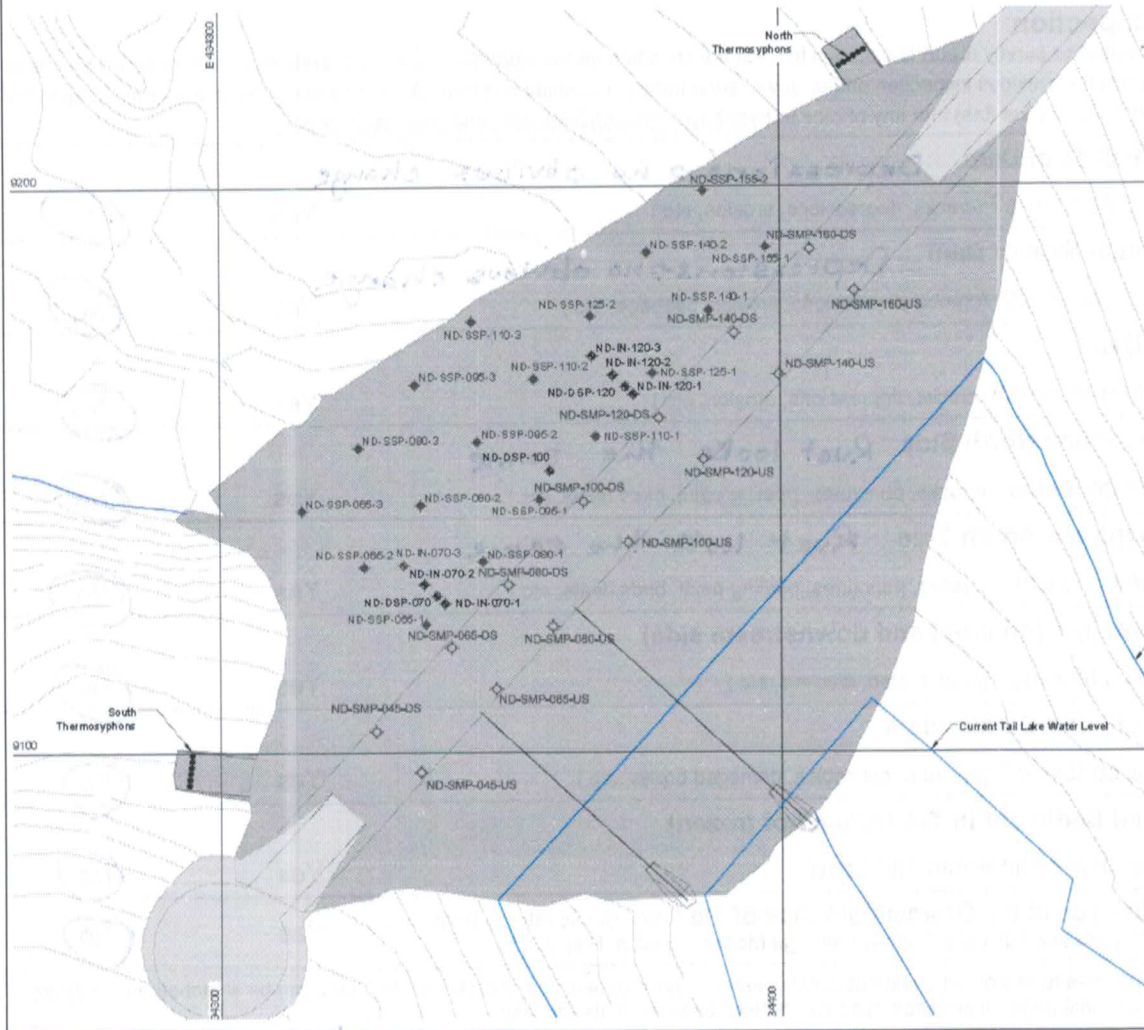
Upstream Side of Dam Depressions → no obvious change		
Any visible concerns? (cracks, depressions, erosion, etc.)	Yes	<input checked="" type="radio"/> No
Downstream Side of Dam Depressions → no obvious change		
Any visible concerns? (cracks, depressions, erosion, seepage, etc.)	Yes	<input checked="" type="radio"/> No
Crest of Dam		
Any visible concerns? (cracks, depressions, erosion, etc.)	Yes	<input checked="" type="radio"/> No
Thermosyphons North Side Rust looks the same		
Any visible concerns? (cracks, punctures, peeling paint, birds nests, etc.)	Yes	<input checked="" type="radio"/> No
Thermosyphons South Side Rust look the same		
Any visible concerns? (cracks, punctures, peeling paint, birds nests, etc.)	Yes	<input checked="" type="radio"/> No
Instrumentation (on crest and downstream side)		
Any visible concerns? (bent, rusted, cracked, etc.)	Yes	<input checked="" type="radio"/> No
Thermistors and Dataloggers

Any visible concerns? (frayed or cut cables, damaged boxes, etc.)	Yes	<input checked="" type="radio"/> No
Suspended Sediment in TIA (When not frozen)		
Any suspended sediment in Tail Lake?	Yes	<input checked="" type="radio"/> No
Water at the Toe of the Downstream Side of the Dam (If yes refer to Doris North – North Dam and Tail Lake Outflow Seepage Monitoring Work Plan 2015)		
	Yes	<input checked="" type="radio"/> No
If you answered yes to any of the questions above please provide details and photos. Observations can be sketched on the figure provided on the next page. If seepage has been noted please estimate the flow.		
U6 - no change	D1 - no change	D10 - no change
U5 - no change	D2 - no change	D11 - no change
U4 - no change	D3 - no change	D12 - no change
U3 - no change	D4 - no change	D13 - no change
U2 - no change	D5 - no change	D14 - no change
U1 - no change	D6 - no change	D15 - no change
U7 - no change	D7 - no change	D16 - no change

U8 - no change	D8 - no change	D17 - no change
	D9 - no change	D18 - no change
		D19 - no change
