January 26, 2017
Project No: 1CT022.009

RE: Doris Project 2016 Annual Geotechnical Inspection

The 2016 geotechnical site inspection was carried out by Principal Consultant Maritz Rykaart, PhD, PEng between July 12 and 15, 2016. The inspection included a comprehensive walkover over the entire Doris site (from the portal to the jetty), followed by a helicopter aerial reconnaissance. In addition, Maritz inspected the 10 km all-weather road to the former Windy Road, and the Secondary Road from the Doris camp to the Tailings Impoundment Area (*aka* Tail Lake Access Road) via truck, with frequent stops for physical inspections at key areas. TMAC staff did not accompany Maritz during the walkover and helicopter survey. Mr. Gordon Morrison, President and Chief Technology Officer of TMAC accompanied Maritz during the entire driving inspection, and Ms. Catherine Farrow, PhD, PGeo, CEO of TMAC accompanied Maritz during a second driving inspection of the Secondary Road. Weather conditions during the inspections were cool and overcast with periods of light rain.

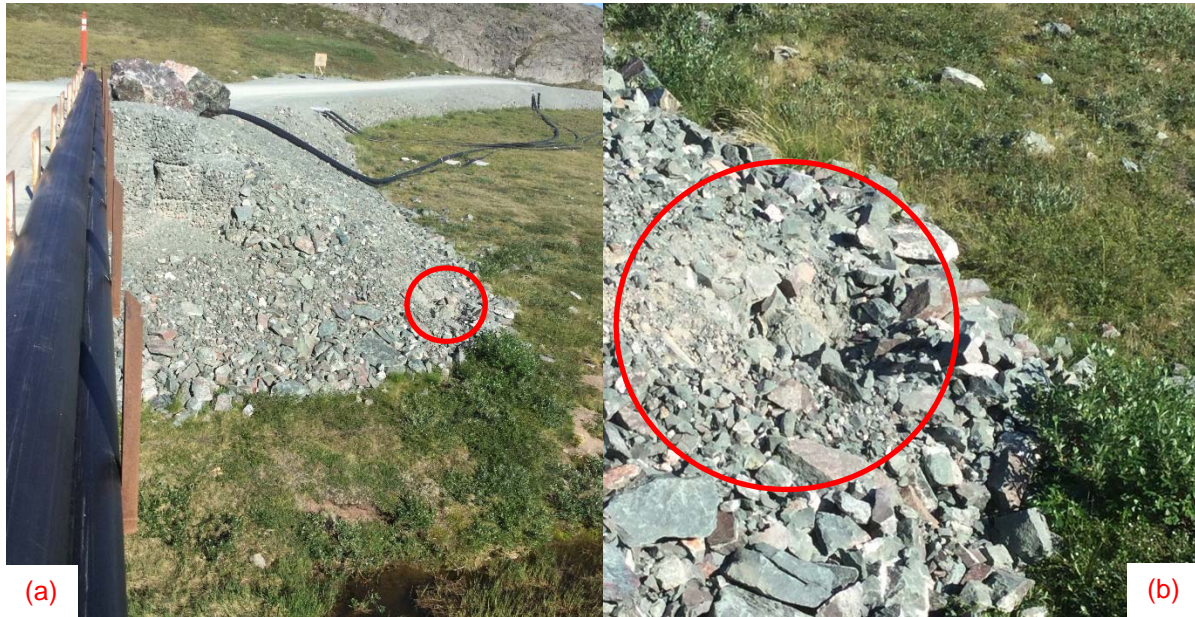
- A small depression was observed along the south-east abutment of the Doris bridge (Photo 1). The depression measured about 0.5 m in diameter and 0.3 m deep, and is near the toe of the abutment. It is postulated the cause may be thaw of localized surficial ice lenses or massive ice. This location, at the interface between the rockfill abutment and the natural ground is where the risk of permafrost degradation is at its greatest due to the contrast in thermal properties between these materials. Geotechnical drill hole SRK-36 was completed within about 10 m of this location in April 2003. The drill log showed a thin layer (25 cm) of random or irregularly oriented ice formations (V_r), intermingled with sand and silt at a depth of 15 cm below ground. There was no core recovery below this layer up to a depth of 1.3 m below, and it was assumed that the upper layer of sand and silt (and associated ice) continued. Between 1.3 and 2.5 m depth the profile was frozen clay, after which the log records layers of 50-90% clear ice in lenses up to 0.7 m thick. The drill log therefore clearly confirms presence of ice, which if thawed would result in thaw settlement.

Ground temperature cables (GTCs) are installed beneath each of the east and west abutments of the Doris bridge. A review of the east abutment GTC (SRK10-DCB2), which is located about 12 m from the location of the depression, confirms no change in the thermal regime beneath the abutment since its installation in 2010. The warmest temperature measured in the upper bead located about 0.6 m above ground surface within in the abutment rockfill in 2016 was -3.7°C. At original ground surface, the warmest temperature in 2016 was -4.9°C, which is well below the minimum design temperature of -2°C. Furthermore, during the winter months, complete freezeback is attained within that same upper GTC bead dropping to a temperature of -15°C.

Photo 1. (a) View of south-east abutment of Doris bridge showing location of depression (red circle). (b) Close-up of depression measuring approximately 0.5 m in diameter with subsidence of about 0.3 m

The system appears to be behaving as designed, and the depression is not likely to be of concern; however, TMAC should monitor this and if there is any indication of the depression increasing in size, a geotechnical engineer should be consulted to further investigate the cause, and remedial measures need to be implemented.

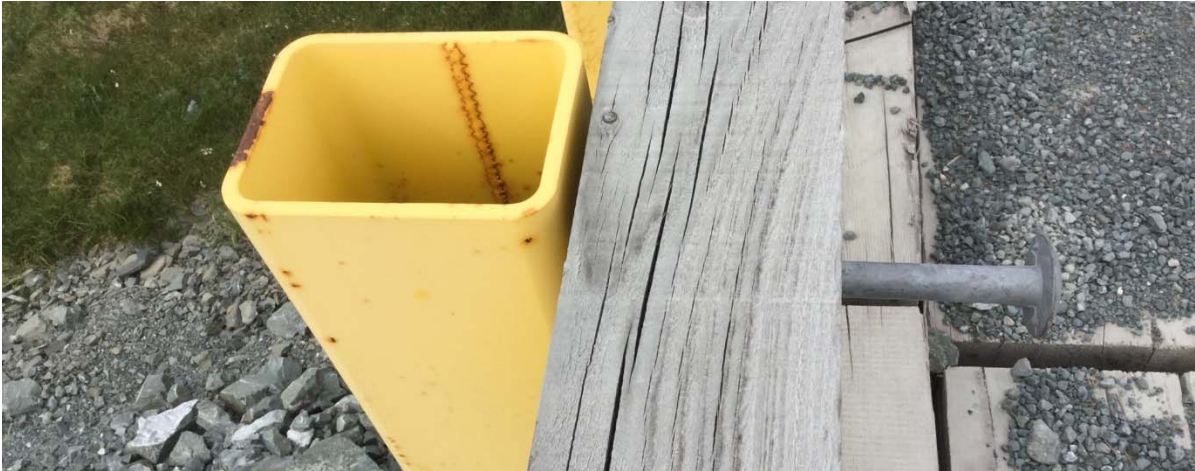
- A large number of bolts attaching the timber guard rail to the steel posts along all three the Doris-Windy all-weather road bridges appear to have worked themselves loose, with many of them completely missing their washers and nuts (Photo 2). The cause of this is not clear, but given the low traffic volume along these bridges, traffic vibration is unlikely to be the cause. Therefore, it is postulated that the cause is freeze-thaw action. Although this is not a geotechnical issue per se, an unattached guard rail is a potentially significant safety risk on site. TMAC should conduct the appropriate repairs to these structures and implement a preventative maintenance program to avoid this from happening in the future.

Photo 2. Example of one of the through bolts securing the timber guard rails to the steel bridge posts which loosened itself along the Doris Windy all-weather road

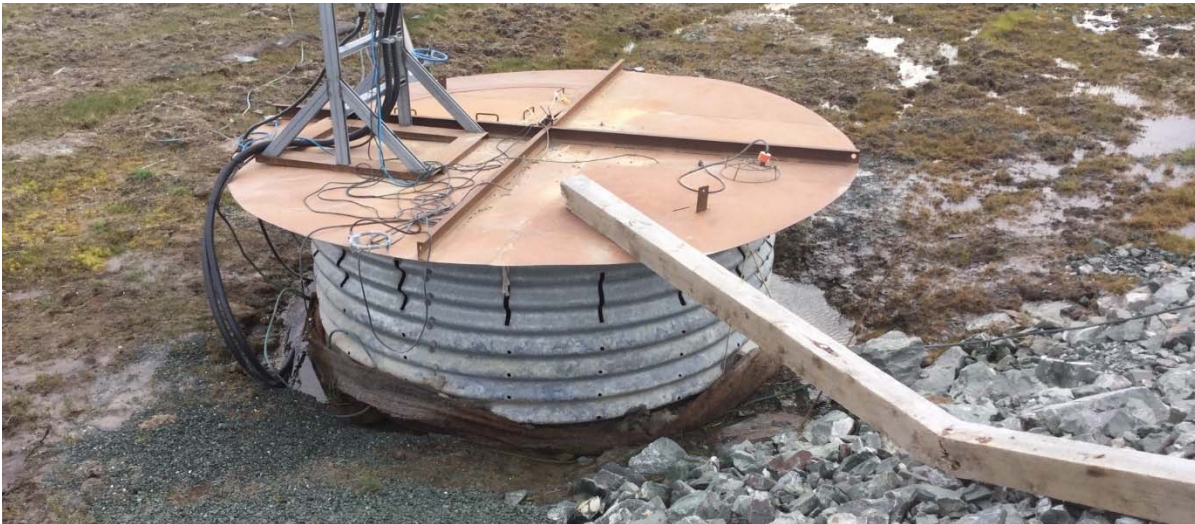
- Sump #1 and Sump #2 are working as designed, but as a result of localized permafrost degradation stemming from their construction, and subsequent associated thaw settlement, the drainage holes directing surface runoff into the sumps are elevated (Photo 3) and are no longer as effective as they should be. This is resulting in prolonged and perpetual ponding immediately adjacent to the sumps, which in turn is resulting in increased permafrost degradation. To remedy this situation, additional drainage slots should be installed at a lower elevation within the sump to facilitate improved drainage below the current ponded elevation. This appears to be a more substantial issue at Sump #1 (Photo 3) where ponded water can be seen throughout the open water season. SRK discussed this matter with Mr. Schwenning while on site, with clear guidance as to the extent to which additional drainage should be provided.

Photo 3. View of Sump #1 showing standing water around the perimeter of the sump which cannot drain due to the lack of drainage holes sufficiently low.
