2016 Geotechnical Inspection		
		North Dam Downstream Face		
Job No: 1CT022.009	Doris Mine	Date: March 2017	Approved: PL	Figure: 6
Filename: 2016GeotechInsp_20170321.pptx

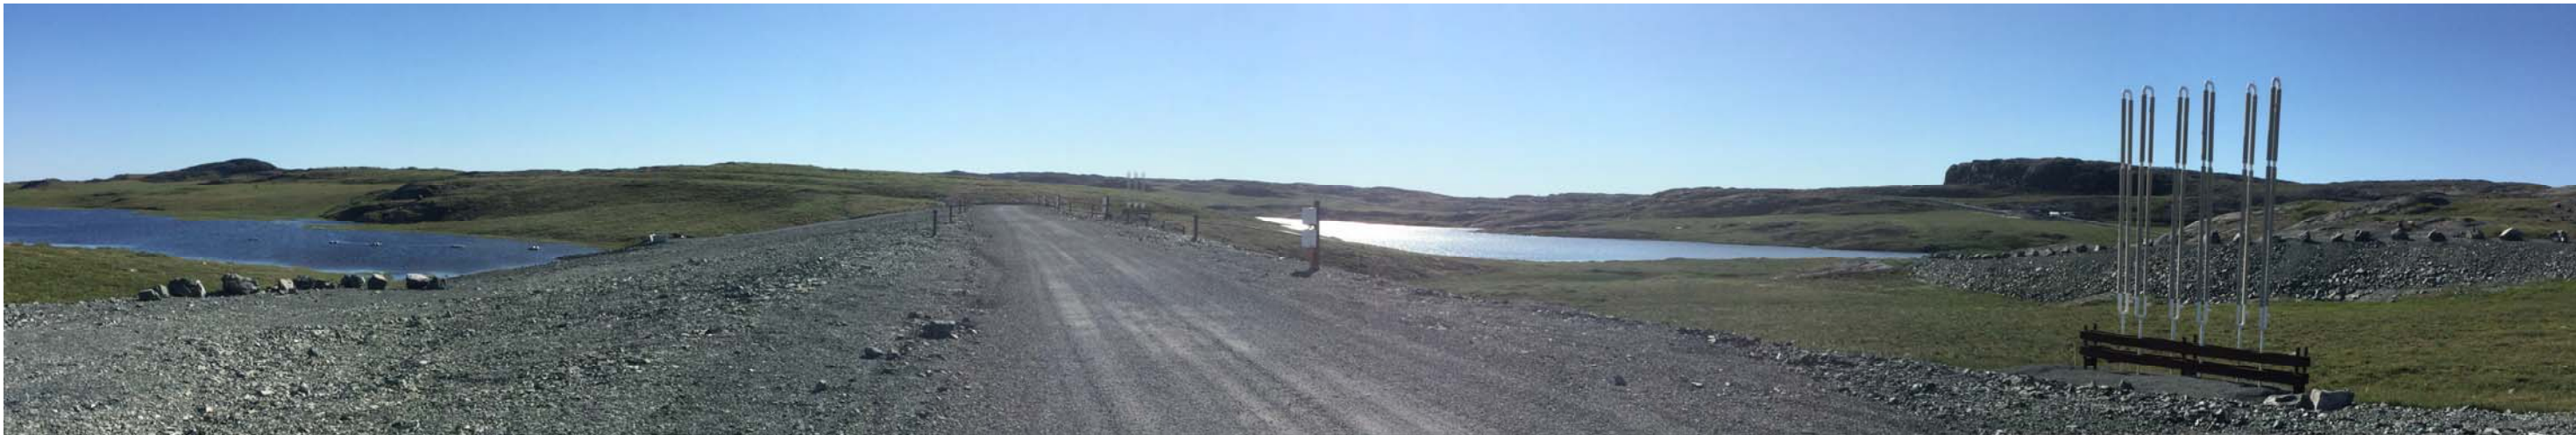
Crest of the North Dam looking southwest from Station 0+140.

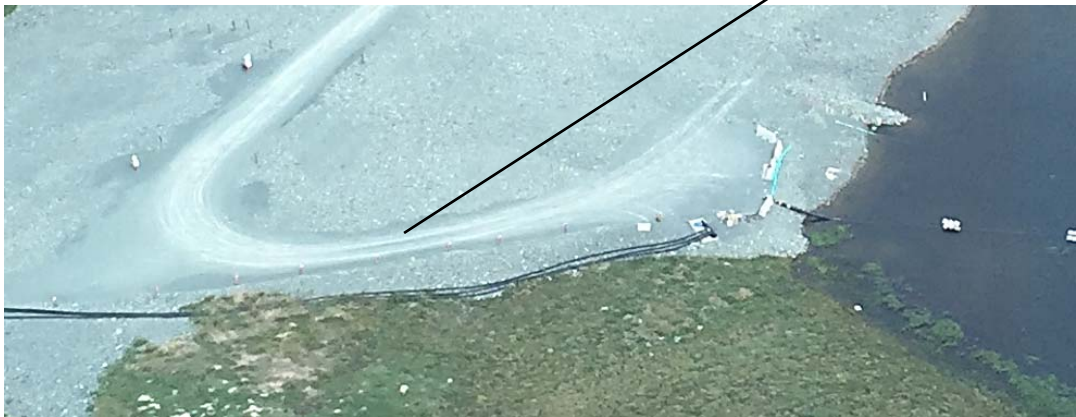
Pump and access road along south side of the upstream face of the North Dam.

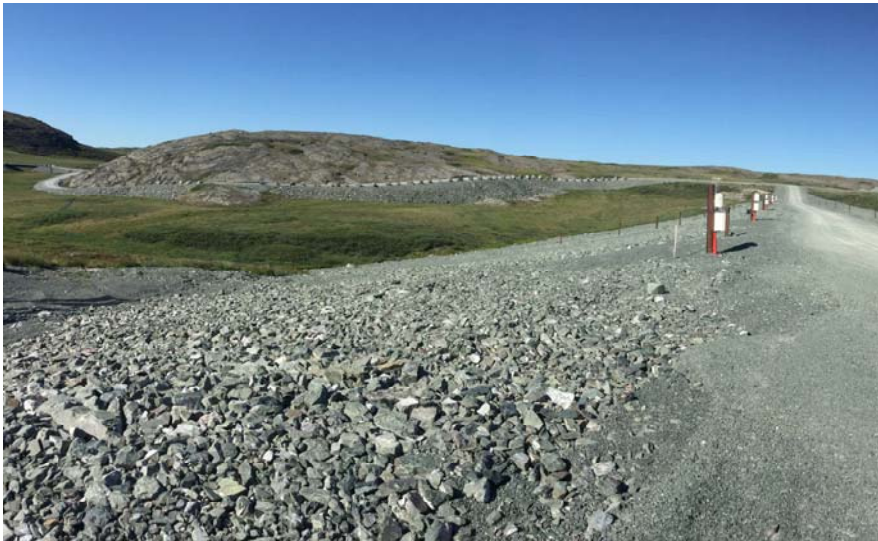
Downstream face of the North Dam looking northeast from Station 0+010.

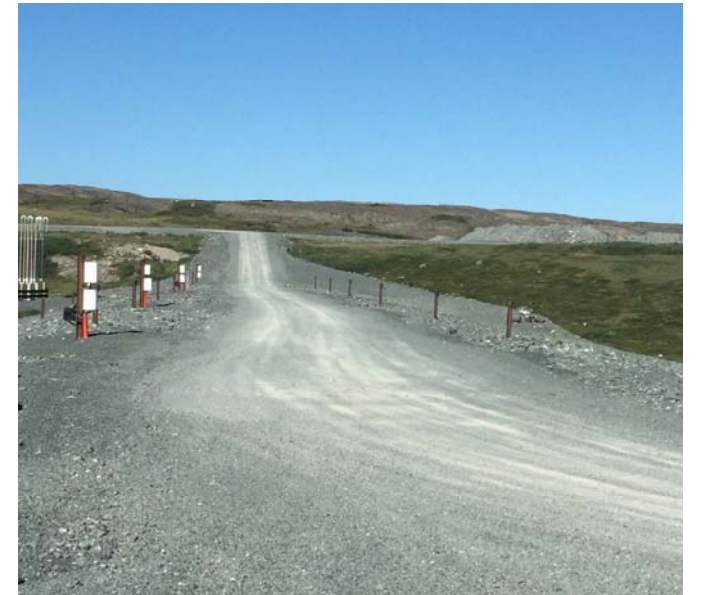
Centerline of the North Dam, looking northeast from Station 0+010.

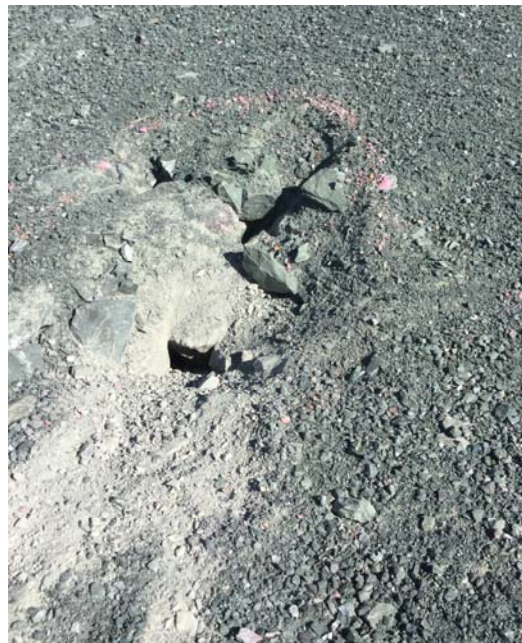
Depression on downstream face of the North Dam, paint markings show limited expansion from previous inspections.
