Job No: 1CT022.009

2016 Geotechnical Inspection

North Dam Instrumentation and Thermosyphons

Doris Mine

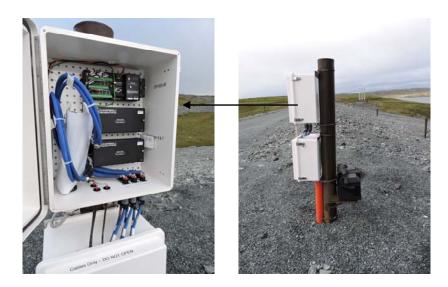
Instrumentation installed at Node A.

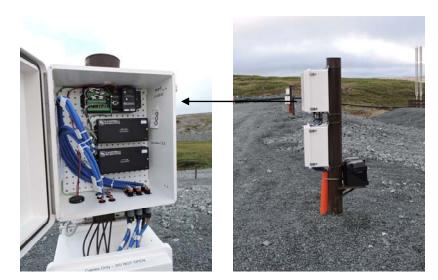
Instrumentation installed at Node B.

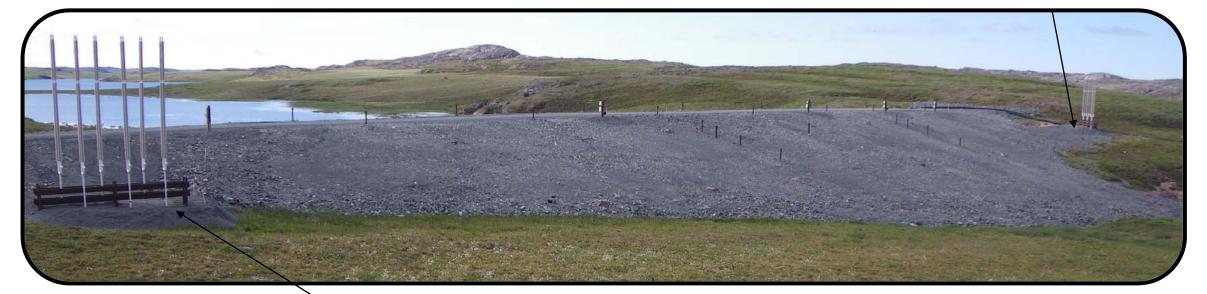
The foundation for the South Thermosyphons.

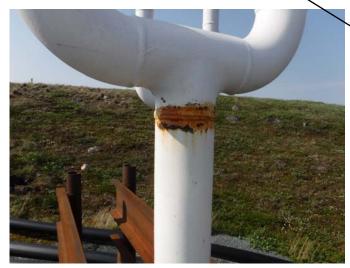
Rust observed at the weld between the evaporator pipe and the radiators.

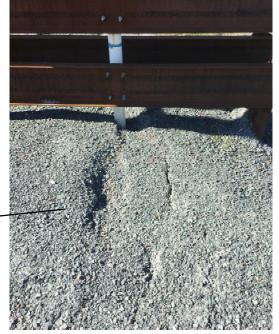
Erosion on the foundation of the North Thermosyphons.

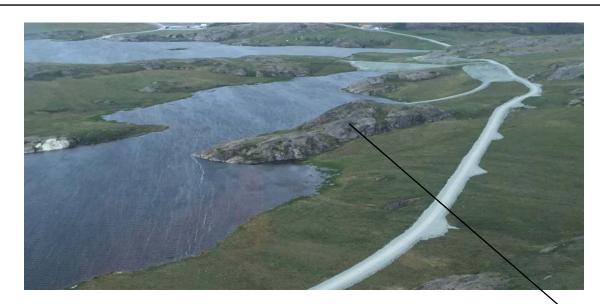
Aerial view of the TIA, looking north towards the dam.

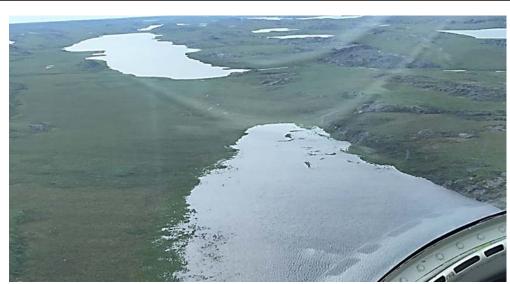
South end of the TIA.

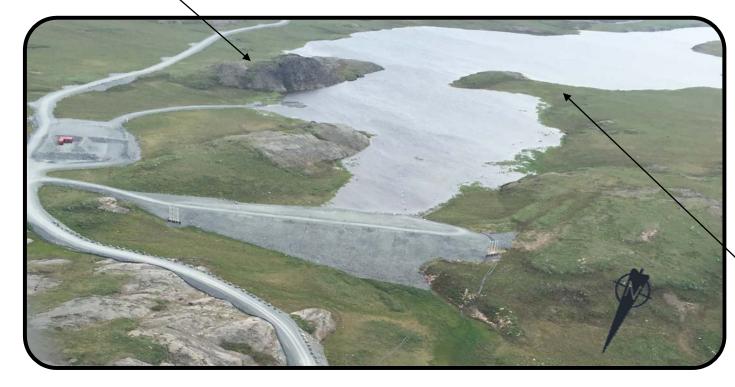
West side of the TIA, looking southwest from above the dam.
