North Dam Weekly Walkover Survey Report

Date:	Sep 19/15
Inspected By:	PAUL CHRISTMAN.
Conditions:	(ie. snow on ground, clear) CLEAR

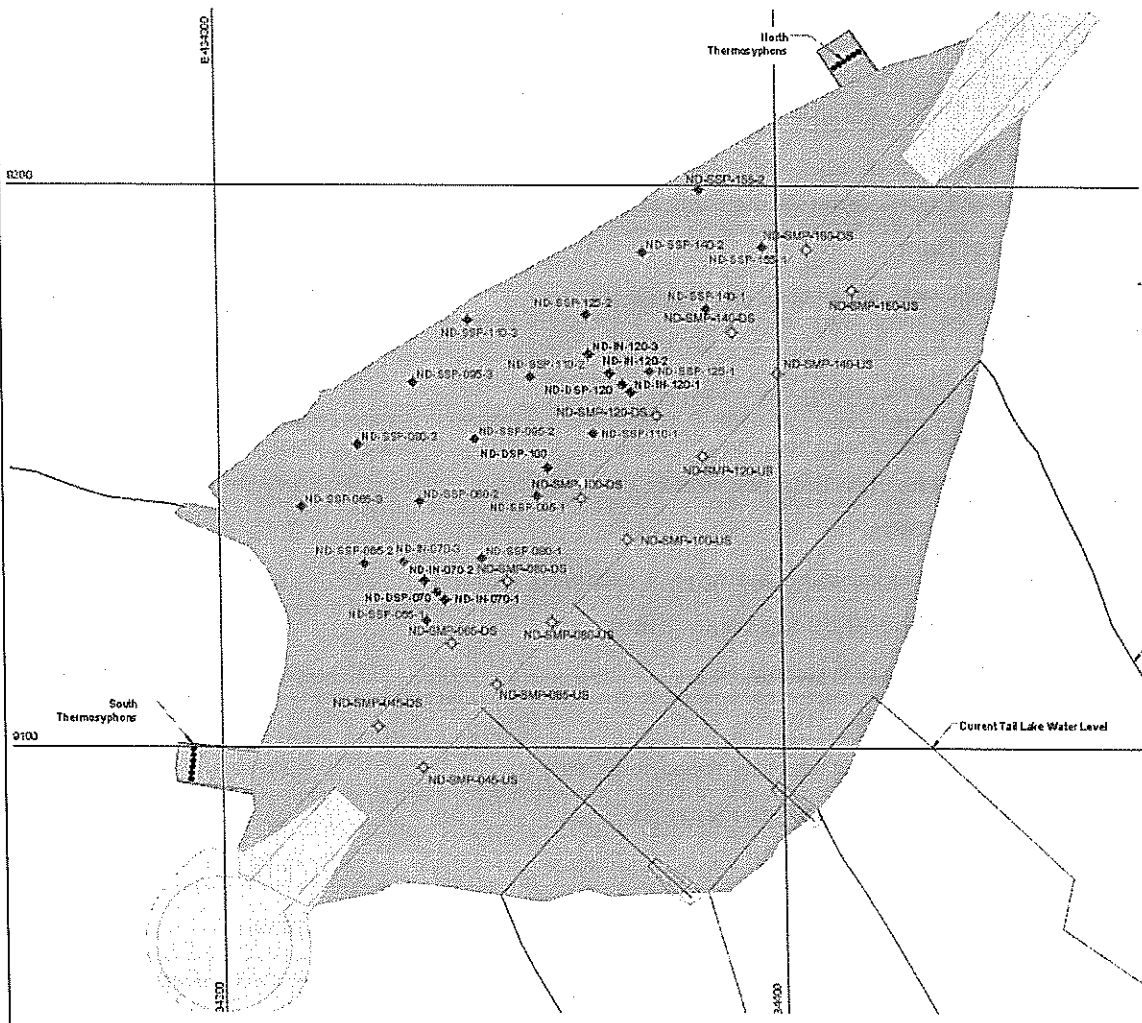
If you answered yes to any of the questions above please provide details and photos. Observations can be sketched on the figure provided on the next page. If seepage has been noted please estimate the flow.		
→ MOVEMENT/DEFLECTION OF THERMOSYPHONS IN WIND

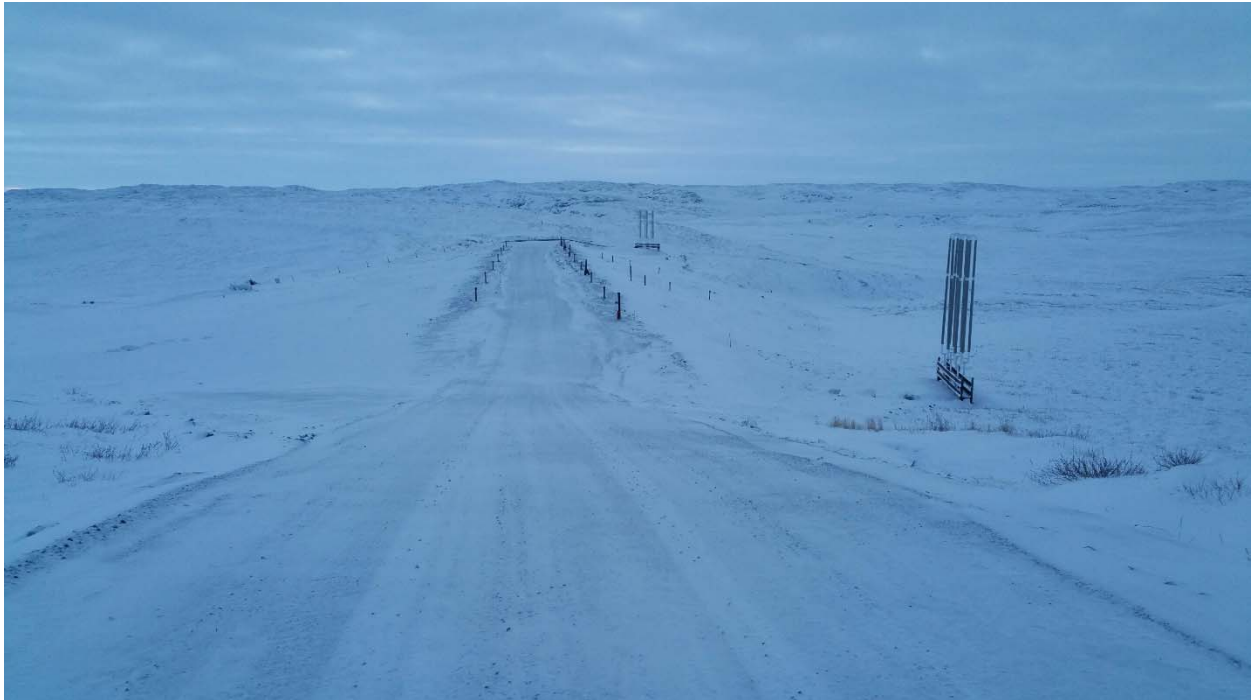
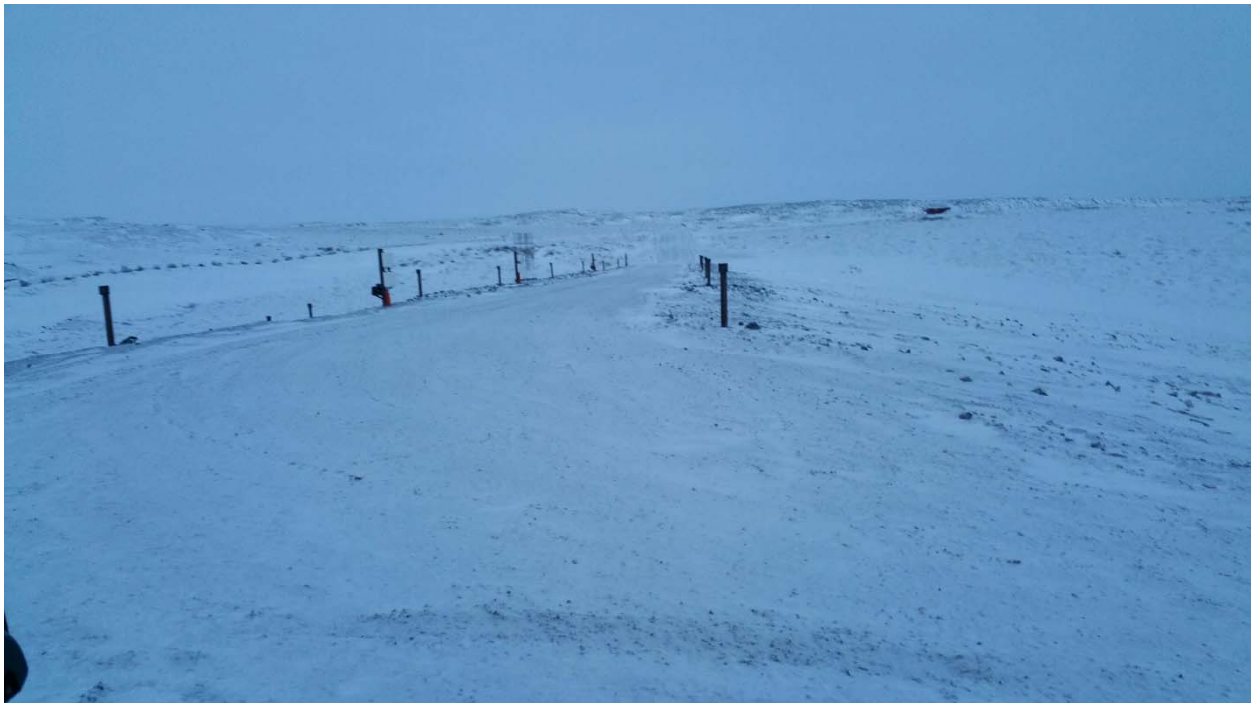
minor surface corrosion at welds on
thermosyphons / paint bubbling
to be repaired winter 2016

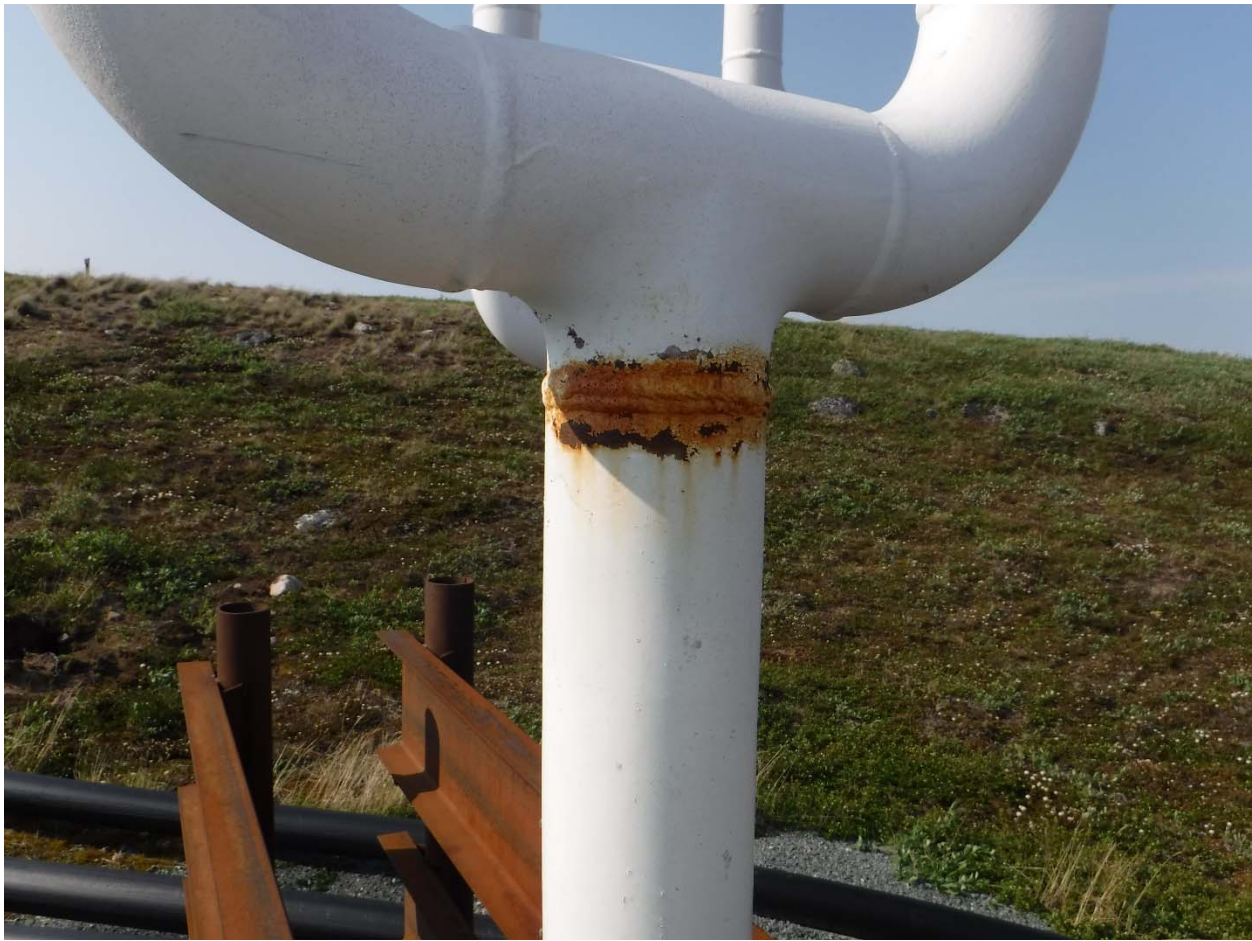
Figure 1- Rust on South Thermosyphon

Yes	Yes	No
If you answered yes to any of the questions above please provide details and photos. Observations can be sketched on the figure provided on the next page. If seepage has been noted please estimate the flow.		
Some rusted spots on south thermosyphon (picture attached).

Rust on South Thermoglyphon

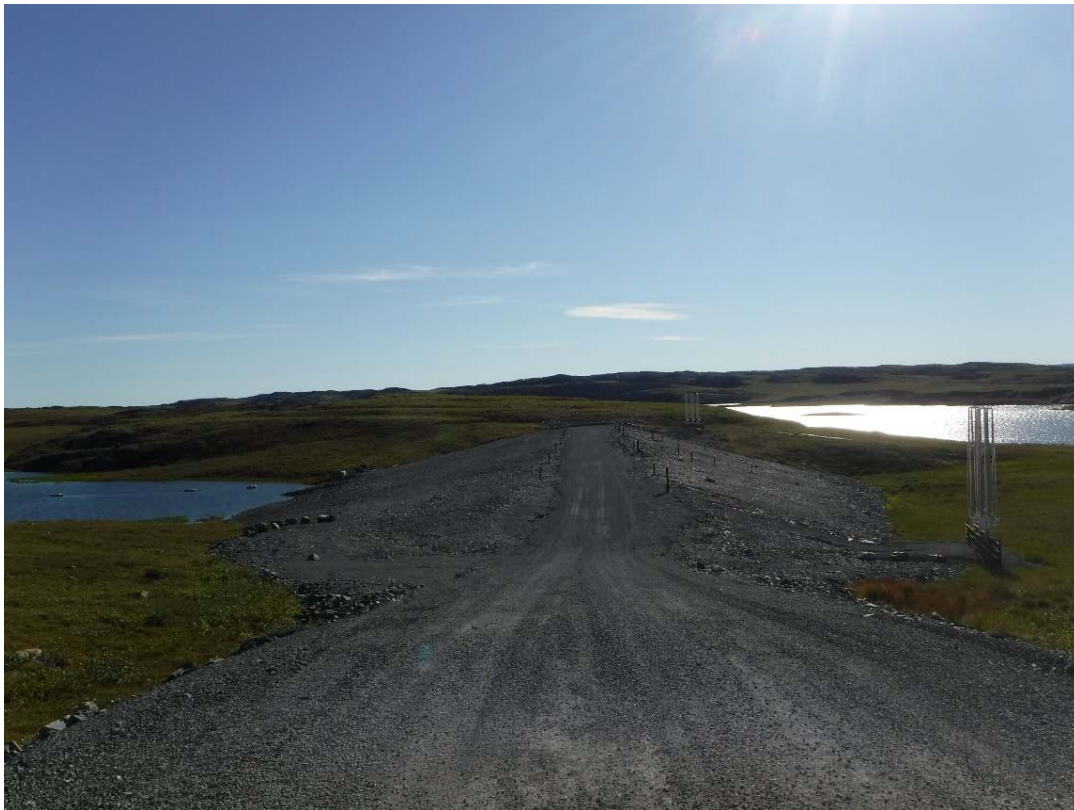
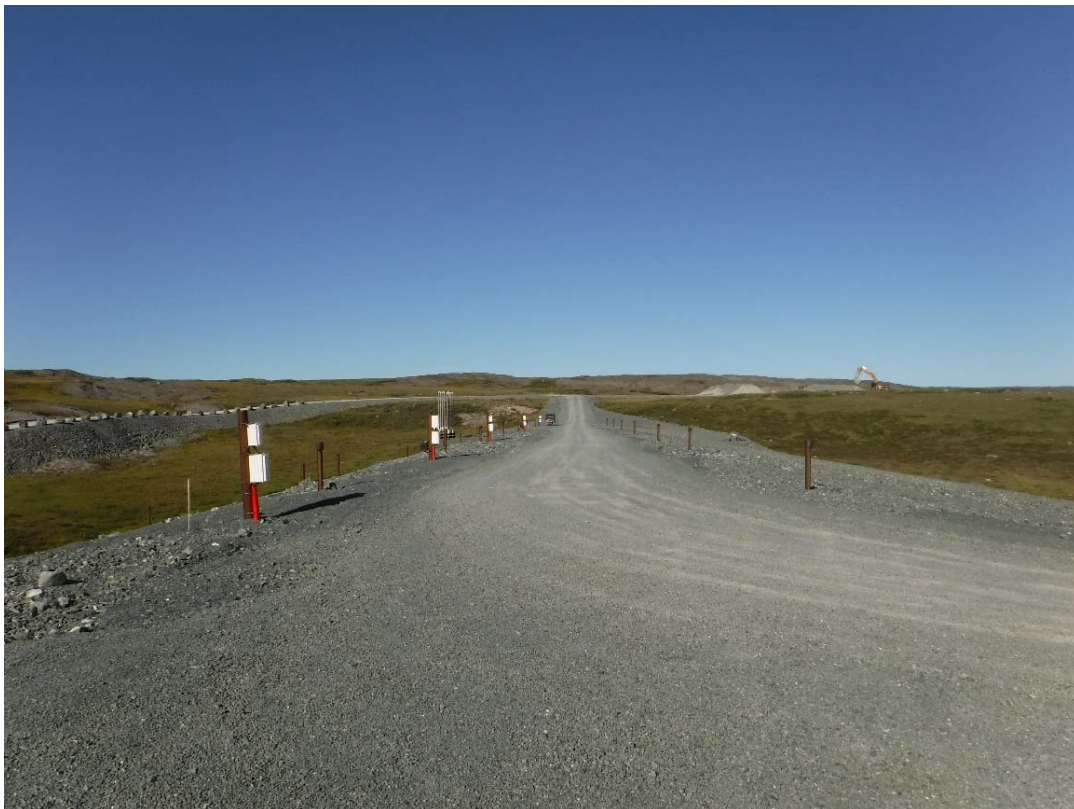
Upstream Side of Dam		
Any visible concerns? (cracks, depressions, erosion, etc.)	Yes	<input checked="" type="radio"/> No
Downstream Side of Dam <i>Small amount of water on North end</i>		
Any visible concerns? (cracks, depressions, erosion, seepage, etc.)	Yes	<input checked="" type="radio"/> No
Crest of Dam		
Any visible concerns? (cracks, depressions, erosion, etc.)	Yes	<input checked="" type="radio"/> No
Thermosyphons North Side		
Any visible concerns? (cracks, punctures, peeling paint, birds nests, etc.)	Yes	<input checked="" type="radio"/> No
Thermosyphons South Side		
Any visible concerns? (cracks, punctures, peeling paint, birds nests, etc.)	Yes	<input checked="" type="radio"/> No
Instrumentation (on crest and downstream side)		
Any visible concerns? (bent, rusted, cracked, etc.)	Yes	<input checked="" type="radio"/> No
Thermistors and Dataloggers		
Any visible concerns? (frayed or cut cables, damaged boxes, etc.)	Yes	<input checked="" type="radio"/> No

Suspended Sediment in TIA (When not frozen)		
Any suspended sediment in Tail Lake?	Yes	<input checked="" type="radio"/> No
Water at the Toe of the Downstream Side of the Dam (If yes refer to Doris North – North Dam and Tail Lake Outflow Seepage Monitoring Work Plan 2015)		
	<input checked="" type="radio"/> Yes	No
If you answered yes to any of the questions above please provide details and photos. Observations can be sketched on the figure provided on the next page. If seepage has been noted please estimate the flow.		
<i>Minor water; no flow just standing.</i>
