DORIS MINE

2017 Annual Geotechnical Inspection

# North Dam Weekly Walkover Survey Report

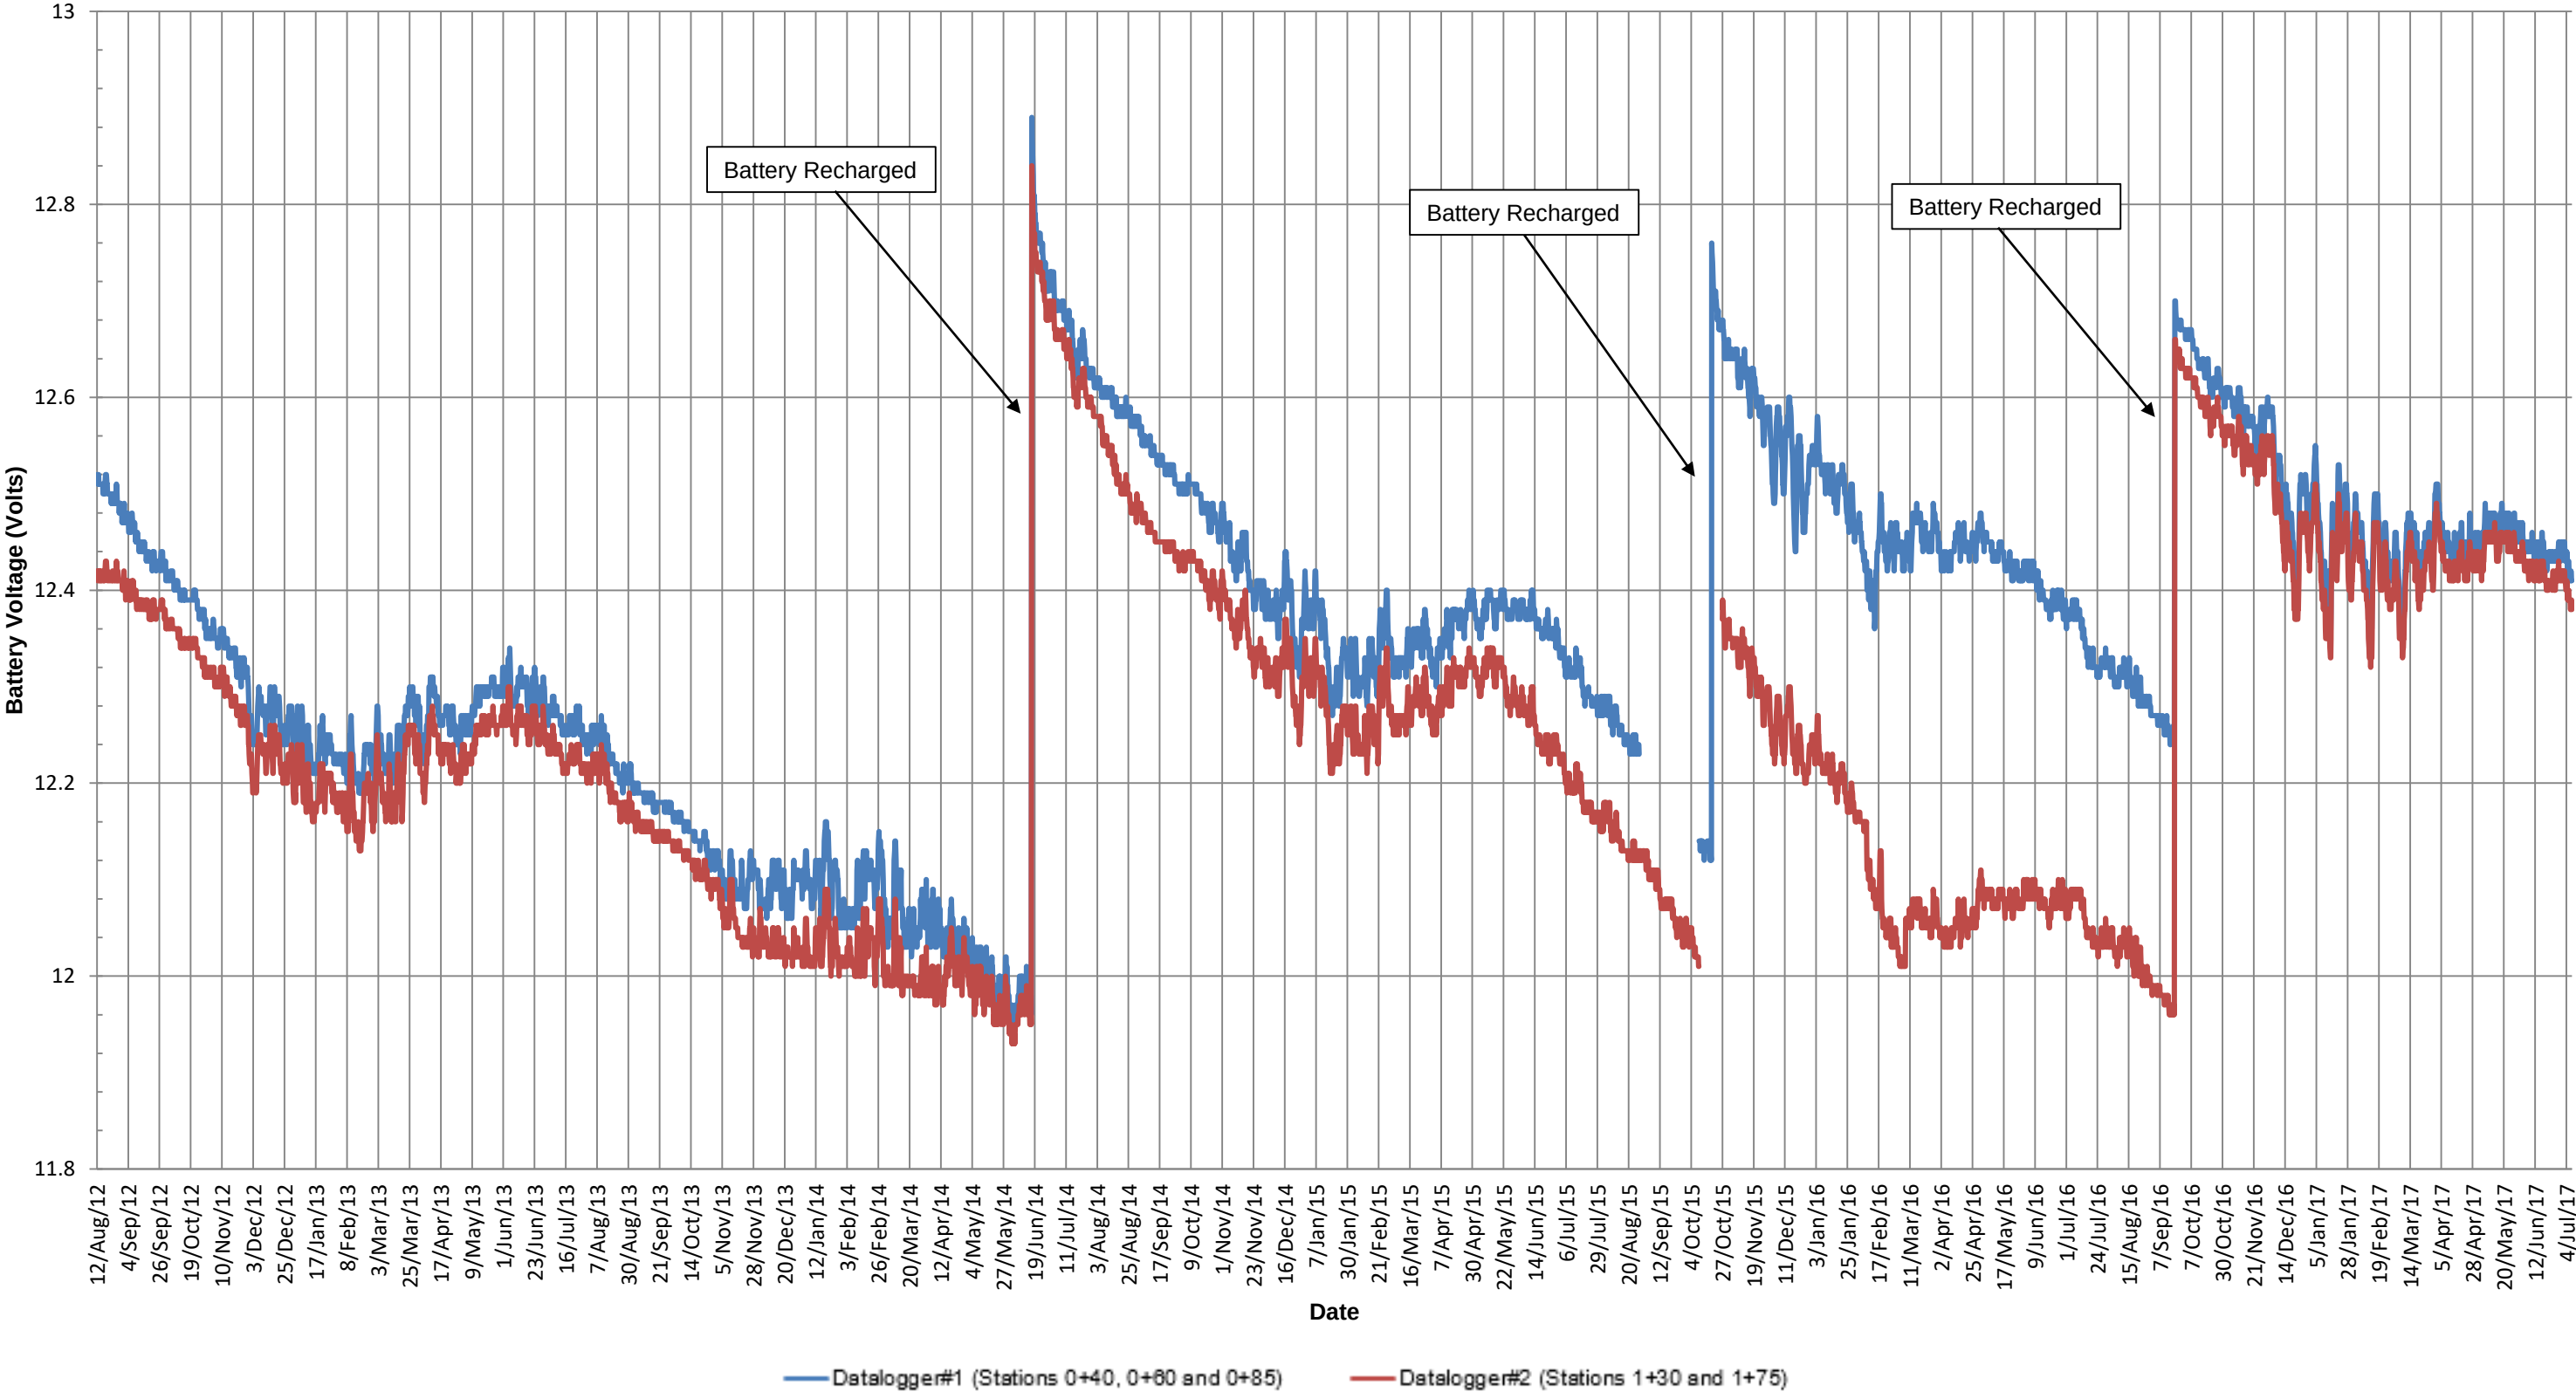
Battery Voltage

- 1. Operating voltage range is 9.6 to 16 V
- 2. Optimal operating voltage is 12 to 14 V
- 3. Datalogger will shut down if voltage drops below 9.6 V

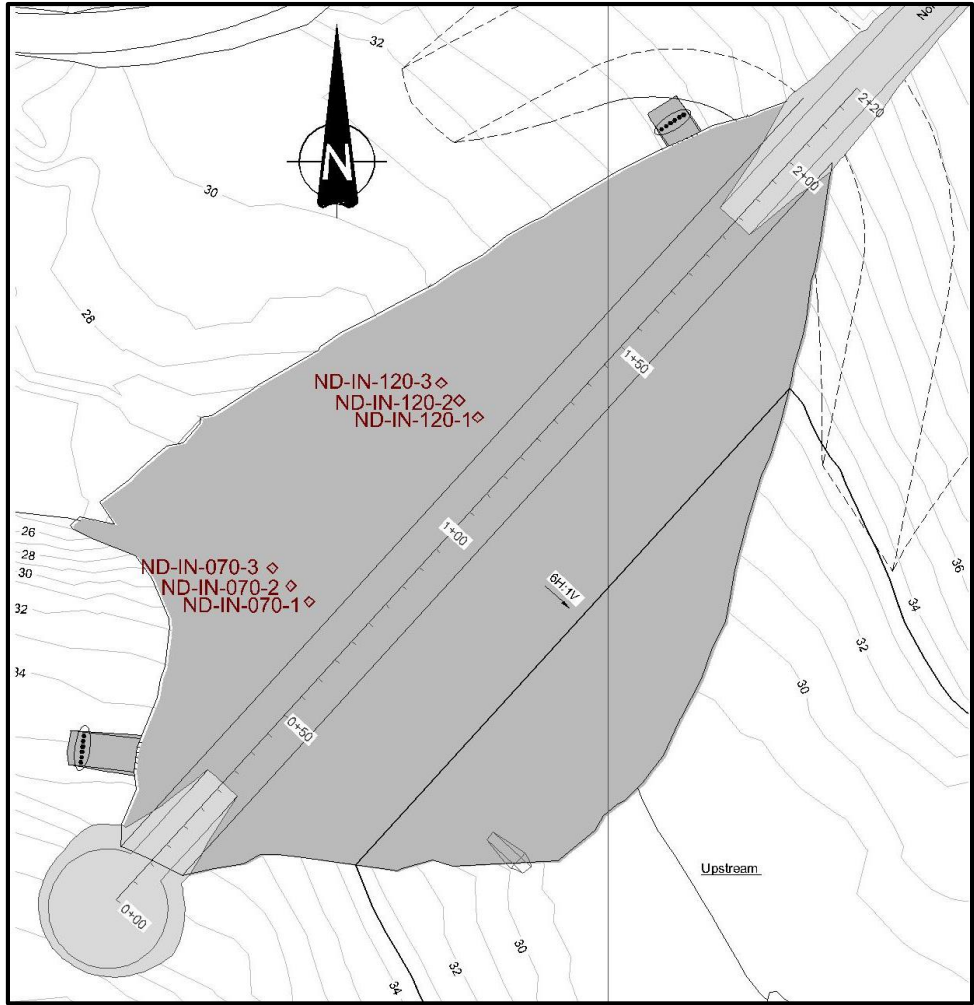
| Inclinometers Measured | | | | | | | Data Quality |
|---|---|---|---|---|---|---|---|
| 26-Sep-16 | x | x | x | x | x | x | 120-1 Checksum slightly out at 0.5m, data received with reverse signs for 120-2 |
| 25-Dec-16 | x | x | x | x | x | x | Data logger issue |
| 26-Jan-17 | x | x | x | x | x | x | Data logger issue |
