North Dam Weekly Walkover Survey Report

2017 Annual Geotechnical Inspection		
		Historic Depression Summary		
Job No: 1CT022.016 Filename: AppH_ND_AGI_DepressionTracking.pptx	DORIS MINE	Date: December 2017	Approved: PDL	Figure: H.1

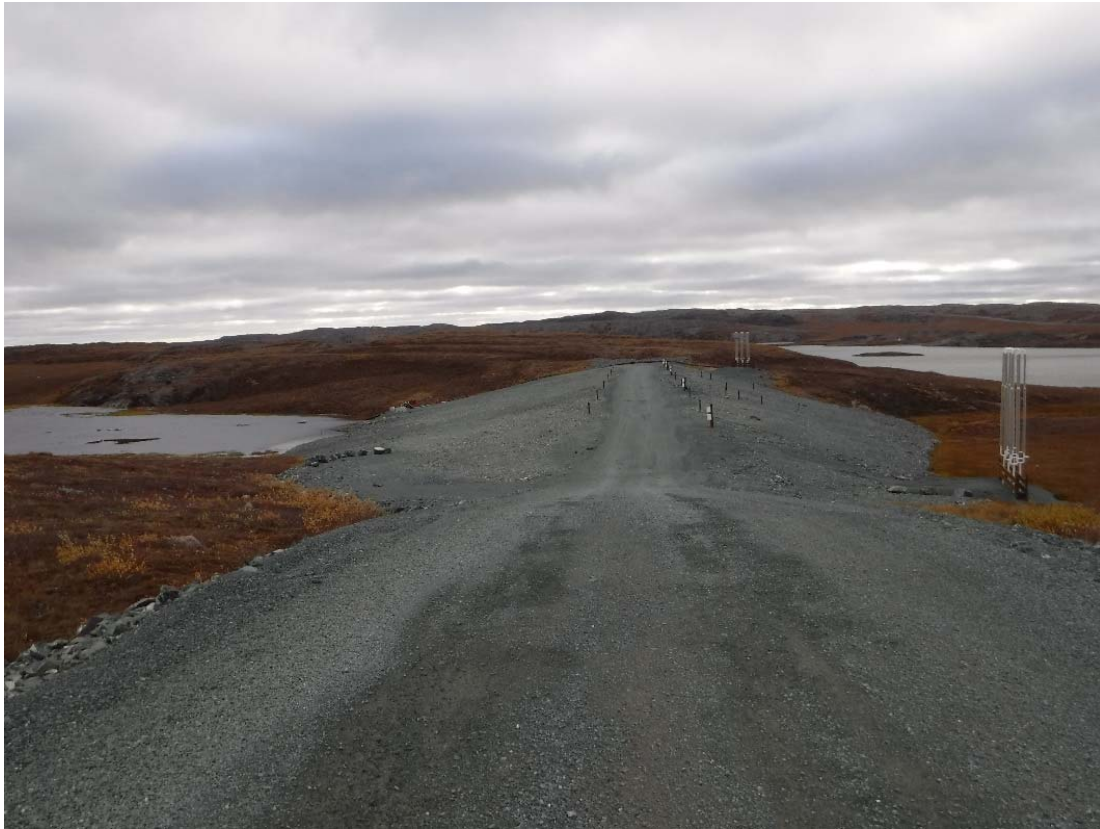
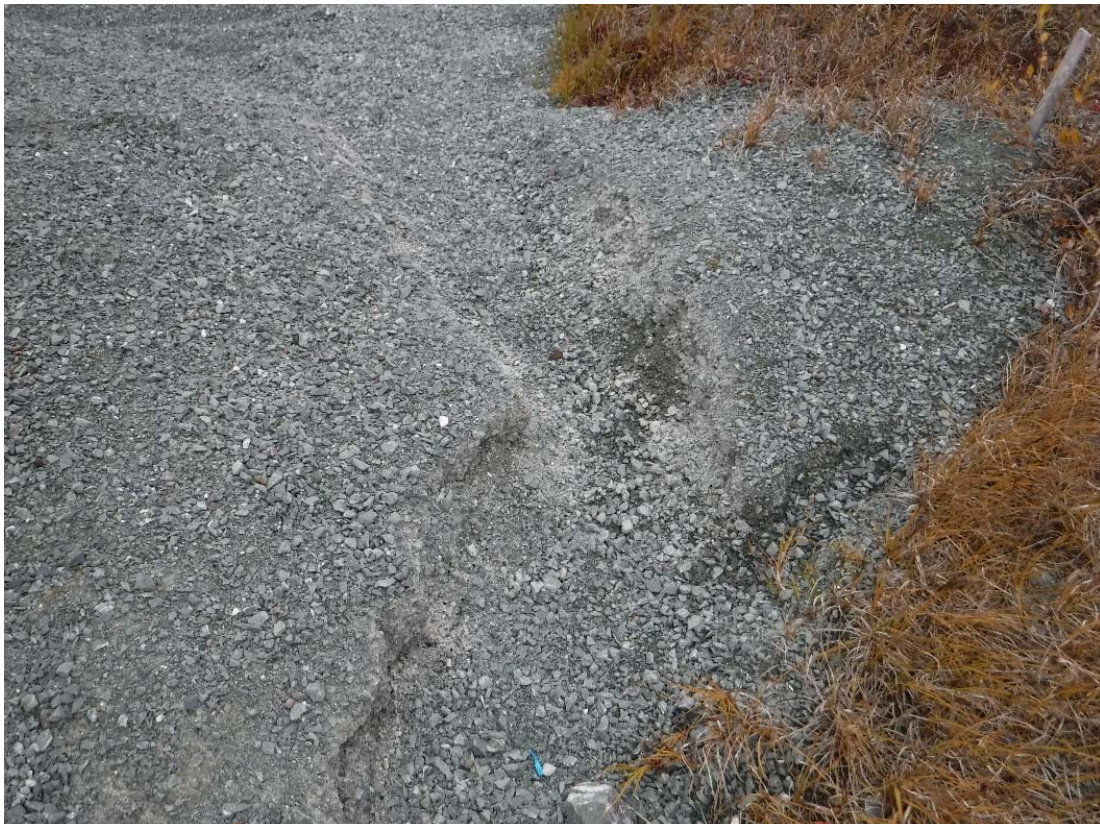
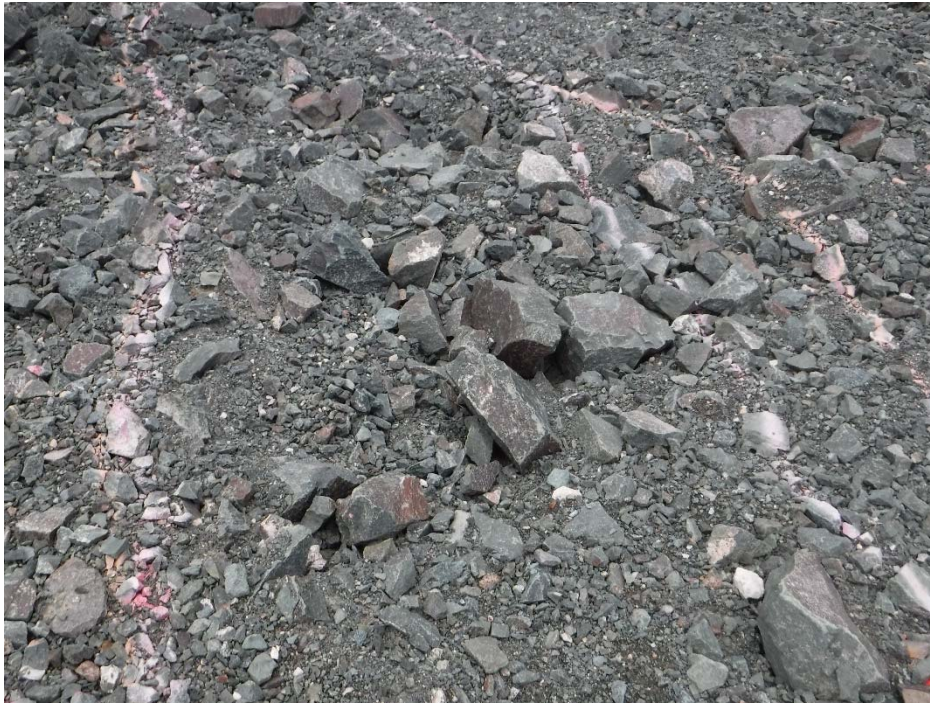
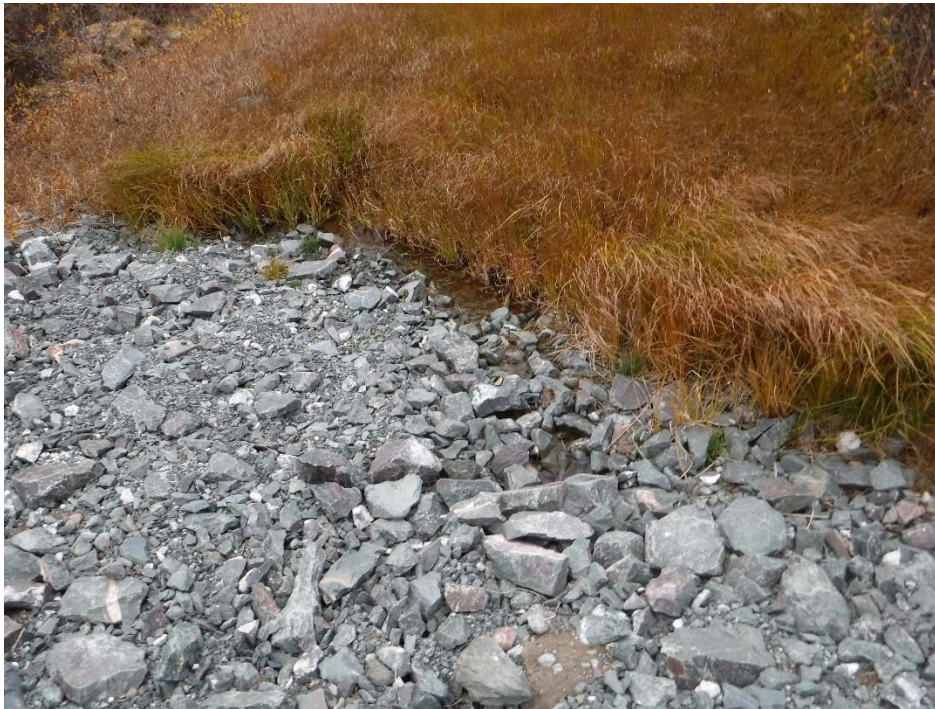
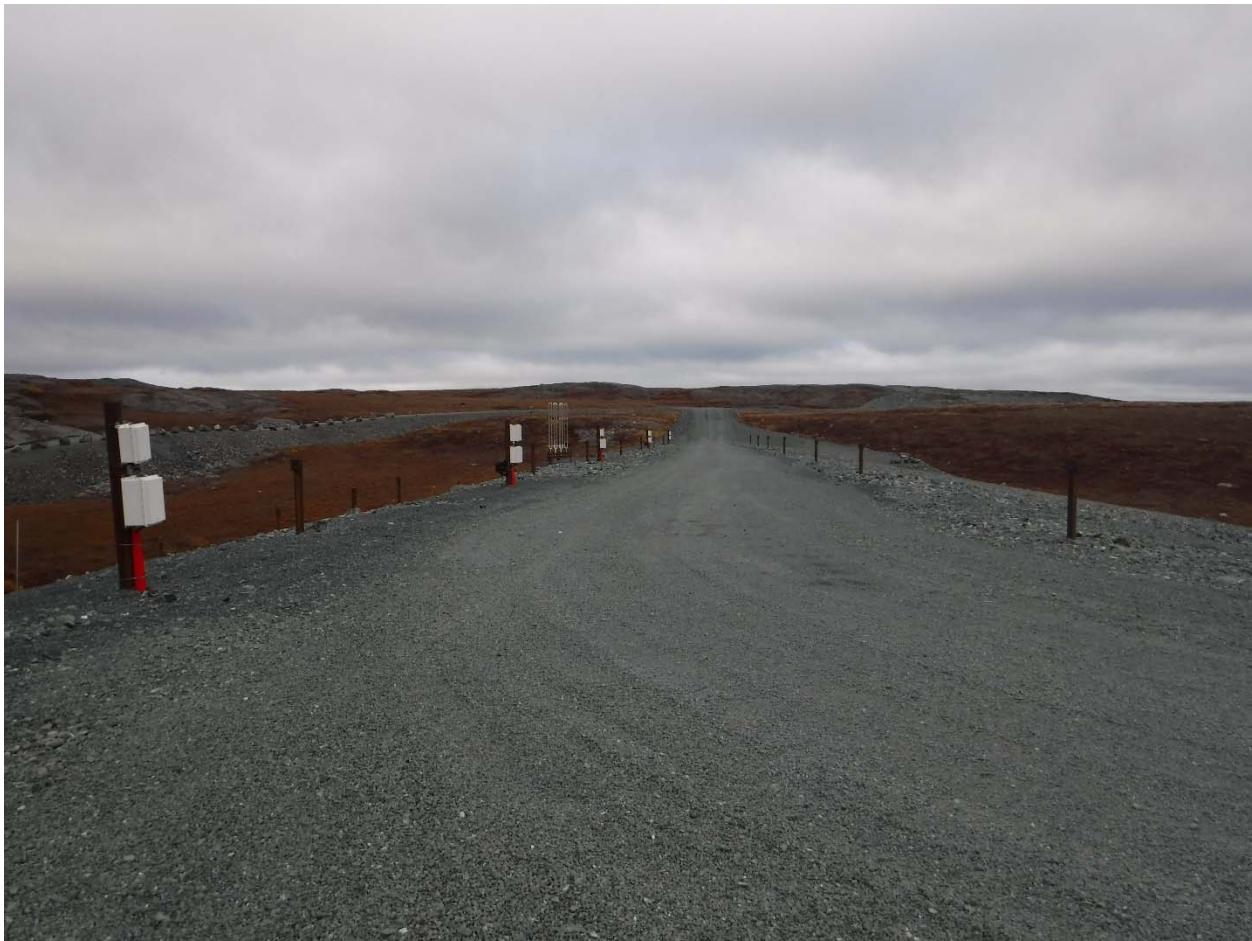
North erosion, animal holes, water on down river side

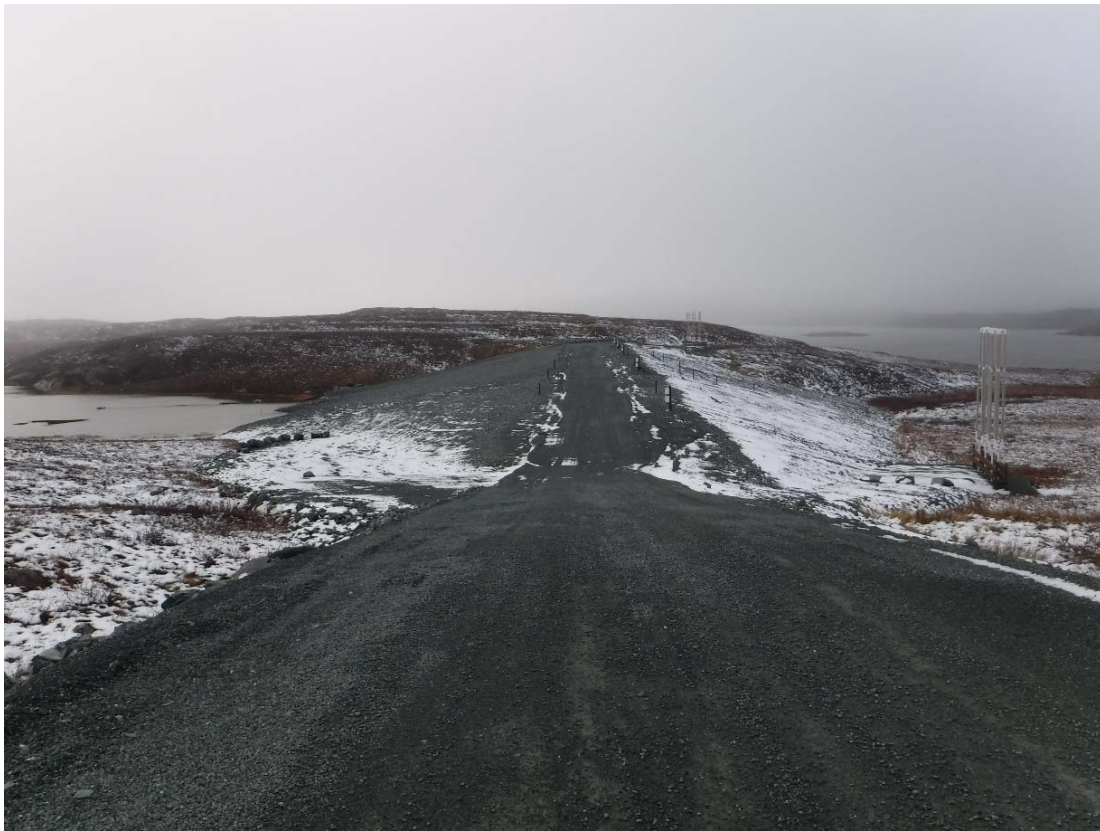
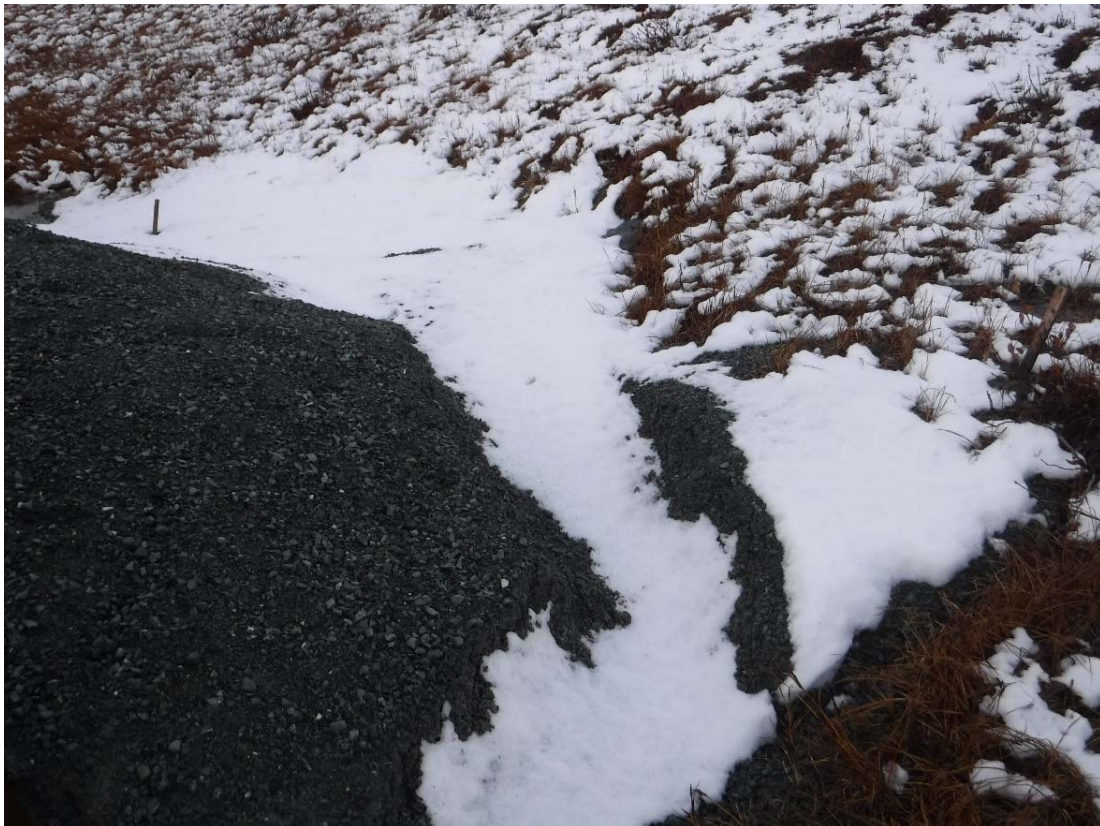
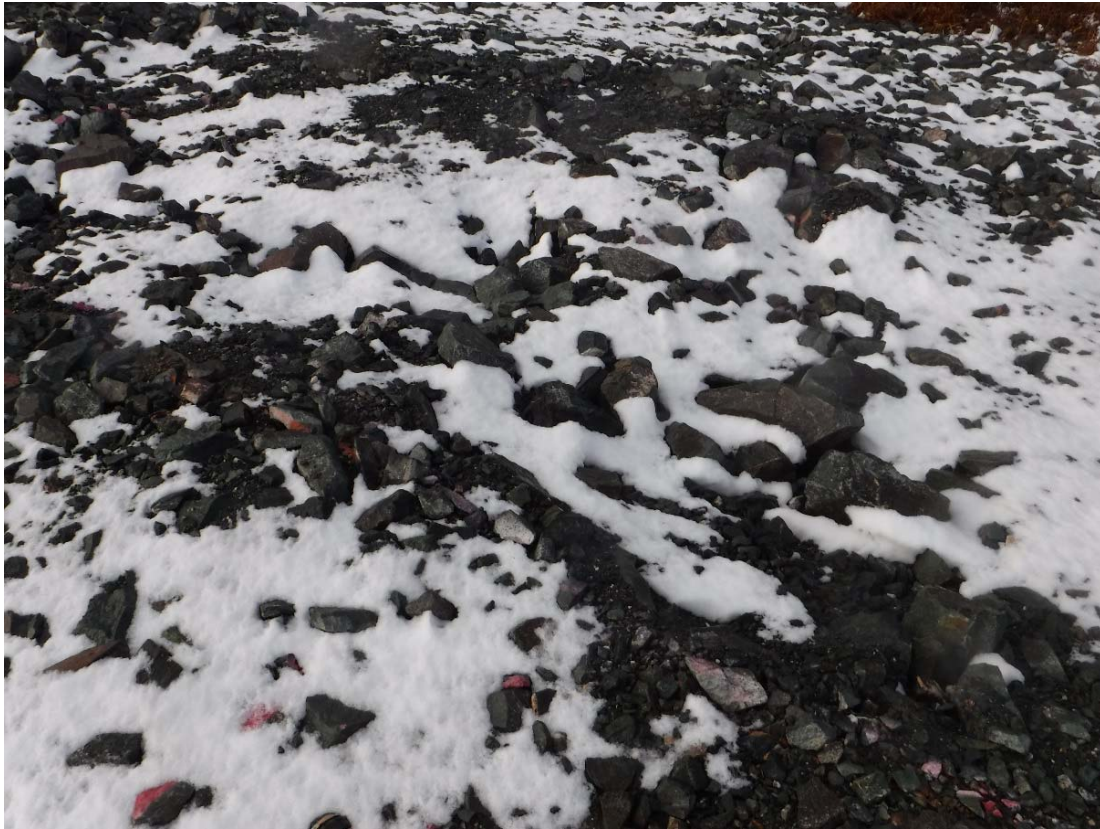
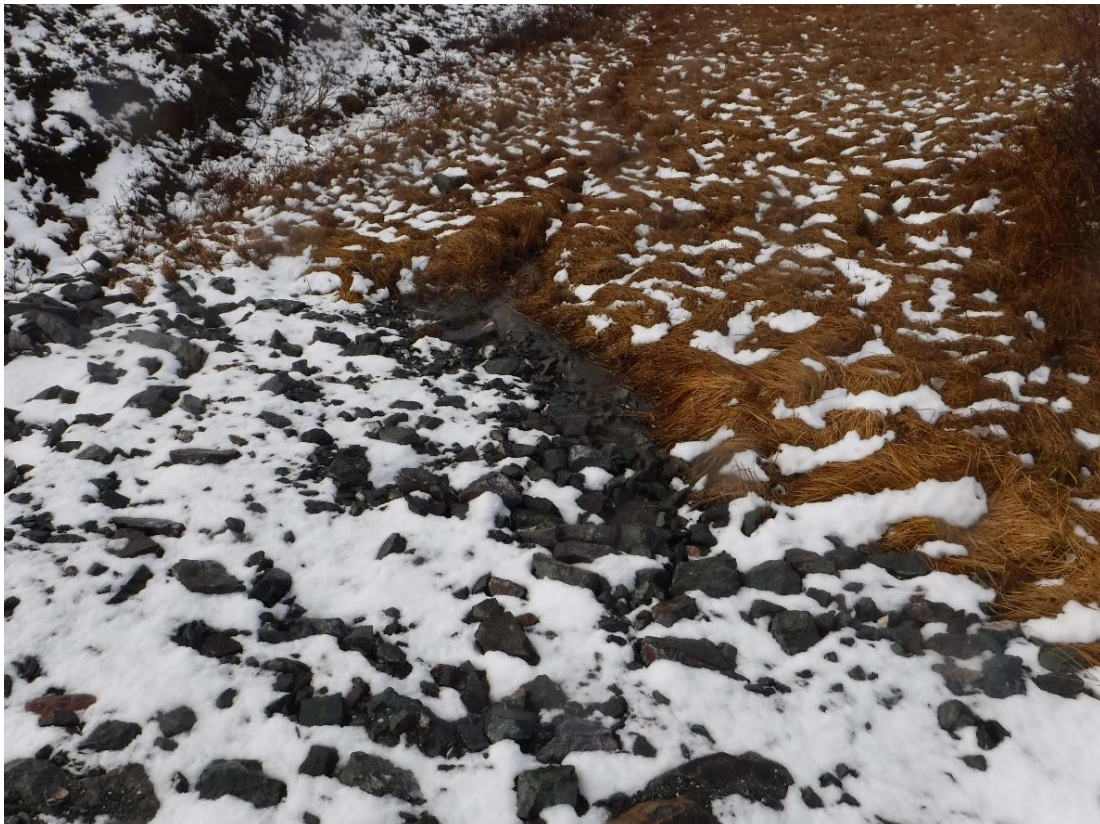
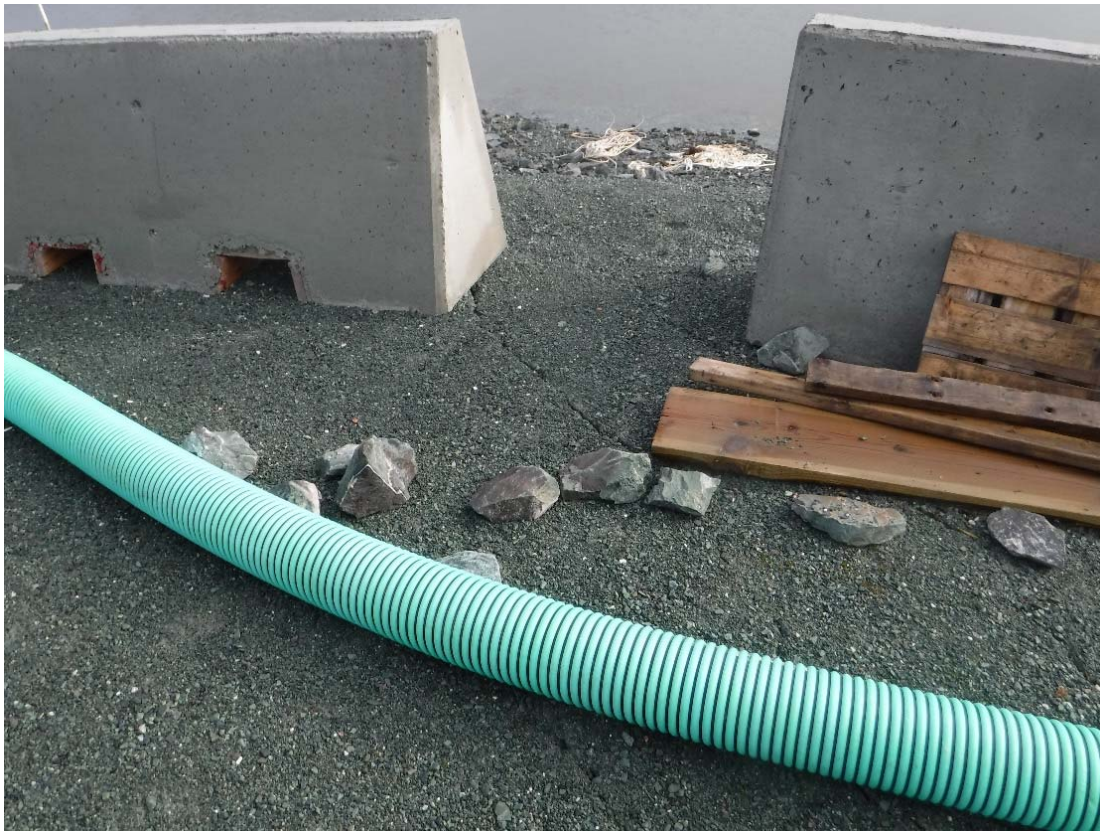
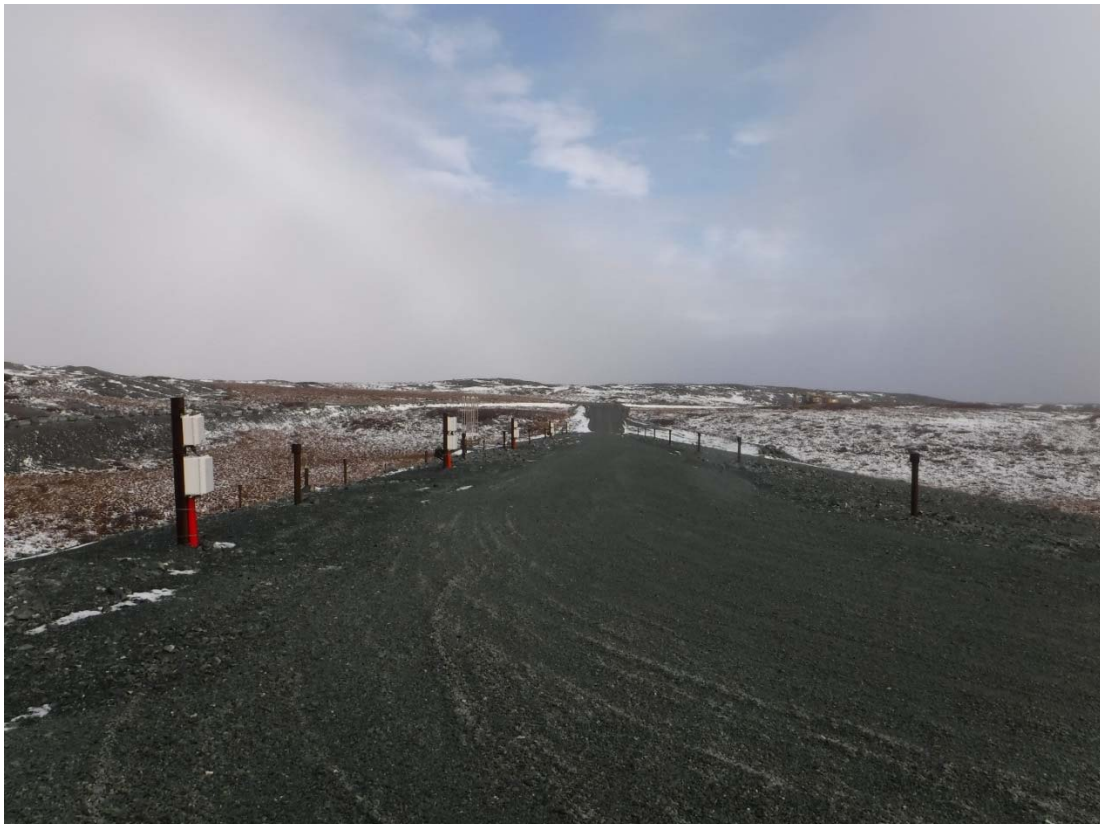
Upstream Side of Dam	Same cracks @ toe	Yes	No
Any visible concerns? (cracks, depressions, erosion, etc.)			
Downstream Side of Dam		Yes	No
Any visible concerns? (cracks, depressions, erosion, seepage, etc.)			
Crest of Dam		Yes	No
Any visible concerns? (cracks, depressions, erosion, etc.)			
Thermosyphons North Side		Yes	No
Any visible concerns? (cracks, punctures, peeling paint, birds nests, etc.)			
Thermosyphons South Side		Yes	No
Any visible concerns? (cracks, punctures, peeling paint, birds nests, etc.)			
Instrumentation (on crest and downstream side)		Yes	No
Any visible concerns? (bent, rusted, cracked, etc.)			
Thermistors and Dataloggers		Yes	No
Any visible concerns? (frayed or cut cables, damaged boxes, etc.)			
Suspended Sediment in TIA (When not frozen)		Yes	No
Any suspended sediment in Tail Lake?			
Water at the Toe of the Downstream Side of the Dam (If yes refer to Doris North – North Dam and Tail Lake Outflow Seepage Monitoring Work Plan 2015)		Yes	No

North thermosyphon, animal holes, water. (No changes).

Cracks @ upstream toe

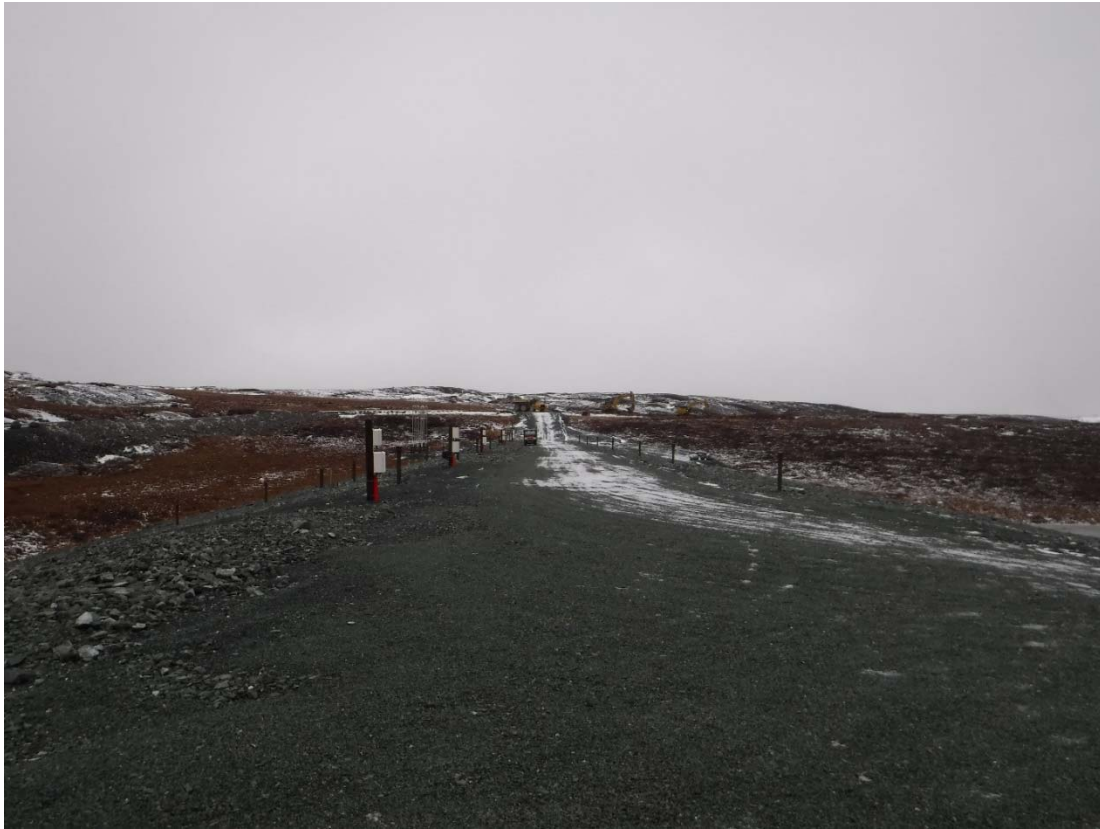
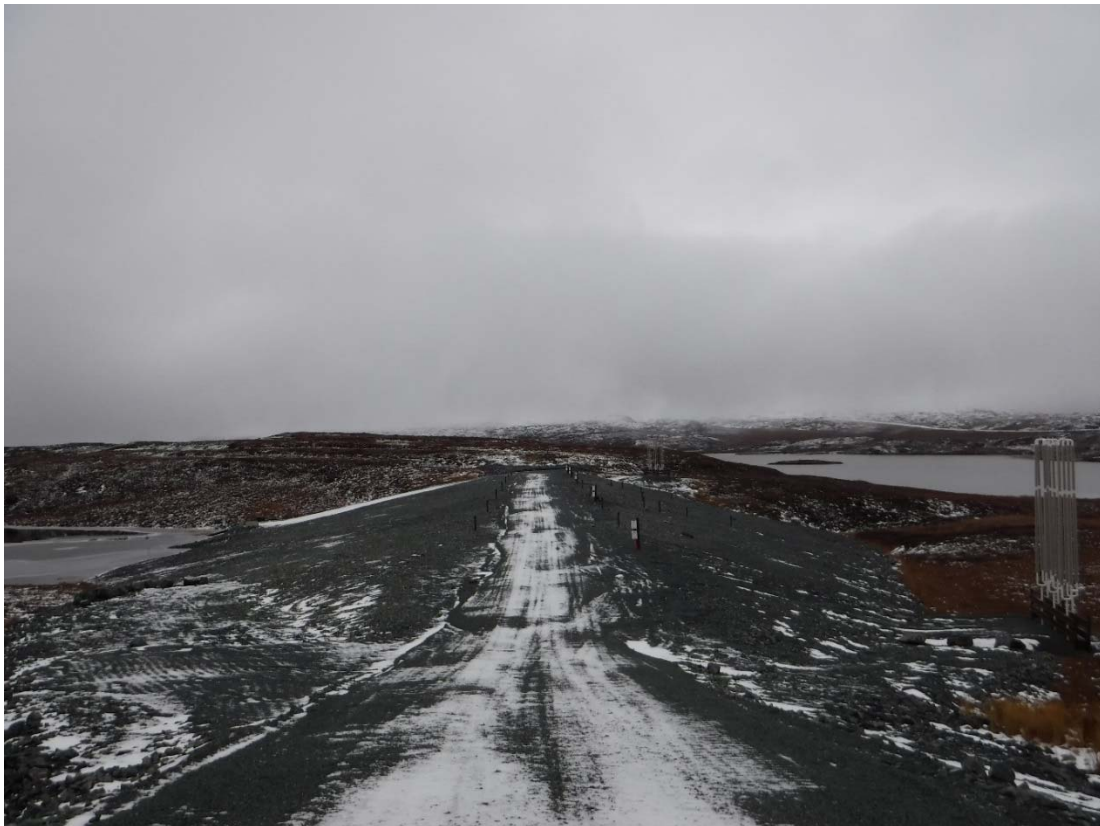
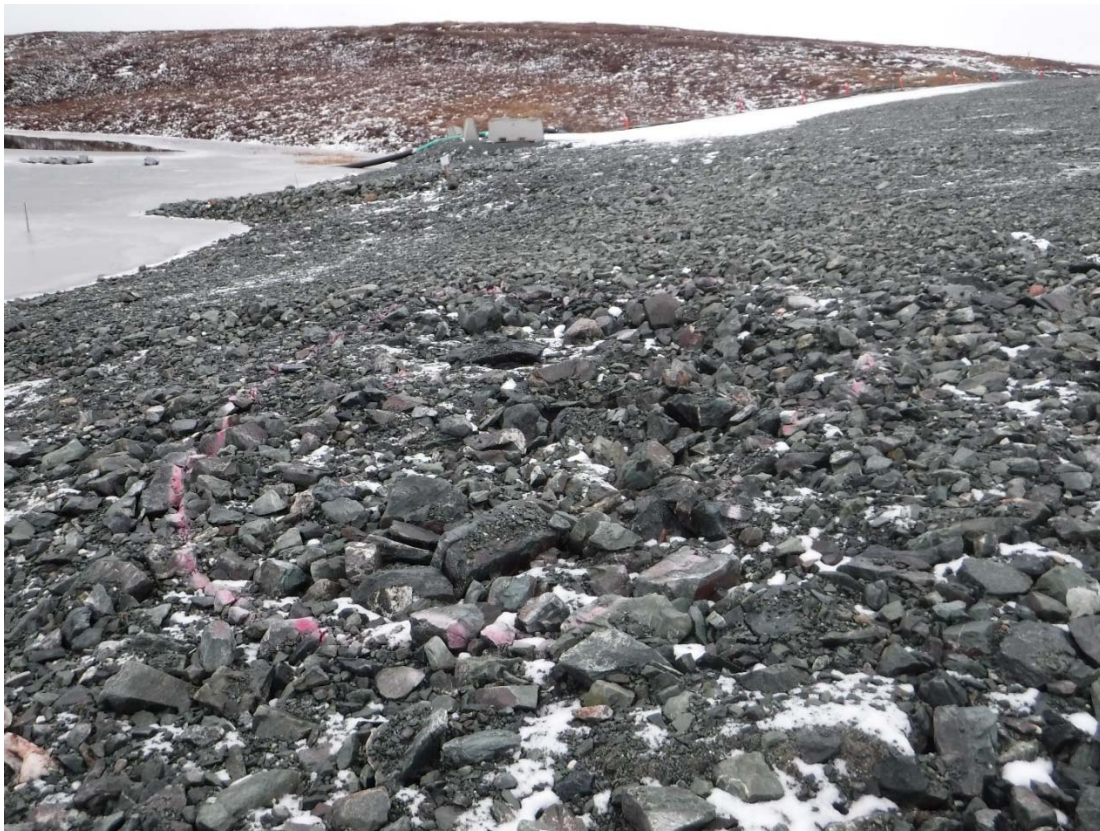
Upstream Side of Dam	Some depressions noted		
Any visible concerns? (cracks, depressions, erosion, etc.)	(see picture)	Yes	No
Downstream Side of Dam			
Any visible concerns? (cracks, depressions, erosion, seepage, etc.)		Yes	No
Crest of Dam			
Any visible concerns? (cracks, depressions, erosion, etc.)		Yes	No
Thermosyphons North Side			
Any visible concerns? (cracks, punctures, peeling paint, birds nests, etc.)		Yes	No
Thermosyphons South Side			
Any visible concerns? (cracks, punctures, peeling paint, birds nests, etc.)		Yes	No
Instrumentation (on crest and downstream side)			
Any visible concerns? (bent, rusted, cracked, etc.)		Yes	No
Thermistors and Dataloggers			
Any visible concerns? (frayed or cut cables, damaged boxes, etc.)		Yes	No
Suspended Sediment in TIA (When not frozen)			
Any suspended sediment in Tail Lake?	starting to freeze over	Yes	No
Water at the Toe of the Downstream Side of the Dam (If yes refer to Doris North – North Dam and Tail Lake Outflow Seepage Monitoring Work Plan 2015)		Yes	No

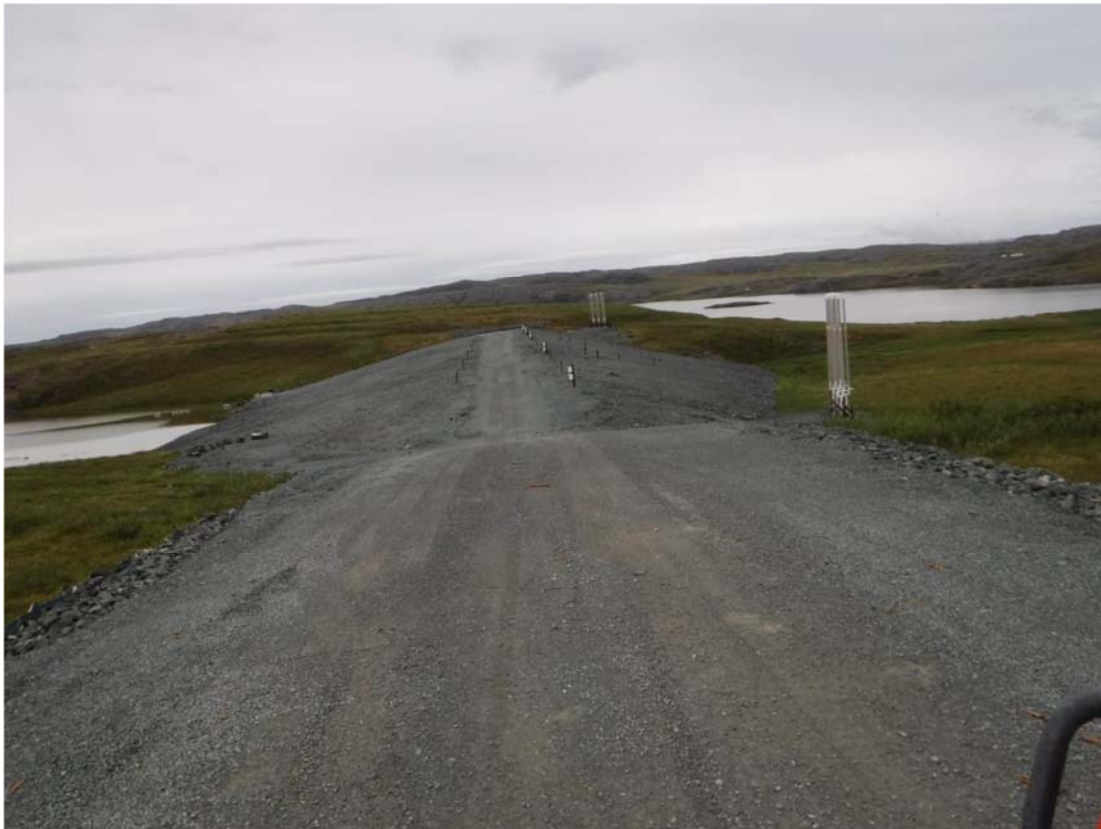
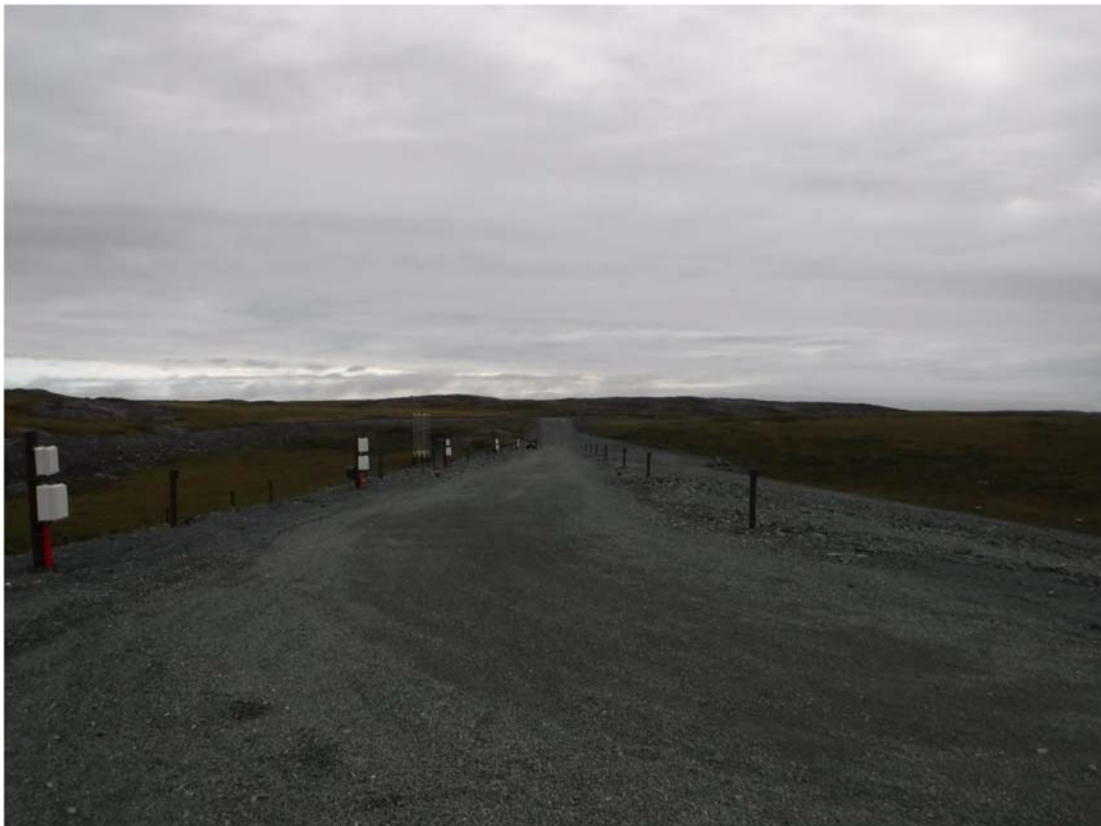
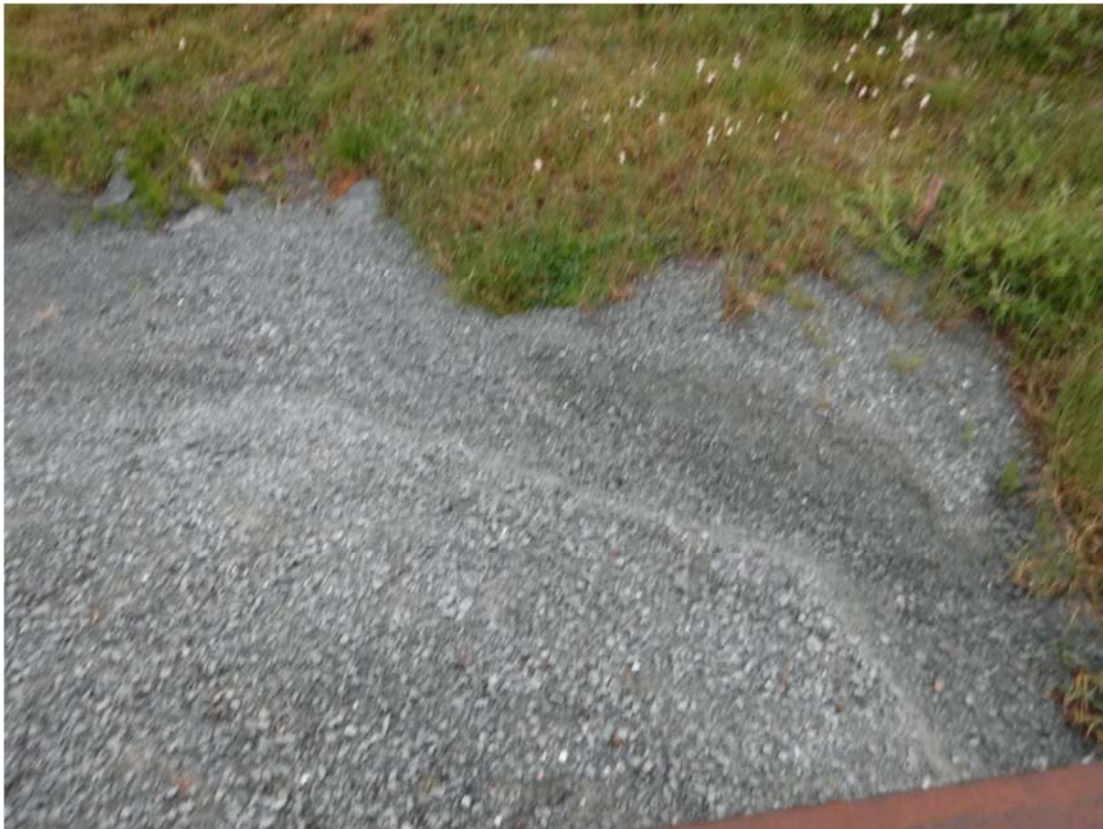
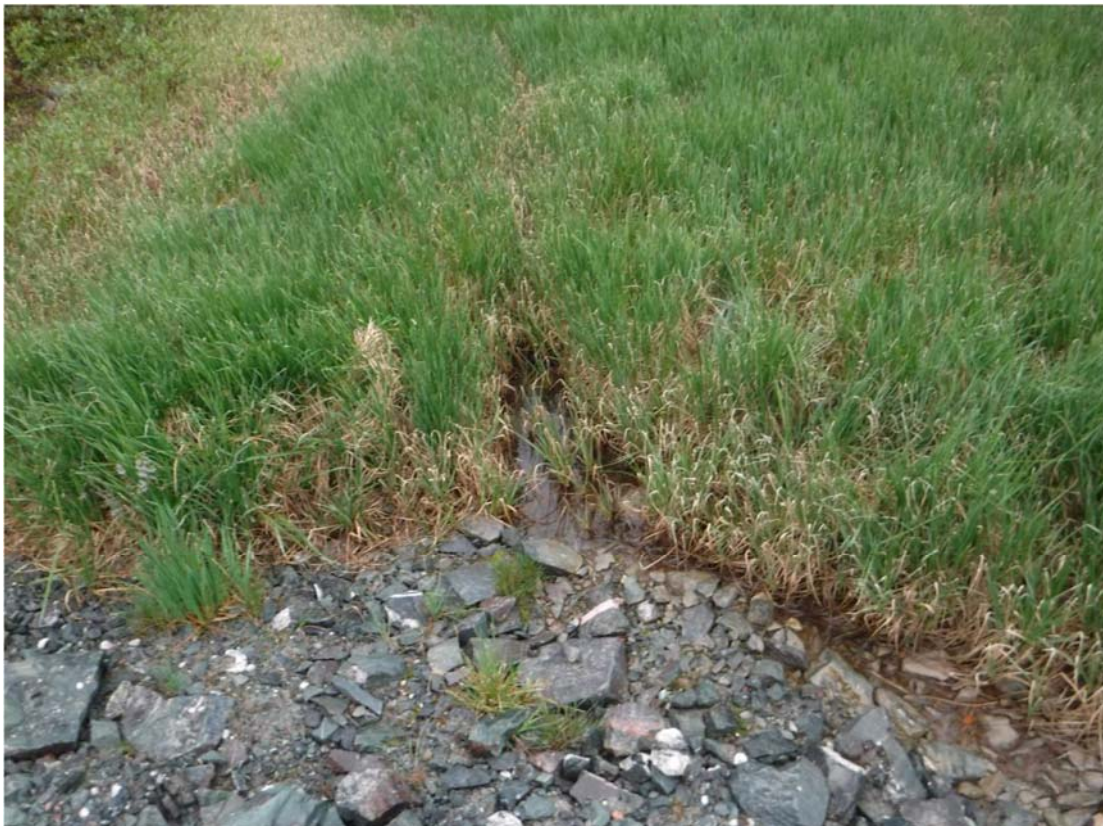
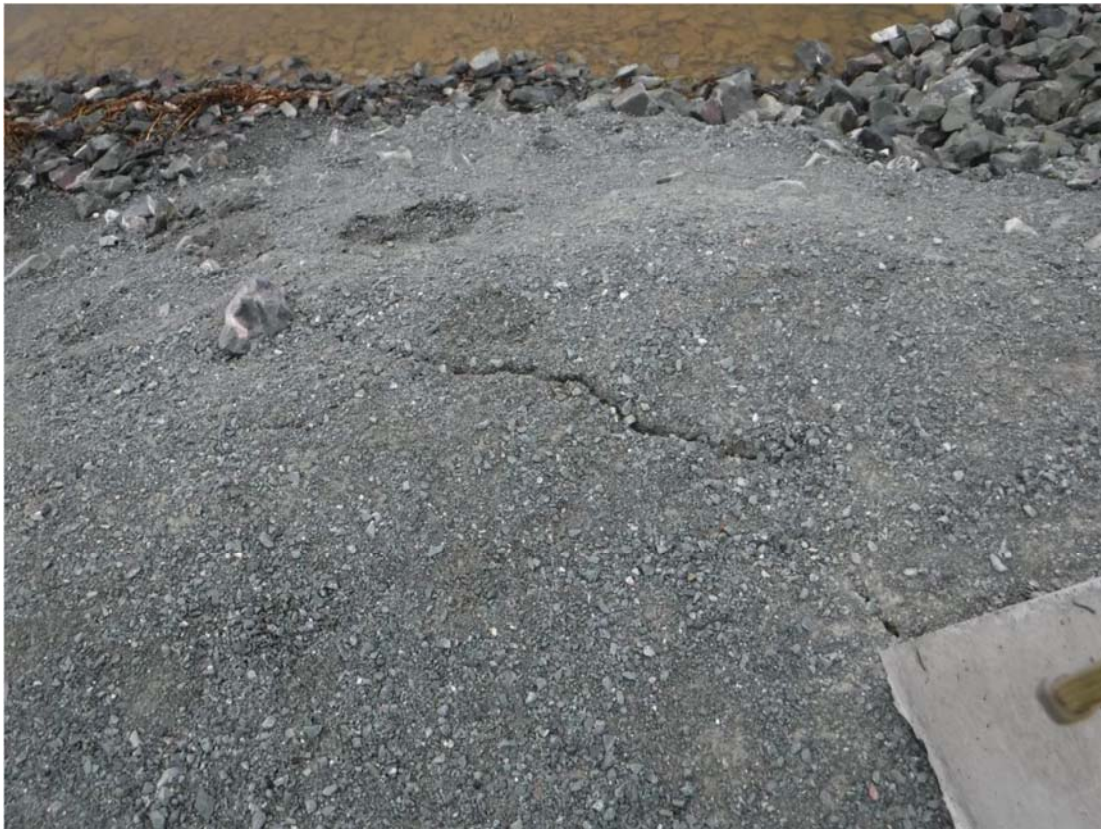
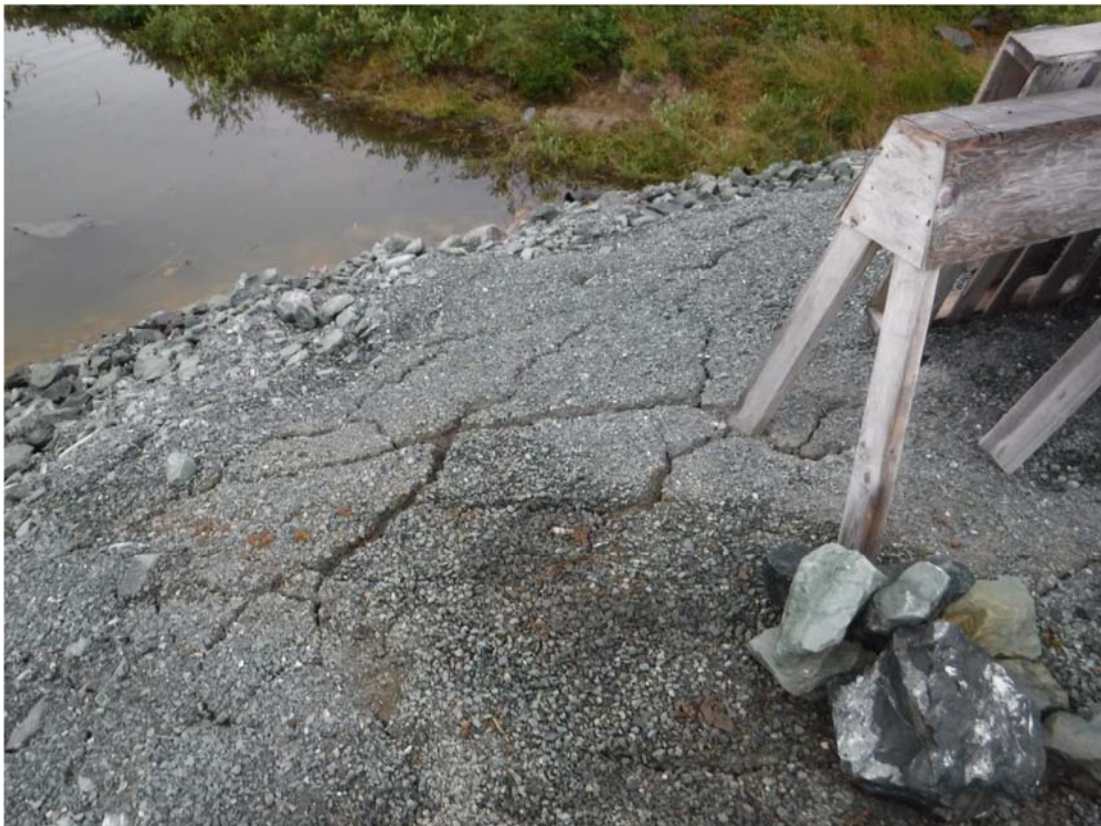
Upstream Side of Dam <i>surface cracks @ toe</i>		
Any visible concerns? (cracks, depressions, erosion, etc.)	Yes	<input checked="" type="radio"/> No
Downstream Side of Dam		
Any visible concerns? (cracks, depressions, erosion, seepage, etc.)	Yes	<input checked="" type="radio"/> No
Crest of Dam		
Any visible concerns? (cracks, depressions, erosion, etc.)	Yes	<input checked="" type="radio"/> No
Thermosyphons North Side <i>minor rust</i>		
Any visible concerns? (cracks, punctures, peeling paint, birds nests, etc.)	Yes	<input checked="" type="radio"/> No
Thermosyphons South Side <i>minor rust</i>		
Any visible concerns? (cracks, punctures, peeling paint, birds nests, etc.)	Yes	<input checked="" type="radio"/> No
Instrumentation (on crest and downstream side)		
Any visible concerns? (bent, rusted, cracked, etc.) <i>minor rust</i>	Yes	<input checked="" type="radio"/> No
Thermistors and Dataloggers		
Any visible concerns? (frayed or cut cables, damaged boxes, etc.)	Yes	<input checked="" type="radio"/> No

Suspended Sediment in TIA (When not frozen)		
Any suspended sediment in Tail Lake?	<i>Recent rain, water murky</i> Yes	No
Water at the Toe of the Downstream Side of the Dam (If yes refer to Doris North - North Dam and Tail Lake Outflow Seepage Monitoring Work Plan 2015) <i>minimal</i>		
	Yes	<input checked="" type="radio"/> No

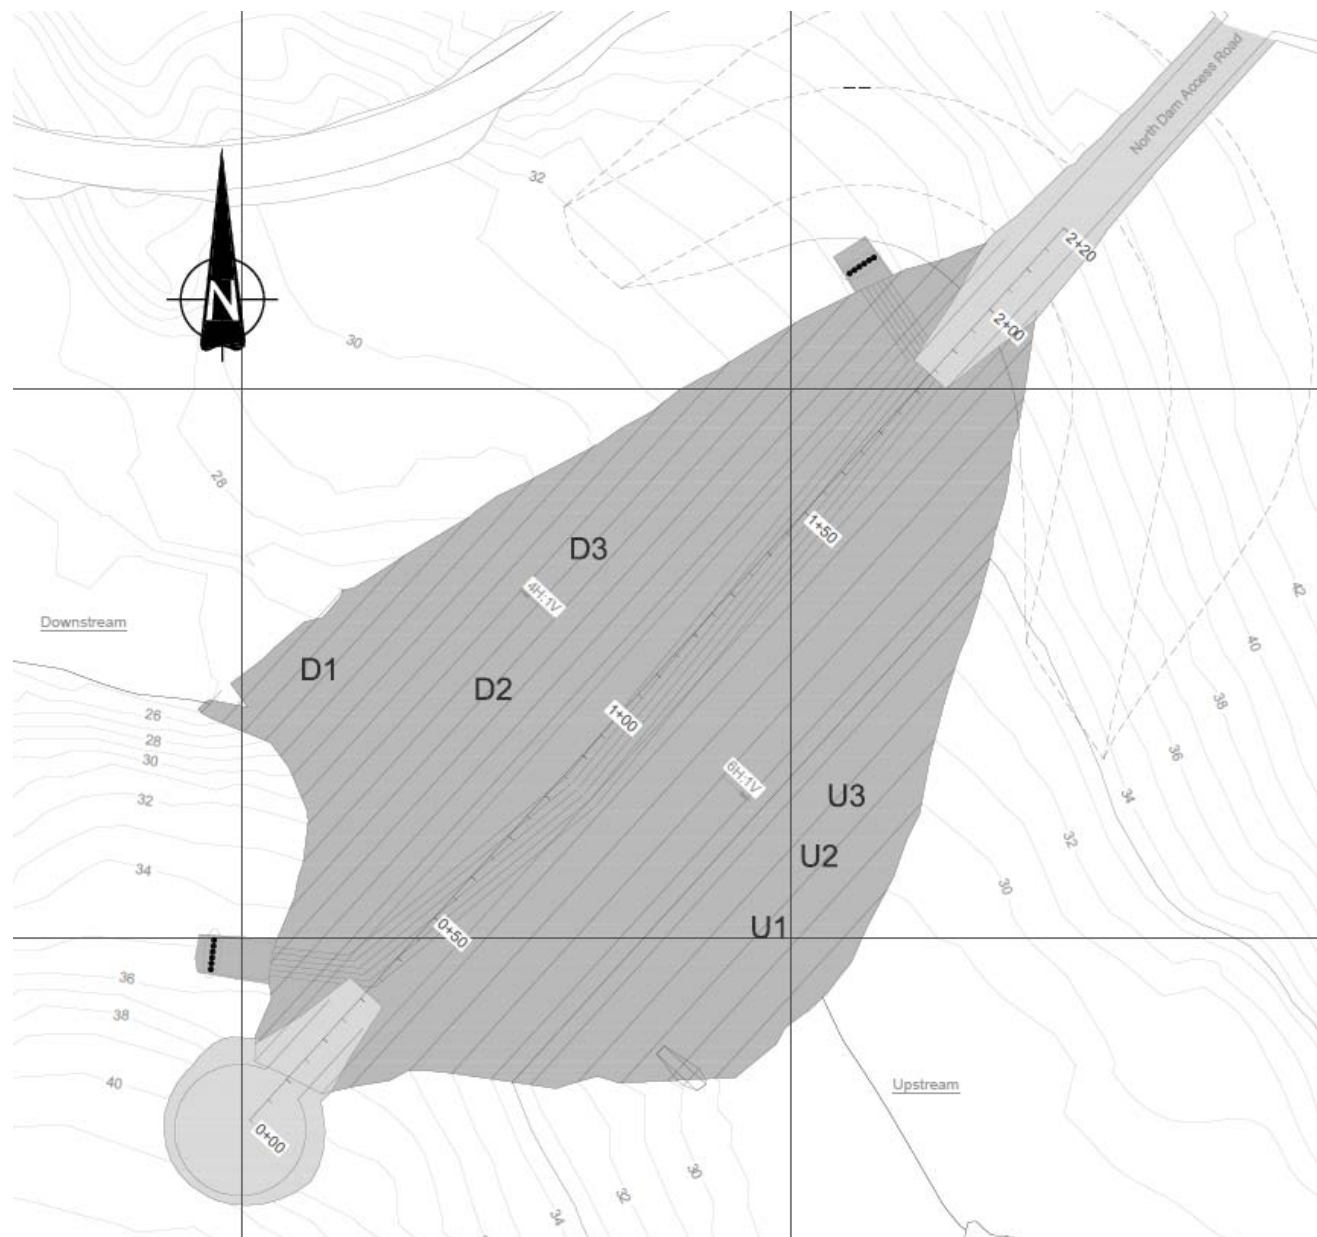
ID	Location	Comments	Northing	Easting
U1	Upstream	First noted June 2014	7559104	434393
		Boundaries spray painted and ID given July 2014		
		No substantial changes from previous inspection		
U2	Upstream	First noted June 2014	7559117	434402
		Boundaries spray painted and ID given July 2014		
		No substantial changes from previous inspection		
U3	Upstream	First noted June 2014	7559128	434407
		Boundaries spray painted and ID given July 2014		
		July 4, 2015 - Expanding toward U2		
		No substantial changes from previous inspection		
D1	Downstream	Identified during 2014 annual geotechnical inspection, spray painted and given ID.	7559151	434311
		September 1, 2014 - expanded towards the south		
		September 20, 2014 - TMAC ESR noted the depression looks to have expanded, paint mark updated.		
		July 4, 2015 - Slight expansion toward the crest was noted in the daily report		
		No substantial changes from previous inspection

D2	Downstream	First noted in 2013 Annual Geotechnical Inspection	7559147	434344
		September 14, 2014 - TMAC ESR noted that the depression may have expanded slightly		
		No substantial changes from previous inspection		
D3	Downstream	First noted in 2013 Annual Geotechnical Inspection	7559173	434360
		August 10, 2014 - larger area marked		
		No substantial changes from previous inspection
