April 26, 2016
Project No: 1CT022.002.511

RE: Doris North Project 2015 Annual Roberts Bay Jetty Inspection

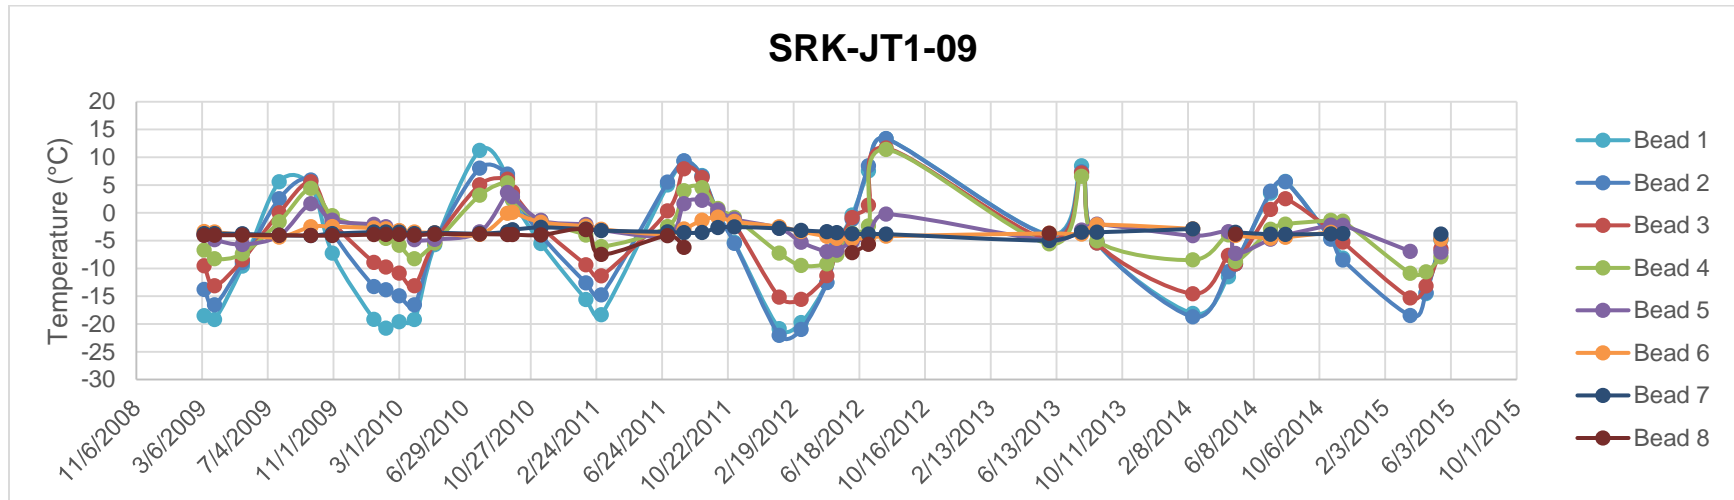
Attachment 1: GTC (SRK-JT1-09) Data

Two GTC's (SRK-JT1-09 and SRK-JT2-09) were installed through the jetty into submarine permafrost in 2009. One (SRK-JT2-09) was damaged in 2011, and a replacement (SRK-JT2-12) was installed in 2012. This GTC was again destroyed when the jetty was reconstructed in 2013. Up to date data for the active GTC (SRK-JT1-09) is presented in Attachment 1, confirming that since construction of the jetty, there has been no change in the composition of the submarine permafrost. SRK is therefore of the opinion that it is not necessary to replace the damaged GTC; however, the active GTC should continue to be monitored.

Ground Temperature Cable Data (SRK-JT1-09)
