# 2008 Monitoring Officer's Site Visit Report for the Jericho Diamond Mine Project

At the time of the site visit, no mining activities were occurring as the site was in Care and Maintenance.

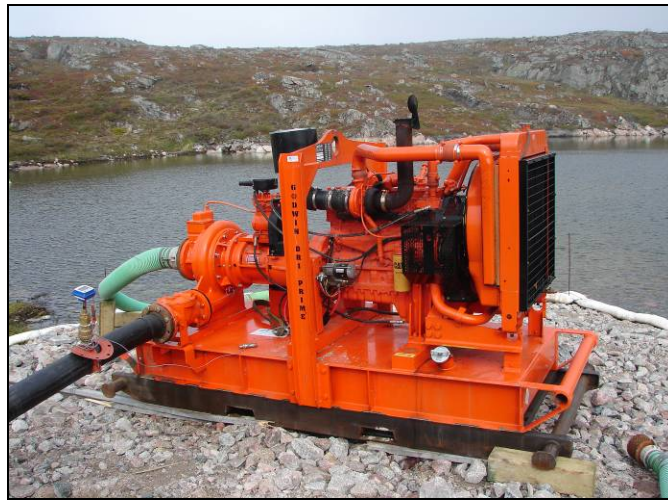
Generally not applicable - the site is currently in Care and Maintenance with no blasting occurring and with approximately 10 – 20 staff on site. The only noticeable source of noise was a large diesel pump used to discharge water from the West Containment Cell over an impermeable dam.

**Photo # 1: Diesel Pump used to discharge water**

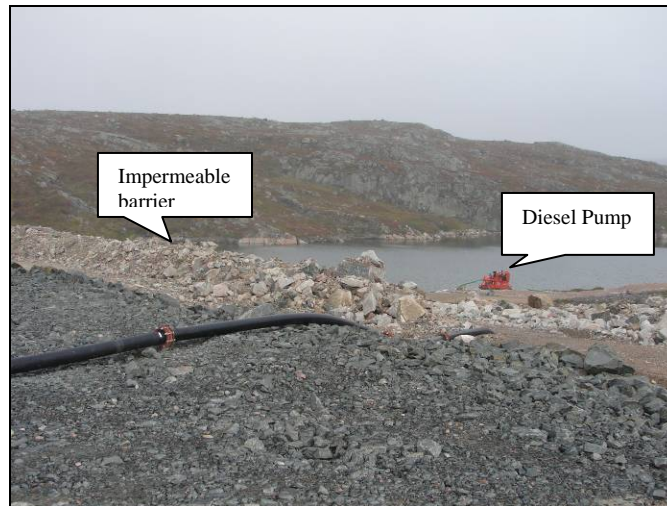
**Photo # 2: Diesel pump at West Containment Cell**

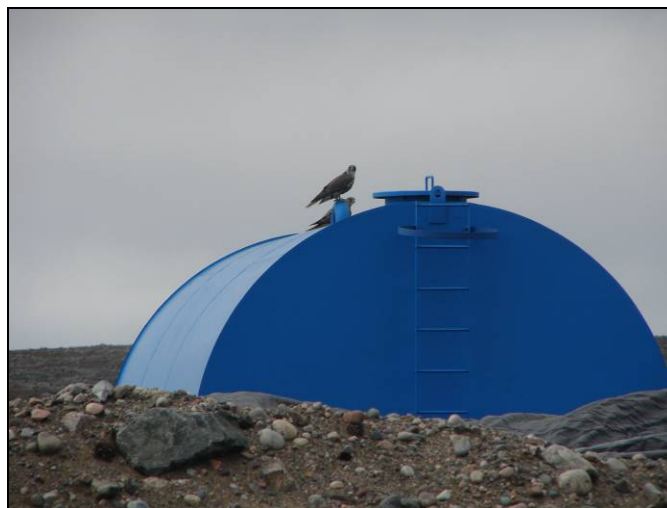
Initial surveys for nests were completed some time ago, and no new nests have been identified around the camp area. During the site visit, a pair of rough-legged hawks with a juvenile were present on the site near the airstrip, but were not believed to be nesting in the immediate vicinity. Andrew Coster mentioned that weekly surveys for wildlife presence around the project footprint are being conducted.

**Photo # 3: Rough-legged hawk perching on fuel tank**

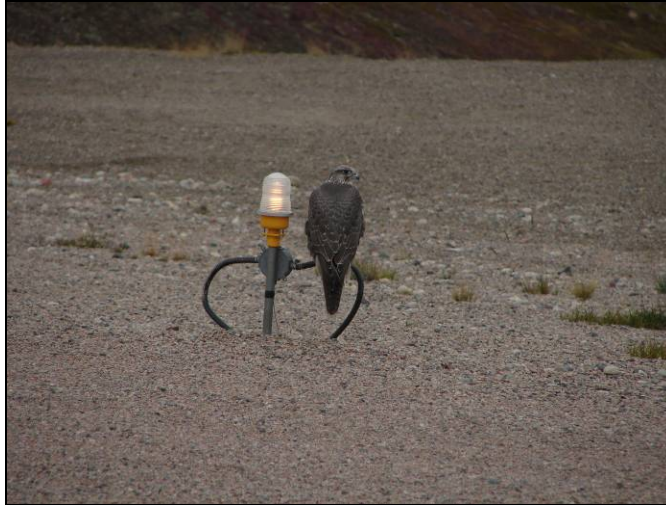
**Photo # 4: Rough-legged hawk on an airstrip light**

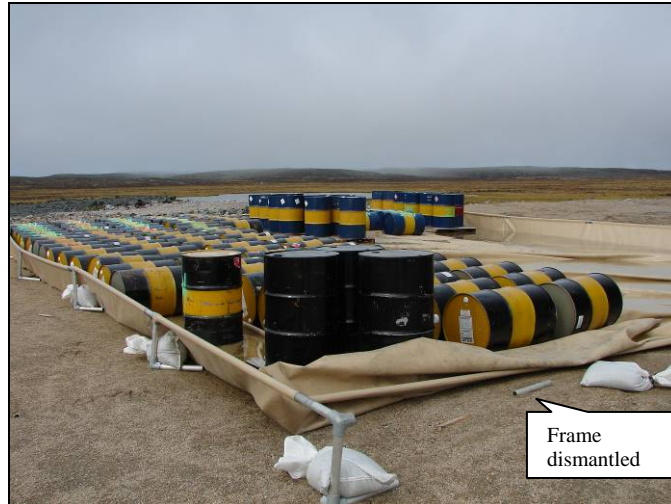
Fuel storage areas were well-bermed, with the exception of a laydown area at the airstrip (see Photo # 5). These fuel barrels were being used by personnel from OZ Minerals, for flights related to baseline research for Izok Lake, and monitoring at Lupin. The amount of fuel being stored appeared to exceed the capacity of the containment area, and the front of the structure was ripped and the frame was dismantled, making it ineffective as secondary containment. Apparently, the cause of the damage was related to propeller wash and frequent refuelling at the airport.

**Photo # 5: Fuel storage containment unit at airport**

The Proponent has not met the requirements of Condition #34, namely, the fuel storage area at the airstrip was not well bermed and did not meet regulatory requirements. The containment unit is damaged and inoperable, and is possibly too small for the amount of fuel stored at the airport.

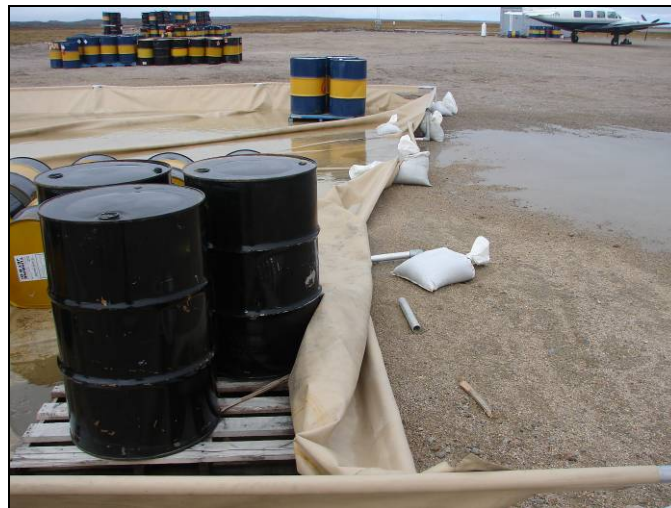
**Photo # 6: Close-up of fuel storage containment unit at airport**

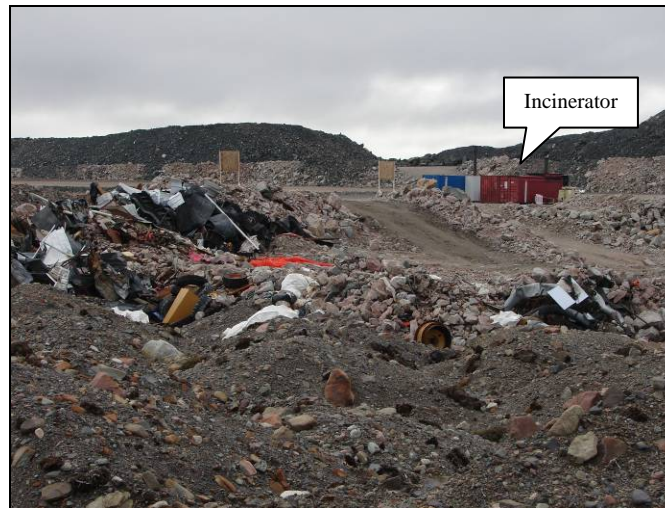
The landfill area was not fenced off and no other deterrents were apparent during the site visit. Wolverine have previously been attracted to this area during the winter months, which has resulted in an accidental kill by an employee in a truck. Another incident was previously reported in which a worker inside the seacan housing the incinerator was confronted by a wolverine barring the exit. The wolverine entered the incinerator stack despite attempts to scare it away. The wolverine left on its own

without incident. Improper incineration techniques were blamed for the attraction and both incidents prompted a review and revision of the techniques.

**Photo # 7: Landfill area with incinerator in the background (red seacan)**

With respect to Condition # 35, the Proponent has not proven to be compliant. Wildlife have been attracted to the landfills and/or waste storage areas. Wolverine incidents have occurred in which wolverine have been found at the landfill area and at the incinerator. The Proponent has indicated that mitigation measures have been put into place to avoid future wildlife encounters (i.e. lighting installed to illuminate haul road, screening on incinerator stack replaced).

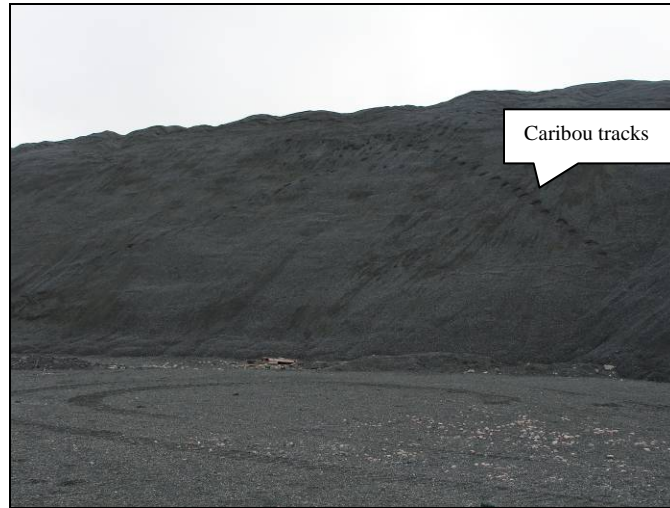
year, caribou migrated through the camp without incident, even climbing very steep tailing piles (see Photo # 8).

**Photo # 8: Caribou tracks on tailings pile from recent migration through the Jericho camp site**

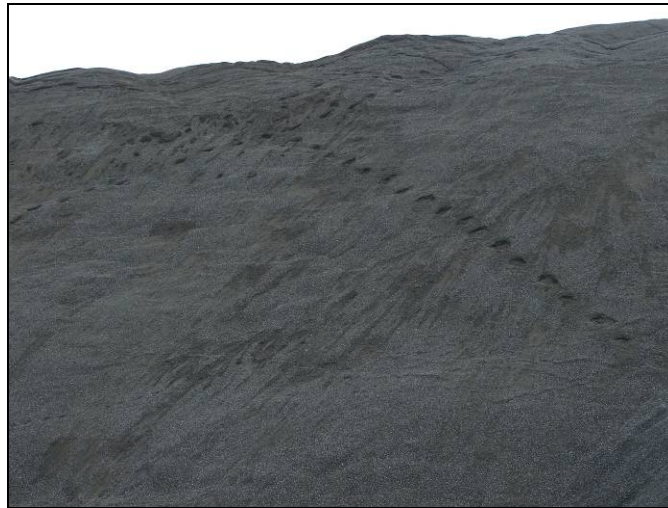
**Photo # 9: Close-up of caribou tracks on tailings pile**

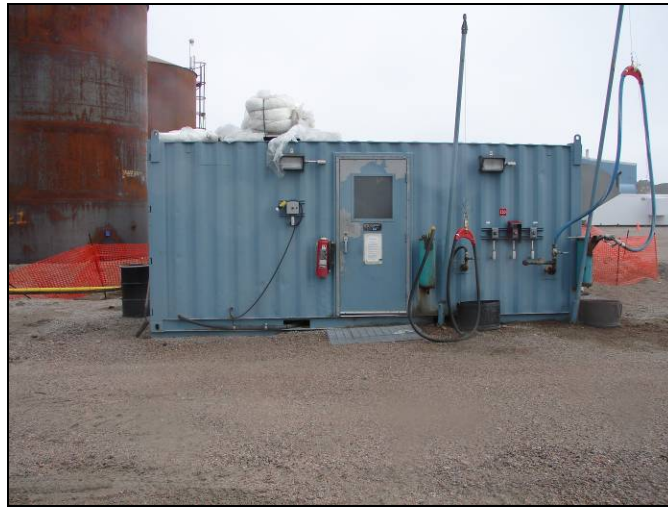
No new construction has been undertaken since Jericho went into Care and Maintenance. No large fuel trucks are used for refuelling; trucks are refuelled at the main station.

**Photo # 10: Fuelling station at the camp's fuel tank farm**

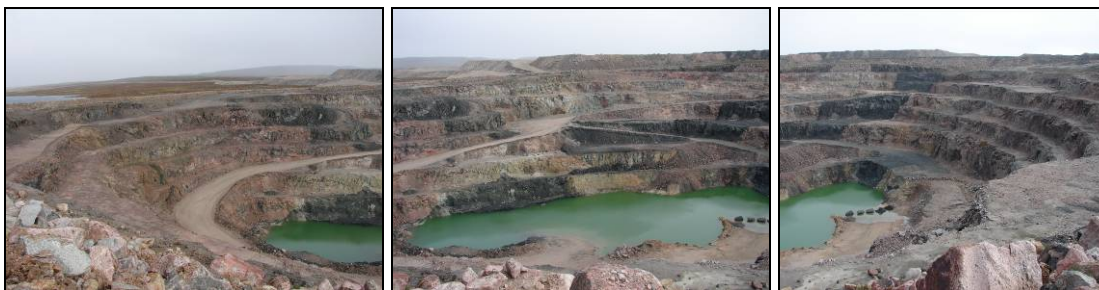
No fencing was visible around the pit area. The open pit does have a large berm constructed around the perimeter of the pit, approximately 4 to 5 feet in height. Currently, the pit is deemed unsafe and no access is permitted down into the pit (a berm was placed across the access road to prevent any vehicles from entering the pit). Water has begun to fill the bottom of the pit as seen in the photos.

**Photo # 11: The open pit at Jericho, from left to right in three overlapping pictures.**

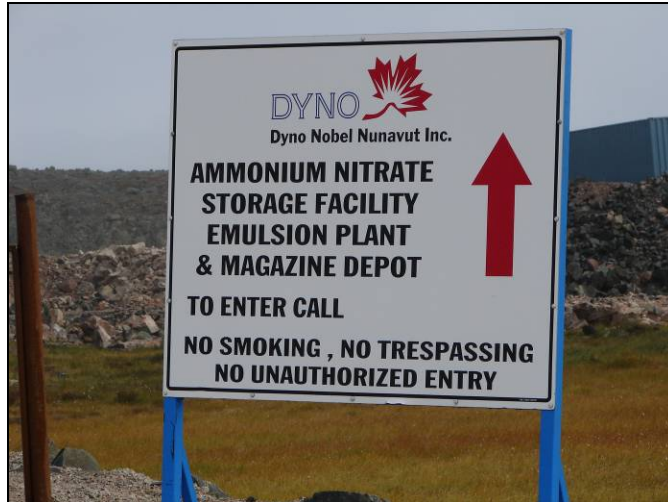
During the site visit it was noticed that there were no blasting constituents on site. All blasting constituents have been sold off to Diavik and removed from the site. Signage was clear and well-posted. Buildings formerly containing blasting materials are in a large contained area separate from the camp site, were empty and kept under lock and key.

Photo # 12(a): Example of signage posted at the entrance to the ammonium nitrate storage and magazine compound

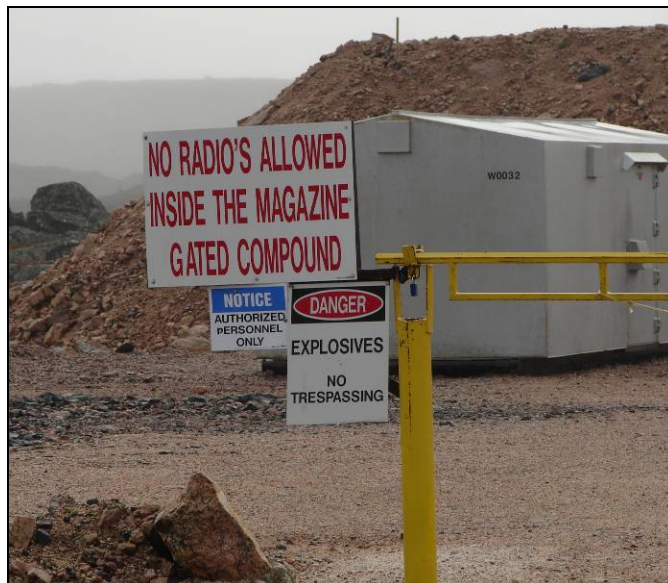
Photo # 12 (b): Example of signage posted at the entrance to the ammonium nitrate storage and magazine compound

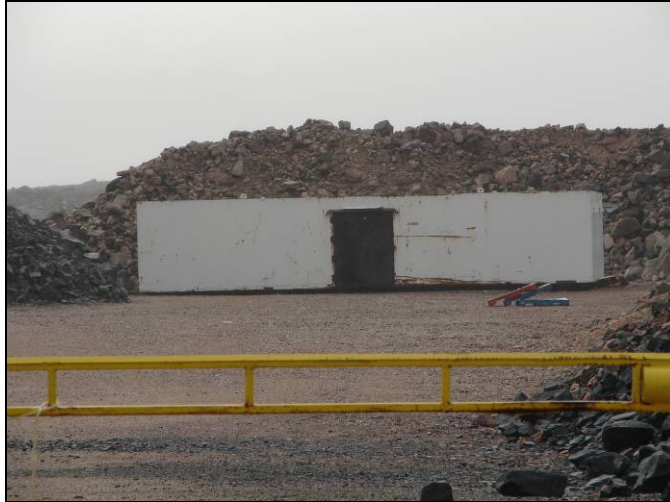
**Photo # 12 (c): Example of signage posted at the entrance to the ammonium nitrate storage and magazine compound**

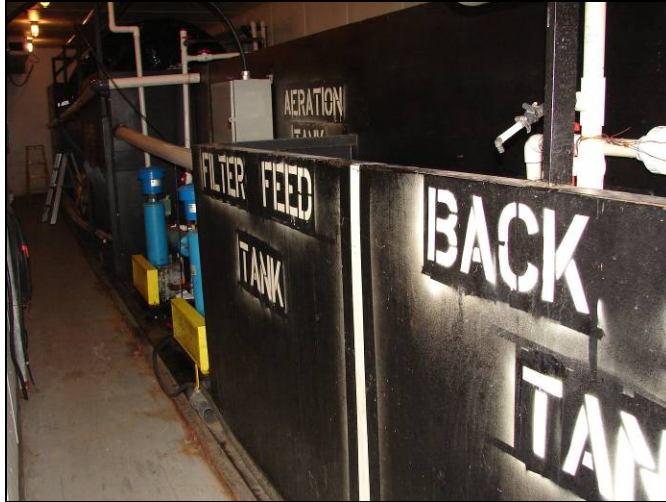
**Photo # 13: Inside the sewage treatment plant**

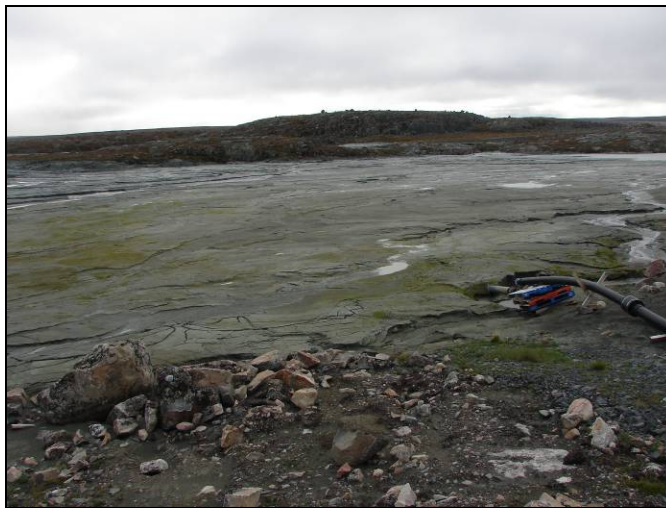
**Photo # 14: Effluent discharge point within the East Containment Cell**

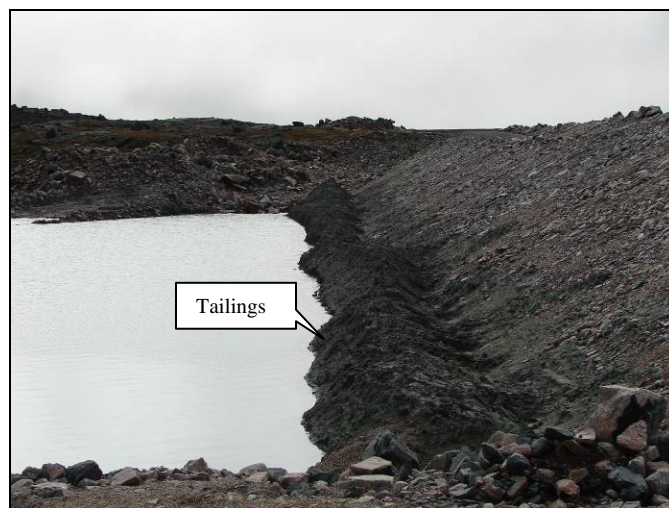
Currently, there is a permeable barrier in the PKCA, dividing it into two containment cells, an East Cell and a West Cell, with only the East Containment Cell having been used for depositing tailings (see Photo # 14). Recently, the staff in the Environmental Department at Tahera noticed excessive seepage beneath the permeable barrier, resulting in increased sedimentation within the West Containment Cell. The permeable barrier was reinforced with tailings to reduce the seepage into the West Cell (see Photo # 15), and appeared to work. However, additional material was needed to further reinforce a corner of the structure (see Photo # 16) and fine granular material was used instead of tailings. In addition, two silt fences were also installed in the West Containment Cell to further reduce the sedimentation (see Photo # 17).

**Photo # 15: Reinforcement of permeable barrier – addition of tailings in the East Containment Cell**

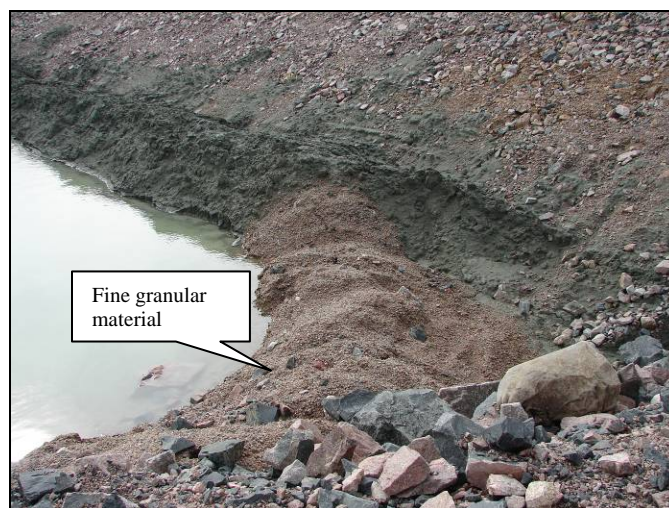
**Photo # 16: Reinforcement of permeable barrier – addition of fine granular material to prevent seepage in the structure's corner**

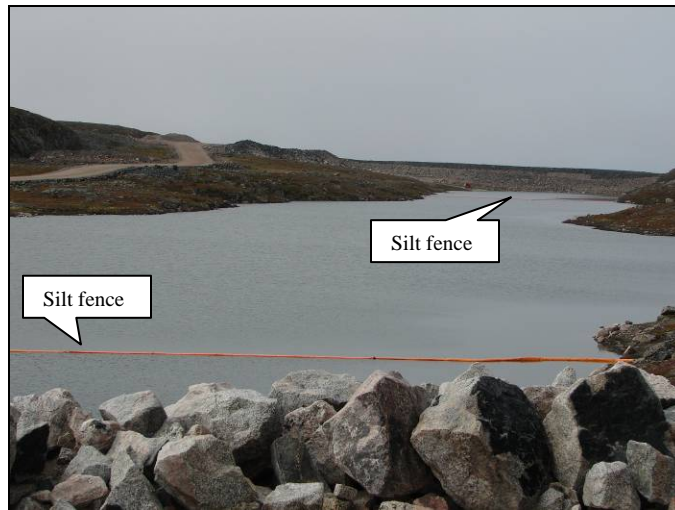
**Photo # 17: West Containment Cell from top of the permeable barrier that separates East and West Cells (two orange silt fences are visible)**

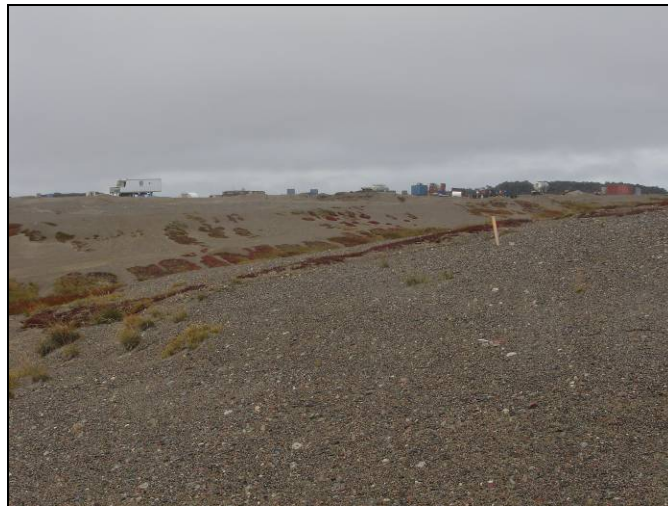
All infrastructure and garbage has been removed, and vegetation is beginning to establish itself. The only structure left near the old camp site is the floating dock on Carat Lake that is used in the summer for Tahera's summer field programs and a small tie-up structure left to be used by helicopters.

**Photo # 18: Old camp site on the edge of Carat Lake**

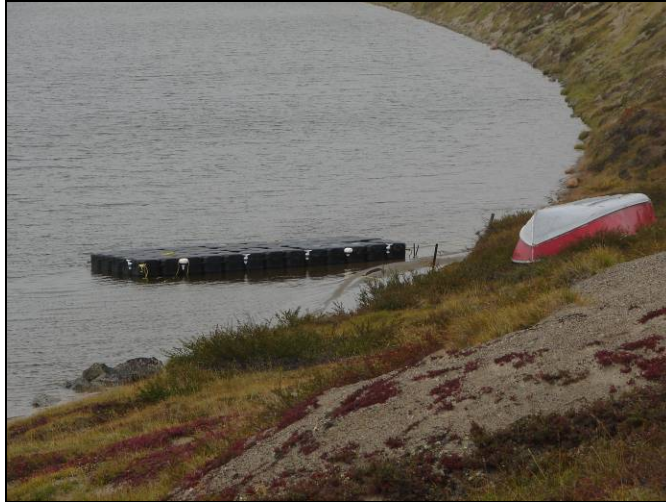
**Photo # 19: Floating dock on Carat Lake, anchored at the edge of the former old camp site**

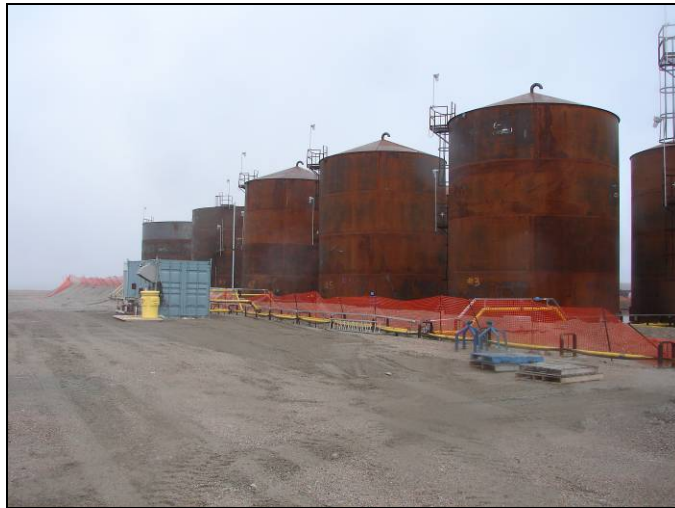
While fuel tank areas were all well-bermed, contamination was evident within both the main fuel tank area at the camp, and at the airstrip. Excessive rain fall in the days leading up to the site visit was responsible for the pooling of water (standing water) within the bermed areas.

**Photo # 20: Fuel tank farm at main camp site**

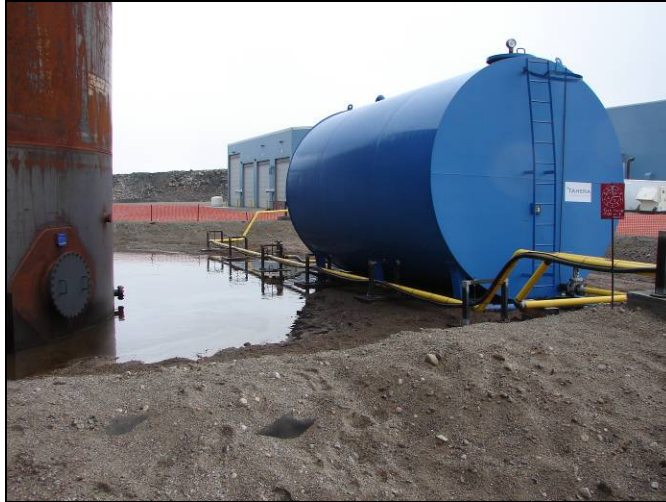
A visible sheen was noticed on the water at both the main fuel tank area and at the airstrip. The berm at the airport showed evidence of contamination from a previous spill and it appeared that the contaminated soil was not removed from the bermed area. At this location, a spill of approximately 30,000 litres was previously reported from one of the tanks due to a faulty valve line.

**Photo # 21: Small amount of sheen visible on water pooled within the bermed area at main fuel containment area**

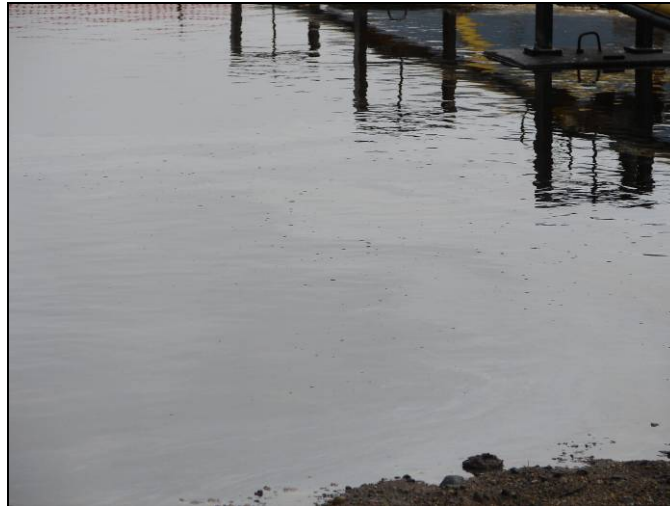
**Photo # 22: Close-up of sheen visible on water pooled within fuel containment area**

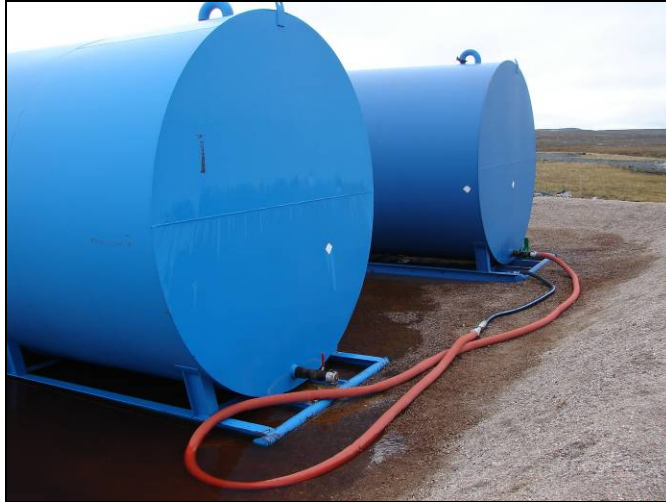
**Photo # 23: Two fuel tanks within a fuel berm at the airstrip**

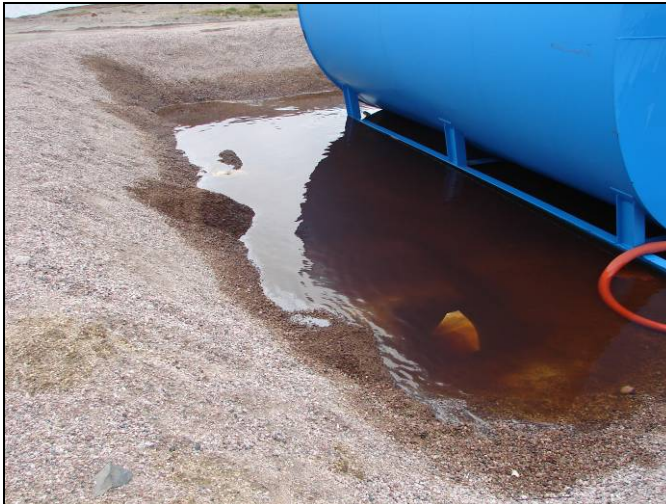
**Photo # 24: Close up of contaminated soil and standing water within bermed area at airport**

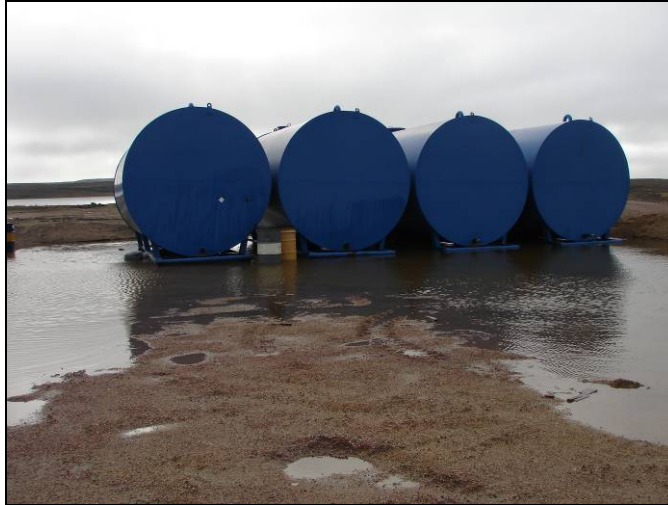
The waste transfer area and fuel tanks containing contaminated fuel appeared to be lined and bermed properly with no visible contamination apparent. As can be seen from Photo # 25 the standing water within the bermed area from previous rain fall did not show any visible contamination (no sheen was observed).

**Photo # 25: Fuel tanks holding contaminated fuels within another bermed area (no visible contamination)**

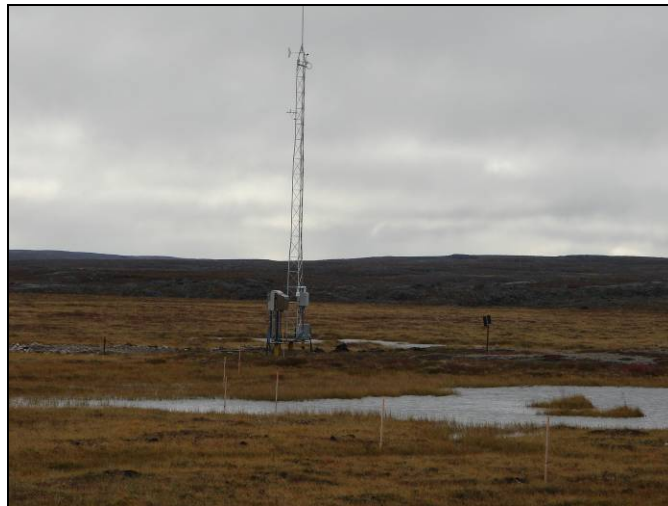
A weather station was installed at the airstrip, with a computer display inside the terminal building.

**Photo # 26: Camp weather station located at the airstrip**
