**Report Title:** 2011 NIRB's Monitoring Officer Site Visit Report for the Jericho Diamond Mine Project

**Project:** Jericho Diamond Mine  
**Project Location:** Kitikmeot Region, Nunavut

**Visit conducted by:** Sophia Granchinho, Monitoring Officer, Nunavut Impact Review Board  
**Telephone:** (867) 793-4633

**Site visit dates:** August 17 – 19, 2011  
**Last site visit:** July 28 – 29, 2009

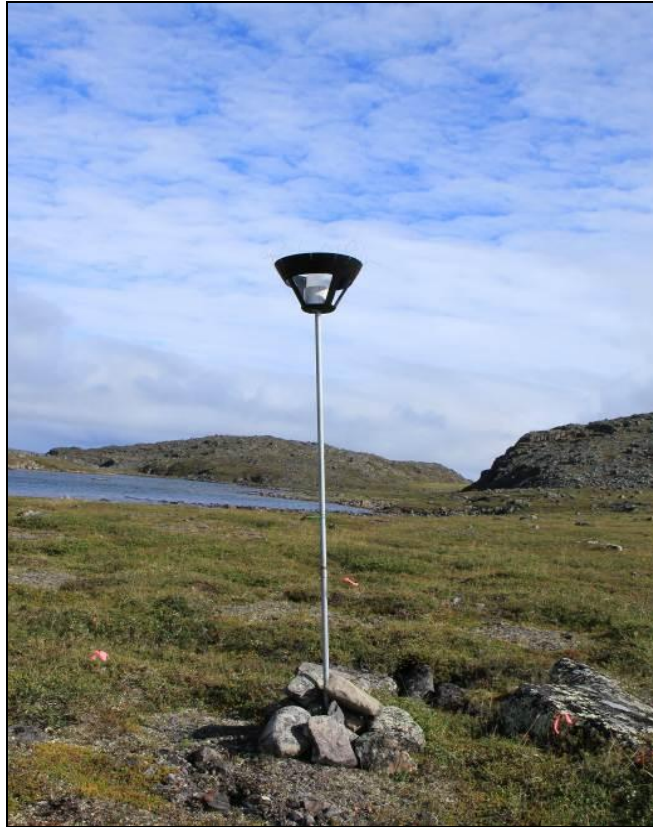
**Photo 1: Dustfall Monitoring Station (DS7) between Lynne Lake and Key Lake**

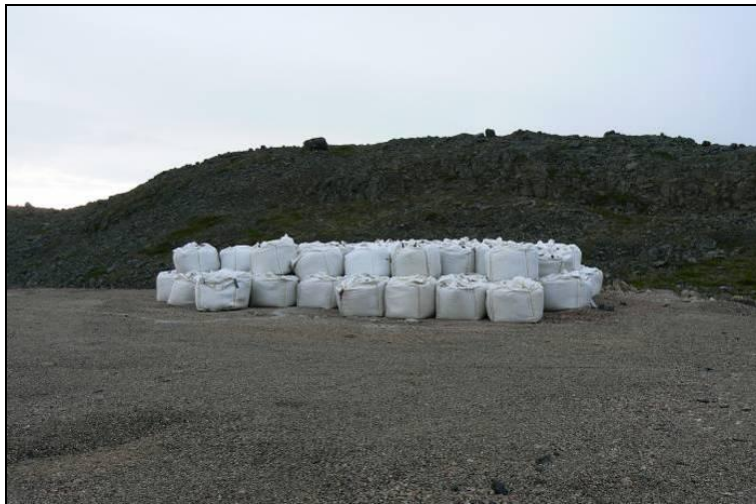
During the site visit, the Monitoring Officer noted bags of cement mix were still being stored at the ammonium nitrate storage pad as was noted in the 2009 site visit. No other materials were found at this storage area. Some bags of the cement mix were open or torn and dried cement was observed on the ground around the bags (see [Photo 10](#) and [Photo 11](#)).

**Photo 10: Bags of cement mix at the ammonium nitrate storage pad (photo taken 2009)**

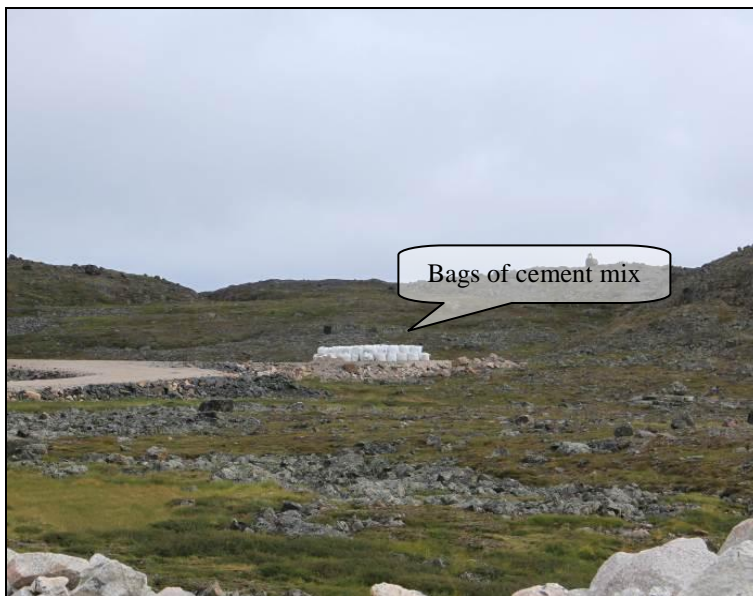
The NIRB’s Monitoring Officer also discussed with Shear staff the historically higher nitrate levels observed in Lynne Lake, downstream of the ammonium nitrate storage pad; and suggested that the ammonium nitrate bags be moved into a building instead of being stored outside on a storage pad.

Ms. Lassonde noted that Dyno Nobel is responsible for the ammonium nitrate storage facility, emulsion plant and magazine depot. During removal of the ammonium nitrate bags in 2008/2009, some of the bags opened up and spilled into the environment. Ms. Lassonde indicated that Dyno Nobel is responsible for clean-up of the observed spillage and any required remediation of the affected area.

**Photo 11: Ammonium nitrate storage pad from emulsion plant**

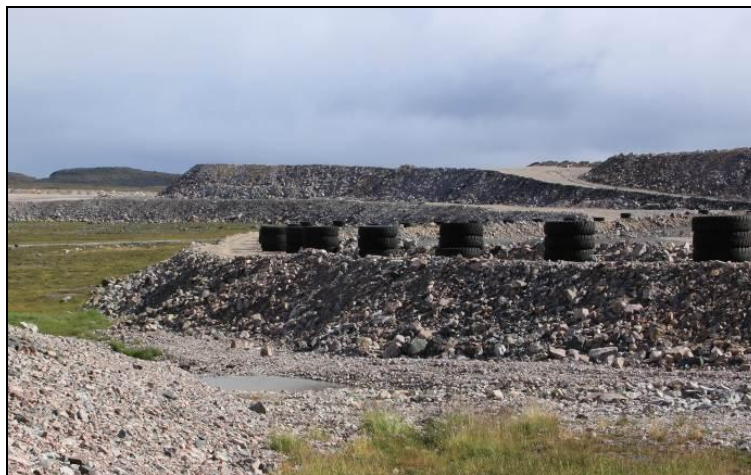
The open pit features a large caribou berm constructed around its perimeter, approximately 4 to 5 feet in height in most places with the main section of the perimeter located on the south side of the pit. During the site visit, the Monitoring Officer noted that no fencing was visible around the open pit area; however tires were placed around the pit area as a deterrent to people, who might be travelling in the area, especially during the winter periods (see [Photo 13](#) and [Photo 14](#)).

**Photo 13: Haul truck tires around open pit area**

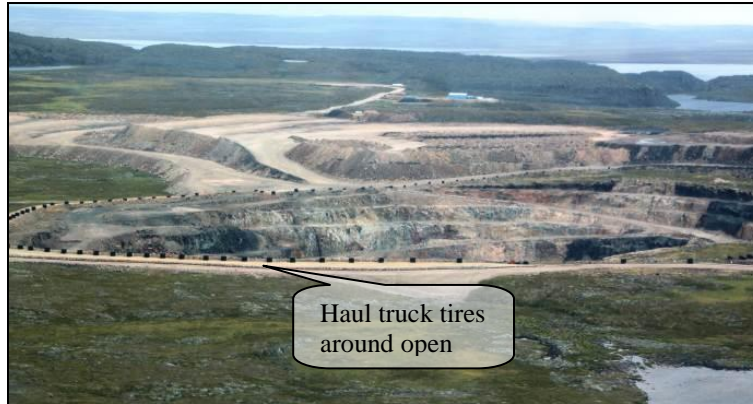
**Photo 14: Aerial view of open pit with tires around perimeter**

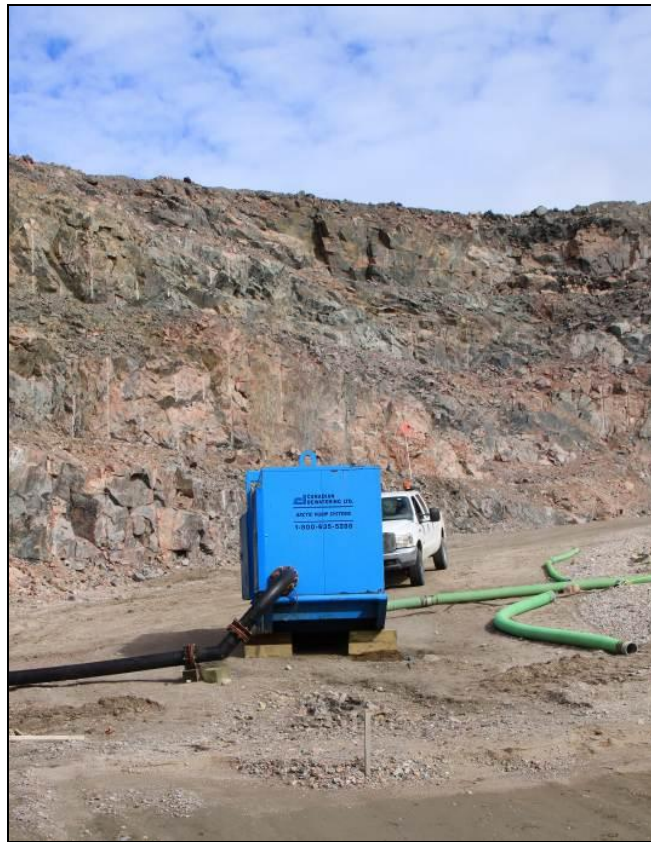
At the time of the site visit, the Jericho pit was deemed unsafe, and no access was permitted down into the pit with the exception of personnel conducting dewatering activities, from the pit to the PKCA. When Tahera suspended activities at the Jericho site in January 2008, the open pit naturally filled with water (see [Photo 15](#), [Photo 16](#) and [Photo 17](#)). Shear commenced dewatering activities of the open pit on July 29, 2011, and the pit water was pumped, discharged, and then diluted within the PKCA. This allowed the pit water to be incorporated and discharged as part of the PKCA discharge while still meeting the water licence discharge criteria. Dewatering activities halted within a week and half due to mechanical failure of the pump.

**Photo 17: Pump used to dewater pit**

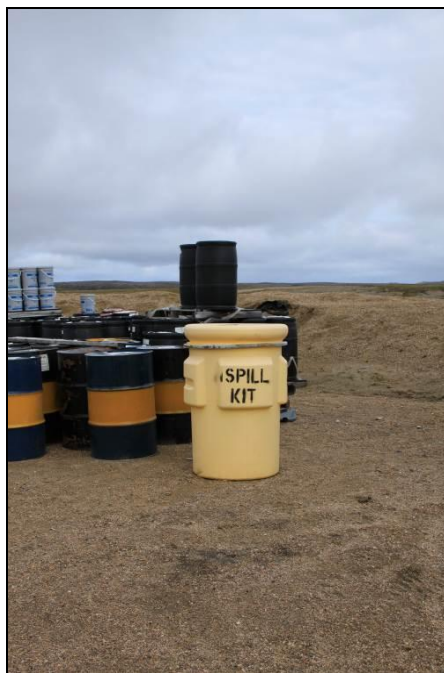
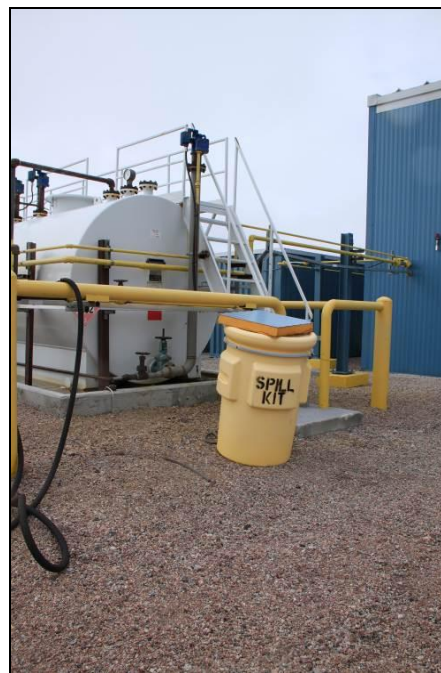
Shear personnel confirmed that all fuel trucks on site were equipped with spill kits, and the Monitoring Officer noted that secondary containment was in place at the fuel transfer station. No large fuel trucks were being used for refuelling at the time of the site visit and all trucks were being refuelled at the main station (see [Photo 18](#)). Spill kits were noted at most fuel storage areas (see [Photo 19](#)).

**Photo 19: Spill kits (HWA and emulsion plant)**

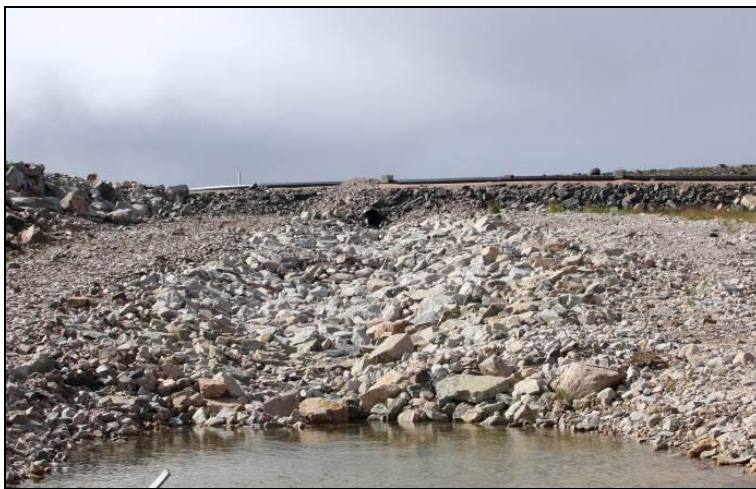
Roads around the mine site were maintained as required and culverts that had been previously installed continued to function properly (see [Photo 20](#)).

**Photo 20: Culvert at C1 Diversion – facing upstream**

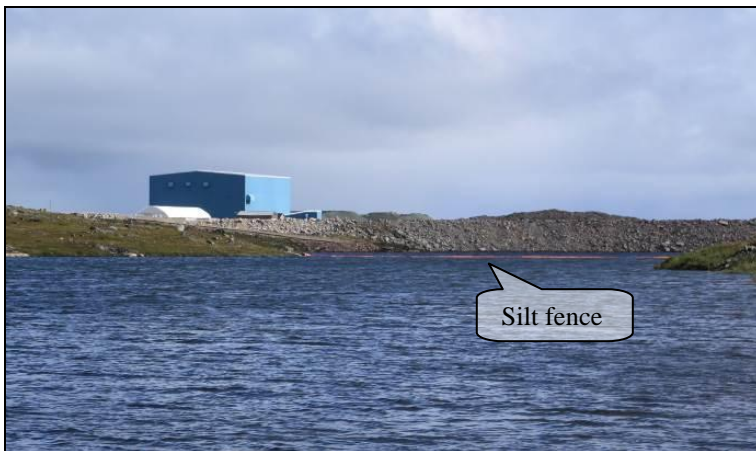
A silt fence was observed in West Containment Cell of the PKCA. This silt fence was installed in order to prevent sediment from entering the lower part of the West Cell and Stream C3 during the dewatering of the pit into the West Cell (see [Photo 21](#)).

**Photo 21: West Containment Cell (facing east towards processing plant)**

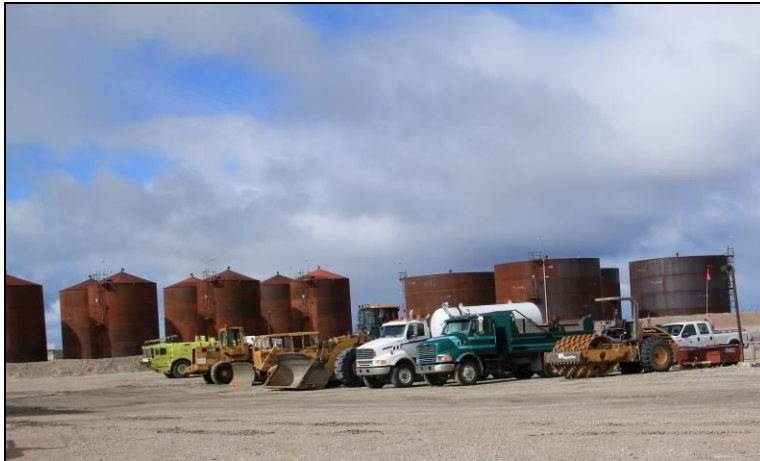
The liner for the main fuel tank farm was exposed in several areas. Substrate in the berms was heavily contaminated with fuel and standing water within the berm contained visible

hydrocarbon sheen. Strong hydrocarbon odours were also noted around the fuel tank farm (see [Photo 24](#) through [Photo 27](#)).

**Photo 24: Main tank fuel farm**

During the 2009 site visit, similar observations were made for the fuel storage areas. The NIRB recommended that Tahera comply with Condition #34 and ensure that the fuel storage areas meet regulatory requirements.

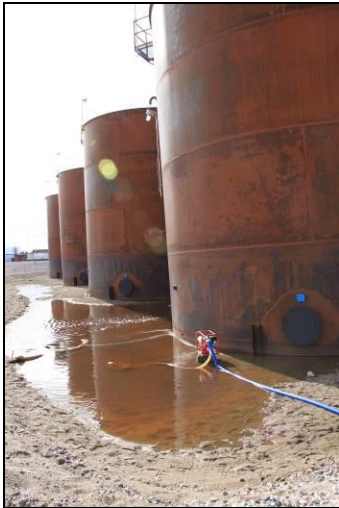
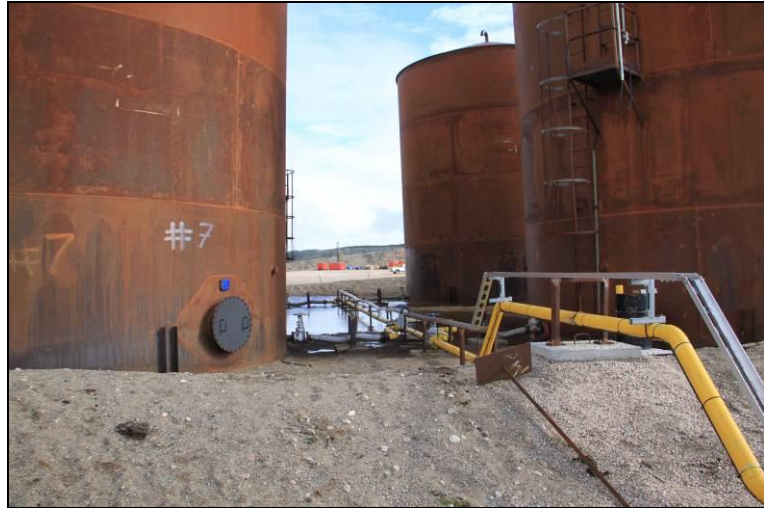
**Photo 25: Standing water within bermed area at main fuel tank**

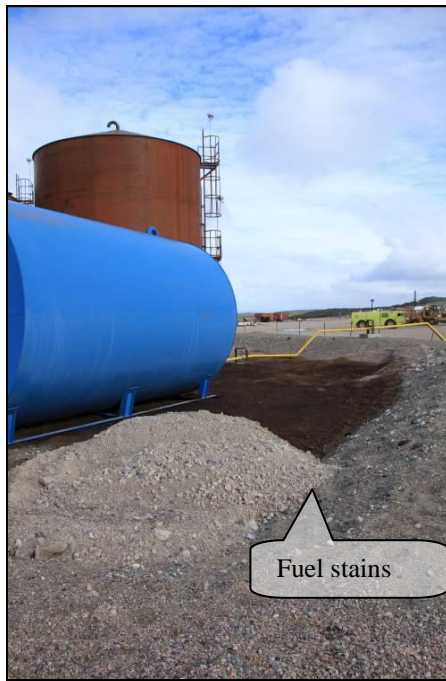
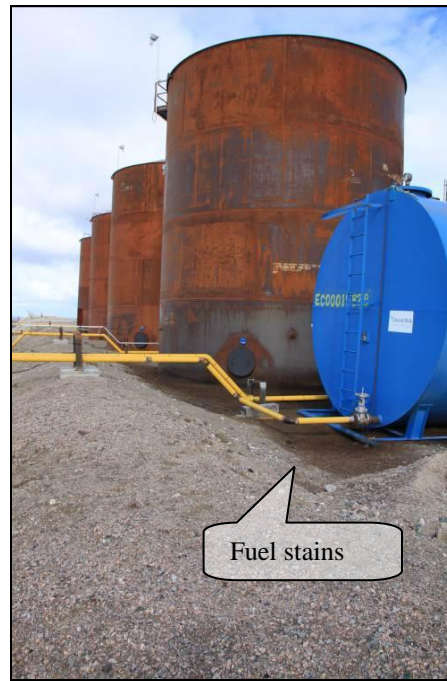
**Photo 27: Contaminated soil within bermed area at main fuel tank**

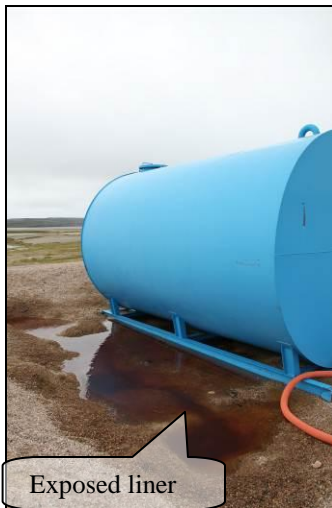
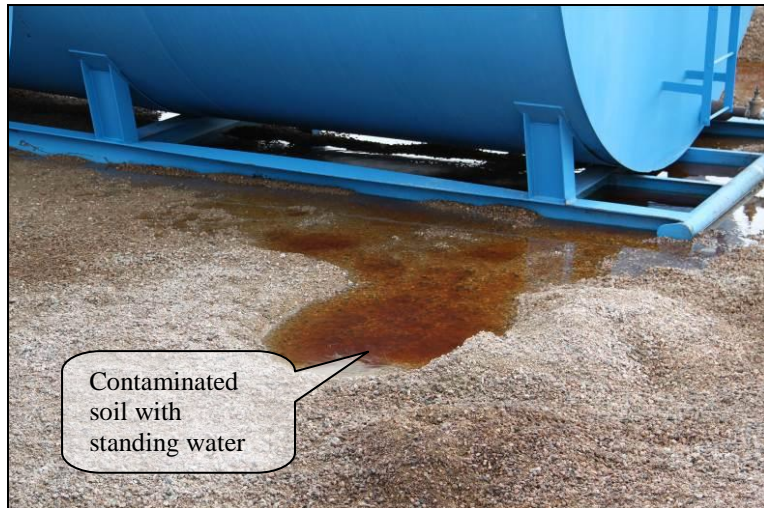
The liner for the airport fuel tanks was exposed in one main area. Standing water was present with visible hydrocarbon sheen. Hydrocarbon odours were also noted at the airport fuel tanks. As described in the 2009 site visit report, the substrate within the berm at the airport showed evidence of contamination from a previous spill in 2007 and it appeared that the contaminated soil had not been removed from the bermed area. The spill that occurred in 2007 at the airport fuel tank farm was approximately 47,000 litres and was due to a faulty valve line<sup>11</sup>.

**Photo 28: Airport fuel tanks**

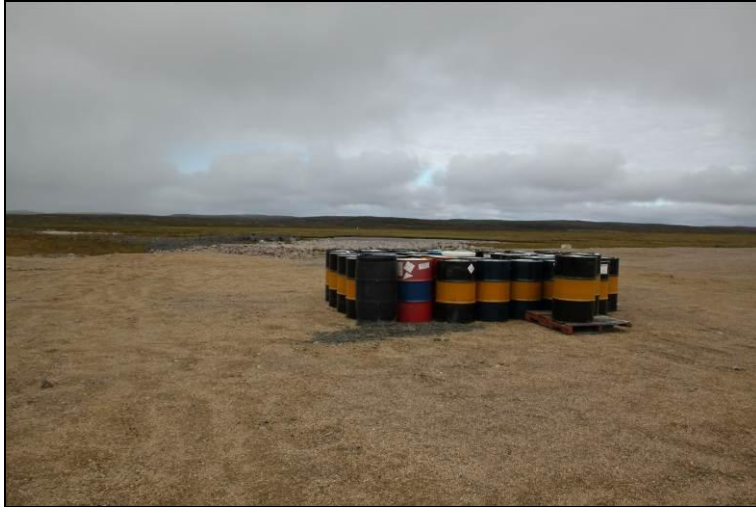
Fuel barrels stored at the airport were not located within a secondary containment facility. Mr. Morton mentioned that the barrels were empty and would be removed from site (see [Photo 29](#)). Fuel stains were also evident on the road next to the airport fuel tank berm.

**Photo 29: Fuel barrels stored at airport**

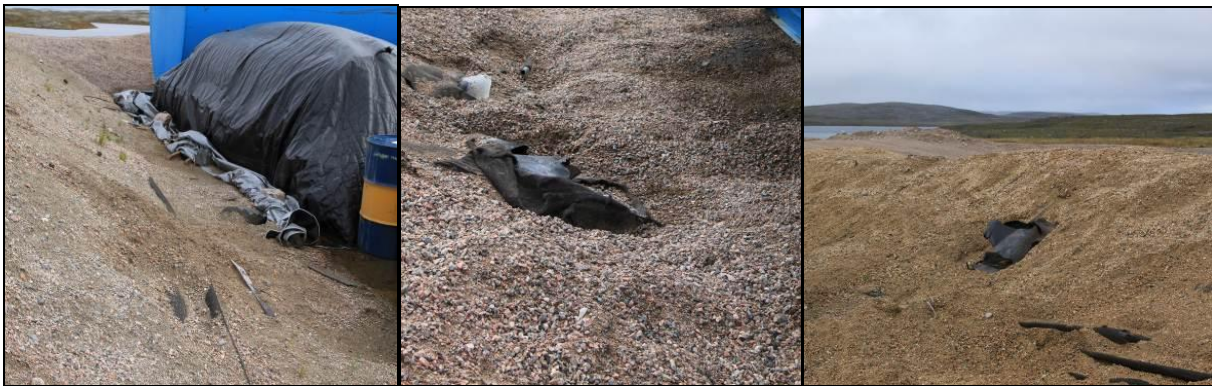
The two waste transfer containment areas (two cells) located near the airport are bermed and lined, but are not completely enclosed as each cell has an access ramp located on its southeast corner. The liner around the perimeter (numerous locations) was exposed, torn and is in need of repair or replacement (see [Photo 30](#)). Hydrocarbon odours were also noted at the waste transfer areas. Shear is currently developing plans to address the damaged liner and is working to sort and properly contain the wastes until they can be shipped off-site for appropriate disposal.

**Photo 30: Exposed liner at the Hazardous Waste Transfer Area**

The Proponent has not met the requirements of Condition #34, as the waste transfer containment area near the airstrip was not completely contained (berm was not enclosed) and the liner was ripped in several locations.

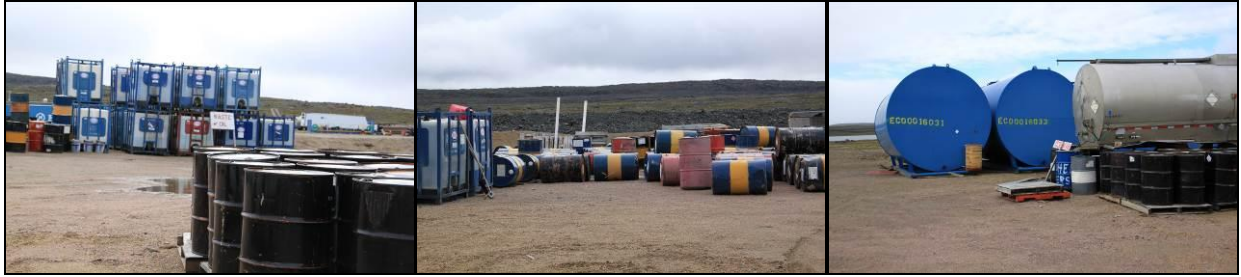
The cell to the east contains bulk waste containers, waste oil, waste fuel in drums and cubes, and drummed diesel fuel (see [Photo 31](#)). Most of the barrels within this cell came from the Muskox site and contain waste oil. The waste oil is currently being used in the boiler at site.

**Photo 31: Waste Transfer Containment Area (easterly direction)**

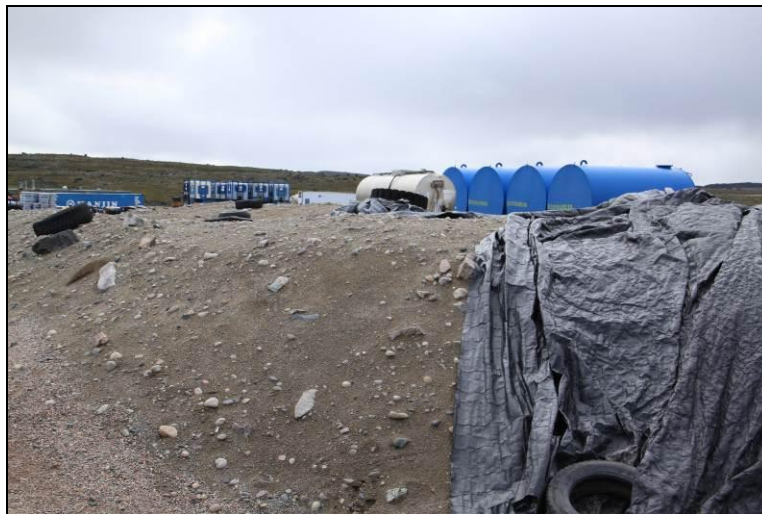
The cell towards the west is being used for storage and/or isolation of contaminated soil (see [Photo 32](#), [Photo 33](#) and [Photo 34](#)), which is stored in one large pile under a tarp, in numerous drums or bags. As there is no current landfarm in place at Jericho, the contaminated soil has not been remediated on site, nor has it been removed off-site for treatment. Shear has submitted a *draft* landfarm plan to the NWB and is awaiting approval of this plan.

The majority of the contaminated soil located in this cell was associated with a DC-4 jet spill that occurred in December 2006 at the airport, along with the remainders of some minor spills that occurred around site since Tahera began construction. The piles of contaminated material have been previously covered by tarps, but the tarps have ripped off in many places and the contaminated material is exposed to the environment (see [Photo 32](#)). The bulk of the contaminated soil is currently being infiltrated by water and there is potential that hydrocarbons could be leaching out of the pile into the secondary containment. Pooling water was noted in this cell with hydrocarbon staining (see [Photo 33](#)). In addition, a visible stain was noted on the south side of this cell at the base of the contaminated soil pile (see [Photo 34](#)).

**Photo 32: Waste Transfer Containment Area (westerly direction) – hydrocarbon contaminated soil**

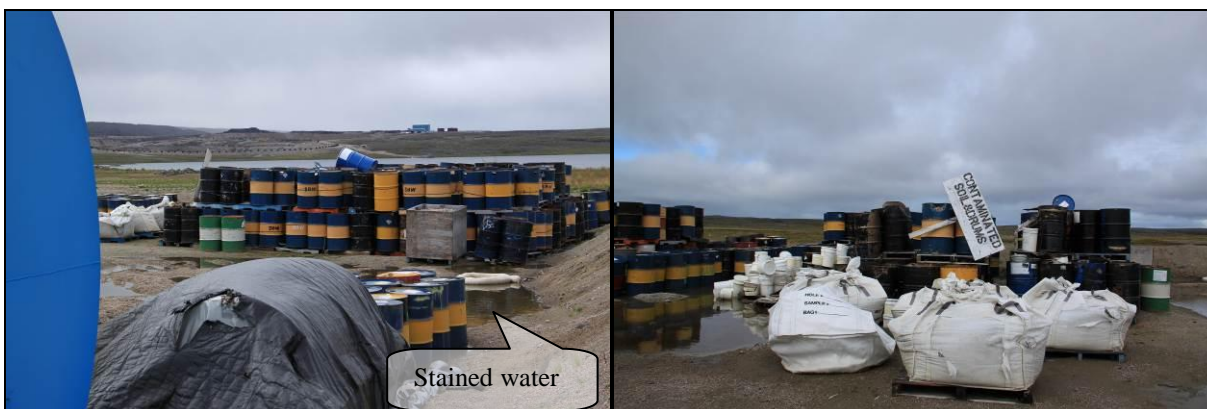
The drummed and bagged contaminated soil materials were previously brought to the Jericho site from Hood River and MuskoX exploration camps where smaller spills had occurred. The soil is contaminated with either diesel fuel or Jet fuel (see [Photo 33](#)).

**Photo 33: Waste Transfer Containment Area (westerly direction) – drummed and bagged hydrocarbon contaminated soil**

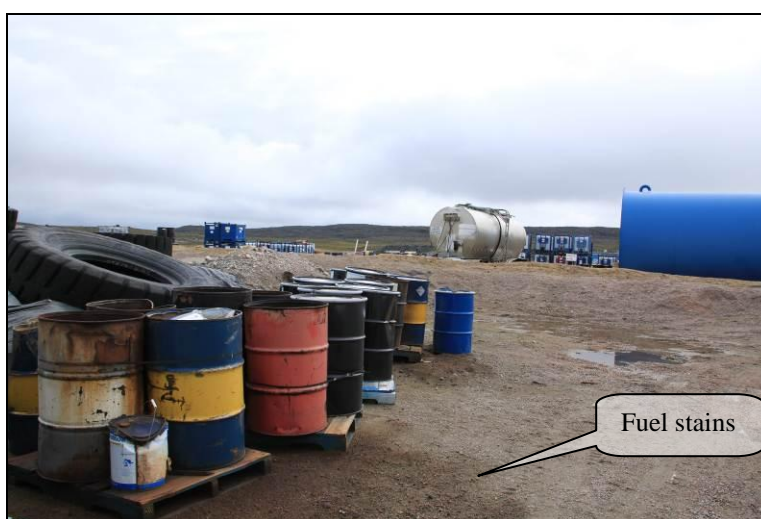
**Photo 34: Waste Transfer Containment Area (westerly direction) – bulked and drummed hydrocarbon contaminated soil**

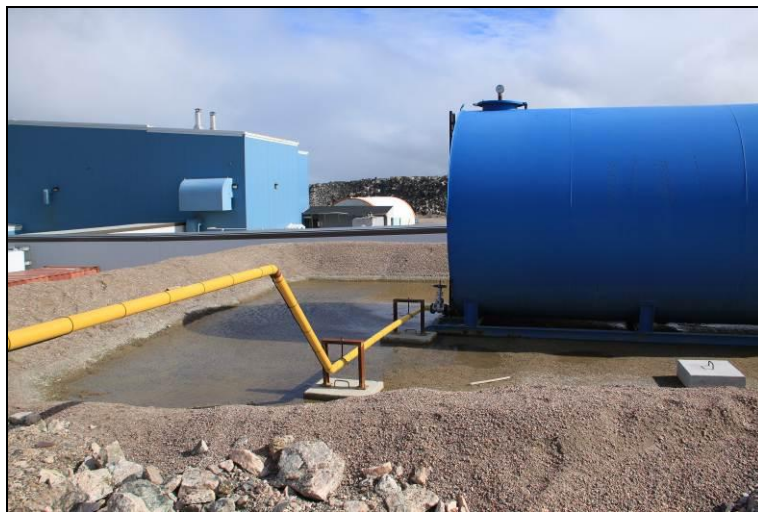
The bermed generator day tank area only contained standing water. There was no evidence of soil staining as was previously noted during the 2009 site visit (see [Photo 36](#)).

**Photo 36: Generator day tank**

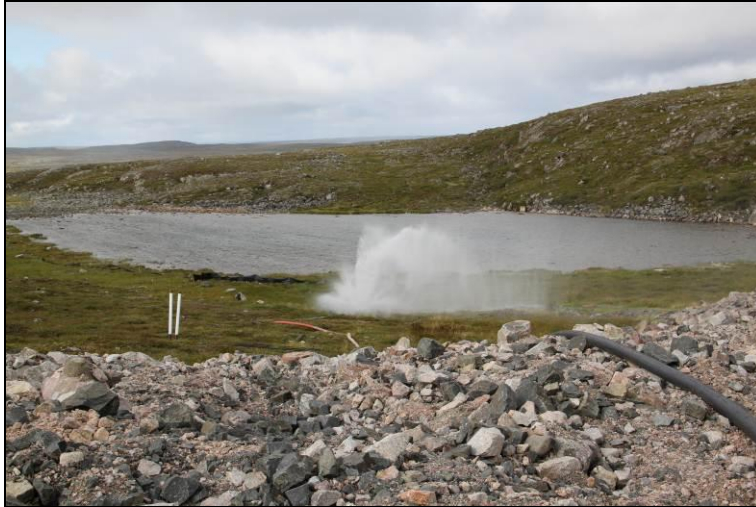
A permeable barrier in the Processed Kimberlite Containment Area (PKCA) divides the area into two containment cells; an East Cell and a West Cell, with only the East Containment Cell having been used for the deposition of tailings material (see [Photo 38](#) through [Photo 40](#)). At the time of the site visit, Shear was discharging water from the West Containment Cell into Stream C3 (see [Photo 41](#)).

**Photo 41: Stream C3 (downstream of West Containment Cell)**

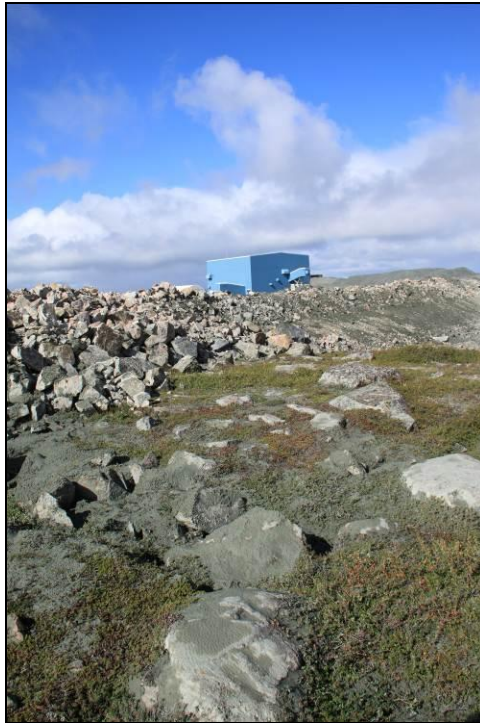
In April 2011, Shear personnel noticed that fine process kimberlite from the PKCA had been dispersed by wind over the Southeast Dam. During the site visit, the Monitoring Officer confirmed that the fine process kimberlite had been dispersed over the Southeast Dam and covered a majority of the ground on the south slope of the dam and rocks (see [Photo 42](#)). Ms. Lassonde indicated that once Jericho went into care and maintenance and the processing of the kimberlite stopped, the fine process kimberlite dried due to lack of sufficient amount of water covering the material. Shear has installed wind fences within the PKCA to prevent the fine process kimberlite from being dispersed and has advised that once processing resumes, the fines within the PKCA will be covered with a layer of water preventing further dispersion of the fine process kimberlite. Fisheries and Oceans Canada has also requested that Shear conduct fish sampling in four of the lakes downstream of the Southeast Dam.

**Photo 42: Fine Processed Kimberlite on the South Slope of the Dam**

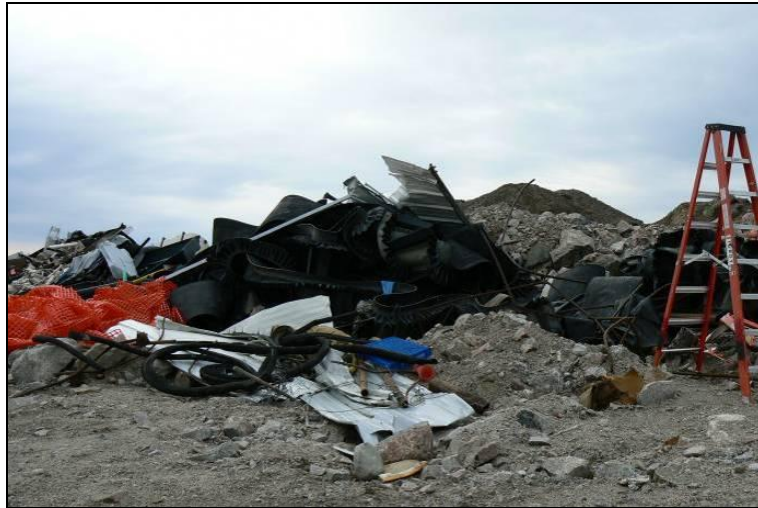
During the 2009 site visit, it was noted that the landfill area was not fenced off and that no other wildlife deterrents were apparent (see [Photo 44](#)). During the 2011 site visit, Mr. Morton informed the Monitoring Officer that the landfill had been covered by a 6 inch cover and that the incinerator was relocated closer to the camp site (see [Photo 45](#)). A new landfill will be developed once the landfill management plan has been approved by the Nunavut Water Board. All approved waste for incineration will be stored in a fenced area prior to incineration and the ash from the incinerator will be captured in drums, sealed and stored in seacans until the new

**Photo 44: Landfill in 2009**

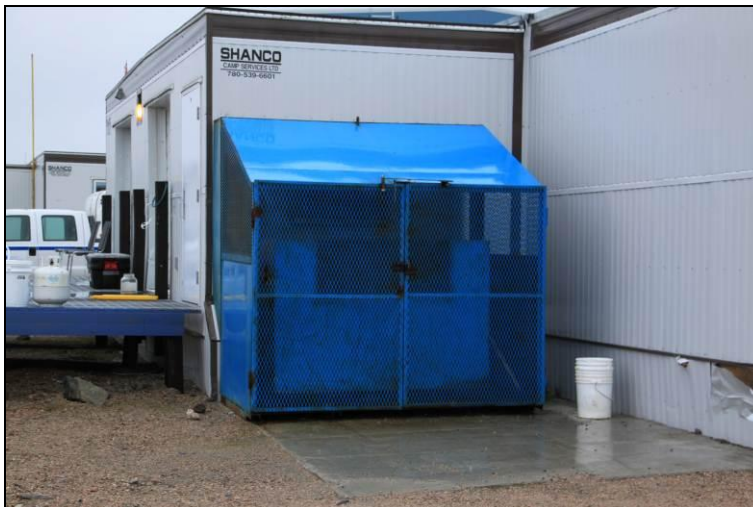
landfill has been approved (see [Photo 46](#)). All other waste materials will be segregated and disposed of at an approved facility or recycled.

**Photo 46: Example of waste management**
