**Report Title:** 2011 NIRB's Monitoring Officer Site Visit Report for the Jericho Diamond Mine Project

**Project:** Jericho Diamond Mine  
**Project Location:** Kitikmeot Region, Nunavut

**Visit conducted by:** Sophia Granchinho, Monitoring Officer, Nunavut Impact Review Board  
**Telephone:** (867) 793-4633

**Site visit dates:** August 17 – 19, 2011  
**Last site visit:** July 28 – 29, 2009

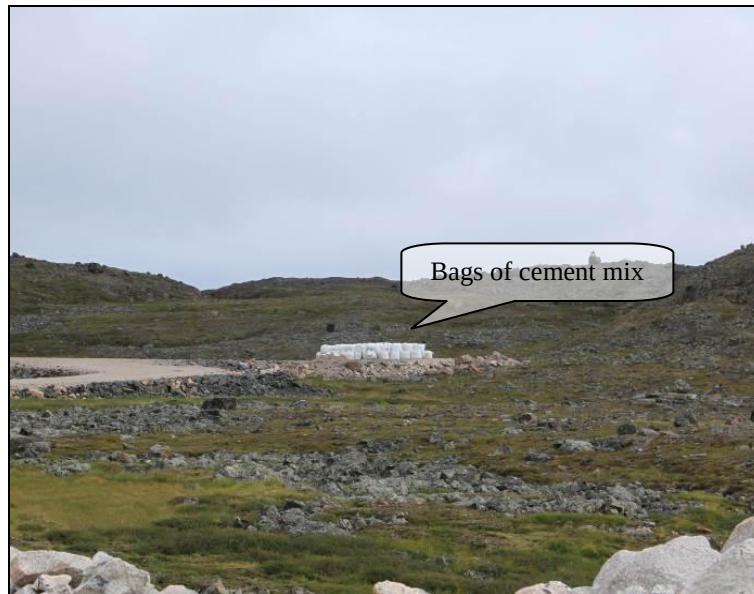
During the site visit, the Monitoring Officer noted bags of cement mix were still being stored at the ammonium nitrate storage pad as was noted in the 2009 site visit. No other materials were found at this storage area. Some bags of the cement mix were open or torn and dried cement was observed on the ground around the bags (see [Photo 10](#) and [Photo 11](#)).

The NIRB’s Monitoring Officer also discussed with Shear staff the historically higher nitrate levels observed in Lynne Lake, downstream of the ammonium nitrate storage pad; and suggested that the ammonium nitrate bags be moved into a building instead of being stored outside on a storage pad.

**Photo 11: Ammonium nitrate storage pad from emulsion plant**

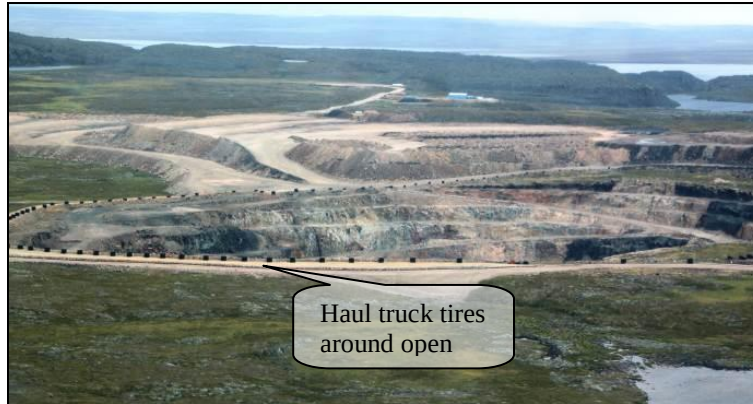
The open pit features a large caribou berm constructed around its perimeter, approximately 4 to 5 feet in height in most places with the main section of the perimeter located on the south side of the pit. During the site visit, the Monitoring Officer noted that no fencing was visible around the open pit area; however tires were placed around the pit area as a deterrent to people, who might be travelling in the area, especially during the winter periods (see [Photo 13](#) and [Photo 14](#)).

**Photo 14: Aerial view of open pit with tires around perimeter**

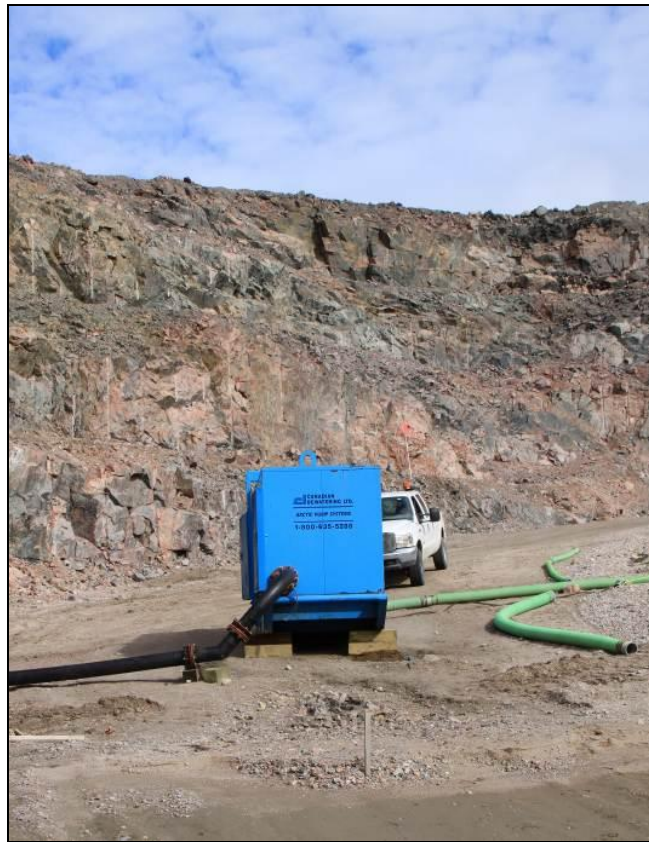
At the time of the site visit, the Jericho pit was deemed unsafe, and no access was permitted down into the pit with the exception of personnel conducting dewatering activities, from the pit to the PKCA. When Tahera suspended activities at the Jericho site in January 2008, the open pit naturally filled with water (see [Photo 15](#), [Photo 16](#) and [Photo 17](#)). Shear commenced dewatering activities of the open pit on July 29, 2011, and the pit water was pumped, discharged, and then diluted within the PKCA. This allowed the pit water to be incorporated and discharged as part of the PKCA discharge while still meeting the water licence discharge criteria. Dewatering activities halted within a week and half due to mechanical failure of the pump.

**Photo 17: Pump used to dewater pit**

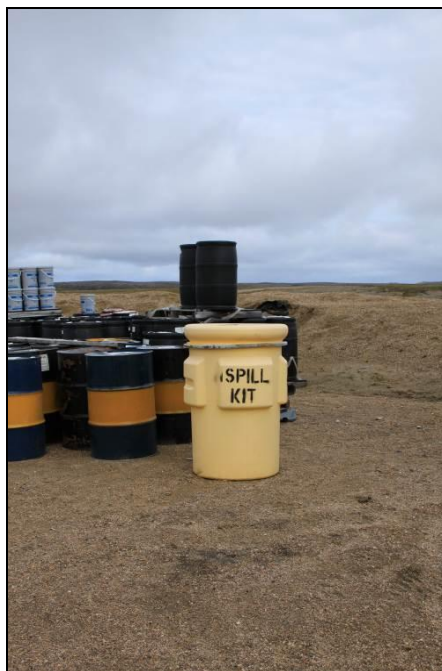
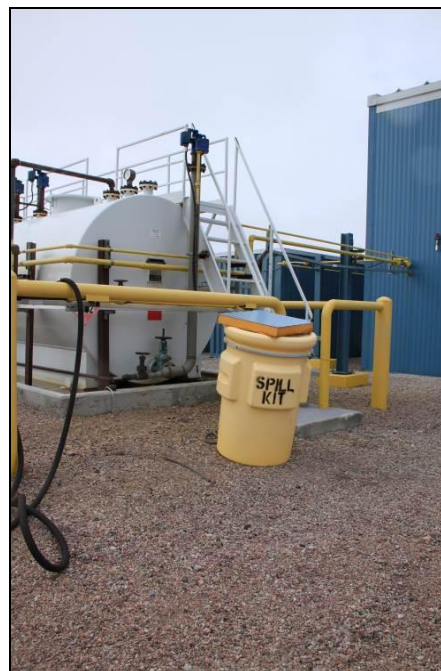
Shear personnel confirmed that all fuel trucks on site were equipped with spill kits, and the Monitoring Officer noted that secondary containment was in place at the fuel transfer station. No large fuel trucks were being used for refuelling at the time of the site visit and all trucks were being refuelled at the main station (see [Photo 18](#)). Spill kits were noted at most fuel storage areas (see [Photo 19](#)).

**Photo 19: Spill kits (HWT and emulsion plant)**

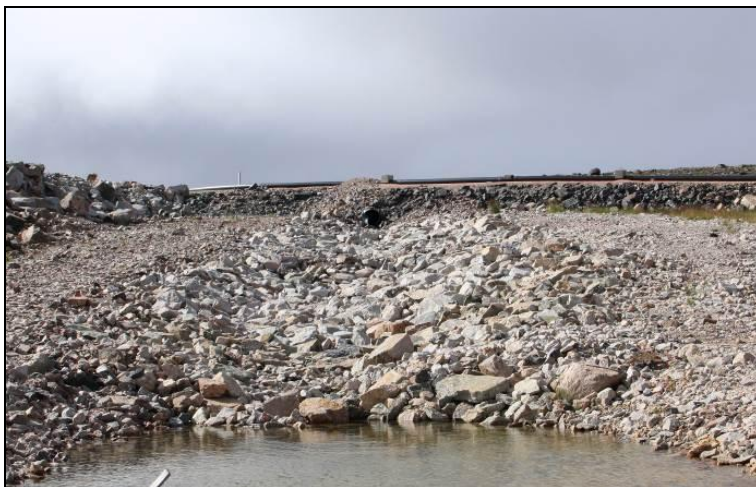
Roads around the mine site were maintained as required and culverts that had been previously installed continued to function properly (see [Photo 20](#)).

**Photo 20: Culvert at C1 Diversion – facing upstream**

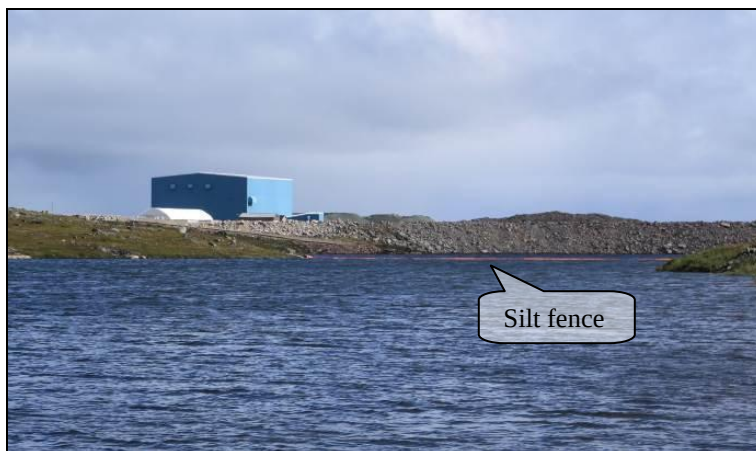
A silt fence was observed in West Containment Cell of the PKCA. This silt fence was installed in order to prevent sediment from entering the lower part of the West Cell and Stream C3 during the dewatering of the pit into the West Cell (see [Photo 21](#)).

**Photo 21: West Containment Cell (facing east towards processing plant)**

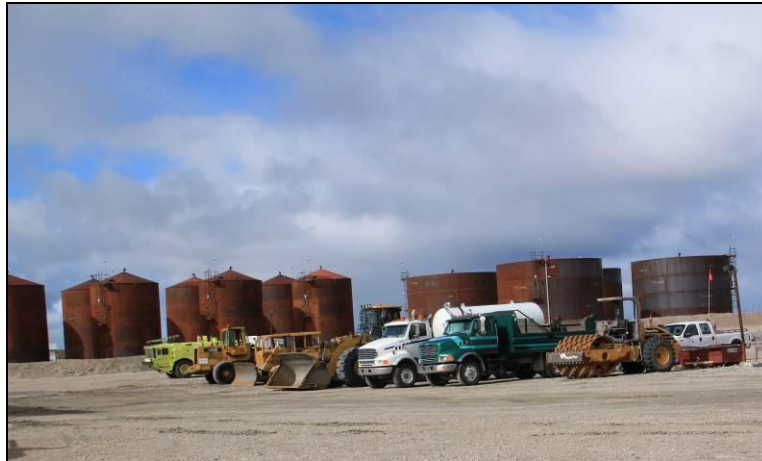
The liner for the main fuel tank farm was exposed in several areas. Substrate in the berms was heavily contaminated with fuel and standing water within the berm contained visible

hydrocarbon sheen. Strong hydrocarbon odours were also noted around the fuel tank farm (see [Photo 24](#) through [Photo 27](#)).

**Photo 24: Main tank fuel farm**

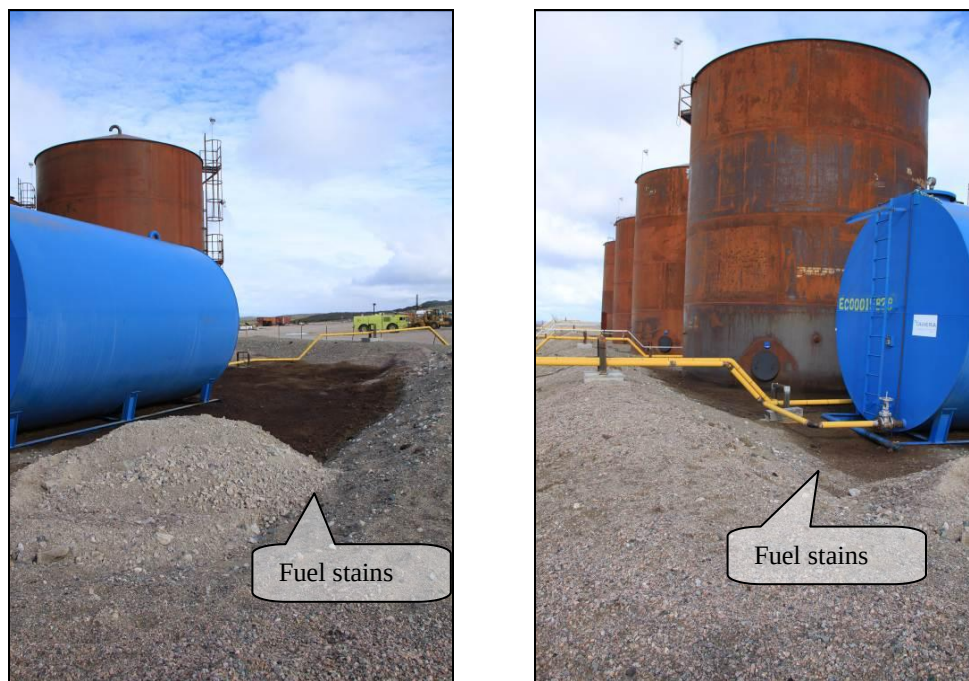
**Photo 27: Contaminated soil within bermed area at main fuel tank**

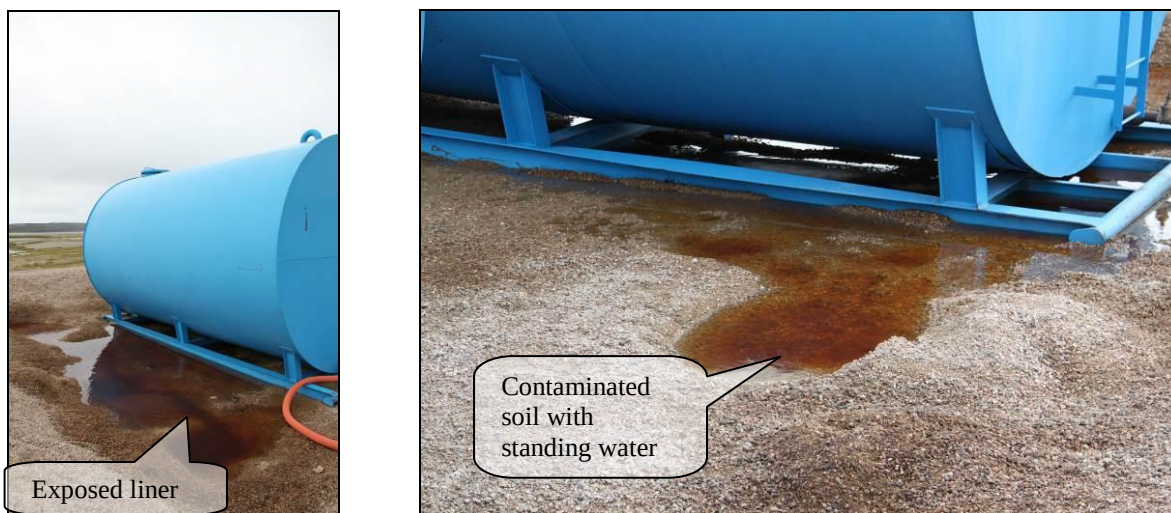
The liner for the airport fuel tanks was exposed in one main area. Standing water was present with visible hydrocarbon sheen. Hydrocarbon odours were also noted at the airport fuel tanks. As described in the 2009 site visit report, the substrate within the berm at the airport showed evidence of contamination from a previous spill in 2007 and it appeared that the contaminated soil had not been removed from the bermed area. The spill that occurred in 2007 at the airport fuel tank farm was approximately 47,000 litres and was due to a faulty valve line<sup>11</sup>.

**Photo 28: Airport fuel tanks**

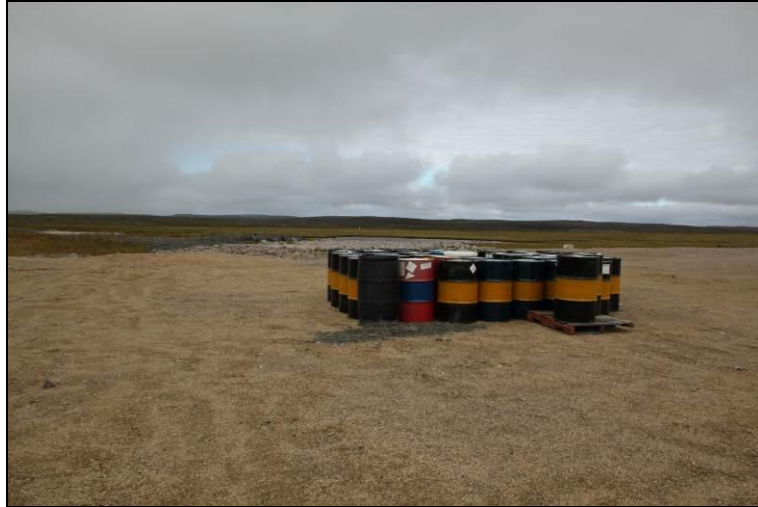
Fuel barrels stored at the airport were not located within a secondary containment facility. Mr. Morton mentioned that the barrels were empty and would be removed from site (see [Photo 29](#)). Fuel stains were also evident on the road next to the airport fuel tank berm.

**Photo 29: Fuel barrels stored at airport**

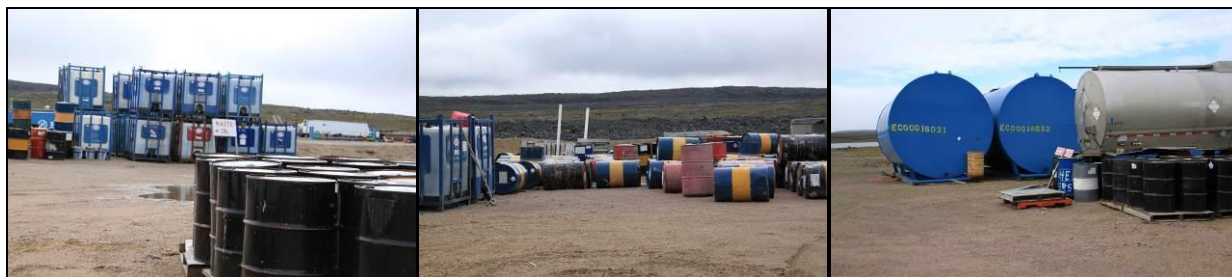
The cell to the east contains bulk waste containers, waste oil, waste fuel in drums and cubes, and drummed diesel fuel (see [Photo 31](#)). Most of the barrels within this cell came from the Muskox site and contain waste oil. The waste oil is currently being used in the boiler at site.

**Photo 31: Waste Transfer Containment Area (easterly direction)**

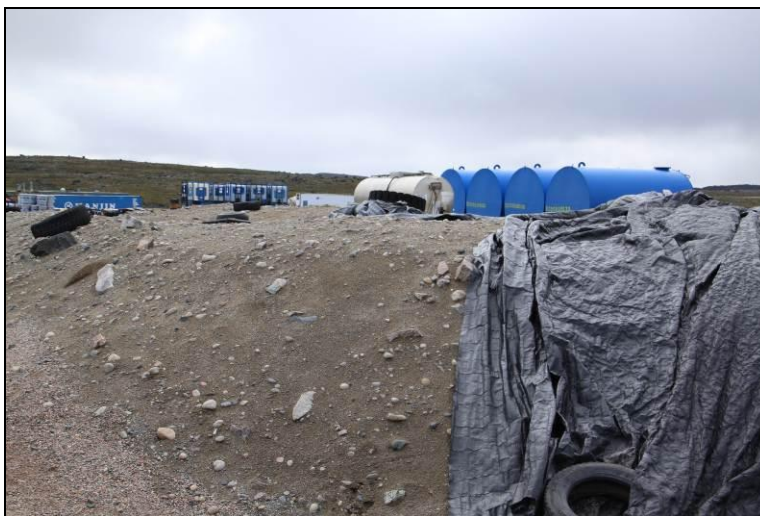
The cell towards the west is being used for storage and/or isolation of contaminated soil (see [Photo 32](#), [Photo 33](#) and [Photo 34](#)), which is stored in one large pile under a tarp, in numerous drums or bags. As there is no current landfarm in place at Jericho, the contaminated soil has not been remediated on site, nor has it been removed off-site for treatment. Shear has submitted a *draft* landfarm plan to the NWB and is awaiting approval of this plan.

**Photo 32: Waste Transfer Containment Area (westerly direction) – hydrocarbon contaminated soil**

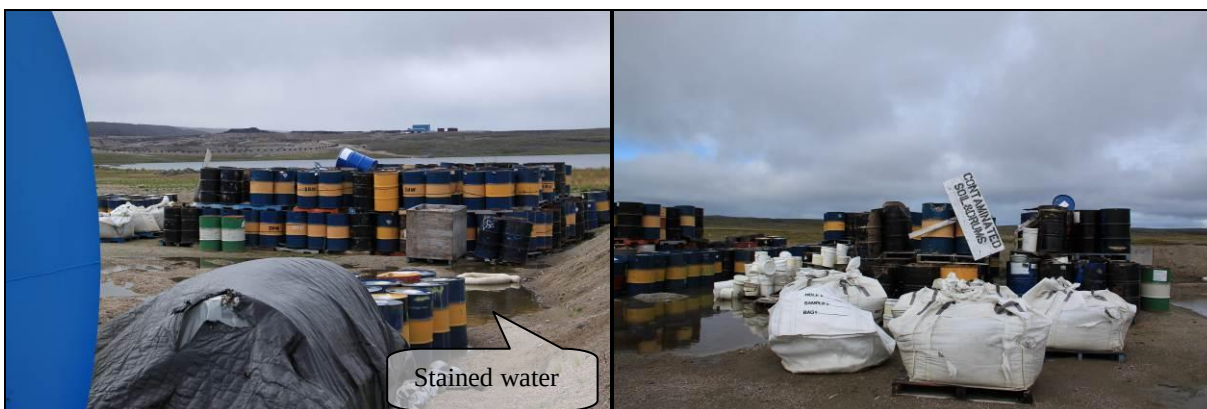
The drummed and bagged contaminated soil materials were previously brought to the Jericho site from Hood River and Muskox exploration camps where smaller spills had occurred. The soil is contaminated with either diesel fuel or Jet fuel (see [Photo 33](#)).

**Photo 33: Waste Transfer Containment Area (westerly direction) – drummed and bagged hydrocarbon contaminated soil**

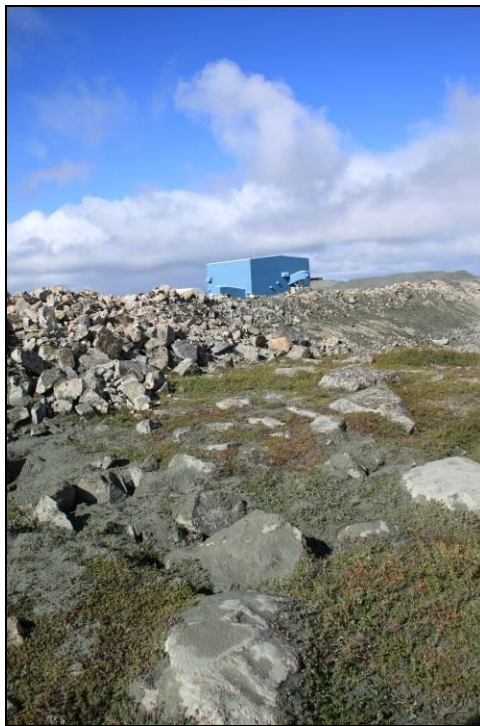
In April 2011, Shear personnel noticed that fine process kimberlite from the PKCA had been dispersed by wind over the Southeast Dam. During the site visit, the Monitoring Officer confirmed that the fine process kimberlite had been dispersed over the Southeast Dam and covered a majority of the ground on the south slope of the dam and rocks (see [Photo 42](#)). Ms. Lassonde indicated that once Jericho went into care and maintenance and the processing of the kimberlite stopped, the fine process kimberlite dried due to lack of sufficient amount of water covering the material. Shear has installed wind fences within the PKCA to prevent the fine process kimberlite from being dispersed and has advised that once processing resumes, the fines within the PKCA will be covered with a layer of water preventing further dispersion of the fine process kimberlite. Fisheries and Oceans Canada has also requested that Shear conduct fish sampling in four of the lakes downstream of the Southeast Dam.

**Photo 42: Fine Processed Kimberlite on the South Slope of the Dam**
