2014-2015 Annual Monitoring Report for the Jericho Diamond Mine Project

Nunavut Impact Review Board File No. 00MN059 October 2015 Report Title: The Nunavut Impact Review Board's 2014 - 2015 Annual

Project: Jericho Diamond Mine Project **Project Location:** Kitikmeot Region, Nunavut

Monitoring Officer: Heather Rasmussen, M.Env-EIA

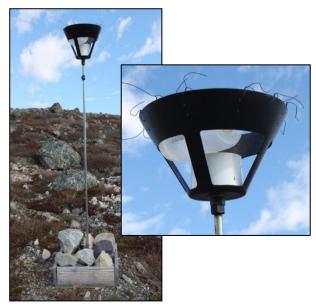
During the 2015 site visit, the NIRB Monitoring Officer observed two standing dustfall monitoring stations: one at the West dam adjacent to Cell B/C and one near East Dam adjacent to the PKCA (see Photos 2-3). Although the site is currently non-operational and there are no onsite personnel to collect and analyze samples and verify the functionality of the stations, the Monitoring Officer observed that the dustfall stations themselves appeared to remain intact.

Photo 2: Dustfall monitoring station at West dam with overturned canister.
