FPK DISPERSION

OBSERVATION AND MITIGATION REPORT DECEMBER 12, 2011

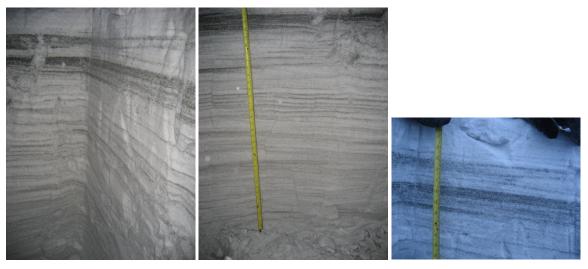
Profile 2 - 25 m E of SE Dam Rd

Profile 2 was located approximately 25 m east of the south east dam road. A profile was cut out of the snow to observe the depth of the FPK layer and its dispersion pattern. The profile was approximately 42 3/4" deep. The FPK layer observed was approximately 6-7" deep which we believe to be during the wind storm. There were multiple layers below what we believe to be the layer brought on by the storm.

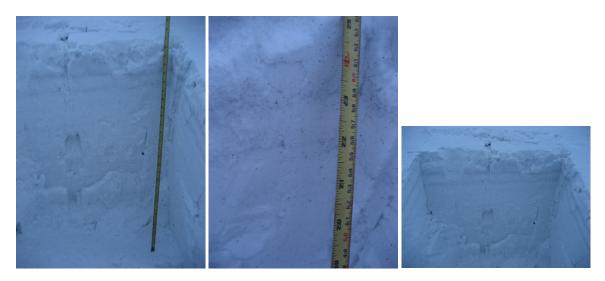
Profile 3 – 40 m E of SE Dam Rd

Profile 3 was located approximately 40 m east of the south east dam road. A profile was cut out of the snow to observe the depth of the FPK layer and its dispersion pattern. The profile was approximately 27" deep. There were small traces of FPK in two thin layers that ranged from ½" to 1" thick.

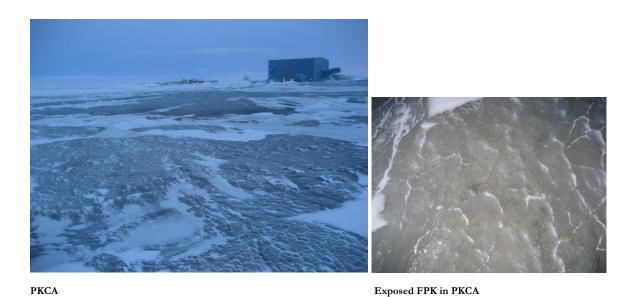
Prior to the wind storm there was a hard layer of snow ranging from 1-3' on top of the FPK contained within the PKCA. As you can see the force of the winds has completely exposed the FPK.
