**RE: Follow up for spill #12-148 reported April 26<sup>th</sup>, 2012**

### **Summary**

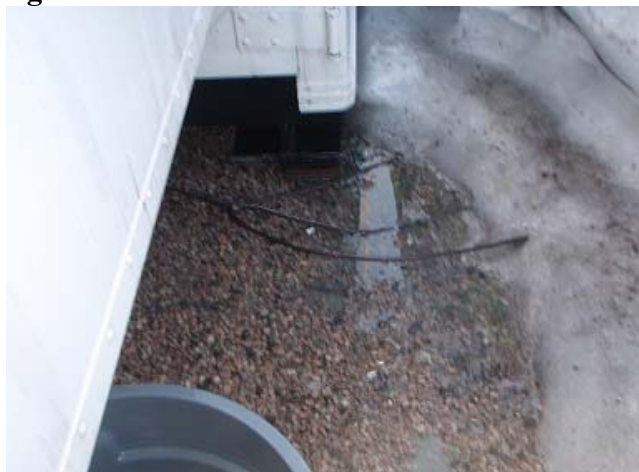
**Figure 1**

On April 25th, 2012 at approximately 4:30 AM it was discovered that a fuel tank located within the powerhouse, generator #3, was left to fill overnight. The tank overflowed into the powerhouse and eventually leaked out onto the ground beneath the powerhouse. At the time it was estimated that there was about 400L that spilled out of the powerhouse. This estimate was based on fuel dips that were taken around that date and comparing to normal fuel usage. The spill was reported to the Site manager and personnel were able to recover 100L of diesel that had pooled on the ground (Figure 1) by bailing it into a drum. The rest of the diesel on the ground was cleaned up by using absorbent pads.

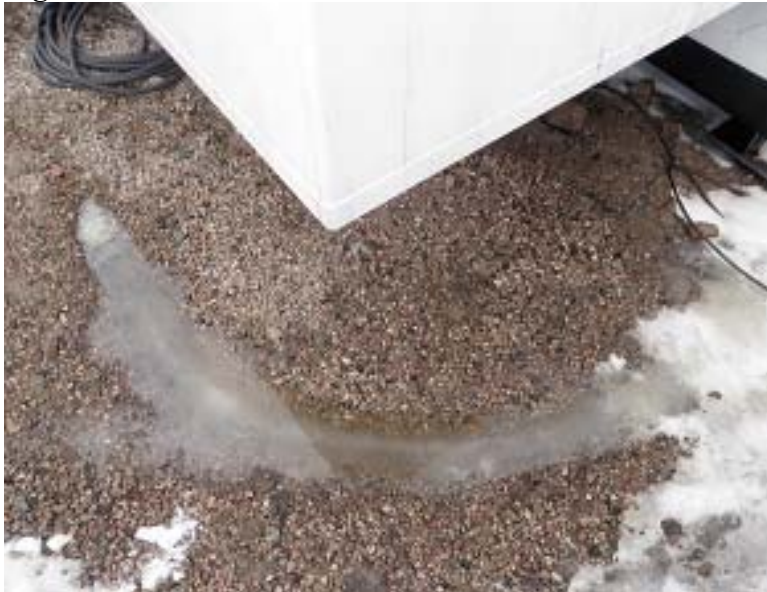
**Figure 2**

The spill was contained following the Diesel Spill Response Procedure outlined in Appendix A of our Contingency Management Plan. As soon as the spill was discovered the pump was turned off. A shallow trench was dug around the area to collect any contaminated runoff (Figure 2).

The trench that was dug around the area will have to be monitored and emptied whenever water pools up to minimize the spread of diesel to the surrounding area. Approximately 40L of diesel contaminated water has been removed from the trench and put in a drum for storage until it can be treated with the Oztek remediation unit. Contaminated dirt located beneath the generator is inaccessible due to buried cables and foundation issues of the building. Therefore the area beneath the building has been declared a contaminated site that will require on-going monitoring until such time as the area can be reclaimed upon mine closure.
