Dear Eva:
RE: Follow up for spill #12-201 reported May 24, 2012

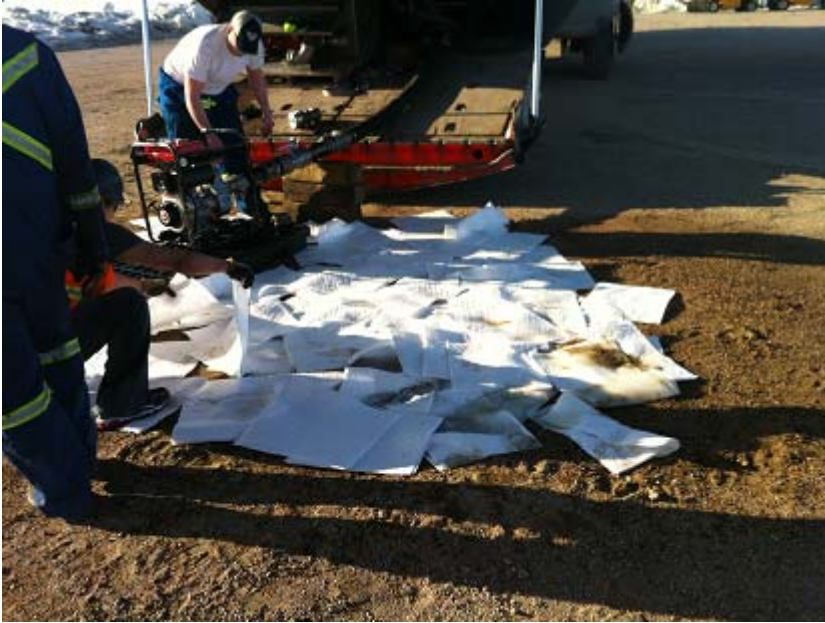
Figure 1

On May 22nd, 2012, at 7:30 pm, approximately 100L of diesel was spilled while transferring fuel from a First Air Herc to storage tank EC-00016028. The herc delivered fuel in large bladders that were pumped directly into the storage tank using a gas powered pump. After the fuel transfer was complete the gas powered pump was turned off. At that time a first air employee disconnected the fuel line from the pump in order to bleed the line of any remaining diesel. The fuel line was running from the pump to the storage tank and the valves on the line were not closed so when the line was disconnected from the pump the line sprayed diesel directly from the storage tank. The spill was reported to the Site manager and personnel were able to remove the diesel that had puddle up on the ground using absorbent pads (Figure 1). The contaminated dirt that remained was dug up with a bobcat and placed into drums that were brought to the HWTa (Figure 2).
