# **Fish Habitat Compensation Work at The Jericho Diamond Mine, Nunavut Territory Construction and Monitoring of Eight Rock Shoals in 2007**

EBA Engineering Consultants Ltd.

E12101016

**July 2007**

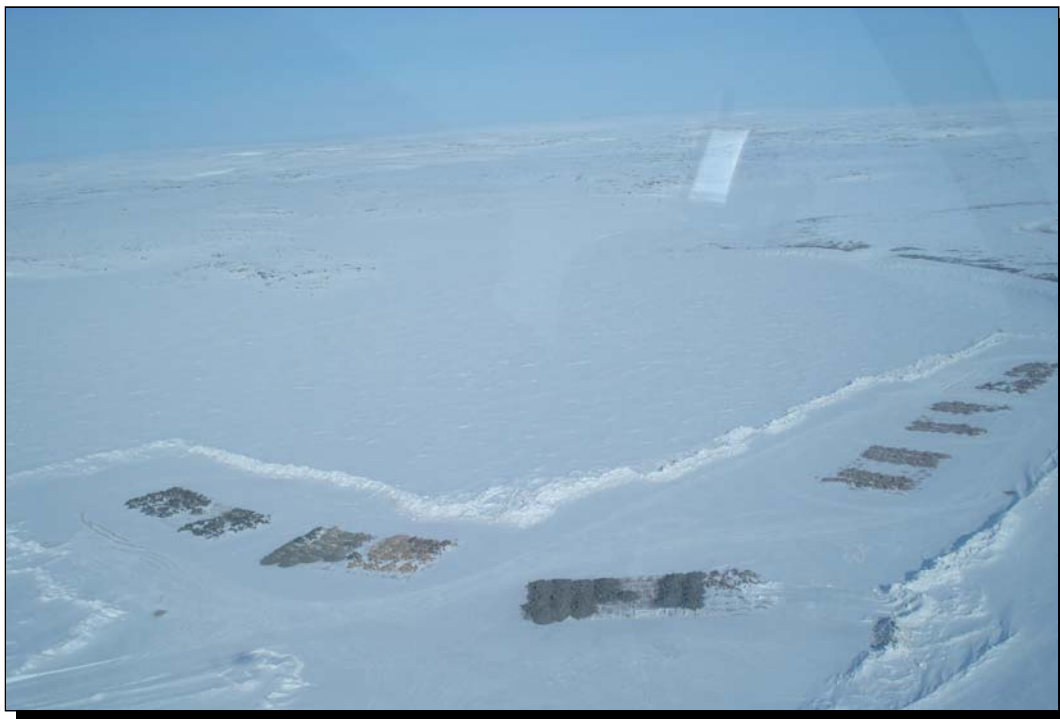
**Photo 5**

In order to avoid ice failure due to high stresses, the rock material placement commenced at the shoal ends and continued towards the shoal centre until excessive crack development and a decrease in FB (water on the ice) caused a stop to the operation. Due to safety considerations, a gap of ROM material at the centre of the Carat Lake shoals can be seen in Photo 5.

Carat Lake – Aerial photo of shoals showing gaps of ROM at shoal centres.

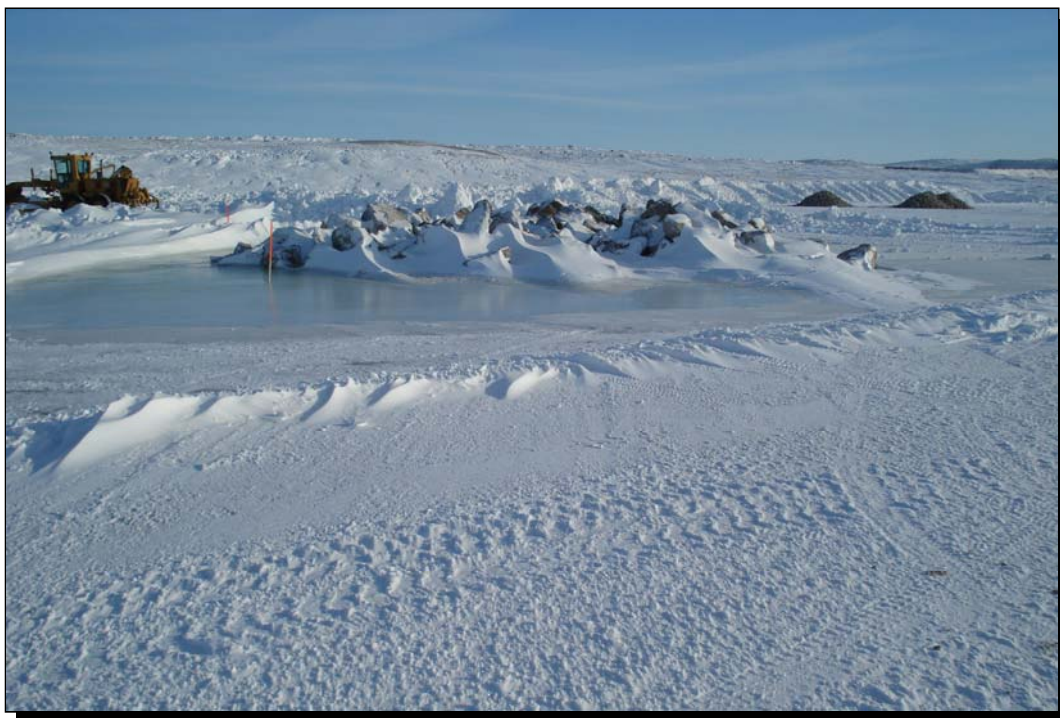
**Photo 6**

Carat Lake – Flooding of Shoal #3 with ROM dumped in February 2007, and grader clearing snow in background, March 22, 2007.

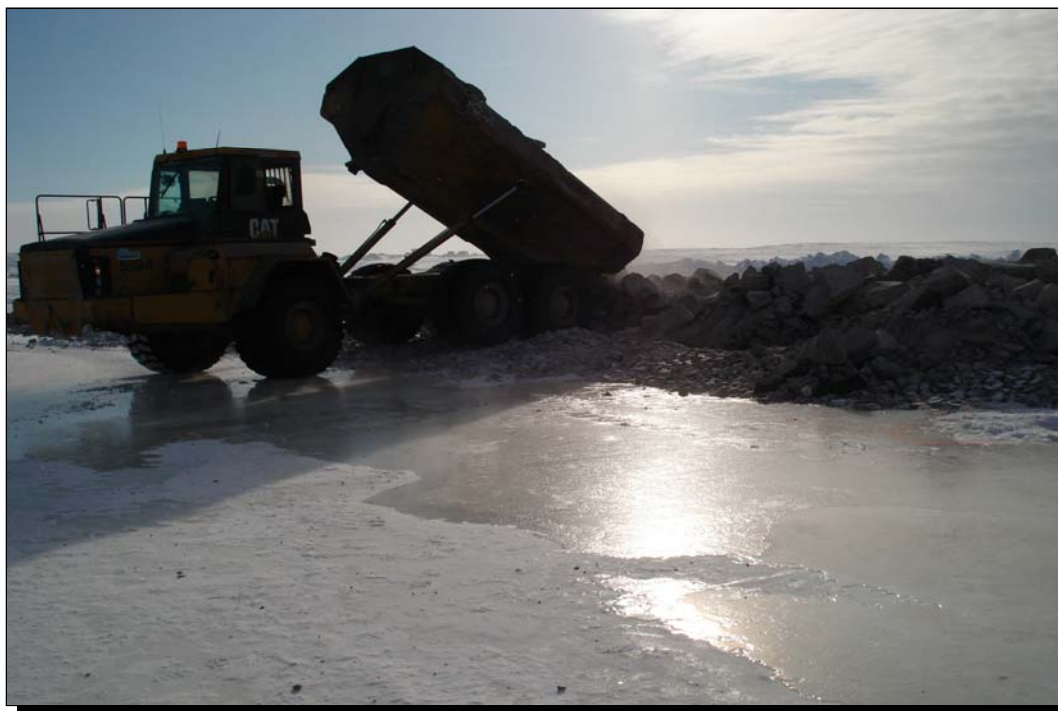
**Photo 11**  
Carat Lake – Flooding east of Shoal #5, March 25, 2007.

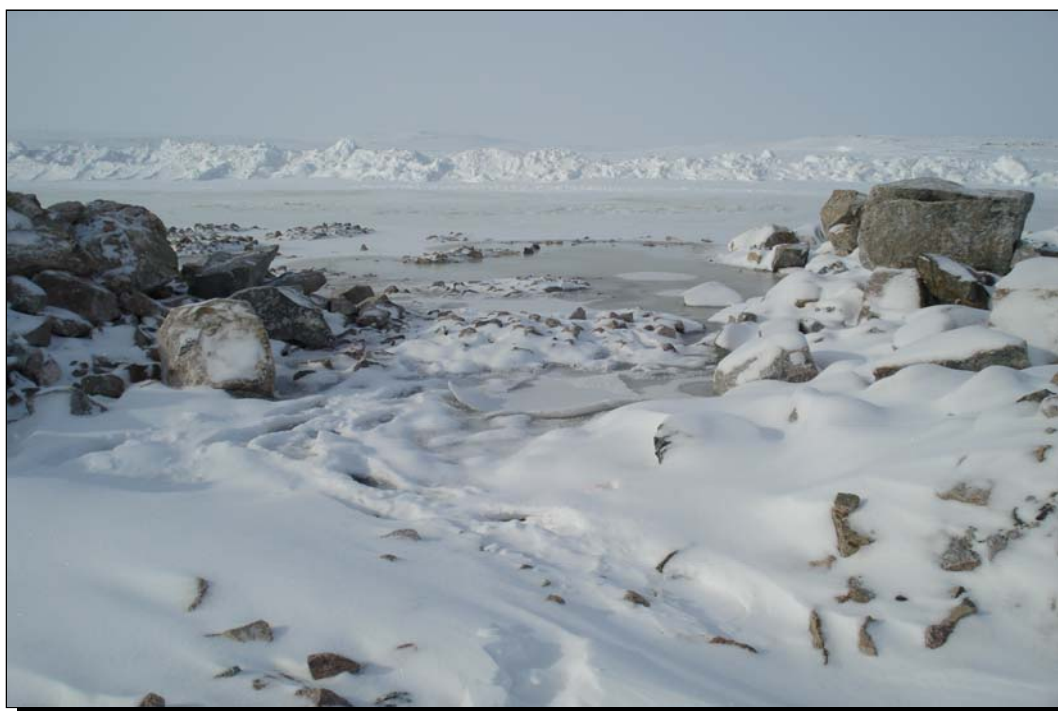
**Photo 12**  
Carat Lake – Flooding of Shoal #6, March 25, 2007

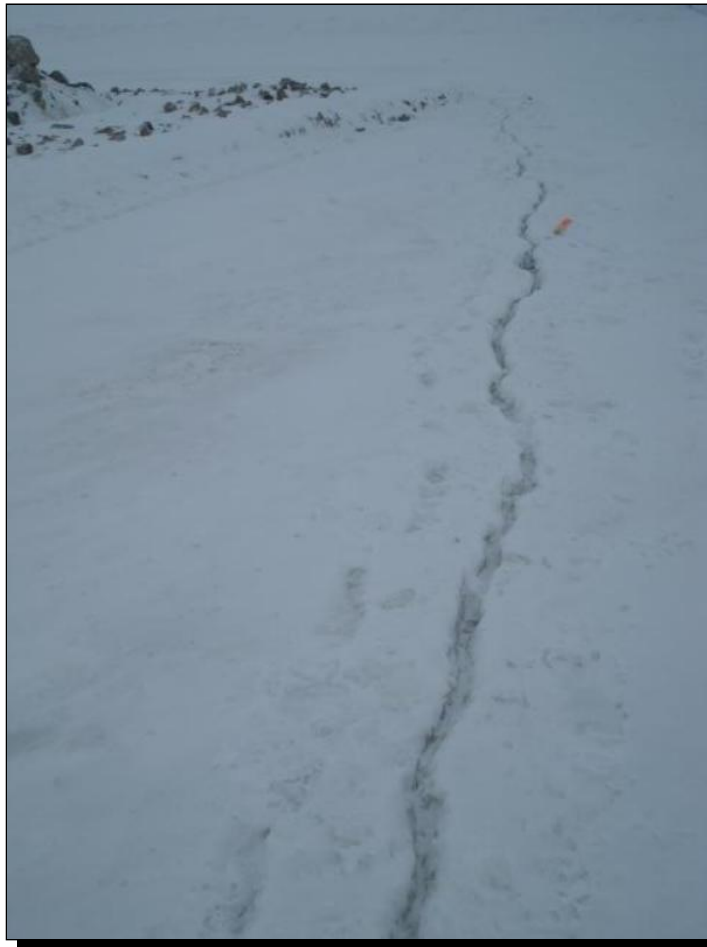
**Photo 16**

Carat Lake – Crack in ice cover at the northeast corner of Shoal #6.

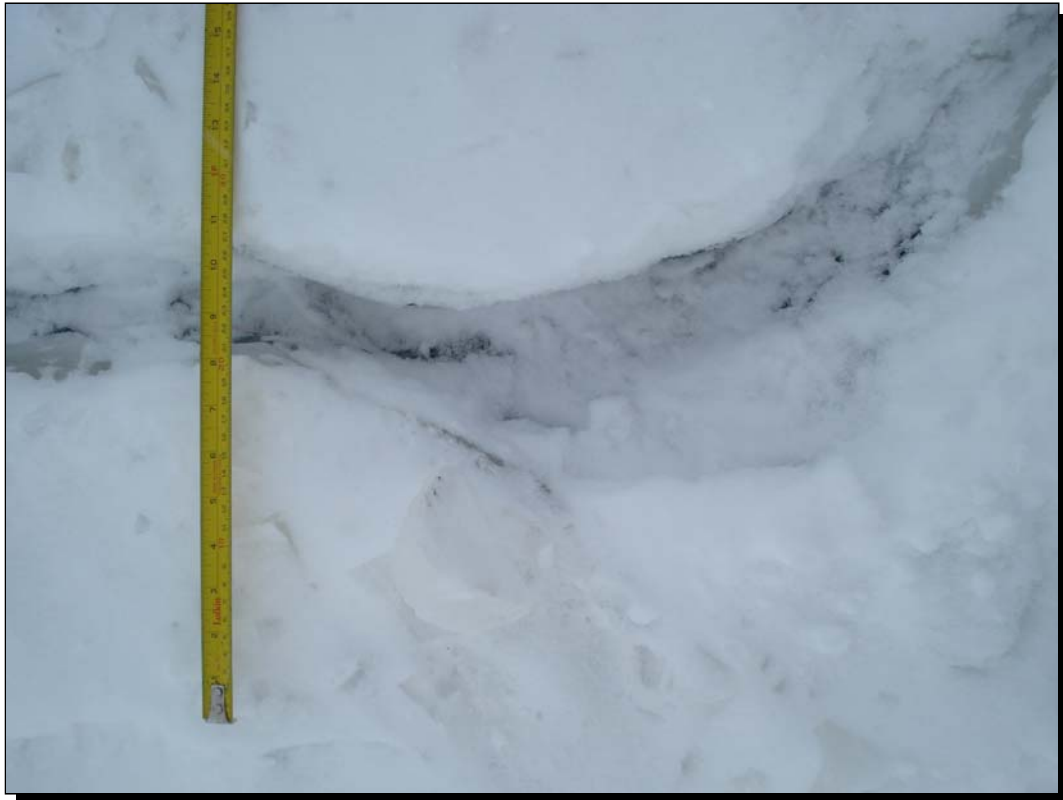
**Photo 17**  
Carat Lake – Close ups of crack at the northeast corner of Shoal #6.

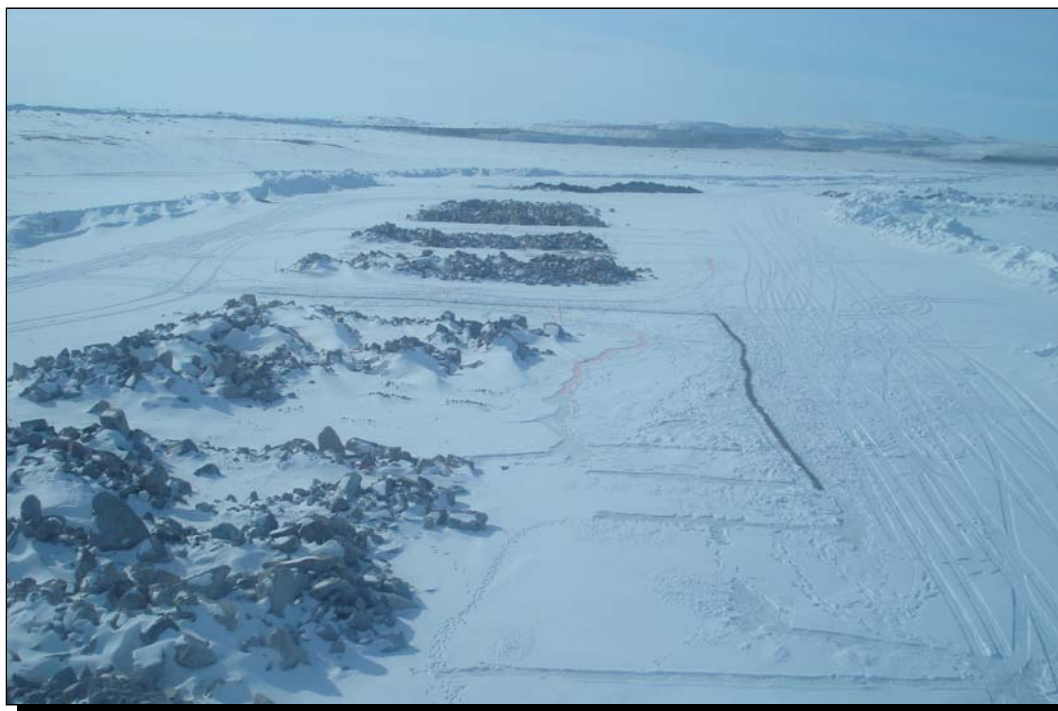
**Photo 21**

Carat Lake – Partial cut of ice cover around Shoal #6, April 17, 2007.

Cutting the ice surrounding Shoal #6 commenced April 17 as can be seen in Photo 21. Cracks on the ice are marked with orange paint.

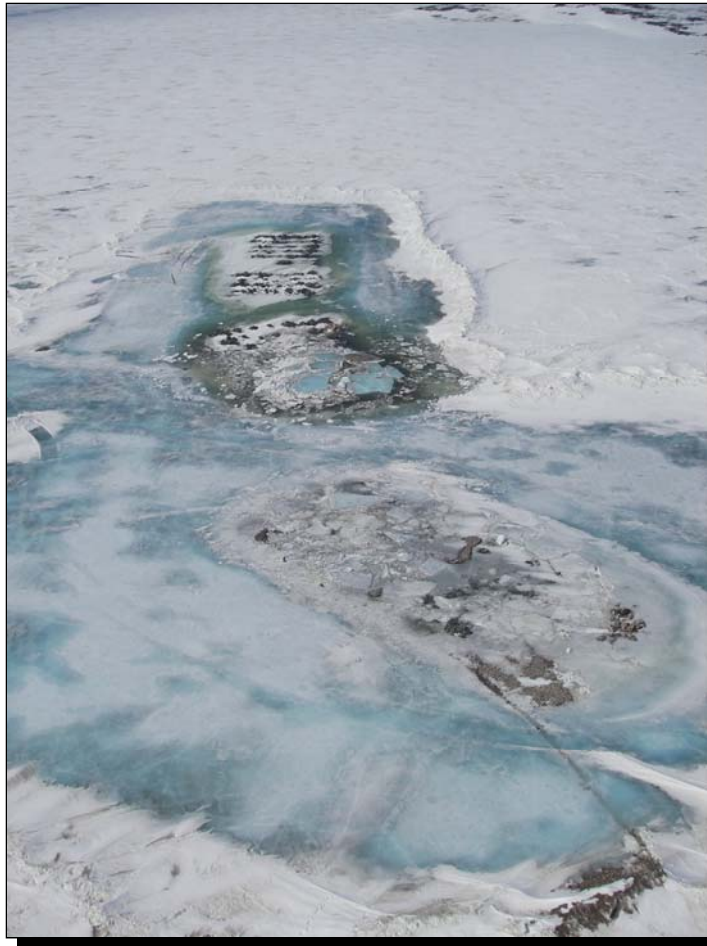
**Photo 23**

Carat Lake –Failure of Shoal #2 and Shoal #3, aerial photo taken east of Shoal #3, May 25, 2007.

Around May 15, Shoal #3, the first shoal, broke through the ice. An aerial photo (Photo 22), was taken April 18 from East, shows the distribution of ROM material on the shoal. Another aerial photo (Photo 23) was taken on May 24 from approximately the same position. A close-up photo (Photo 24) shows some rock material above the water/ice surface which can be attributed to the shallower water depth. Of interest is the difference in texture of the broken ice pieces floating over the shoal area. Large ice blocks turned up in the middle of the shoal as shown on Photo 25 which was taken on May 16, shortly after the rock broke through the ice.

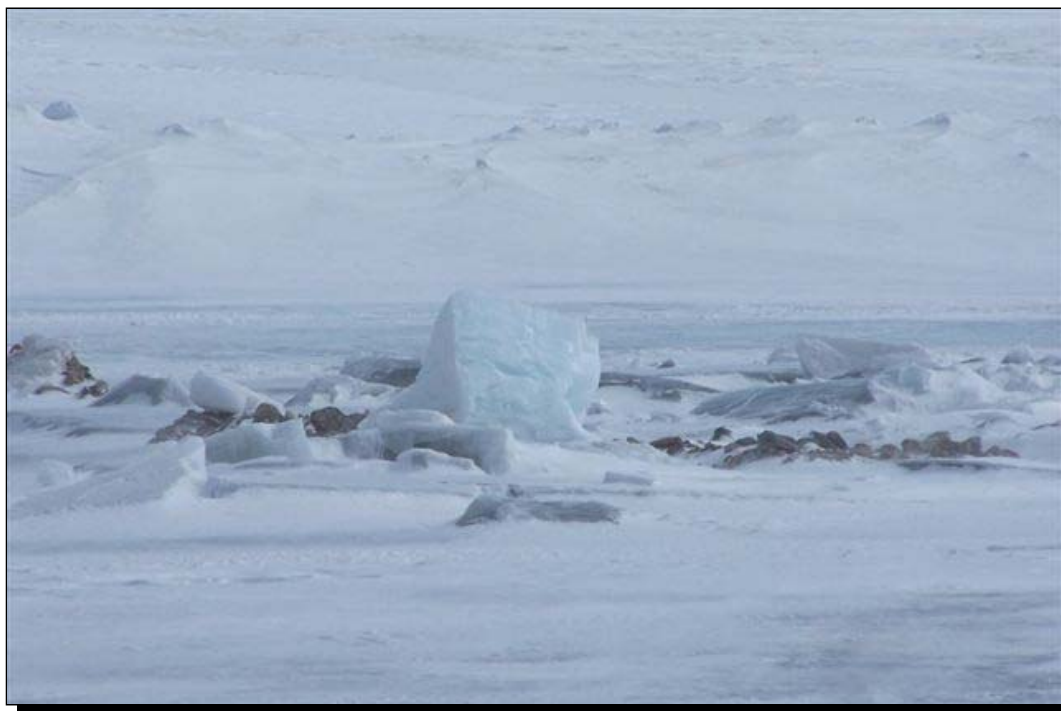
**Photo 25**  
Carat Lake – Ice blocks at Shoal #3, May 16, 2007.

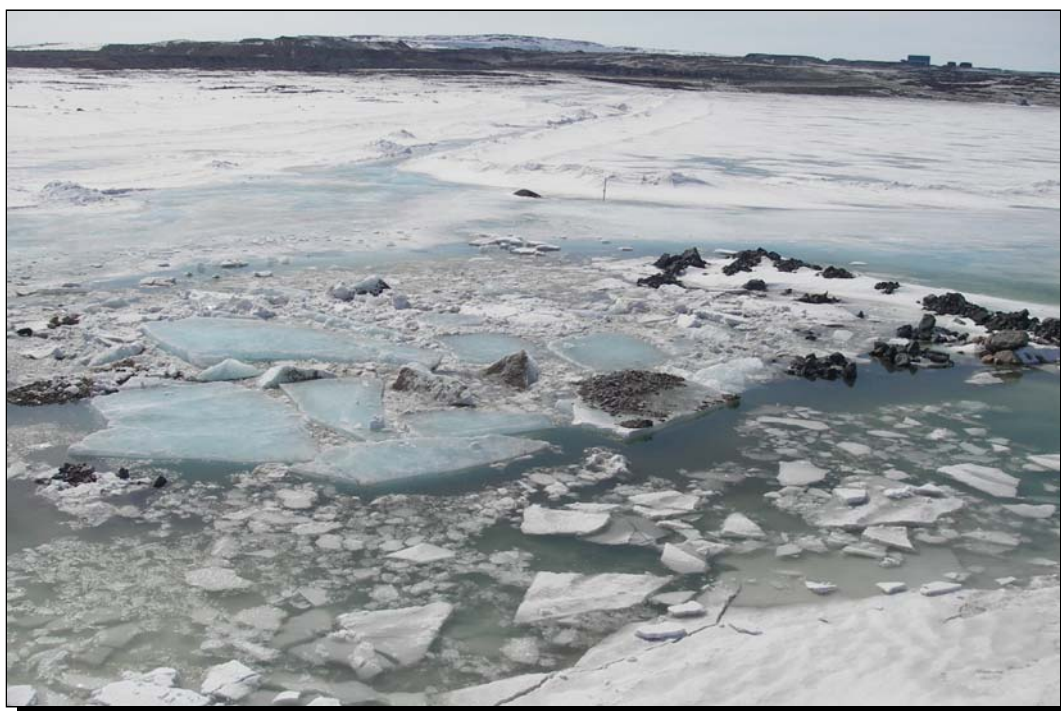
**Photo 26**  
Carat Lake – Broken ice at Shoal #2, May 25, 2007.

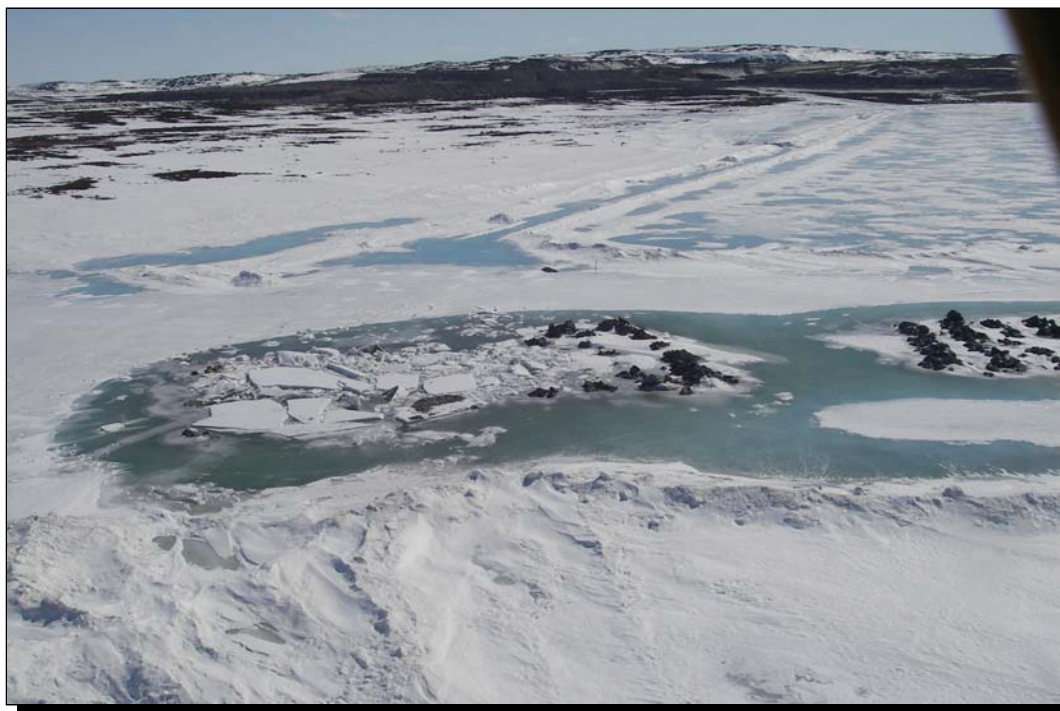
**Photo 27**

Carat Lake – Broken ice at Shoal #2 and flooded ice road, May 28, 2007.

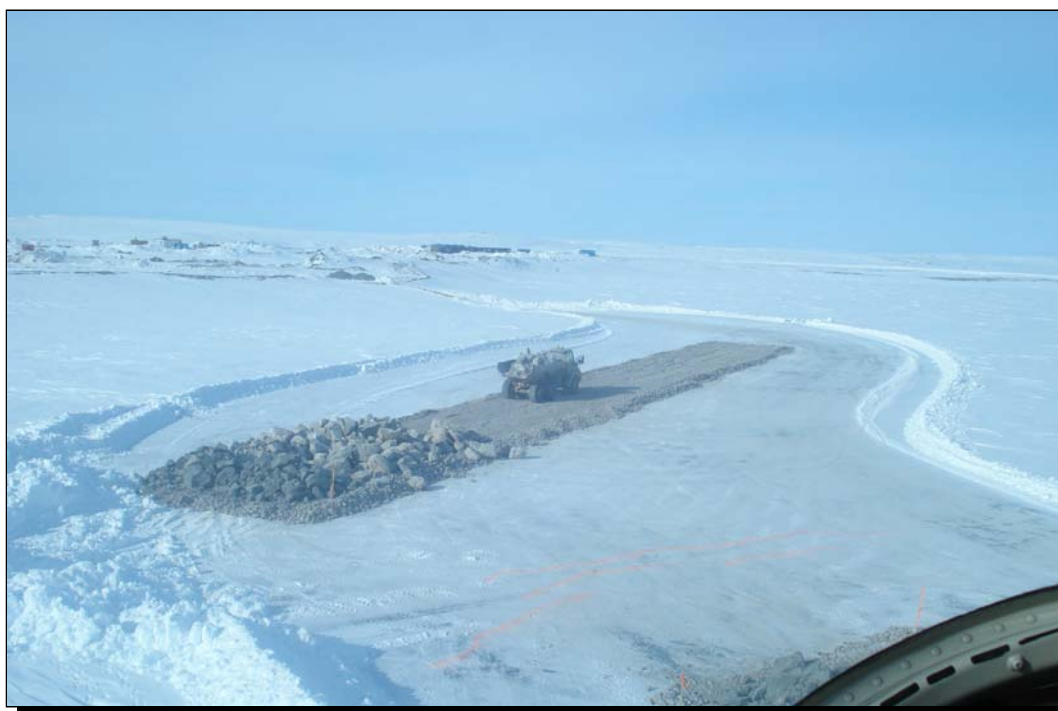
**Photo 30**

Lake O1 – Loading Shoal #2 with ROM, circumferential cracks at the end of Shoal #1.

Substantial cracks of the ice cover developed between Shoal #1 and the shore fast ice (Photo 31) as well as some circumferential cracks at the ends of Shoal #1 as shown in Photo 30 and Photo 32.

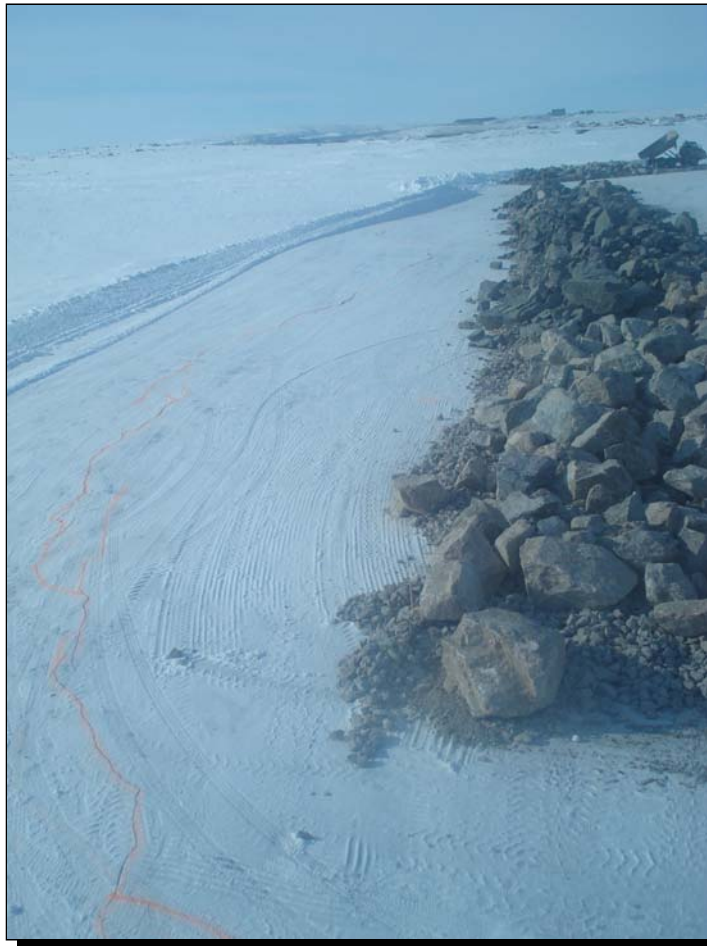
**Photo 31**

Lake O1 – Large cracks between Shoal #1 and shore fast ice.

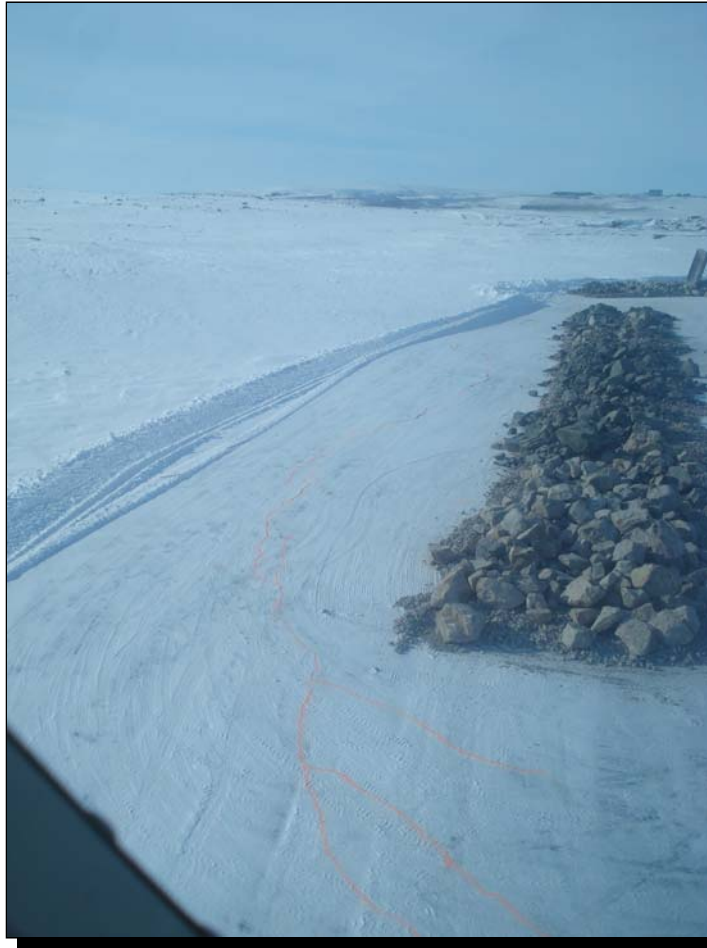
**Photo 32**

Lake O1 – Development of circumferential cracks at the north end of Shoal #1.

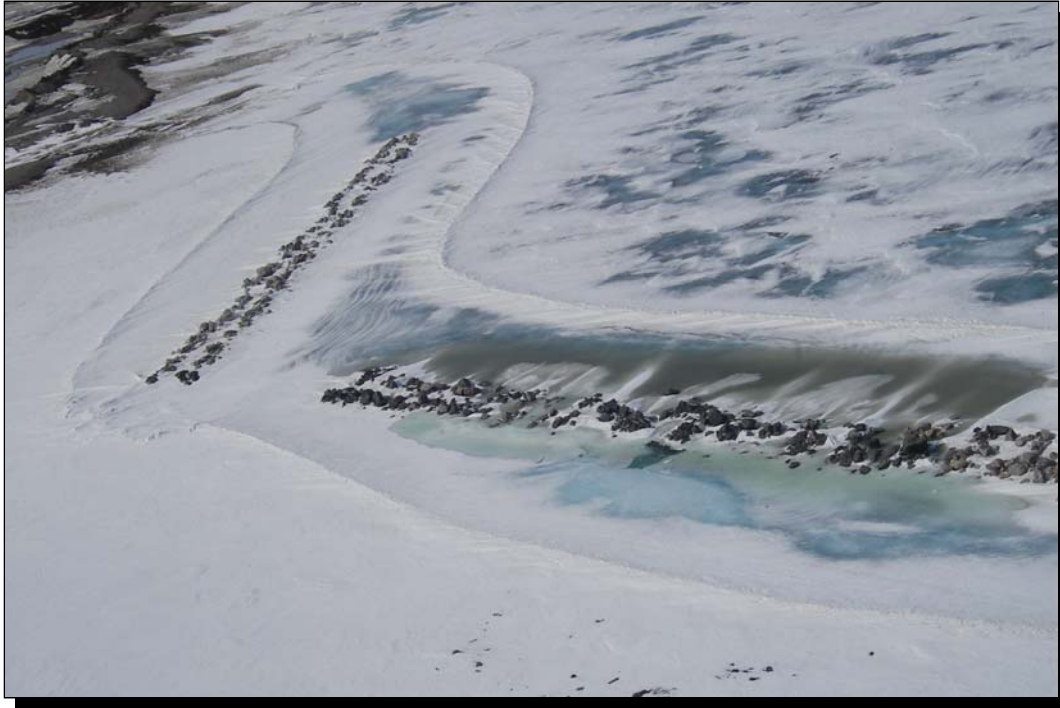
**Photo 33**  
Lake O1 – Flooding of Shoal #1, May 25, 2007.
