TYPE A WATER LICENSE

2AM-JER1119

Jericho Diamond Mine

Monthly Report

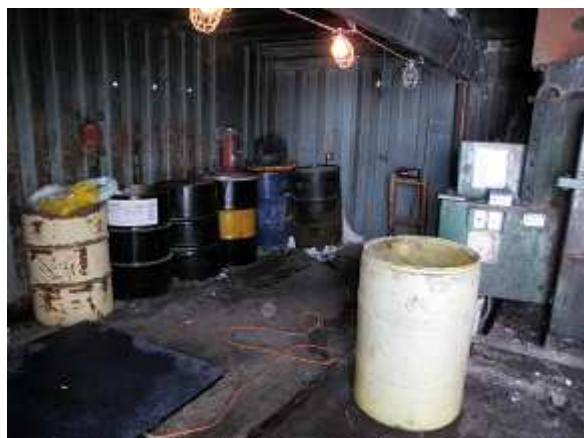
Photo 5

Oil Cubes	A	Waste oil cubes have been removed from the shop. There should be an empty one at all times in the shop to pump out grate/sump when it is full.
Waste Oil Traps	A	Waste oil traps are acceptable.
Central Grate	A	Grate is empty.
Oil Burner Stacks	A	Burner is clean again.
Snow beneath oil burners	A	Snow below the stack is has been removed and placed in the PKCA
Waste storage	U	There is still some more cleaning up to do but the situation has improved. Still issues with waste containers. A lot of unlabelled waste. 3 full drums of oil/diesel soaked rags (Photo 5) .

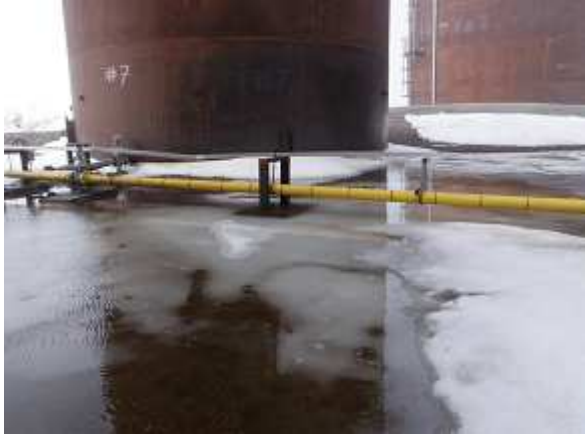
Photo 1

Tank farm	U	There is a leaning tank in the S berm. Flex pipes on tank 11 and 12 should be replaced. Some of the supports are looking warped. (Photo 1)
Vehicle fueling station (Inside and outside)	A	Strong evidence of spillage within fuel transfer station, stained pads and strong odor of diesel. Seals may need to be replaced.

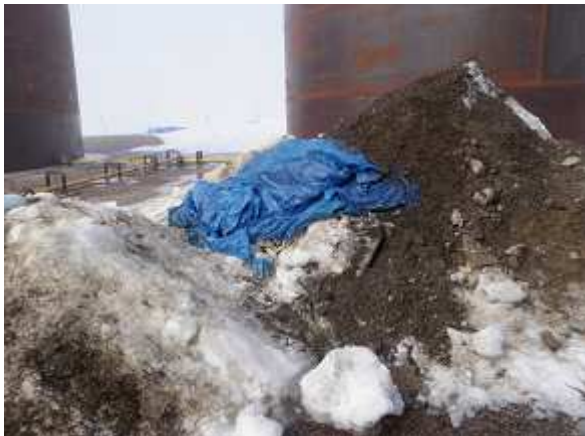
Photo 3

Tank farm	U	Fuel present on the ground. Contaminated snow, dirt, and now a tarp are stored in phase II. (Photo 3) A lot of water build up.
Reclaim Area	A	No issues present.
Vehicle fueling station	A	Not looking as bad now.
HWTA	U	Damage to berm liner. Slumping and erosion of berm presents a potential containment issue. Melted snow is starting to puddle up.
By Generator	A	Evidence of historical spills. Spill evidence down side of tank. Almost completely full of water. (Photo 2)
Helicopter Landing	A	Rain drain will need to be attached to the berms soon.
Airport	A	Evidence of spillage. Most of berm is now filled with water. (Photo 6)

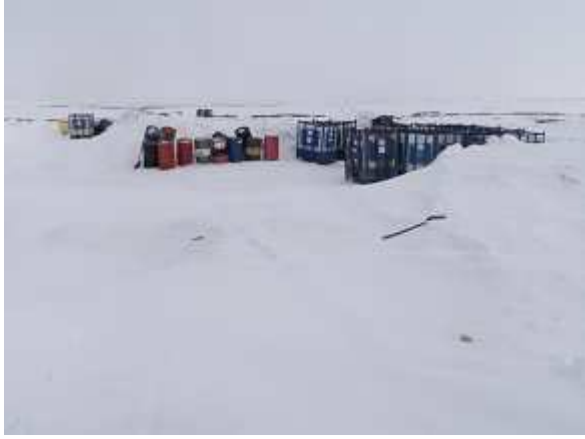
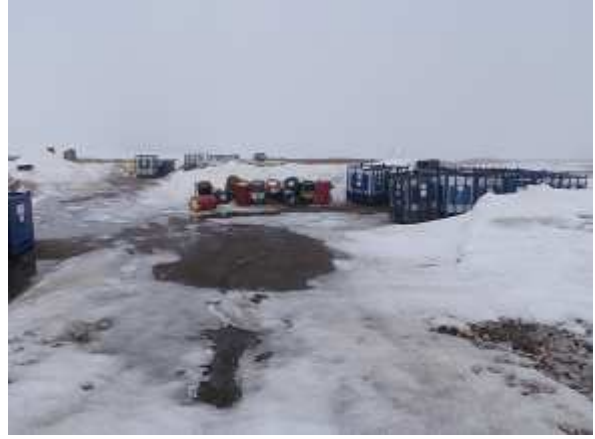
Photo 4

HWTA	U	Drums and tanks will need to be organized when snow melts. Snow is starting to melt and flooding the area (Photo 4)
By Generator	A	No issues with the tank.
Helicopter Landing	A	All drums are properly sealed and placed at 9:00-3:00.
Airport	A	No leaks present at the airstrip day tanks.
Signage	U	Many of the signs have been knocked down by weather. Will need to be replaced during summer months.
MSDS Sheets	A	Present where needed.
Spill Kits	A	Present where required. We have 2 brand new vehicle spill kits in the site services shack.

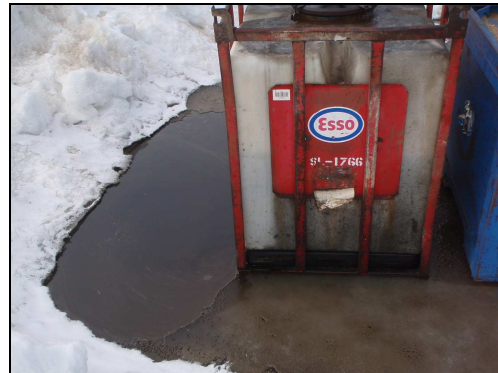
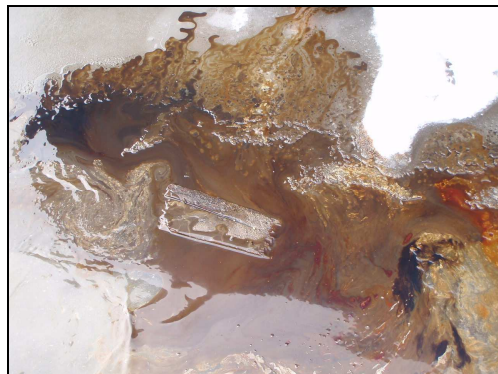
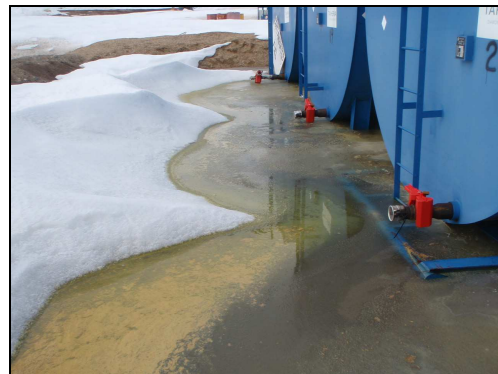
leaking within the containment berm. Water within berm will need to be treating with both oil/water separator as well as the Oztec water remediation unit. (Photo 2-5)
By Generator	A	No issues with the tank.
Helicopter Landing	A	All drums are properly sealed and placed at 9:00-3:00. Snow has been removed from atop.
Airport	A	No leaks present at the airstrip day tanks or Jet A fuel drums.
Signage	U	Many of the signs have been knocked down by weather. Will need to be repaired or replaced during summer months.
MSDS Sheets	A	Present where needed.
Spill Kits	A	Present where required. We have 2 brand new vehicle spill kits in the site services shack. Contents of all kits will need to be inspected regularly.

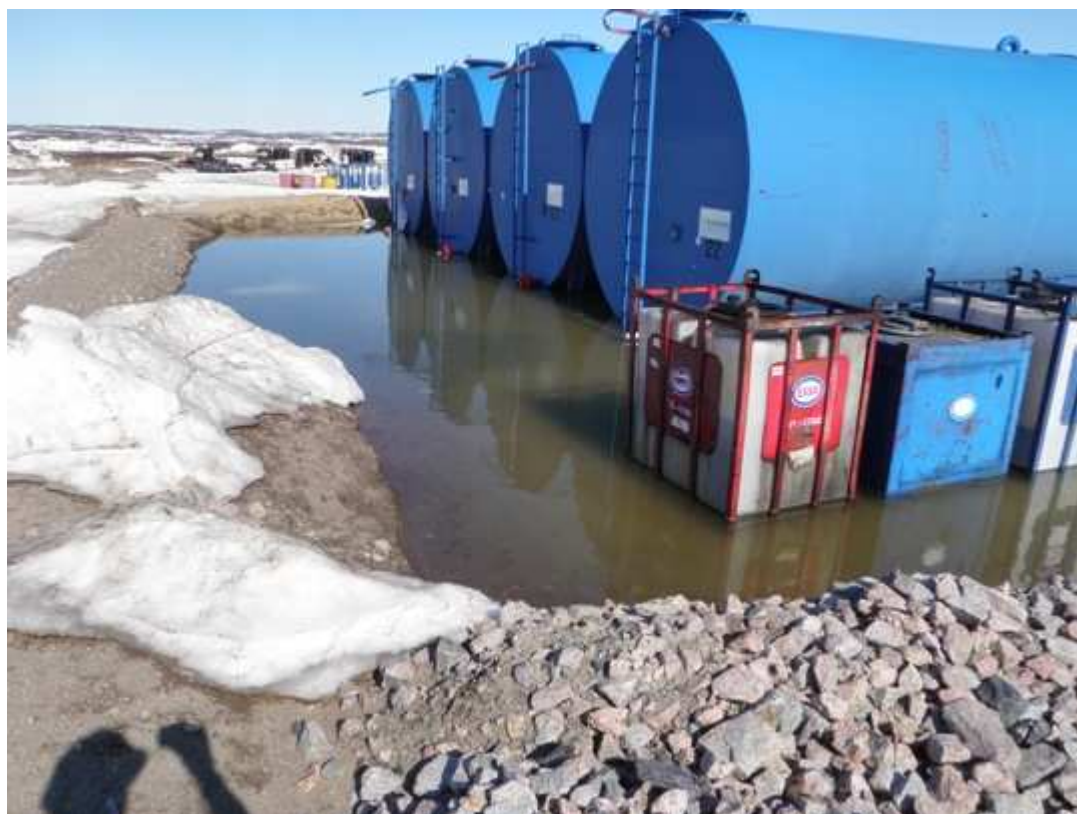
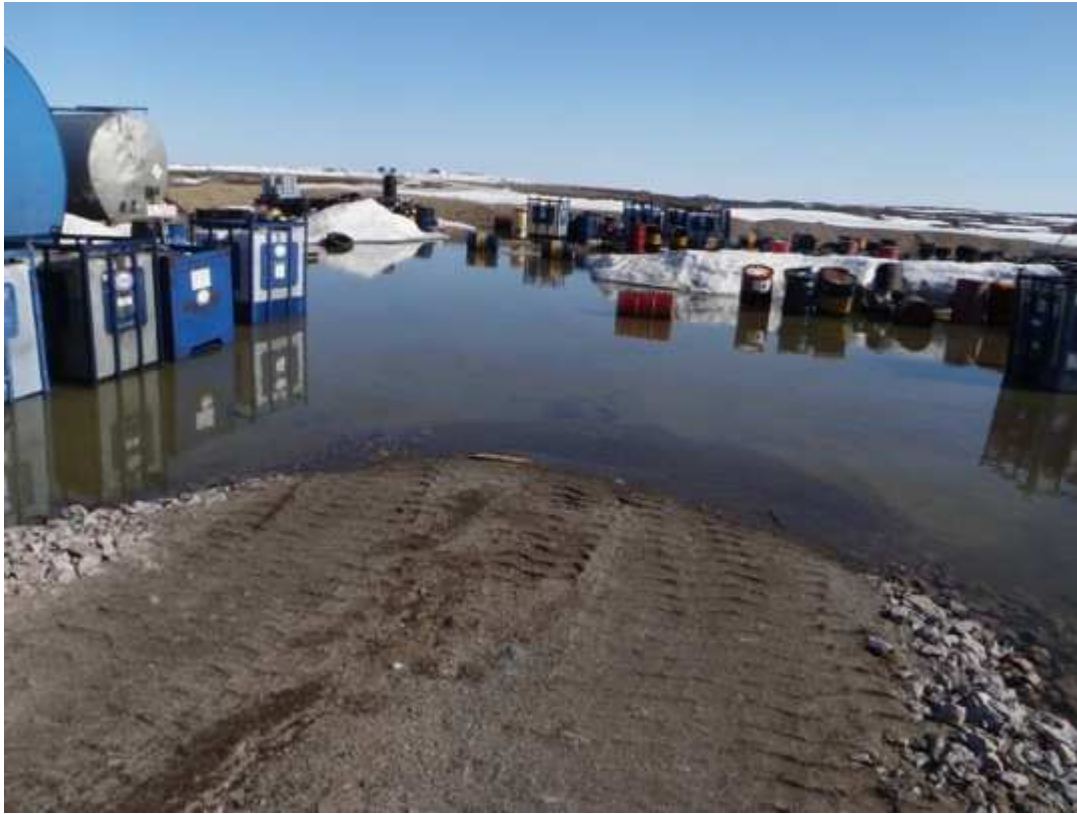
Photos 1 & 2 - HWT A

HWTa	U	Damage to berm liner. Flooded. Water will need to be pumped out and treated using oil/water separator along with the Oztec water remediation unit (Photo 1-3) .
By Generator	A	Evidence of historical spills. Water within the berm will need to be pumped out and treated.
Helicopter Landing	A	Snow has melted, rain drains have been attached. Drums are now accessible. Spill kits are now accessible due to snow melt.
Airport	A	Fuel hoses need to be drained and put away. Large spills that have appeared where annual fuel transfer occurred over the winter have begun to get dug up and relocated to HWTa for future remediation but are still present (Photo 6) . Still presence of a previous spill outside of the Wacker genset that will need to be dug up and relocated to the HWTa.
Spill Pallets	A	Most of the pill pallets are in good shape. There is one in particular in between the shop and incinerator that should be emptied and relocated to an area with level ground.

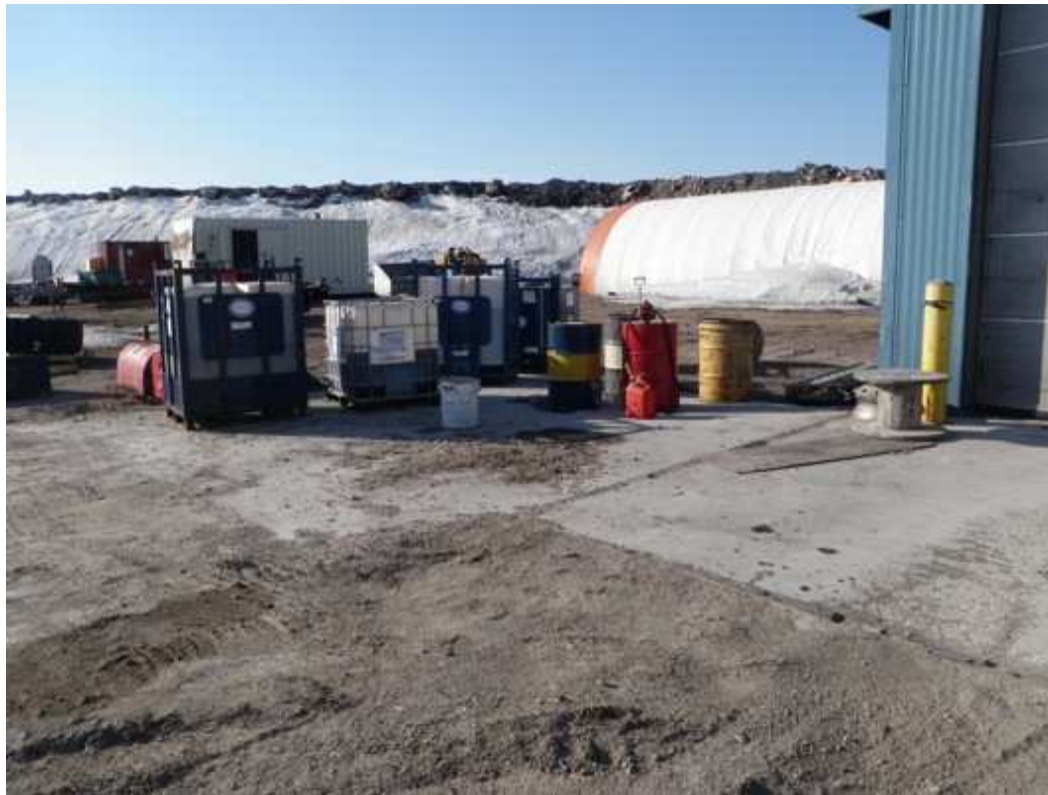
Oil Cubes	U	There are cubes and gasoline outside of truckshop that need to be brought inside or placed in secondary containment. (Photo 7)
Waste Oil Traps	A	Waste oil traps are acceptable however, catchments should be pumped out ASAP as they are close to maximum capacity.
Central Grate	A	Grate is low.
Oil Burner Stacks	A	Burner is no longer in use.
Waste Storage	U	Waste disposal is an ongoing issue in here. A lot of non burnable waste is generated in this area.
Powerhouse Area	U	Lots of stains are showing up on the ground now that the snow is melted. Oil cubes that were used for a recent oil change need to be put away (Photo 8)
Parking Lot	U	Now that the snow has melted there are a number of small spills where vehicles and heavy equipment were stored over the winter. These will need to be cleaned up ASAP.

Photo 7 – Cubes and drums outside of the Truck Shop, no secondary containment

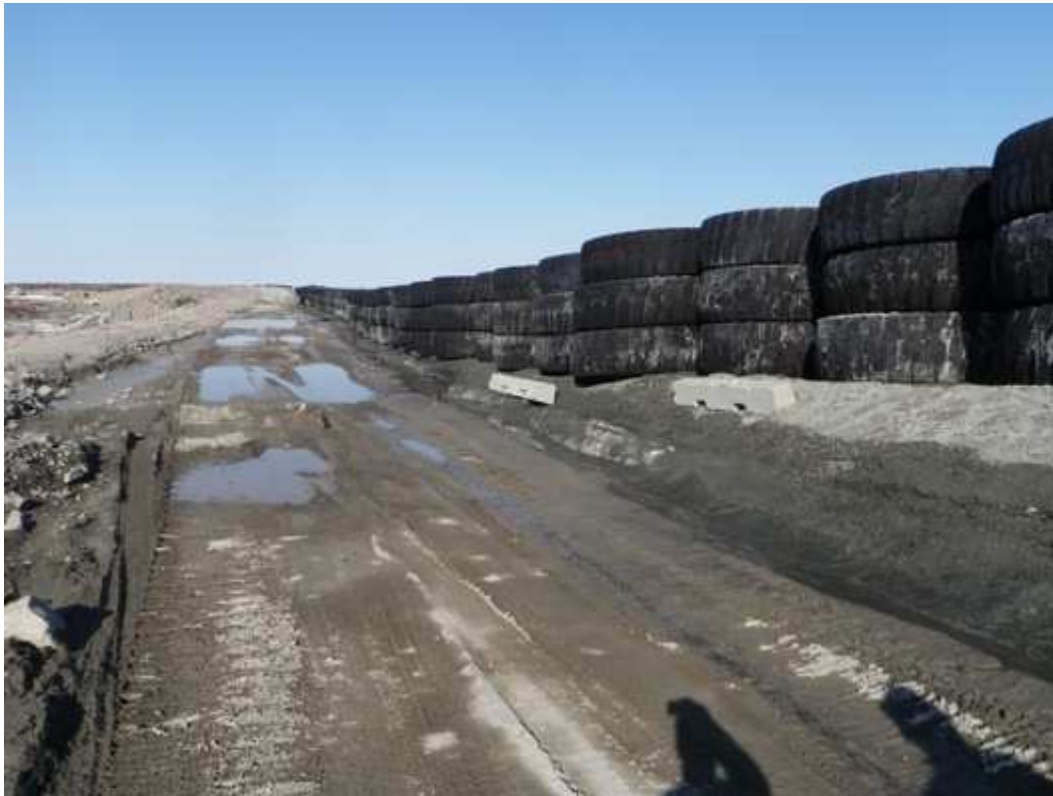
Photo 9 – Tire wall along the Southeast Dam – monitor during snow melt
