Tahera Diamond Corporation

JERICO DIAMOND MINE  
2006 GEOTHECNICAL INSPECTION

1100060.010

September 2006

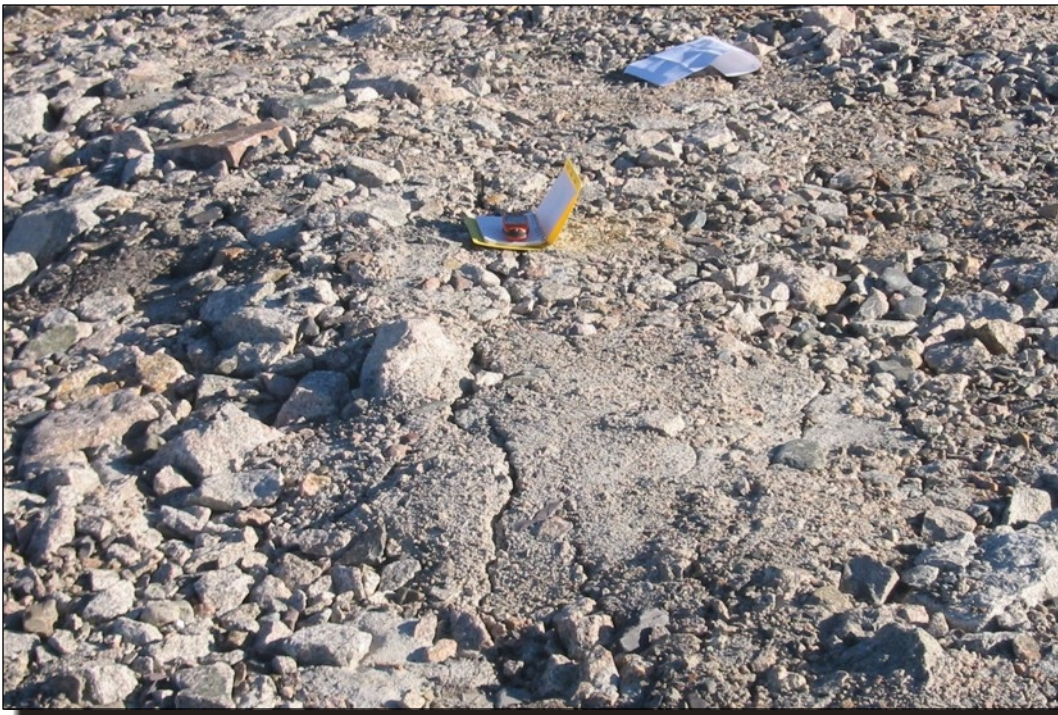
Minor settlement and cracking was noted in the dam surface as described in Appendix A. This performance is as expected in winter placed fill and will not affect the dam performance.

Features:	Present (Yes/No)	Dimensions	Extent	Description	Photographic Records
Erosion	None noted				
Cracking	WD-1	3 to 10 mm wide, 10 m long approximately 200 mm deep	Isolated	Several discontinuous cracks associated with settlement	A4
Settlement	WD-2	Numerous Voids 200 mm by 100 mm by 200 mm deep in an area 13 m by 7 m	Isolated	Voids in cover	A5
	WD-4	Area 6 m by 6 m, up to 150 mm deep	Isolated	Settlement area, 1cm wide cracks, subsidence holes 50 mm by 200 mm, by 300 m deep and 200 mm by 300 by 100 mm deep	A8
Seepage	None noted

**Photo A4**  
West Dam - Feature WD-1, isolated cracking in downstream shell.

Inspect and possibly strip top layer of frozen core when construction recommences in 2006.

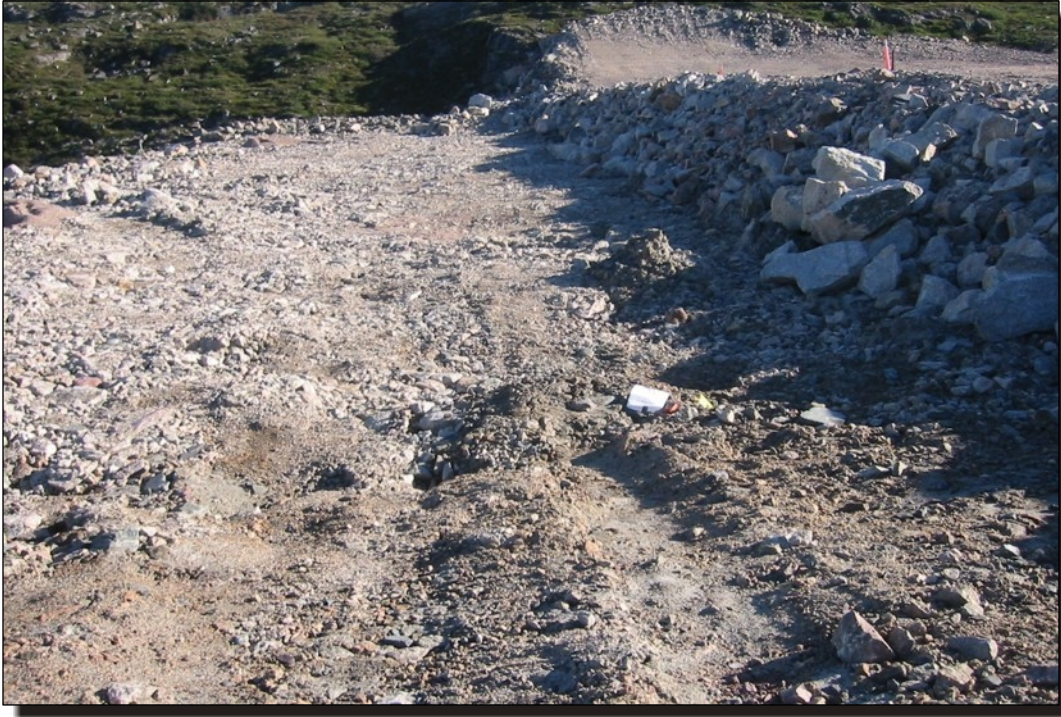
**Photo A5**  
West Dam - Feature WD-2, voids in downstream shell.

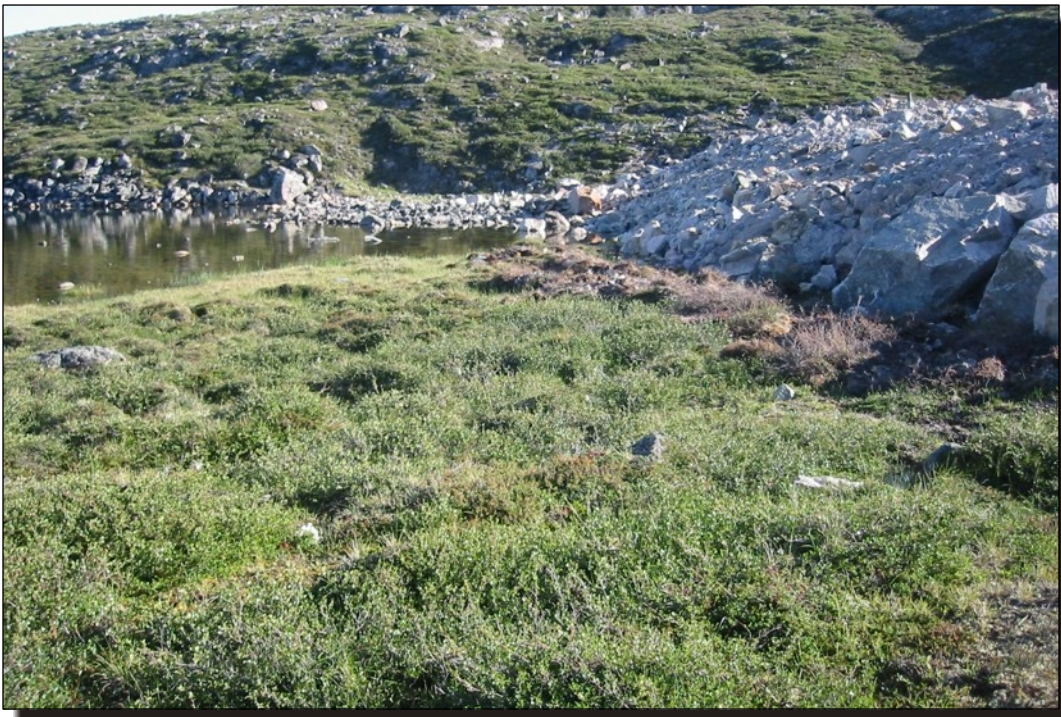
Other Features	WD-3 Wet area downstream south dam toe.	20 by 25 m	Isolated	Appeared to be a natural wet area, made wetter by a small leak from the discharge line.	A6, A7
----------------	--	------------	----------	---	--------

**Photo A6**  
West Dam - Feature WD-3, wet area at downstream dam toe.

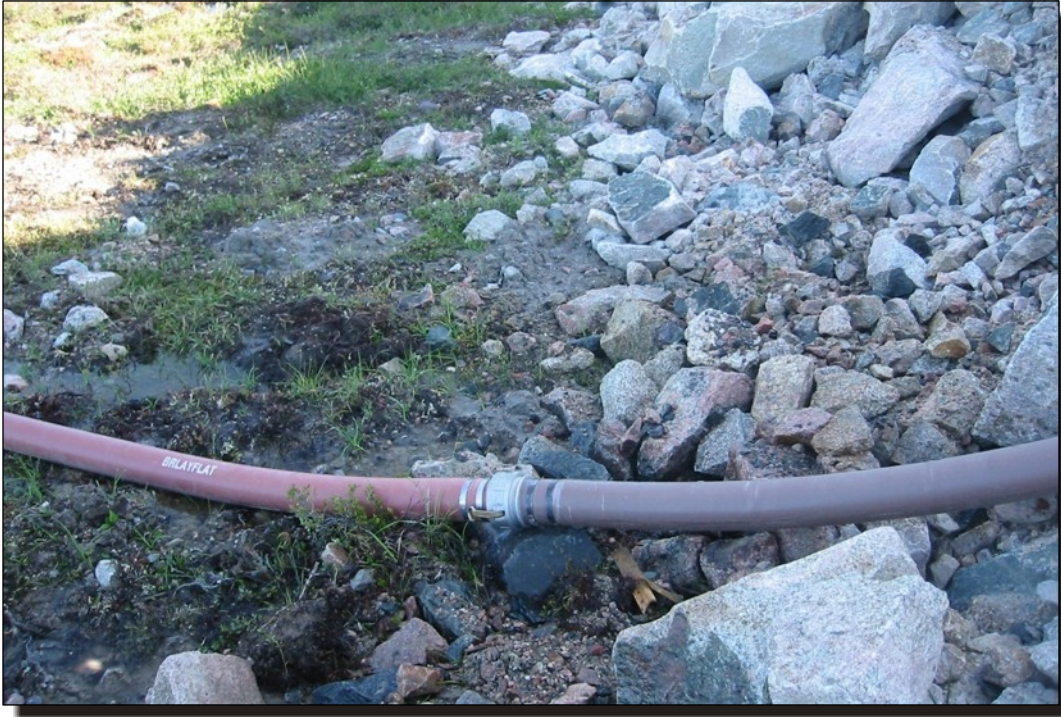
**Photo A7**

West Dam - Feature WD-3, wet area at downstream toe, discharge line.

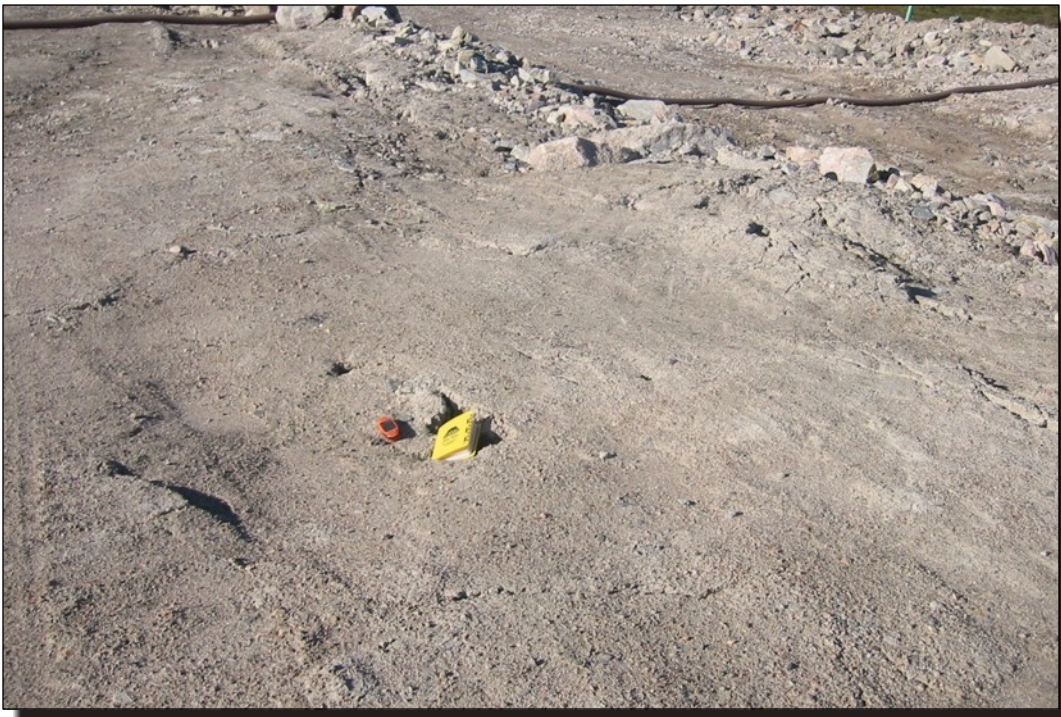
**Photo A8**

West Dam - Feature WD-4, settlement in dam crest fill.

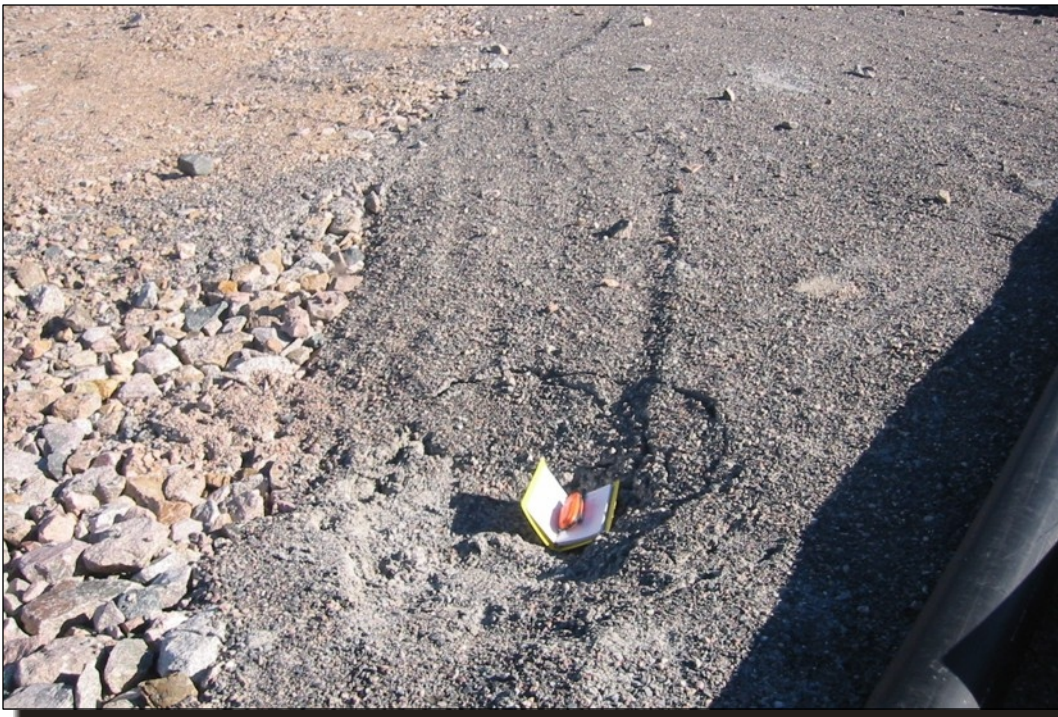
The inspection report and photos are in Appendix B. Cracks and settlement were observed in the surface of the dyke filter zone. It is recommended that the cracked zone of the filter be excavated and recompacted in the fall of 2006, prior to raising the dyke.

**Photo B4**  
Feature DD-1 - Settlement.

Excavate and recompact top layer of filter zone to eliminate settlement cracks.

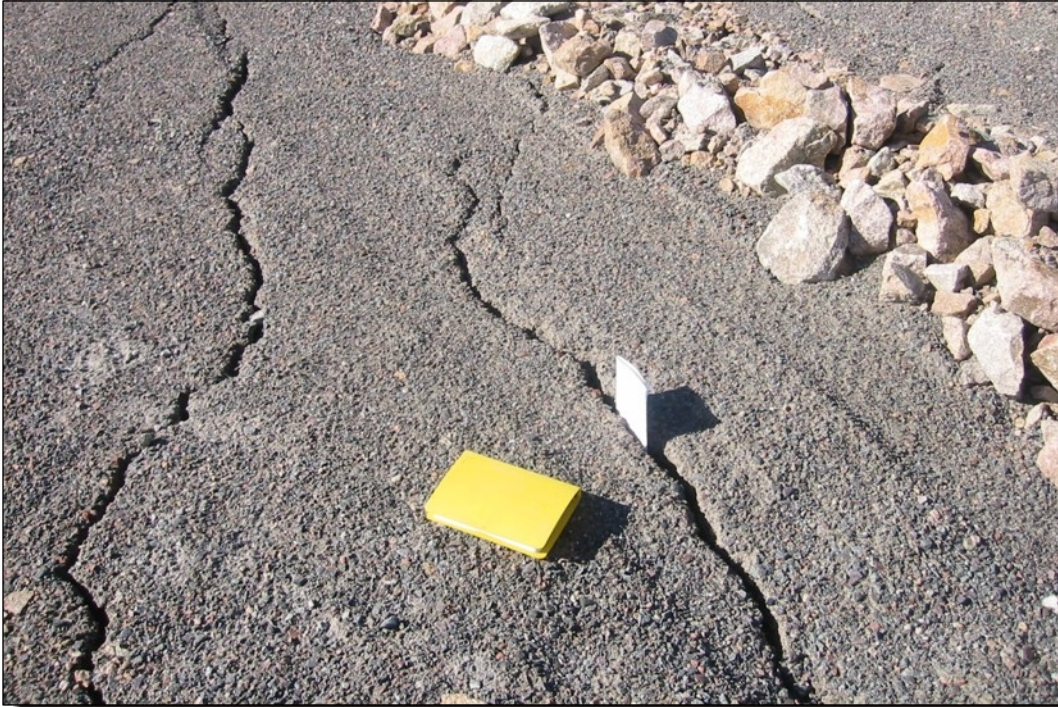
Features:	Present	Dimensions	Extent	Description	Photographic Records
Erosion	None noted				
Cracking	DD-2	10 to 40 mm wide, 400 to 800 mm deep	Discontinuous along most of the exposed filter zone	Cracks parallel to the dyke axis	B5, B6
Settlement	DD-1	1 m diameter, 150 mm deep	Isolated	Settlement in dyke filter zone.	B4
Seepage	None noted			No visible seepage, but seepage is occurring as evidence that the water levels upstream and downstream of the dyke are essentially equal, and Fine PK discharge is occurring upstream of the dyke.

**Photo B5**  
Feature DD-2 - Cracking in dyke filter.

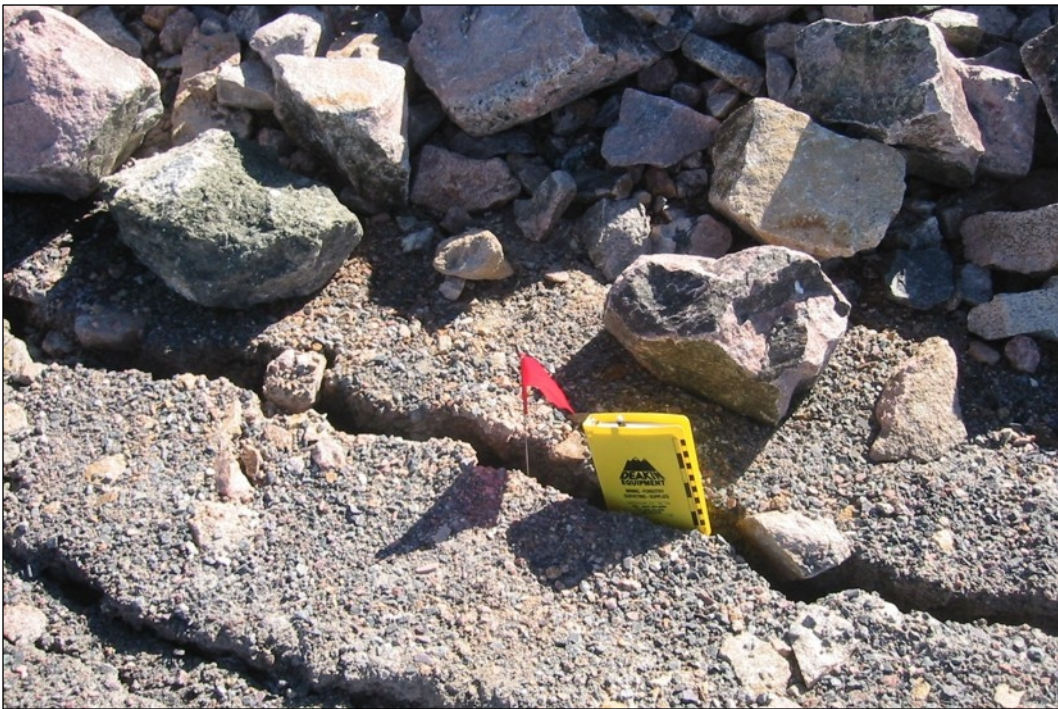
**Photo B6**  
Feature DD-3 - Cracking in dyke filter.

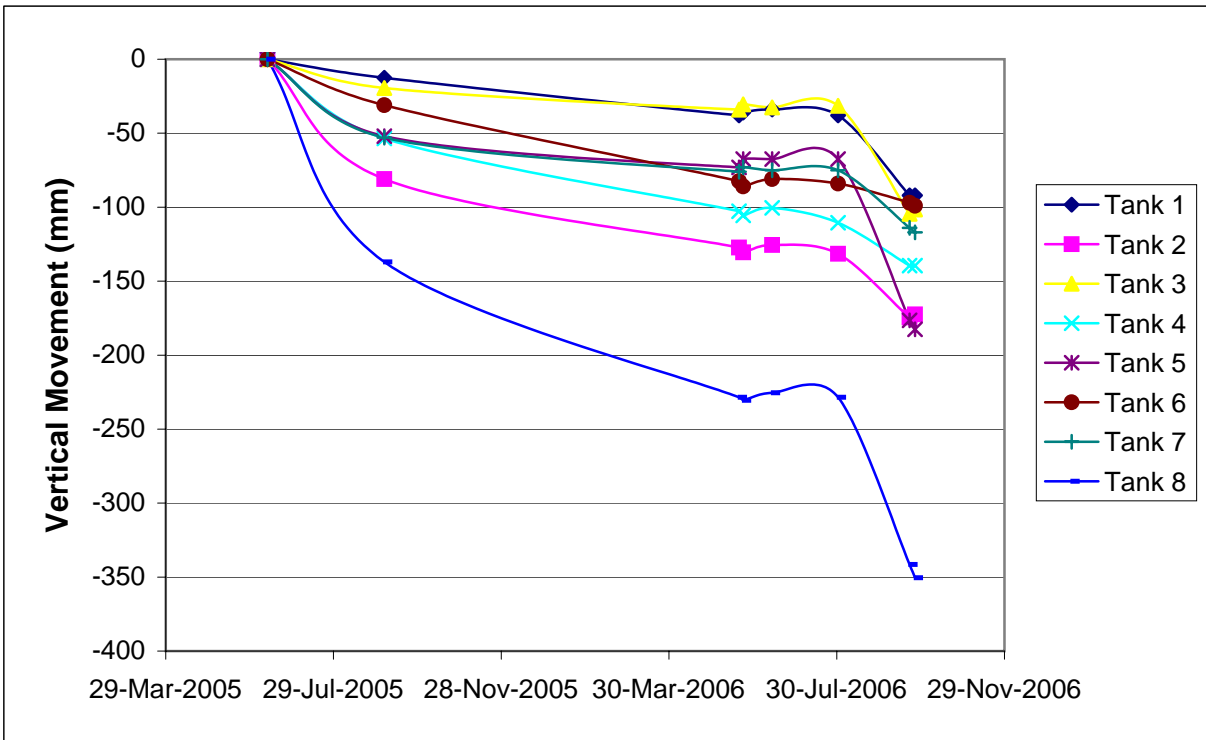
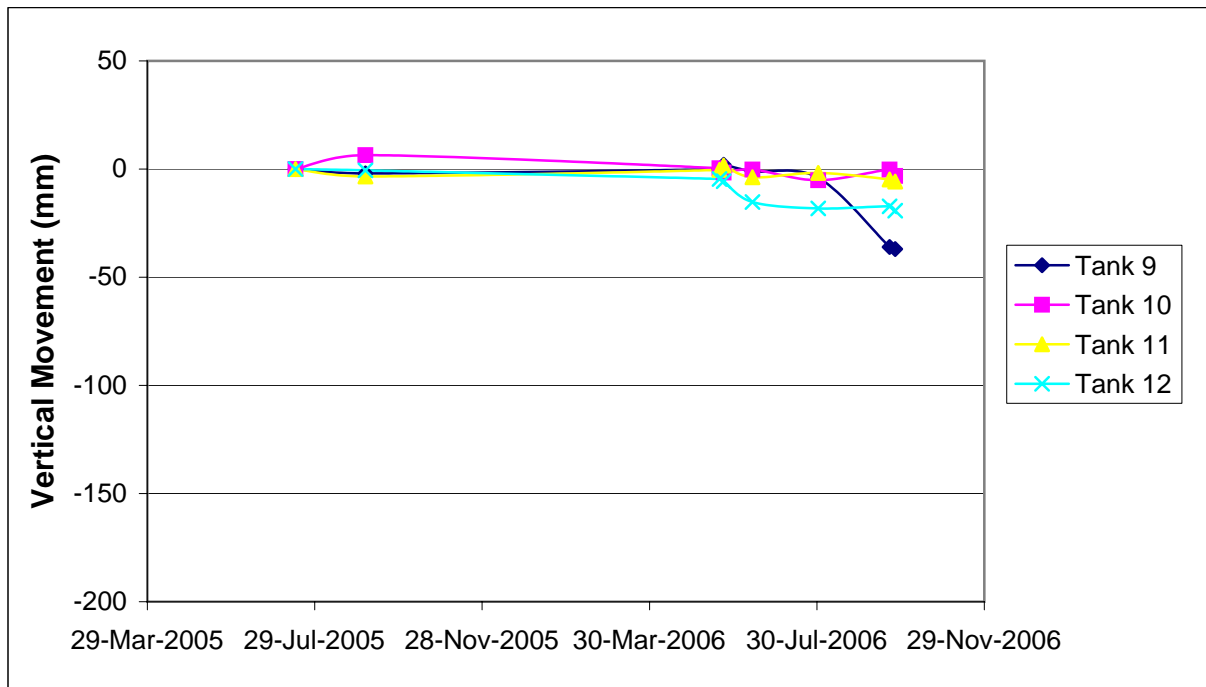
Settlement of the tanks has been measured on a regular basis using survey prisms on the top of the tanks. The vertical tank movement is shown in Figure D-2 in Appendix D.

Vertical settlement of the tanks in Phase 1 ranges from 100 to 350 mm over the past fifteen months. The settlement is visually apparent in the piping connections to the tanks. It is understood that new flexible connections were installed after the geotechnical inspection. Small gaps (up to 15 mm high) are apparent below the tank bases in Phase 1 due to differential settlement of the tank farm base.

Minimal vertical movement of the tanks in Phase 2 has been measured (up to 37 mm) over the past fourteen months. No obvious signs of movement or tank distress was noted.

Tank Farm Settlement Monitoring

The settlement of the tanks should continue to be monitored. It is recommended that the tank manufacturer be requested to evaluate the Phase 1 tanks' integrity prior to filling with fuel. It is also recommended that the integrity of the secondary containment liner in Phase 1 be evaluated by filling the area with a water head and monitoring water level drop over a period of time while observing if seepage occurs out of the tank containment area.

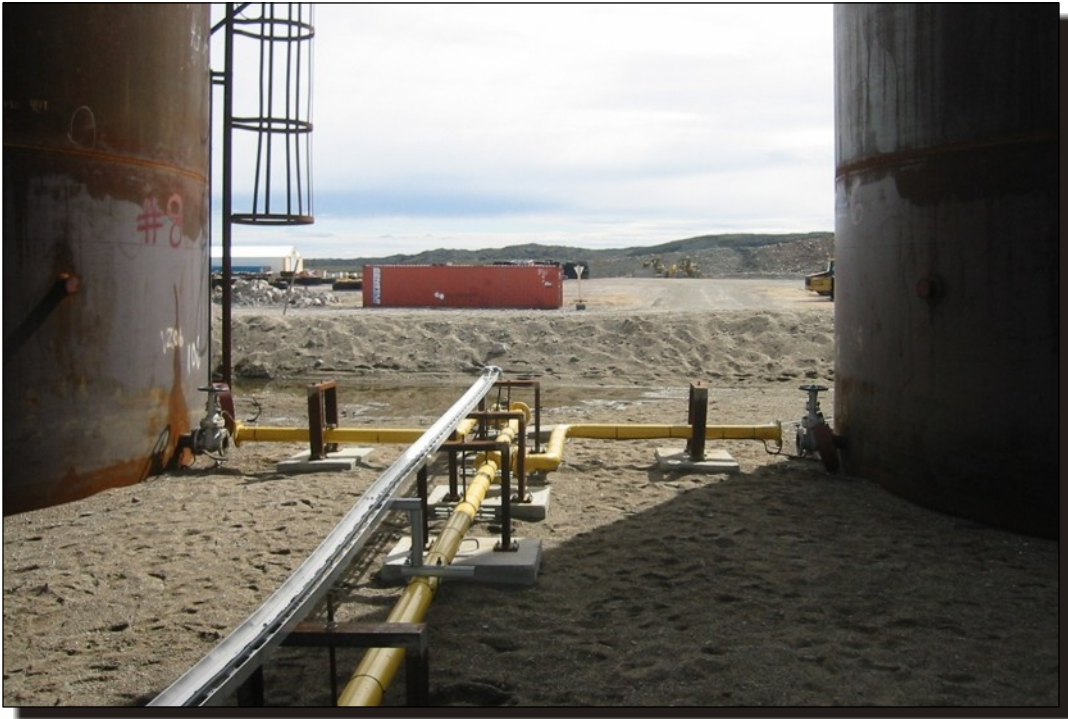
**Photo D3**

Features:	Present	Dimensions	Extent	Description	Photographic Records
Erosion	None noted				
Cracking	None noted				
Settlement	TF-1 Settlement in the south portion of the tankfarm	Uneven surface throughout the southern half of the tank farm	Throughout southern portion	Settlement apparent under tanks. Gaps 15 mm high under several of the tanks. Piping connections higher than tank flanges due to tanks settling (up to 60 mm higher). Some of the tanks appear to be listing.	D3, D4, D5, D6
Seepage	None noted				
Other Features	TF-2 Stained Soil	Numerous small areas, larger area at south end of area	Sporadic, most at valve locations	Hydrocarbon stained soil on inside surface of tankfarm base	D7

Tankfarm - Feature TF-1, pipes disconnected from tank flanges. Note difference in elevation from pipe to tank flange.

Continue monitoring to determine if settlement is ongoing. Obtain clarification from tank engineer to determine if the tanks are safe to fill with petroleum products. Confirm geomembrane liner integrity.

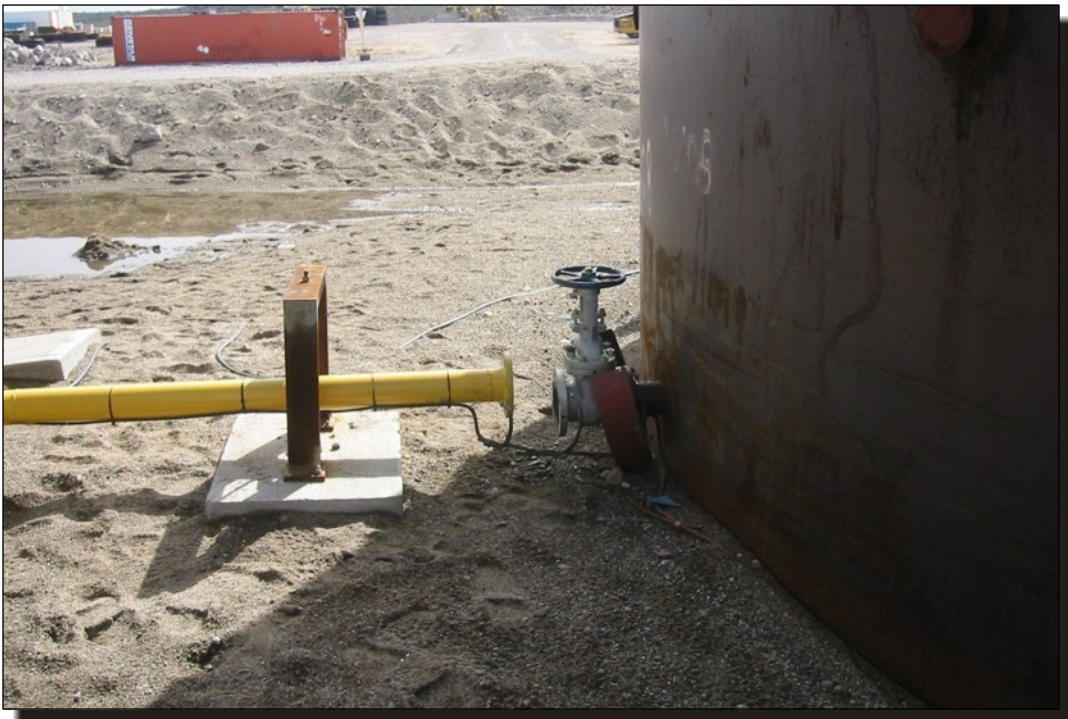
**Photo D4**

Tankfarm - Feature TF-1, pipes disconnected from tank flanges. Note difference in elevation from pipe to tank flange.

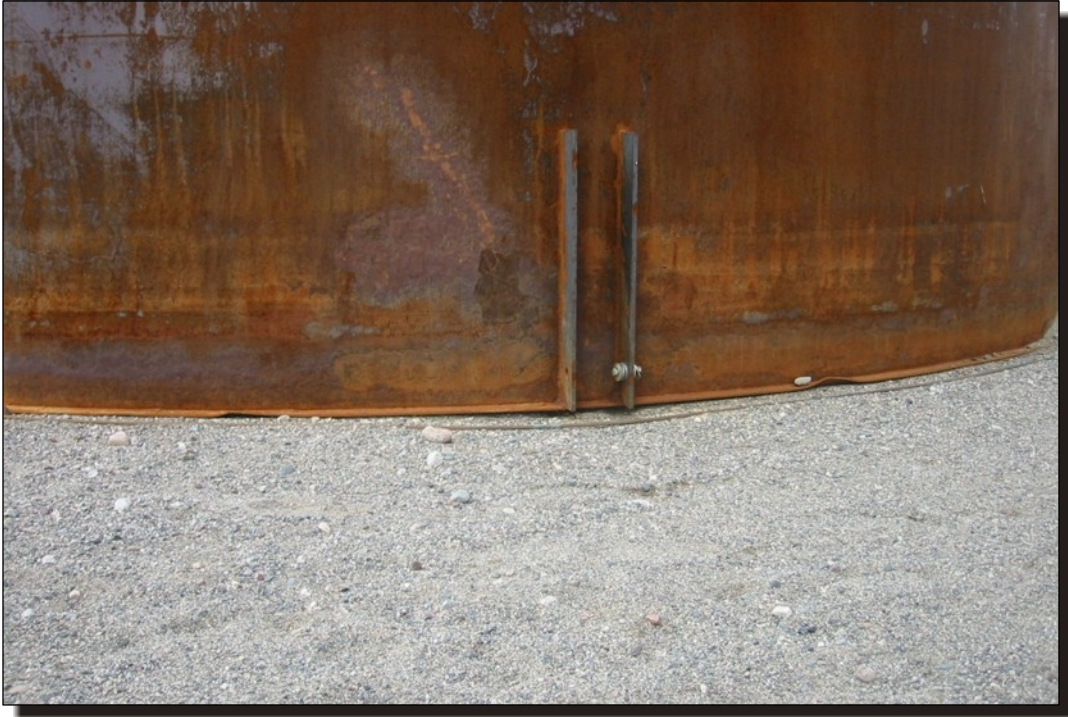
**Photo D5**

Tankfarm - Feature TF-1, gap under tank due to differential settlement of pad.

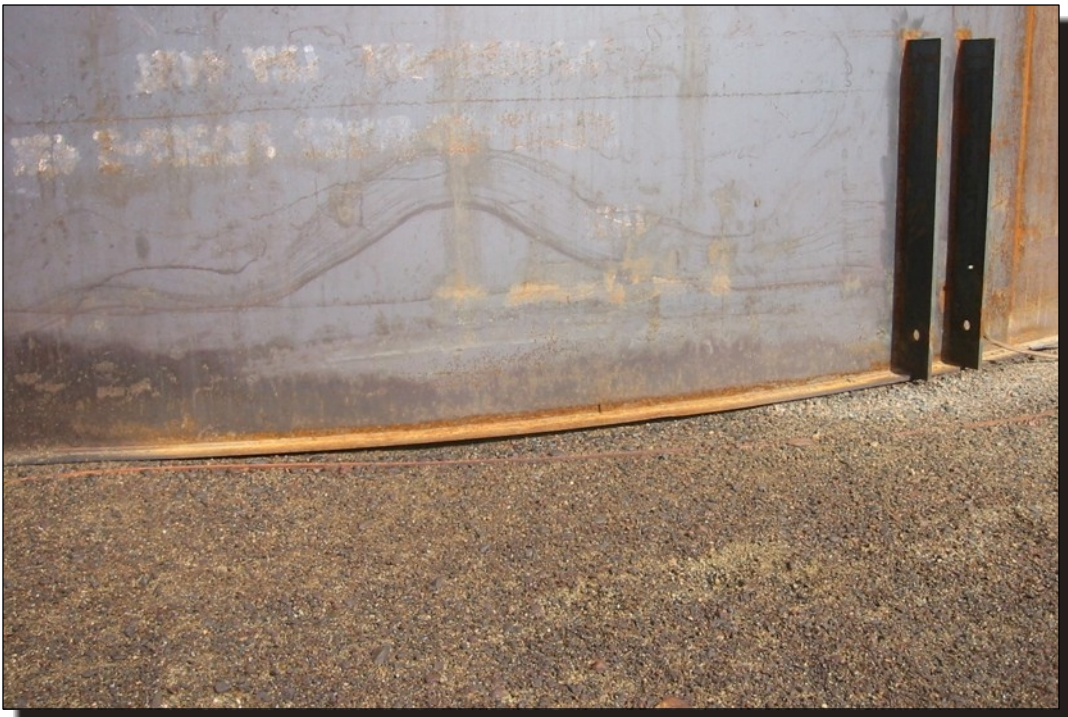
**Photo D6**

Tankfarm - Feature TF-1, gap under tank due to differential settlement of pad.

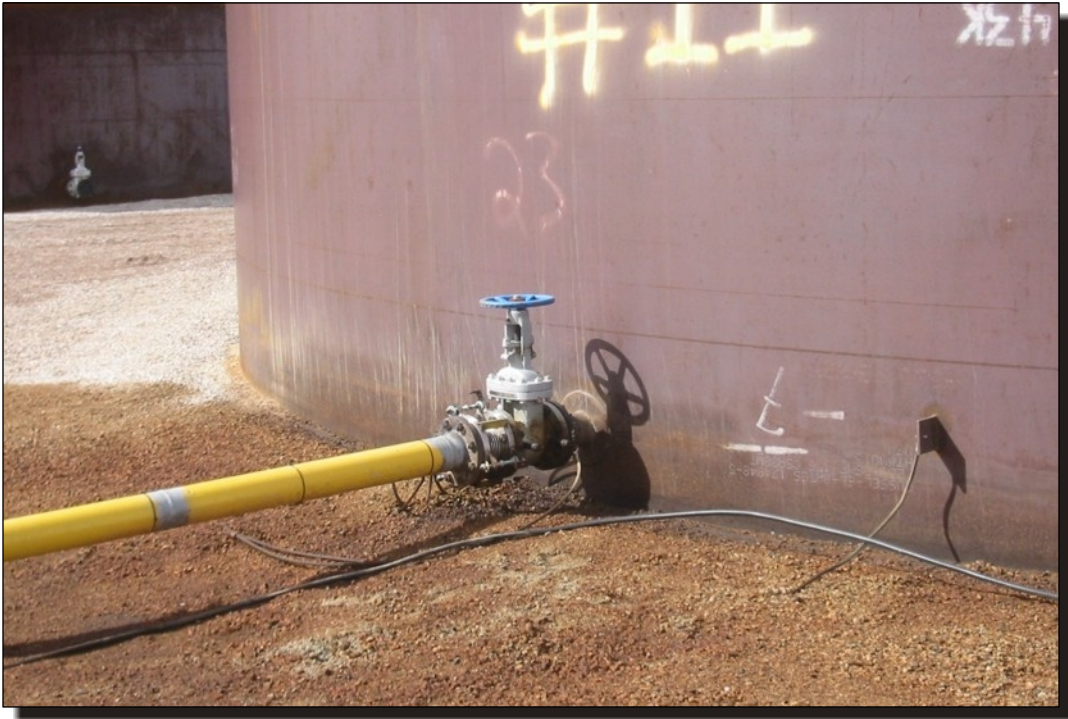
**Photo D7**  
Tankfarm - Feature TF-2, stained soil.

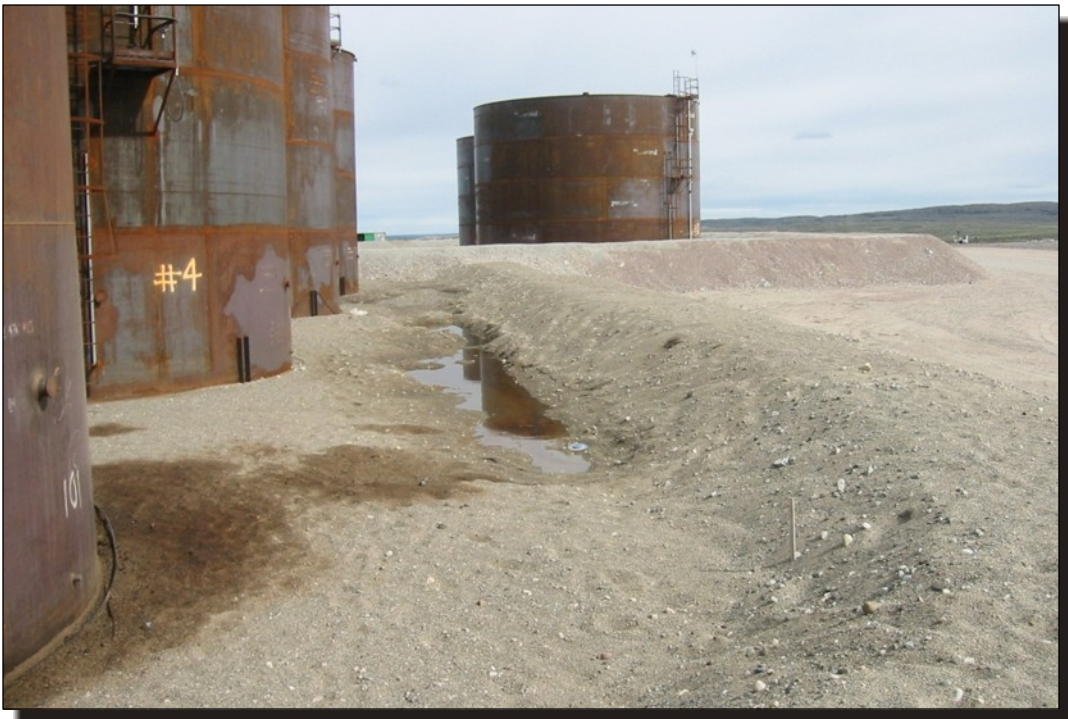
**Photo D8**  
Tankfarm - Feature TF-3, ponded water in tankfarm containment area.

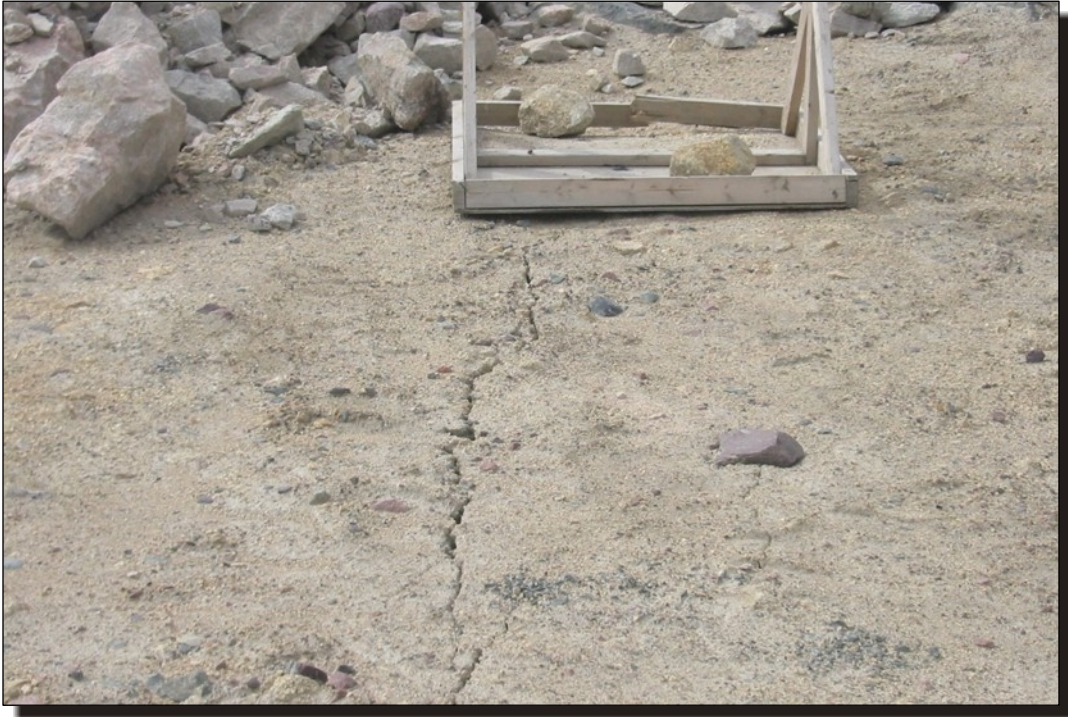
A small surface crack was observed adjacent to the current landfill pit. This may be a result of settlement of landfill waste. It is recommended that the waste within the pit be compacted prior to placing backfill over the waste.

OBSERVED CONDITION:					
Features:	Present	Dimensions	Extent	Description	Photographic Records
Erosion	None noted				
Cracking	None noted	LF-1 - 10 m long, 15 mm wide, 0.3 m deep	Isolated	Surface crack adjacent to landfill – could be a result of settlement of landfilled area.	E5
Settlement	None noted				
Seepage	None noted				
Other Features	None noted				
Erosion	None noted

**Photo E5**  
Landfill - surface crack.

The landfill is constructed within the center of the till dump. Incinerated debris is covered over with till. Metallic debris and non-burnable debris is separated from the burnable debris. Some settlement cracks were observed near the active pit. It is recommended that the debris is compacted prior to covering to reduce the amount of settlement.

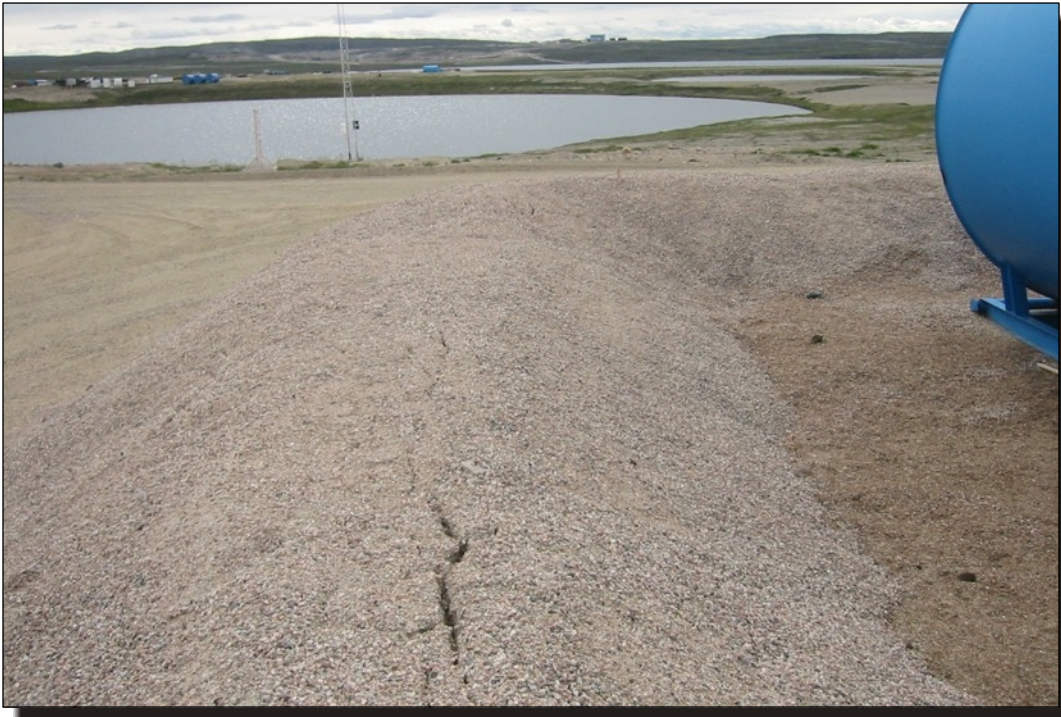
The secondary containment liner is covered with a layer of crushed gravel. Small cracks were observed in the top of the berms. No other signs of berm instability were noted. It is suspected the cracks are due to settlement of the berm fill.

OBSERVED CONDITION:					
Features:	Present	Dimensions	Extent	Description	Photographic Records
Erosion	None noted				
Cracking	ATF-1	3 to 15 mm wide cracks	Around most of the berm tops.	Appears to be settlement cracks. No signs of instability on the berms, i.e. no elevation difference from one side of the cracks to the other.	F2
Settlement	None noted				
Seepage	None noted				
Other Features	None noted

**Photo F2**  
Airstrip tank farm - settlement cracks.

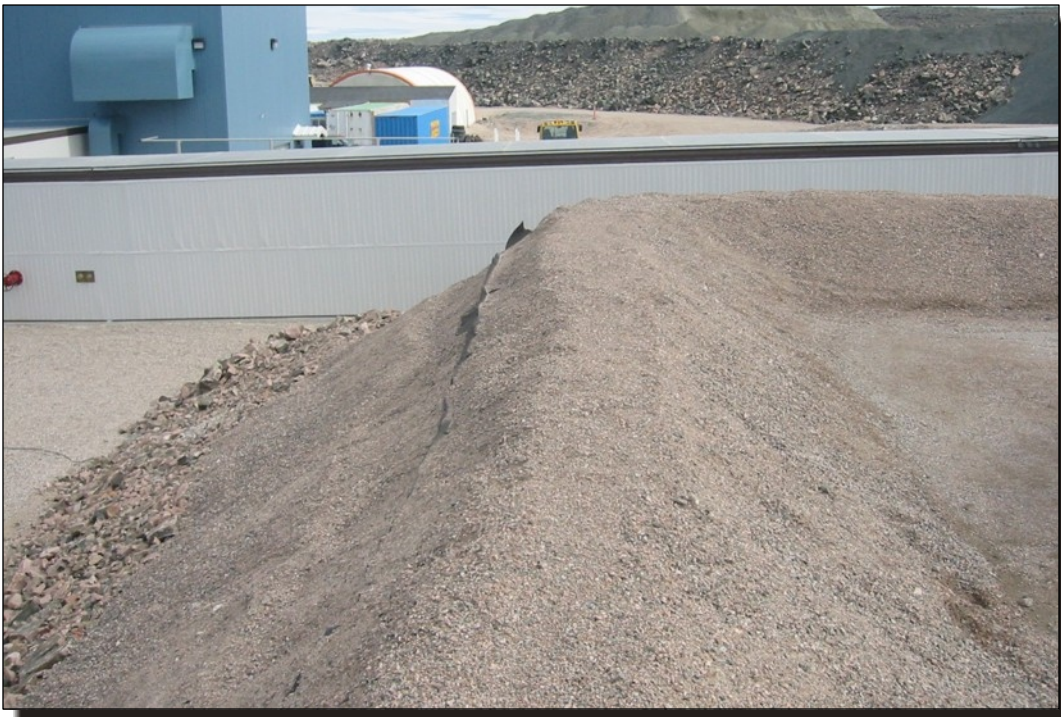
**Photo G2**  
Generator tank farm - liner exposed.

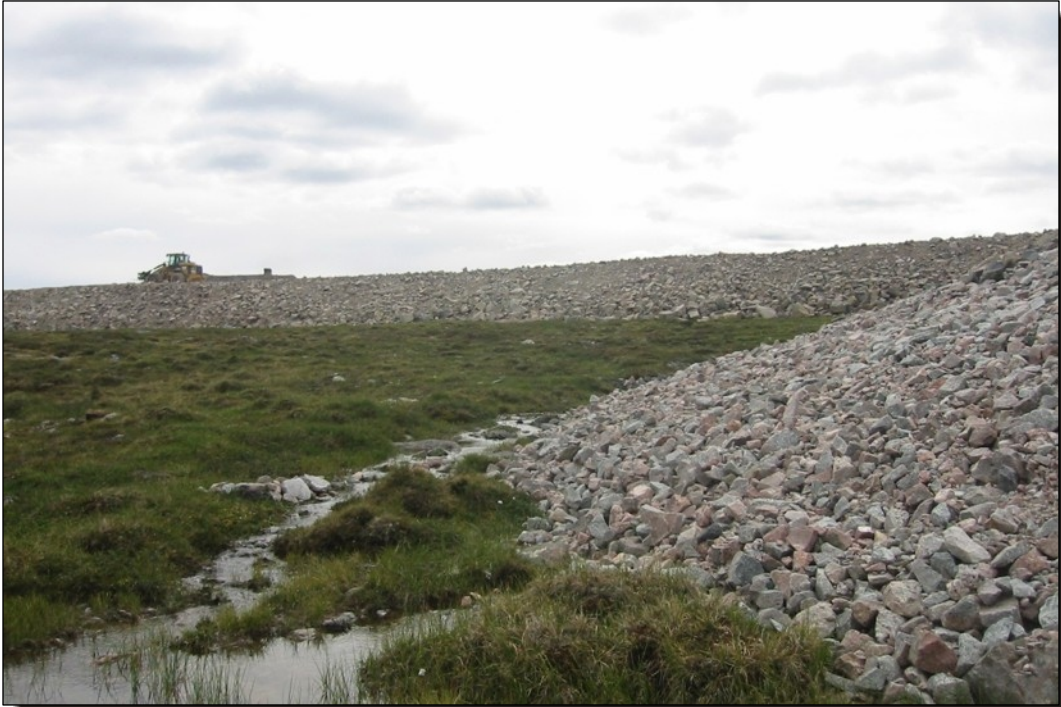
**Photo I13**

C1 Diversion - Reach C - end of Reach C berm - water flowing around the berm.

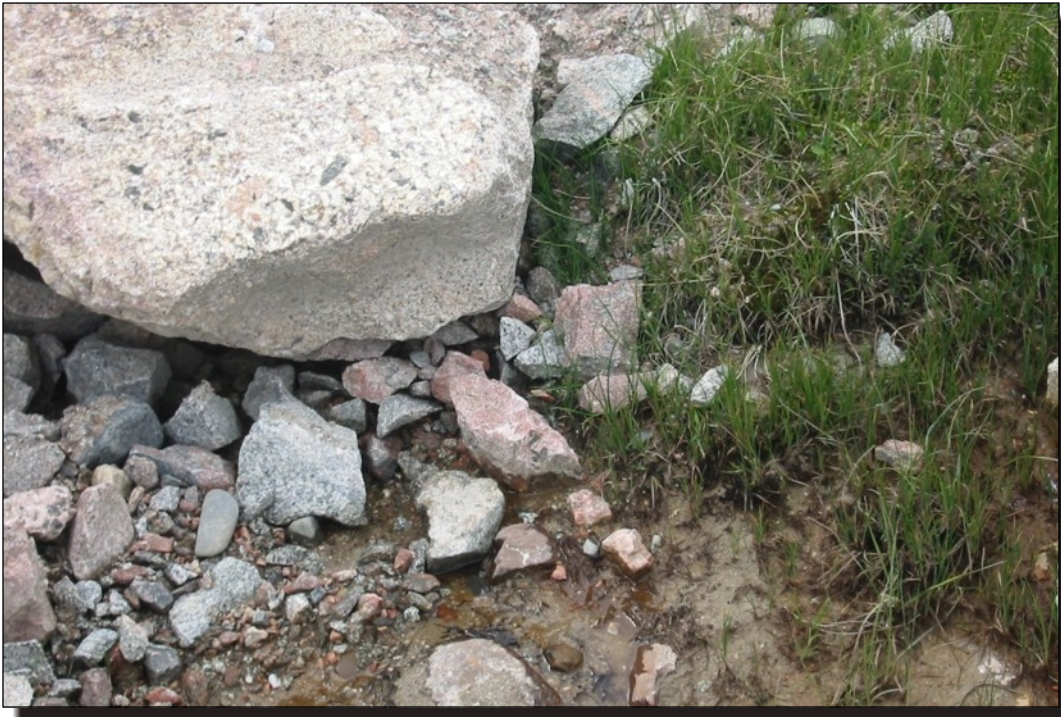
The water flows were relatively small at the time of the inspection. Very small wet areas were noted adjacent to both the north and south diversion berms but no seepage through the diversion berms was noted. A ponded area was noted downstream of the original stream C1 cutoff, but again no seepage into the ponded area was noted.

**Photo I16**  
Feature CD-1, Wet area adjacent to upstream Reach C berm.

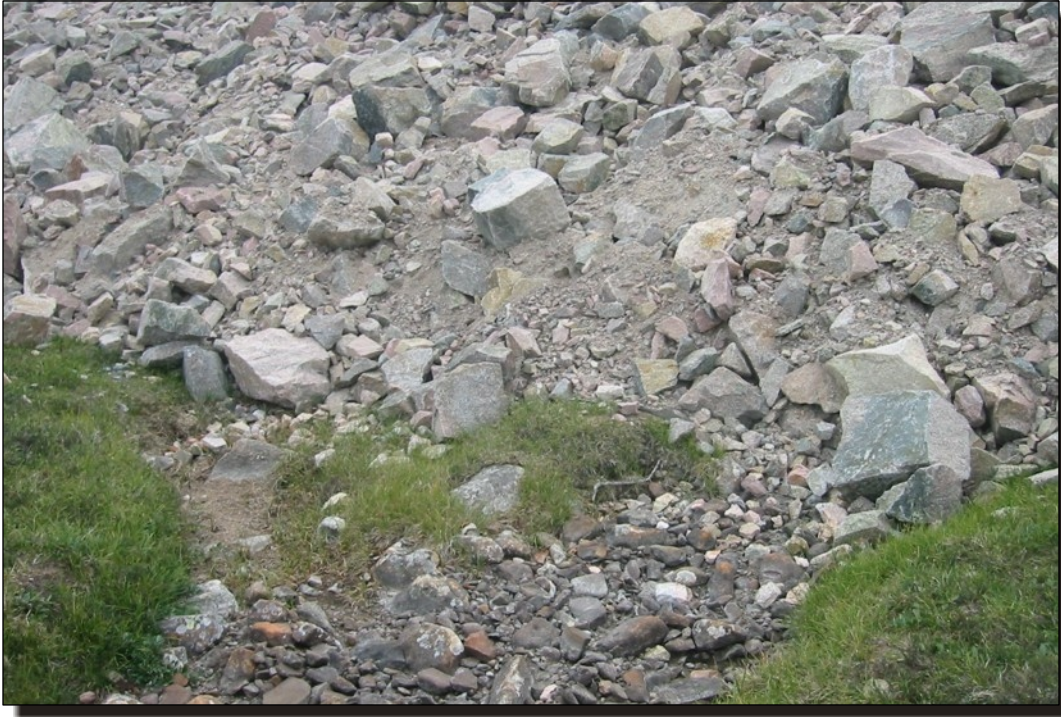
Features:	Present	Dimensions	Extent	Description	Photographic Records
Erosion	None noted				
Cracking	None noted				
Settlement	None noted				
Seepage	None noted				
Other Features	C1-1 – Damp Area	0.3 m by 0.5 m	Isolated	Damp area at downstream edge of south berm (pit road). No seepage observed. Area nearby to original stream channels in C1 area.	I16
	C1-2 – Damp Area	0.5 by 0.5 m	Isolated	Damp area downstream of north berm. No seepage observed.	I17

**Photo I17**  
Feature C1-2, Damp area downstream of north berm. No seepage observed.

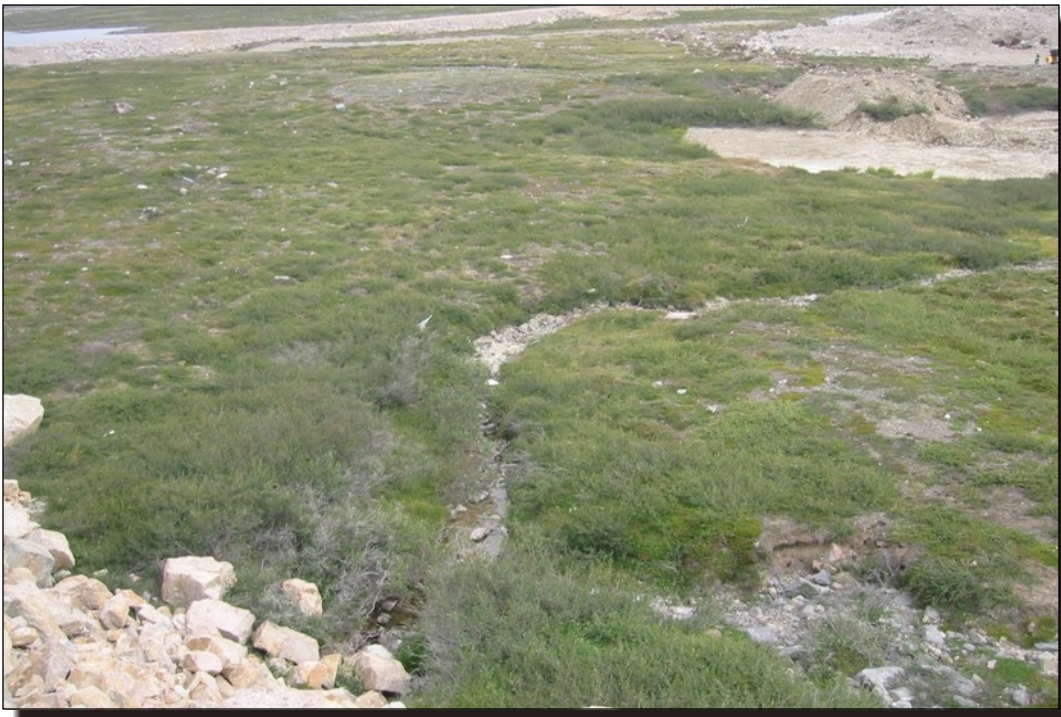
**Photo I18**  
Feature C1-3, Ponded water in remnant stream channel below C1 channel cut off. No seepage apparent.
