**Shear Minerals Ltd.**

**ISSUED FOR USE – REV 1**

**JERICO DIAMOND MINE  
2010 GEOTECHNICAL INSPECTION**

**E14101117**

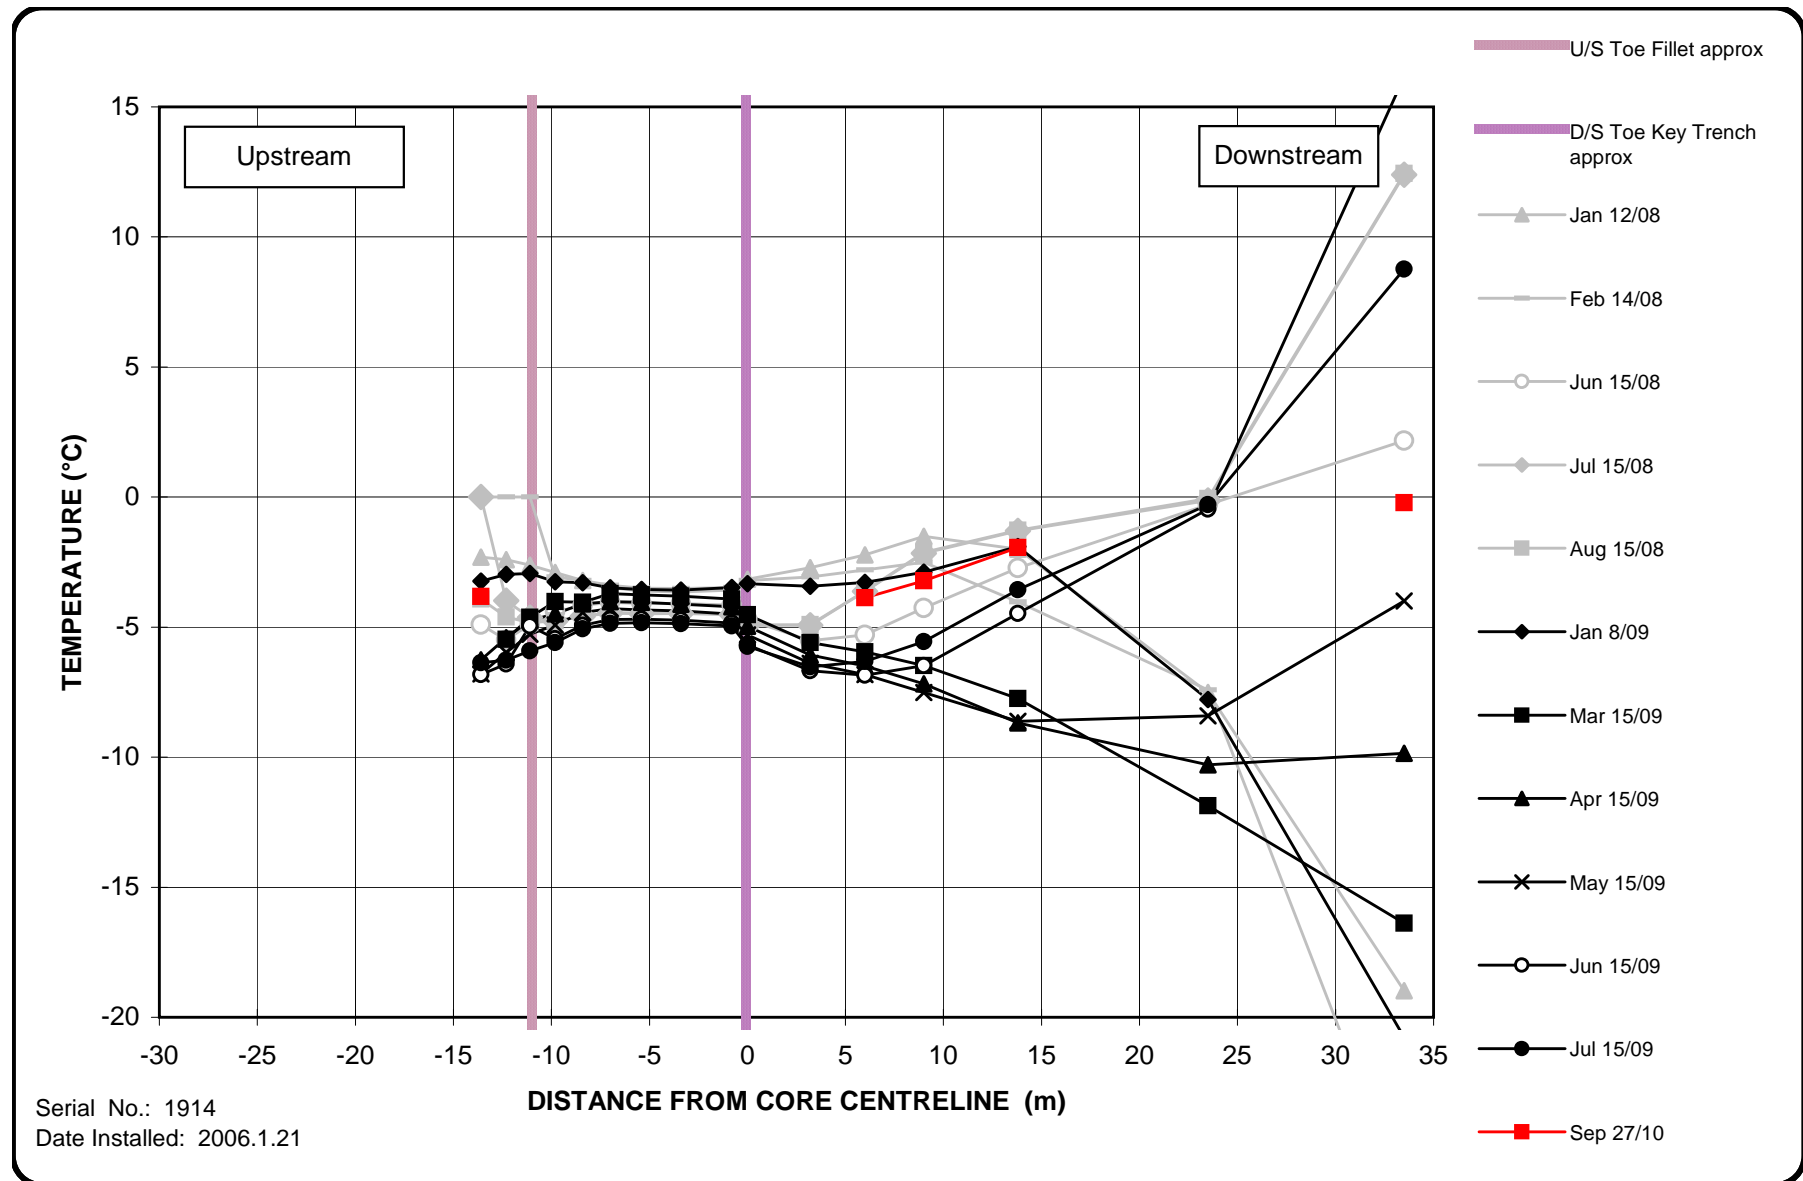
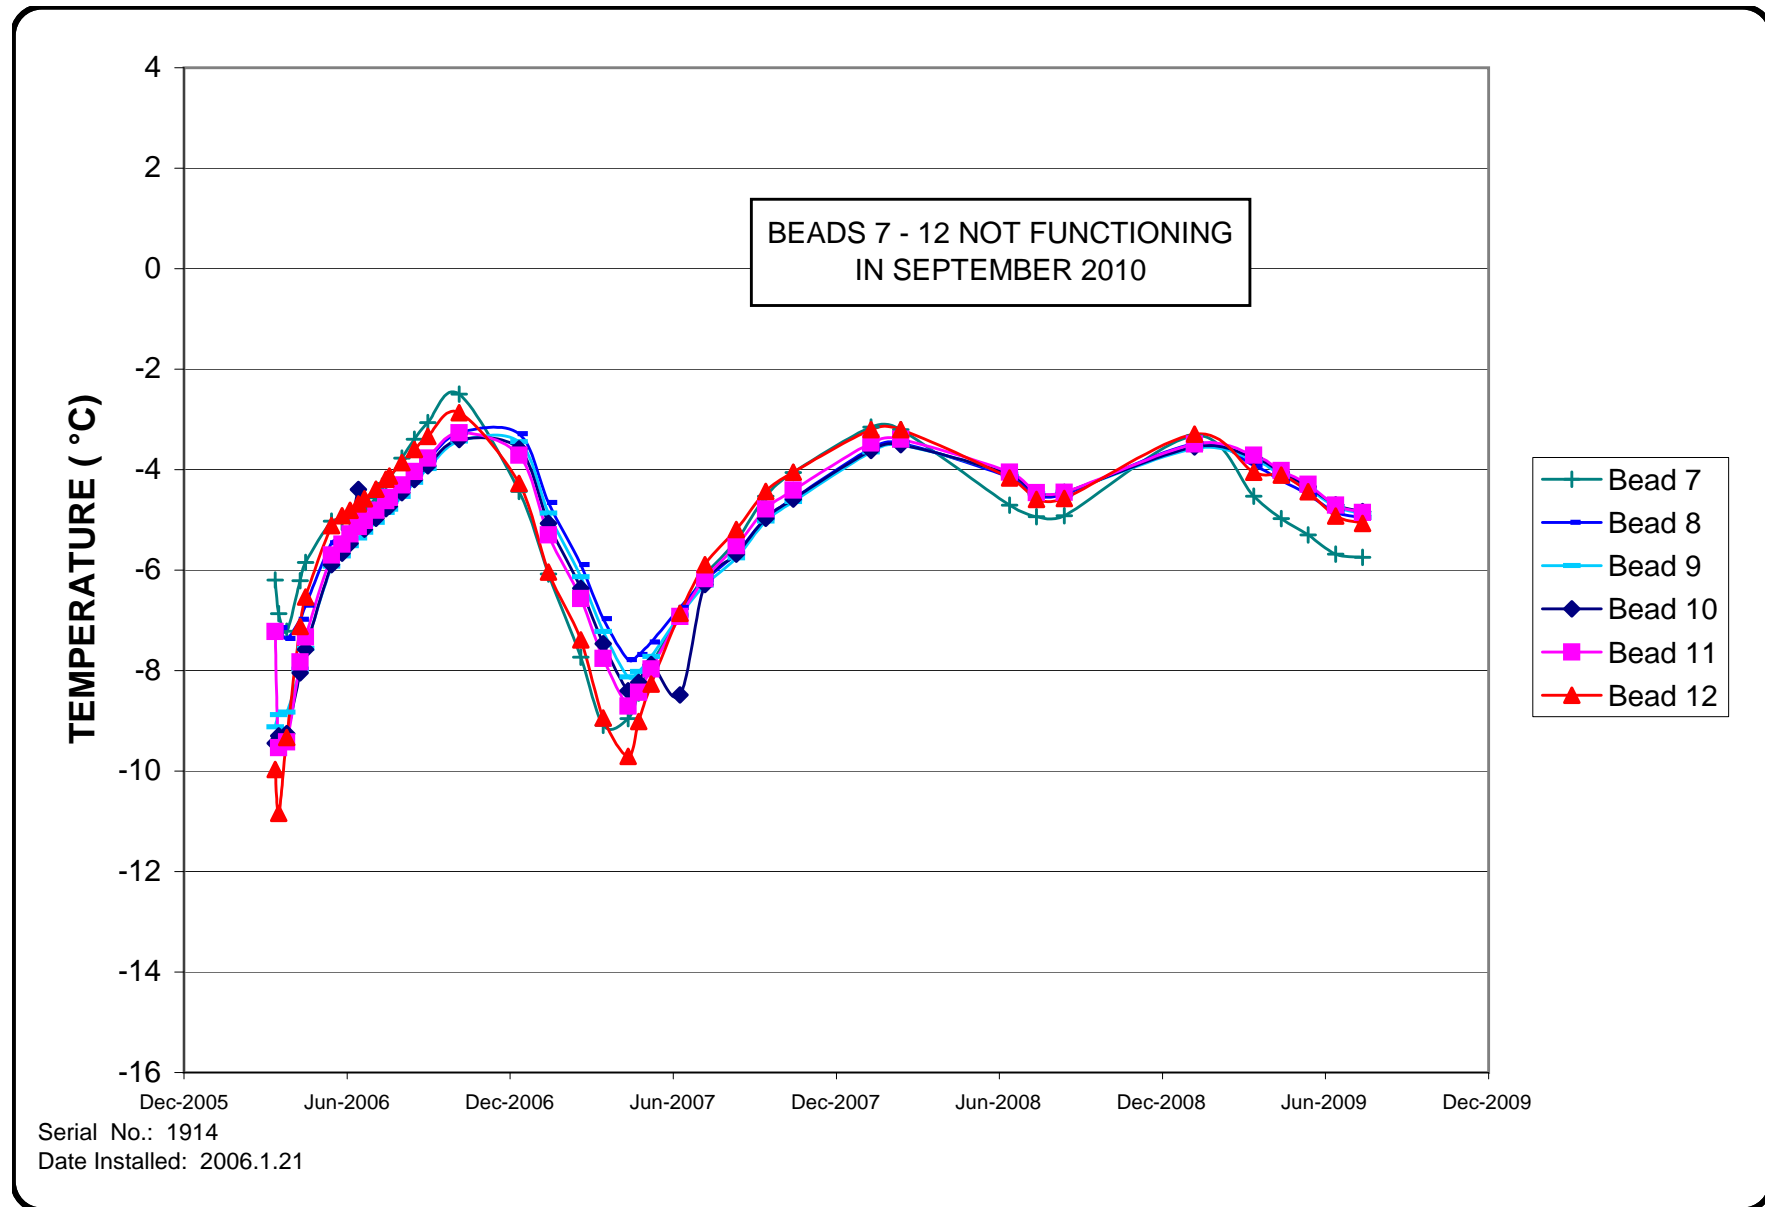
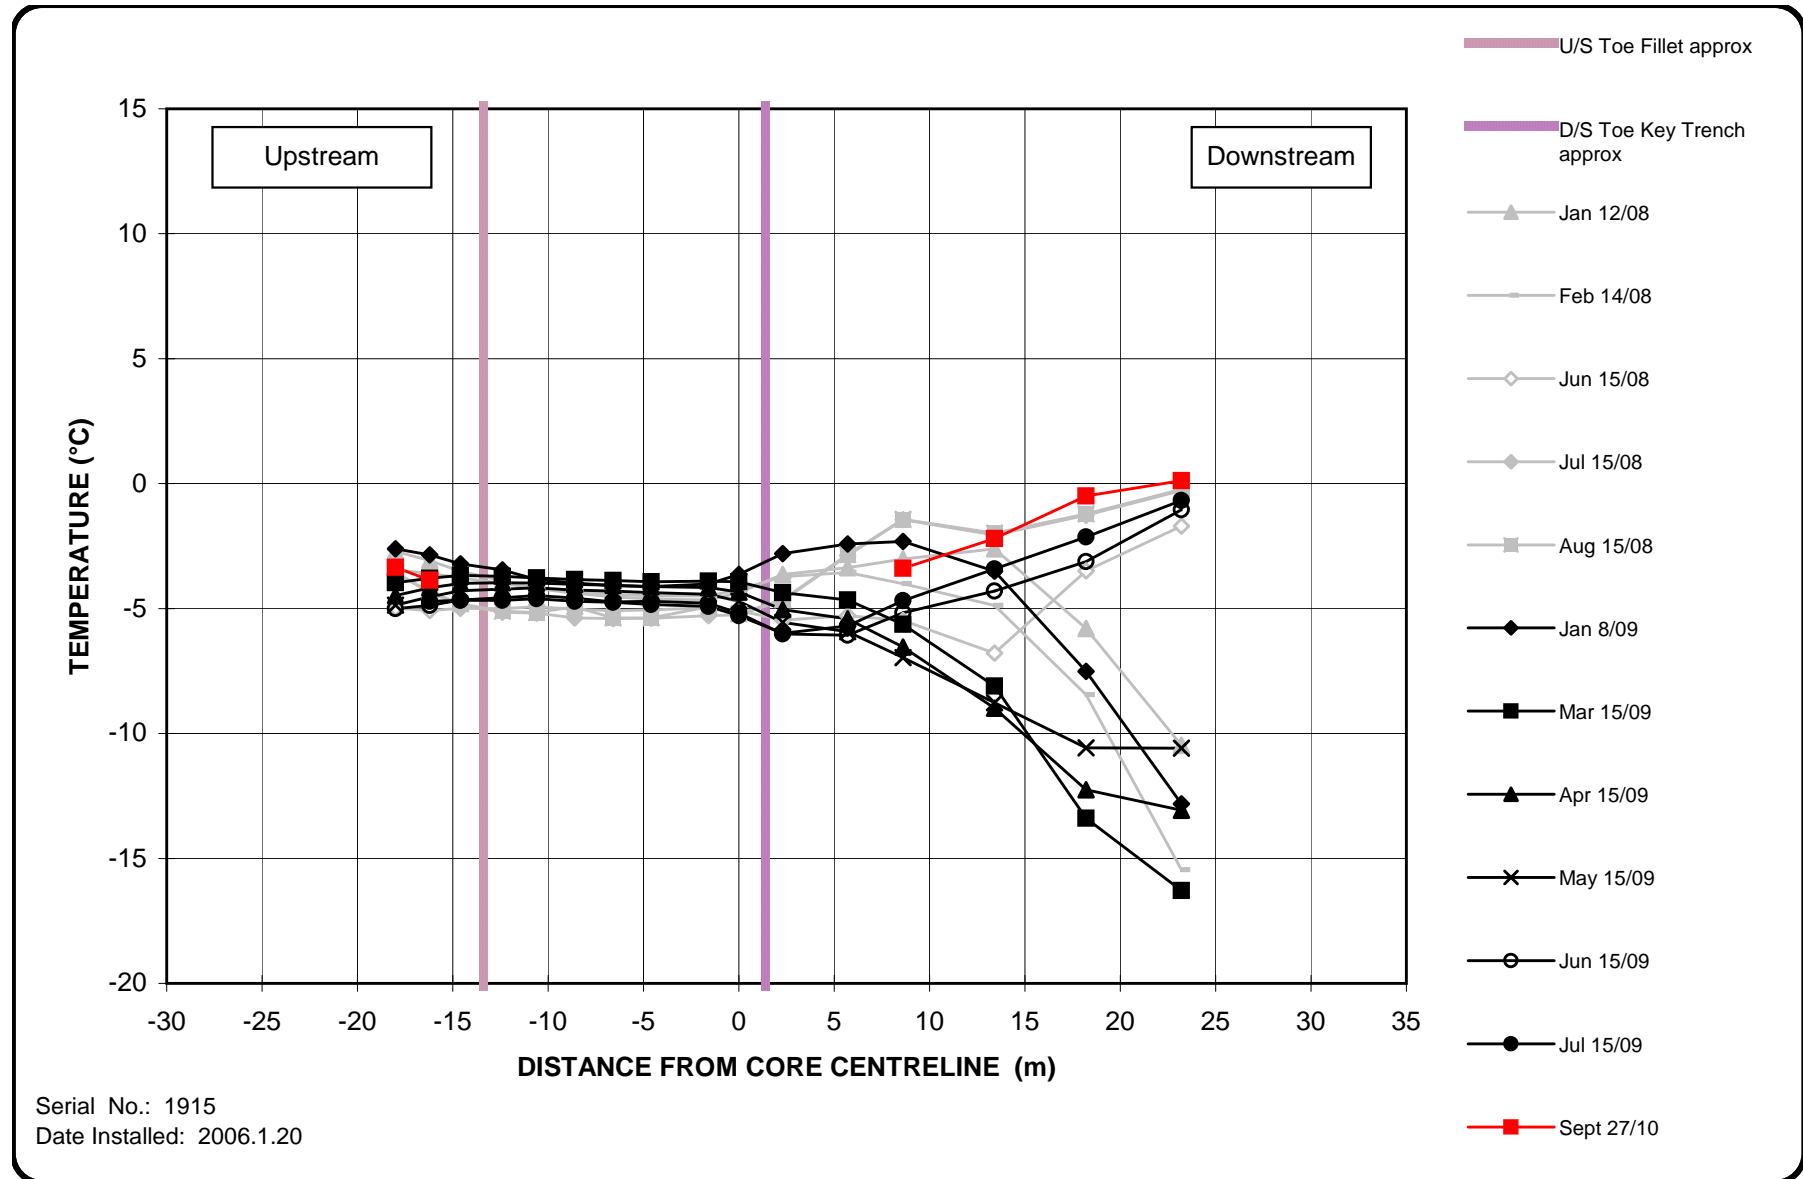
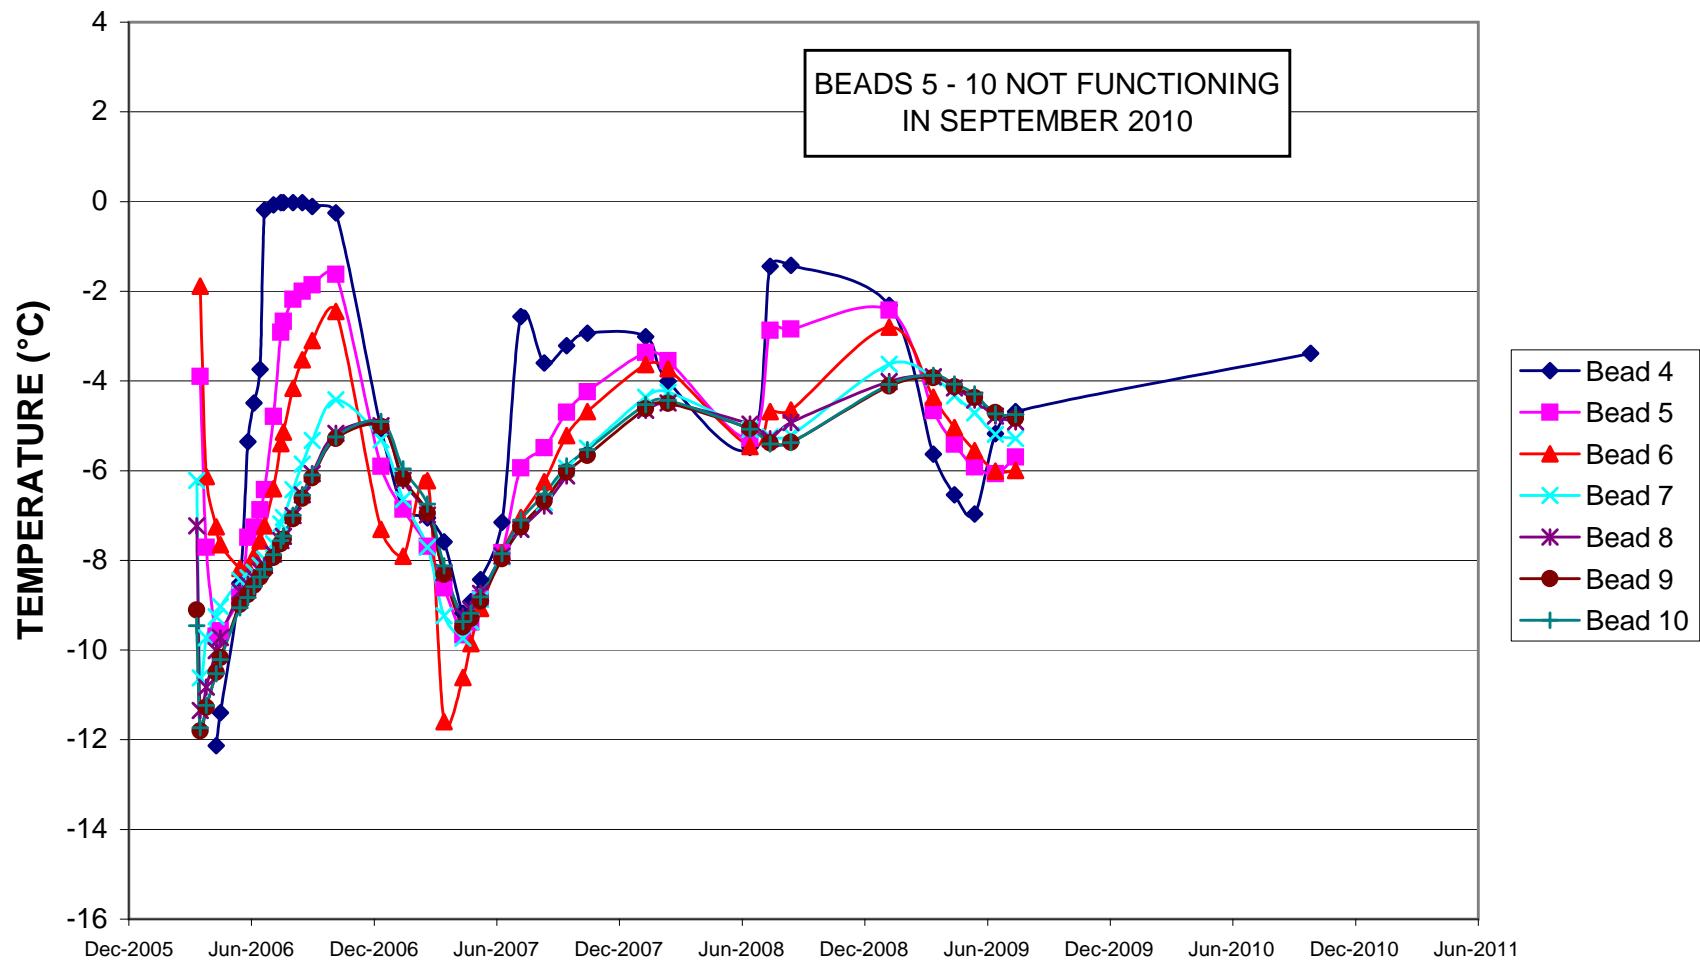
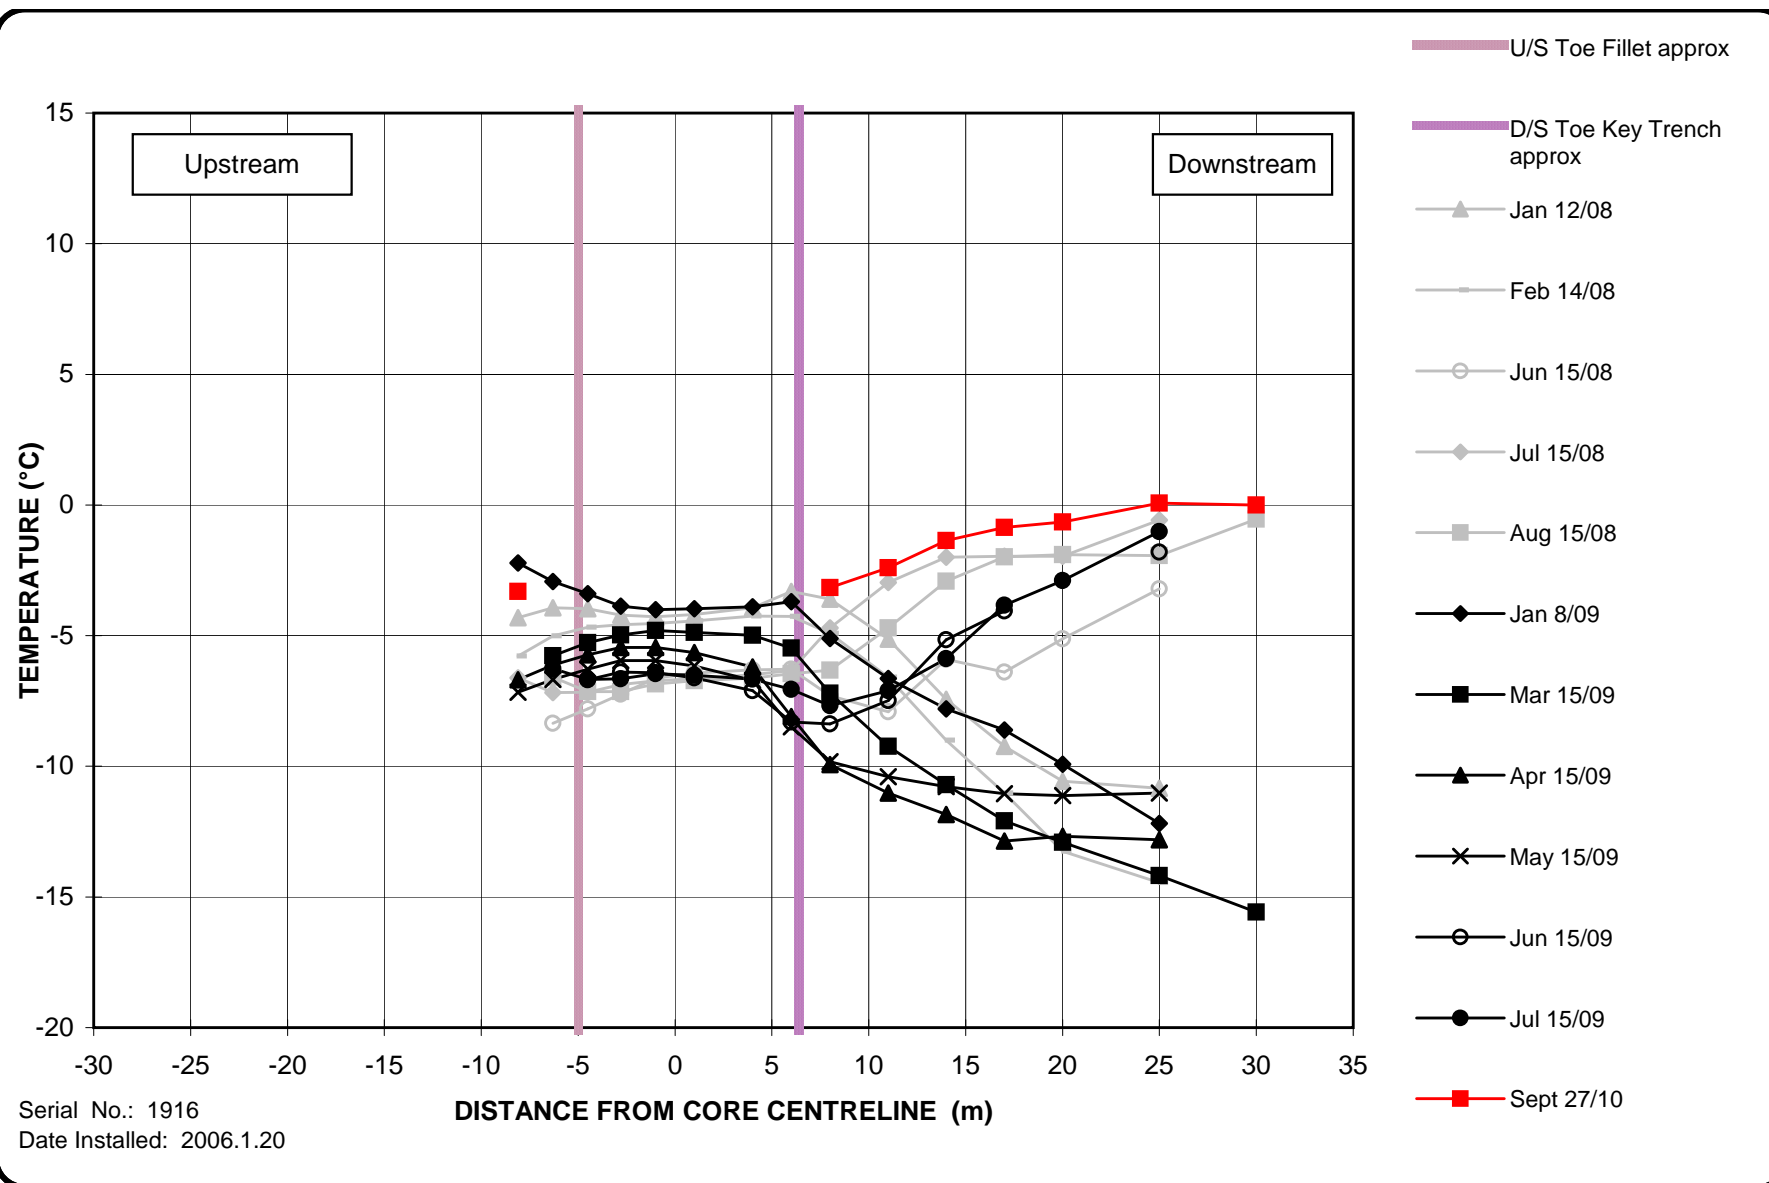
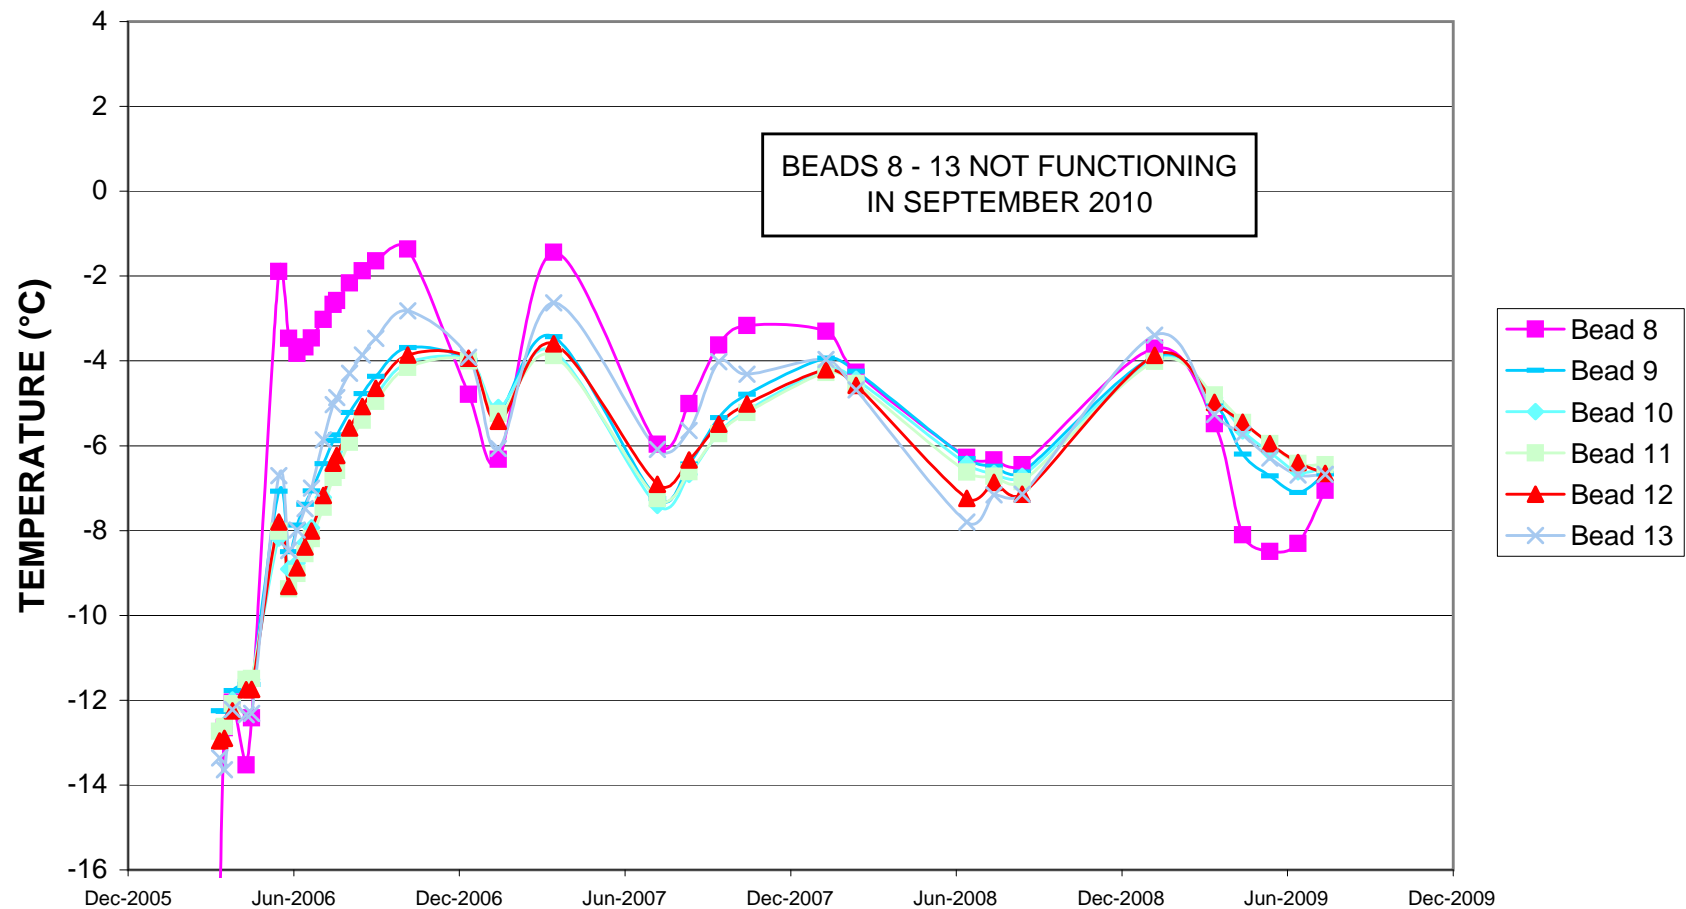
Horizontal ground temperature cables have been installed through the dam core and downstream shell at base of the key trench, at original ground elevation, and at elevation 522 m. Plots of the ground temperature are presented in Appendix A. Temperature readings indicate that the base of the key trench is, in general, consistent with expectations. Several null readings were present however, as were warmer temperatures indicated by some beads. EBA believes that these deviations may be caused by malfunctioning cables or, more likely, by the equipment used to take the readings. EBA recommends that the cables be re-read as soon as possible in the spring of 2011.

Dam Core Frozen – Ground temperature measurements in attached Figures A-2 to A-17. Temperature readings indicate that the base of the key trench is, in general, consistent with expectations. However, several null readings were present as was some unanticipated deviation measured from some beads. EBA believes that the deviations may be caused by malfunctioning cables or, more likely, by the equipment used to take the readings. EBA recommends that the cables be re-read as soon as possible in the Spring.

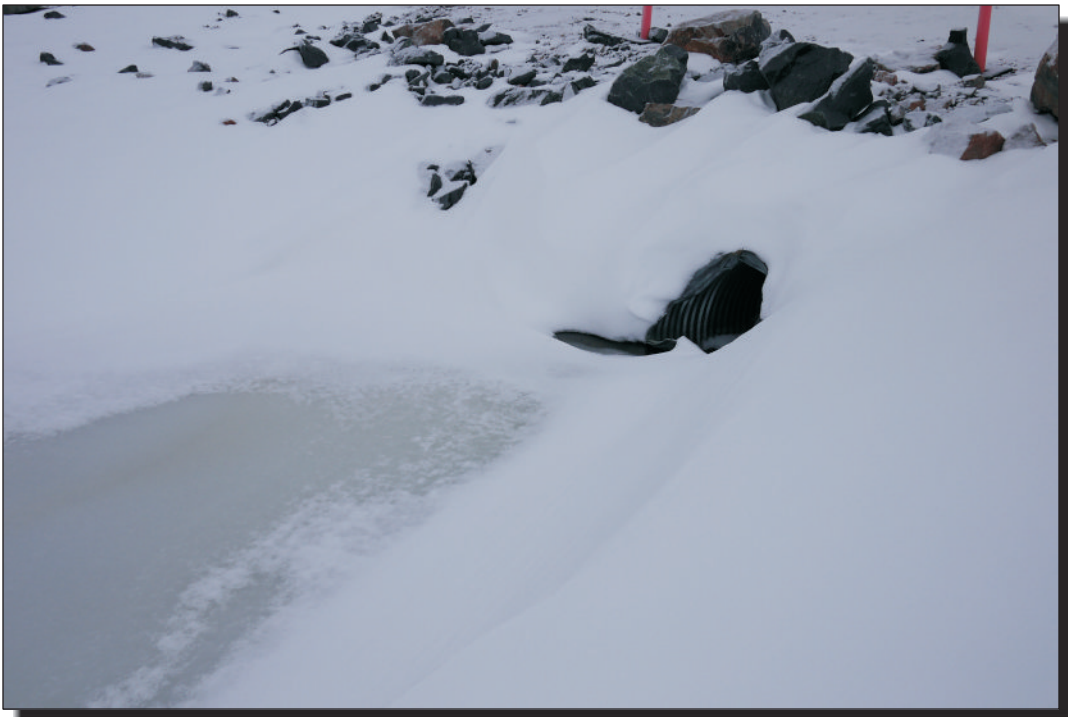
Features	Present	Dimensions	Extent	Description	Photographic Records
Erosion	None noted				
Cracking	None noted	0.1 m wide by 6 m+ long	Localized	Cracking on Reach C till berm	E-7
Settlement	None noted				
Seepage	None noted				
Other Features	C1-4 – Bent culvert inlet and outlet			As noted in the 2009 inspection, the Reach B culvert has been bent.	E-4

**Photo E-4**  
Culvert in Reach B

C1 Diversion structure performance is satisfactory. Minor repairs to culvert inlet and outlet may be required to sustain flow during high flow.

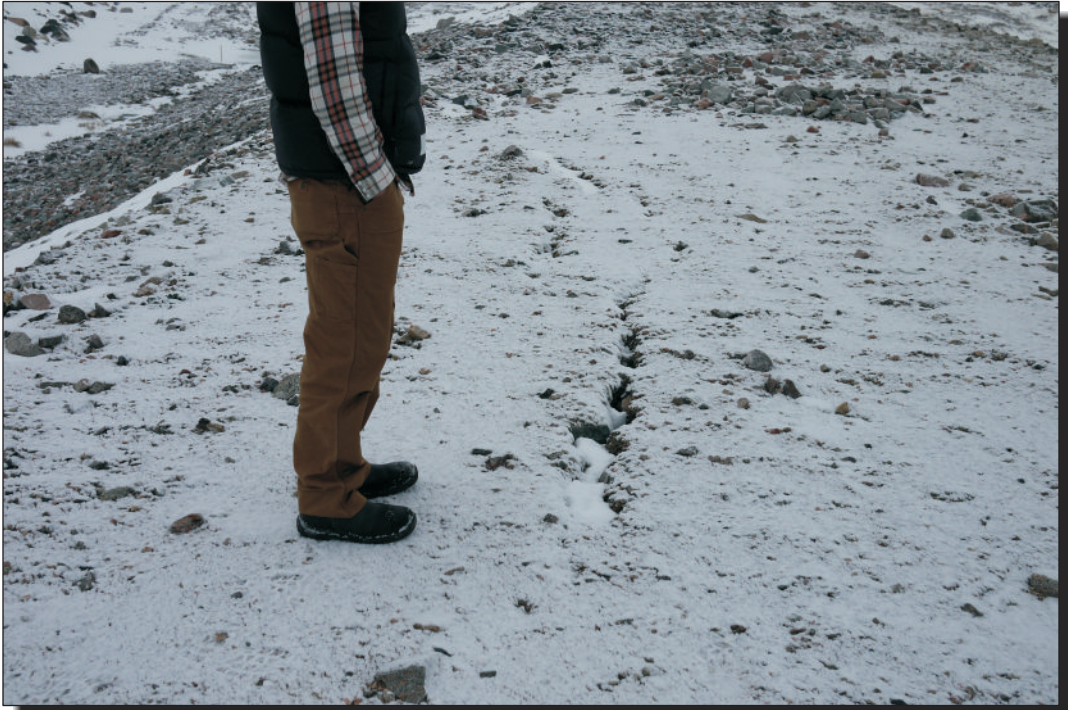
**Photo E-7**  
Cracking noted in Reach C berm

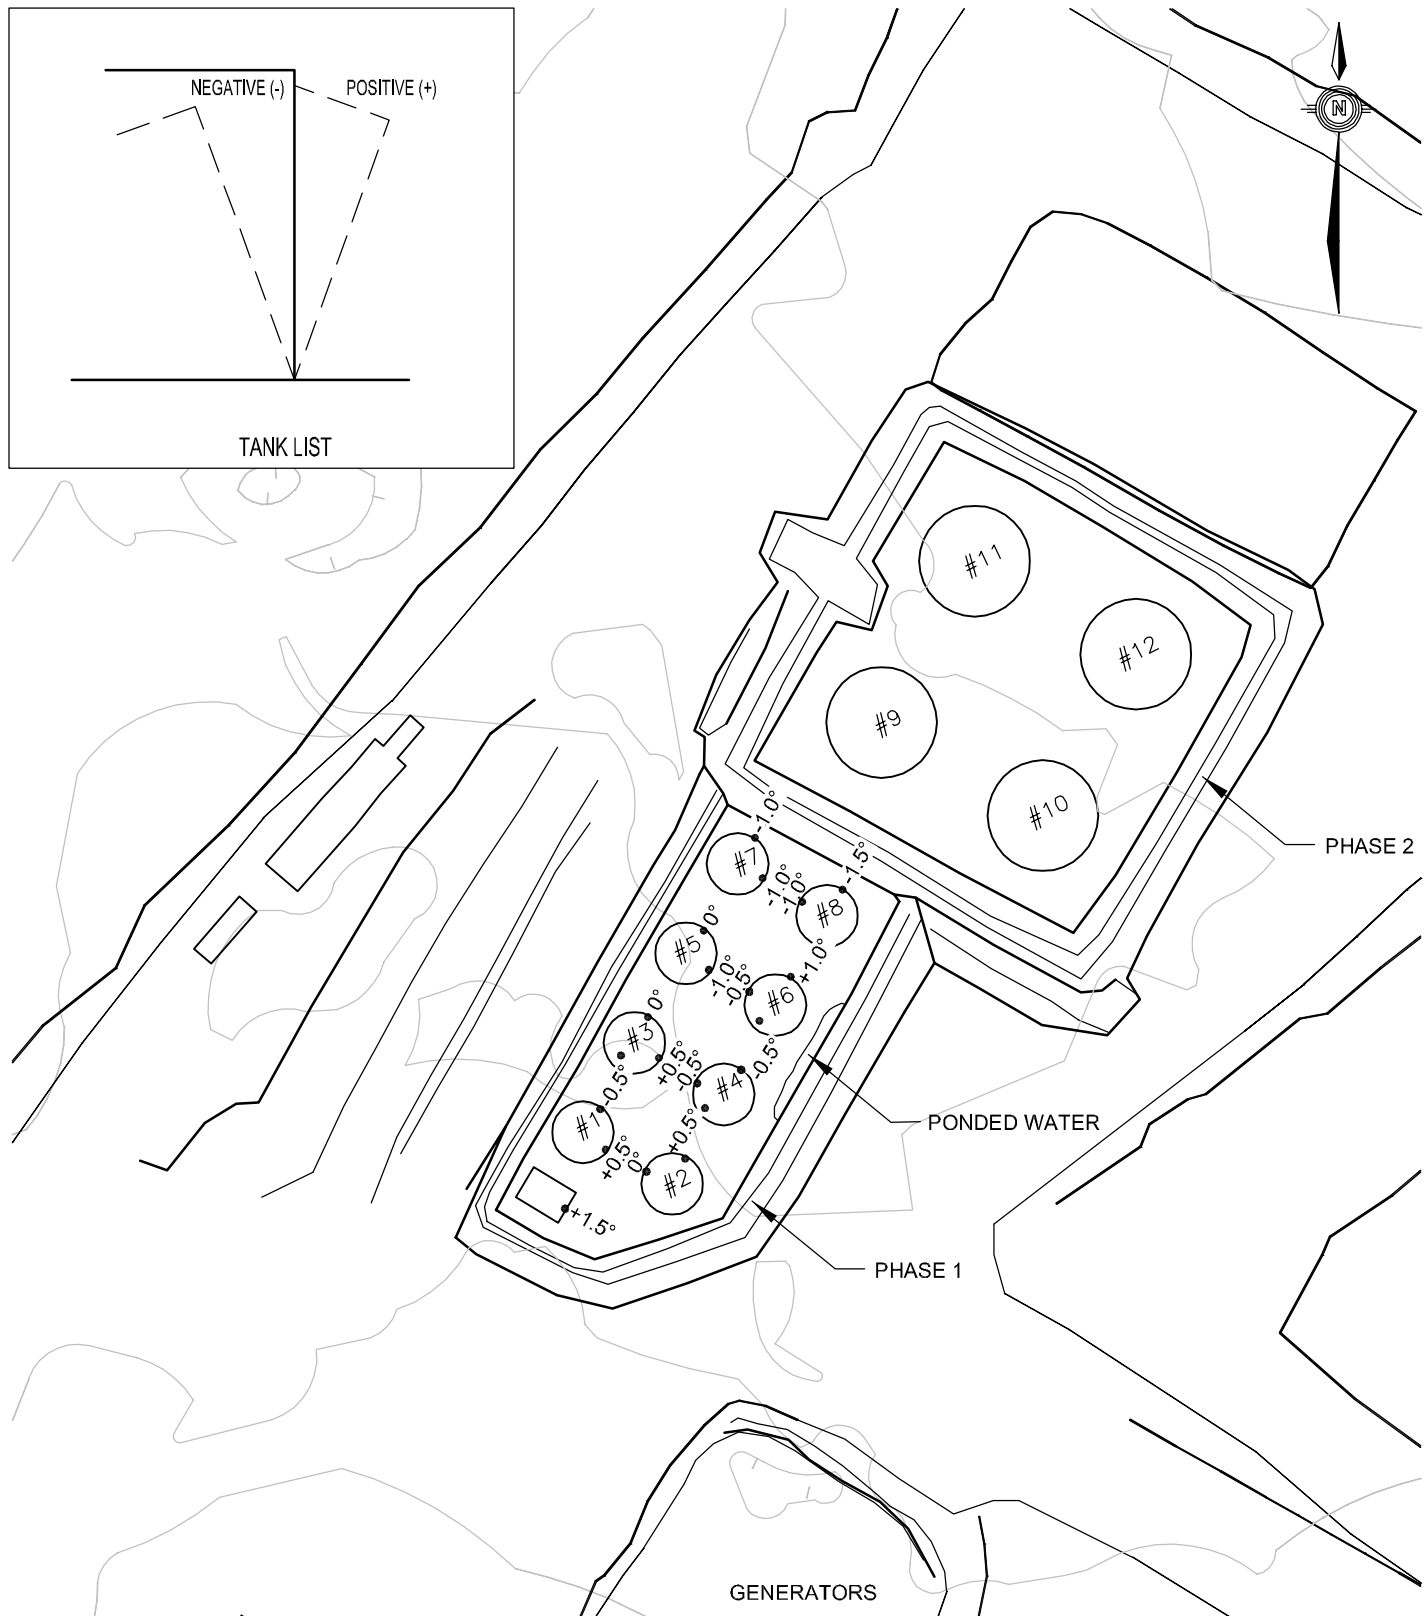
**Figure F-1**

During the inspection, EBA used a magnetic protractor (see photo F-3) to measure the approximate list of the tanks in the Phase 1 tankfarm. Two measurements, ninety degrees apart were taken on each tank. The range of listing observed during the inspection was from 0° to 1.5° in a single direction. It should be noted that the measurements taken are for reference only and must not be used in place of a proper survey of the tanks. The list angles and locations of the measurements are presented in Figure F-1.

The deficiencies noted in the Tank Farm are similar to the previous inspection indicating that settlement has slowed or stopped at present. List angles of the tanks were measured by EBA but a survey of the tanks should be performed when possible.

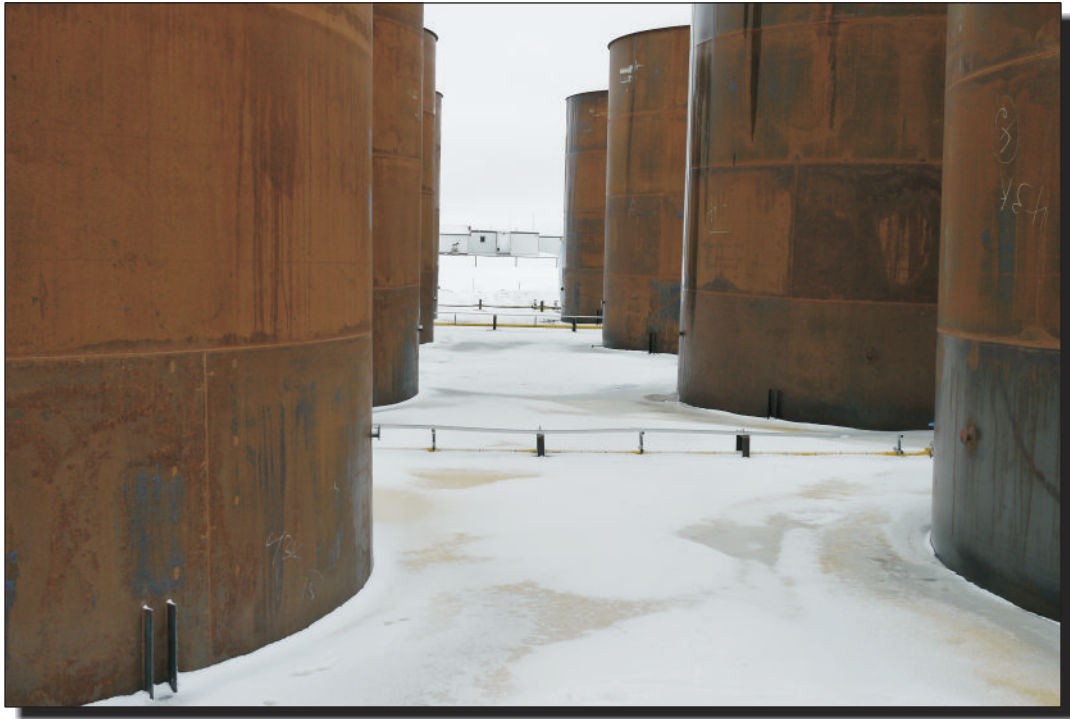
Ponded water, snow and ice was observed throughout the Phase 1 tankfarm during the inspection. Stained soil and a slight sheen on the ponded water were also observed in several places around the Phase 1 area. The staining and sheen do not appear to be recent rather EBA has noted the same conditions within the tank farm berms over the past several years.

Seepage	None noted				
Other Features	Stained Soil	Numerous large stain areas	Sporadic, most at valve locations	Hydrocarbon stained soil on inside surface of tankfarm base	
	Ponded/Frozen Water		Sporadic	Sections throughout Phase 1	F-1, F-2

**Photo F-1**  
Area between the tanks in Phase 1 of the tank farm (Aspect: S)

As stated in previous inspection reports, EBA recommends that the tank manufacturer be retained to evaluate the integrity of the Phase 1 tanks before they are put back in service. That being said, the tankfarm appears to be performing adequately given the low volume of fuel stored on site at this time. The inspection report and photos for the structure are presented in Appendix F

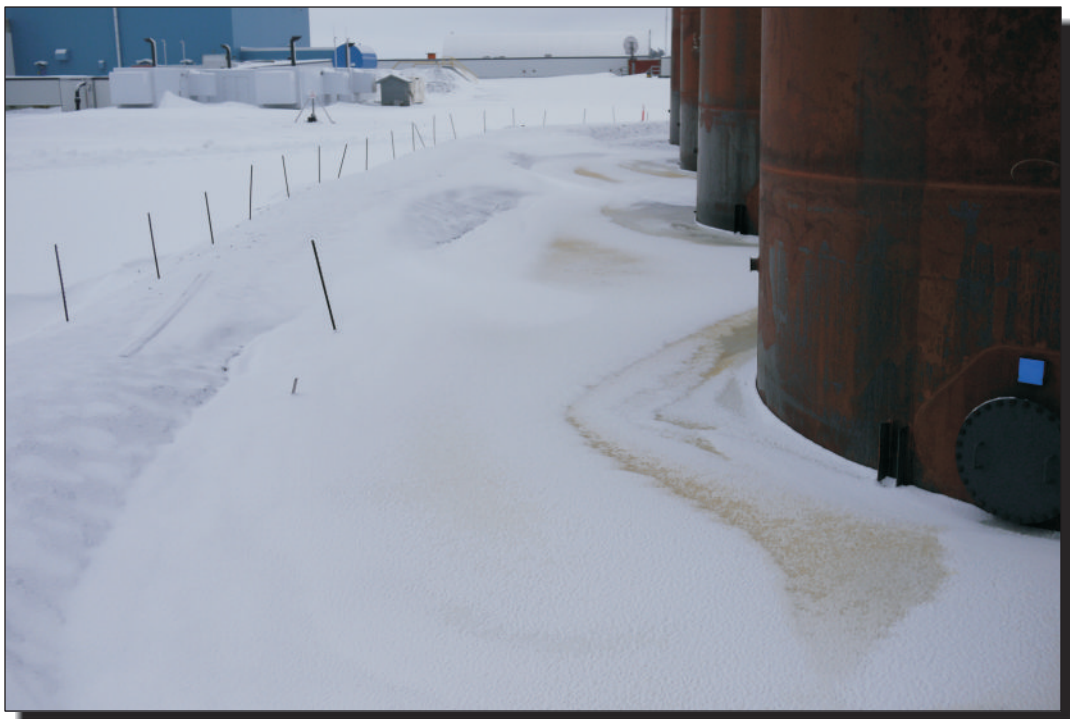
**Photo F-2**  
General condition of the east bern of Phase 1 at the tank farm (Aspect: S)

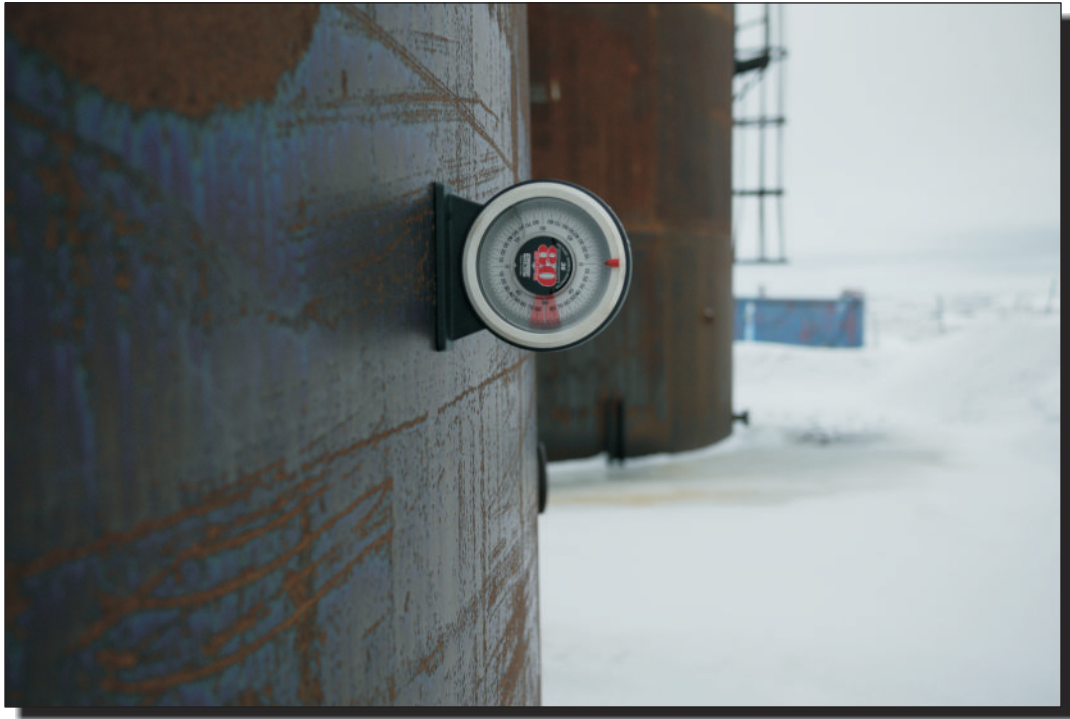
**Photo F-3**

Magnetic protractor used to measure the list of the tanks in Phase 1 tank farm

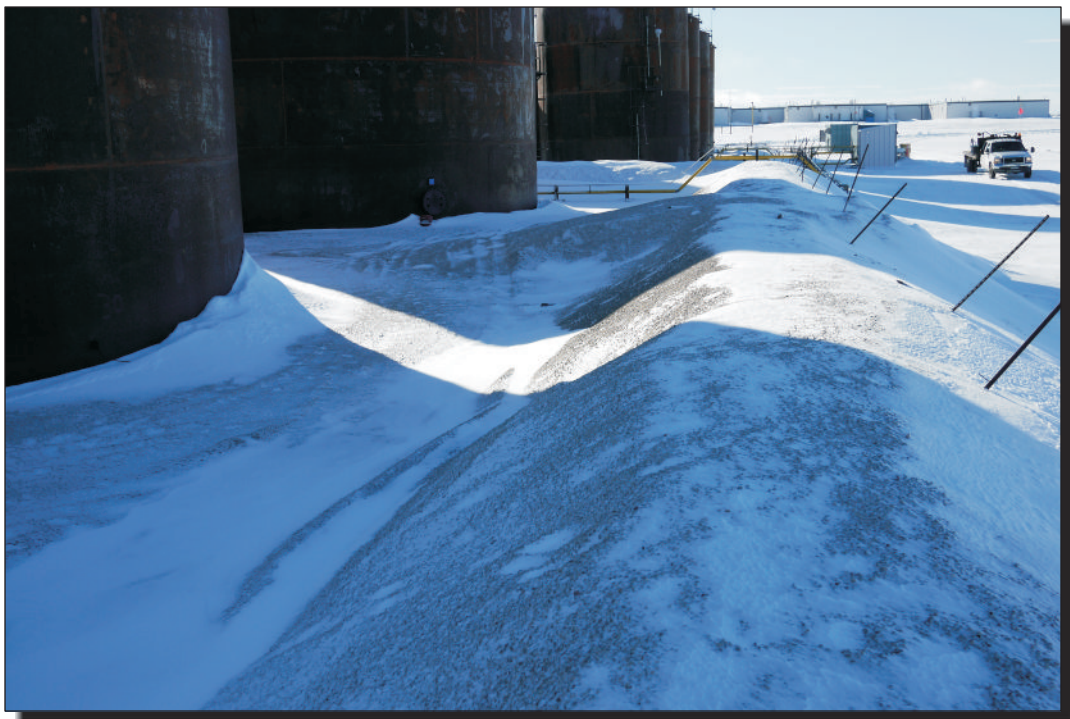
OBSERVED CONDITION:					
Features:	Present	Dimensions	Extent	Description	Photographic Records
Erosion	None noted				
Cracking	None noted				
Settlement	Settlement within Phase 1 Tankfarm	Uneven surface throughout tank farm Gaps up to 50 mm high under several of the tanks. Tanks in Phase 1 tilting. Previous monitoring indicated settlement during the first year, settlement appeared to slow down. Has not been monitored recently. Presently no fuel in Phase 1. Berm settlement along east berm.	Throughout the tankfarm and berm.	Settlement apparent under tanks. New flexible pipe connections were installed in 2007 to accommodate the settlement. Settlement in east berm appears to be greater than 0.3 m.	
Settlement	Settlement with Phase 2 Tankfarm	Gap under edge of Tank 9 - up to 35 mm.	Only noted on Tank 9	Settlement has resulted in gap under edge of the tank. Edges tanks partially obscured by snow and ice.	F-4

West berm of Phase 2 tank farm (Aspect: S); North berm of Phase 2 tank farm (Aspect: W)

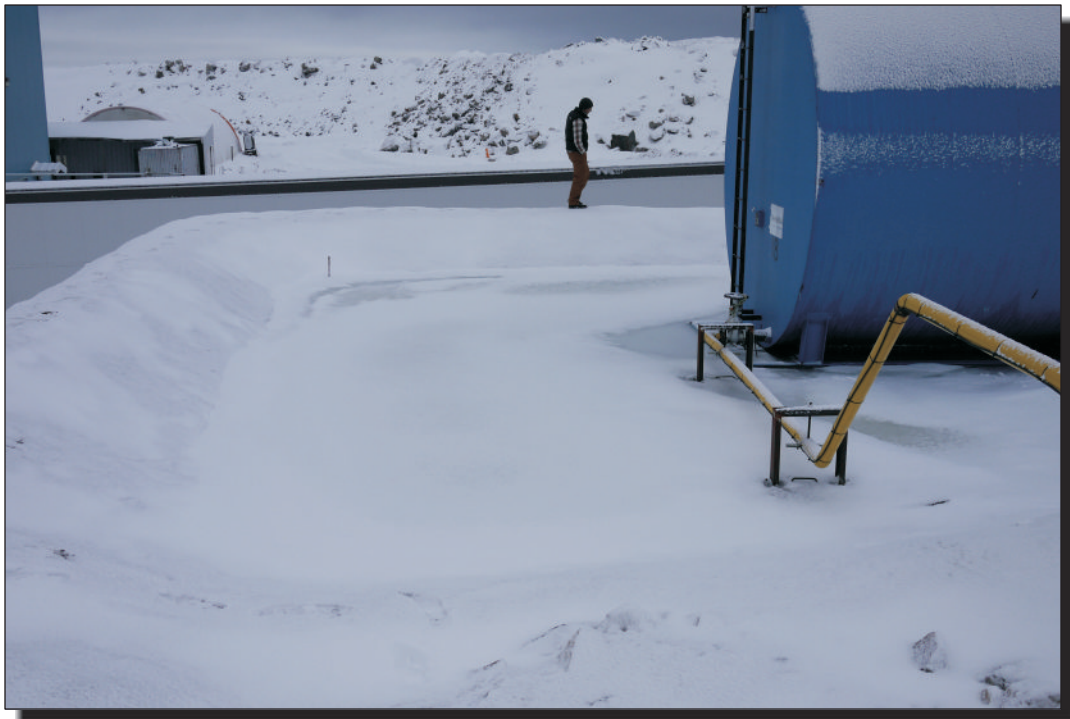
Features:	Present	Dimensions	Extent	Description	Photographic Records
Erosion	None noted				
Cracking	None noted				
Settlement	None noted				
Seepage	None noted				
Other Features	Low area in 20 mm crush on West berm	Berm is approximately 0.4 m low along the north berm	5% of berm	Low area in berm (as noted in 2009)	
Other Features	Ponded Water	Some ice present in the base of the berm. Obscured by snow cover.	100% of berm base		G-2, G-3

**Photo G-2**  
Generator Tank containment crest and base (Aspect: SE)

Low spot in the 20 mm crush berm – berm supported by 150 mm crush berm. Record drawings should be reviewed to determine where the liner is located to determine if there is a low area in the liner along the north berm. If so, the containment capacity should be reviewed to determine if berm modifications are required.

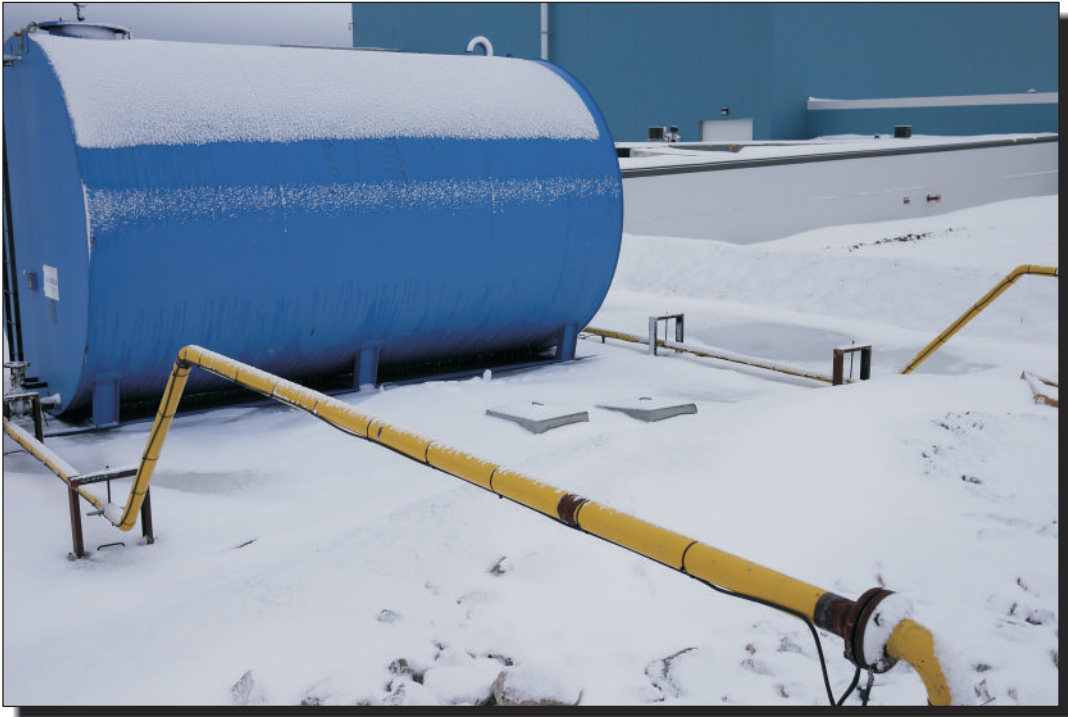
**Photo G-3**  
Generator Tank containment crest and base (Aspect: E)

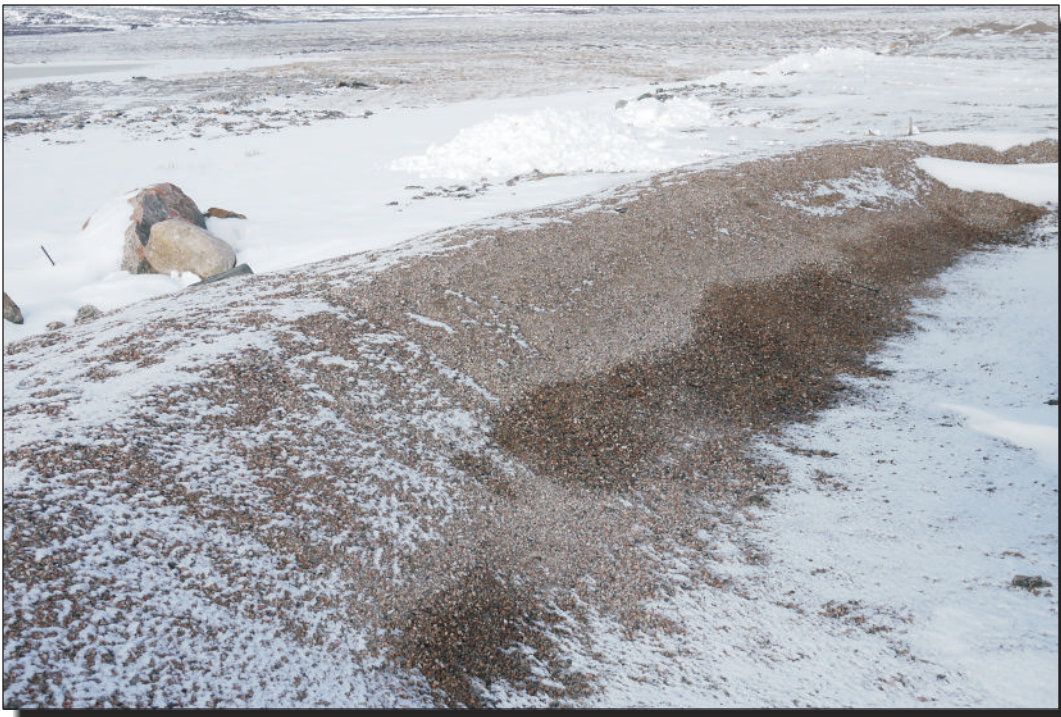
It is understood that a fuel spill occurred within the tankfarm area in the winter of 2006/2007. Stained soil is present inside the base of the tank farm containment area. The current inspection deals only with the geotechnical issues of the tankfarm and does not address the fuel spill.

Features:	Present	Dimensions	Extent	Description	Photographic Records
Erosion	None noted				
Cracking	None noted				
Settlement	None noted				
Seepage	None noted				
Other Features	Stained Soil	Base of bermed area.	Prevalent	A spill occurred in the tankfarm winter of 2007/2008. It is understood product was collected and disposed of elsewhere. Contaminated soil in tankfarm remains.	H-2

**Photo H-2**  
Soil staining in Airstrip tank containment
