2011 ANNUAL GEOTECHNICAL INSPECTION
JERICHO DIAMOND MINE, NU

PROJECT NO.
E14101140

APPENDIX J LANDFILL

APPENDIX K HAZARDOUS WASTE MATERIAL AREA

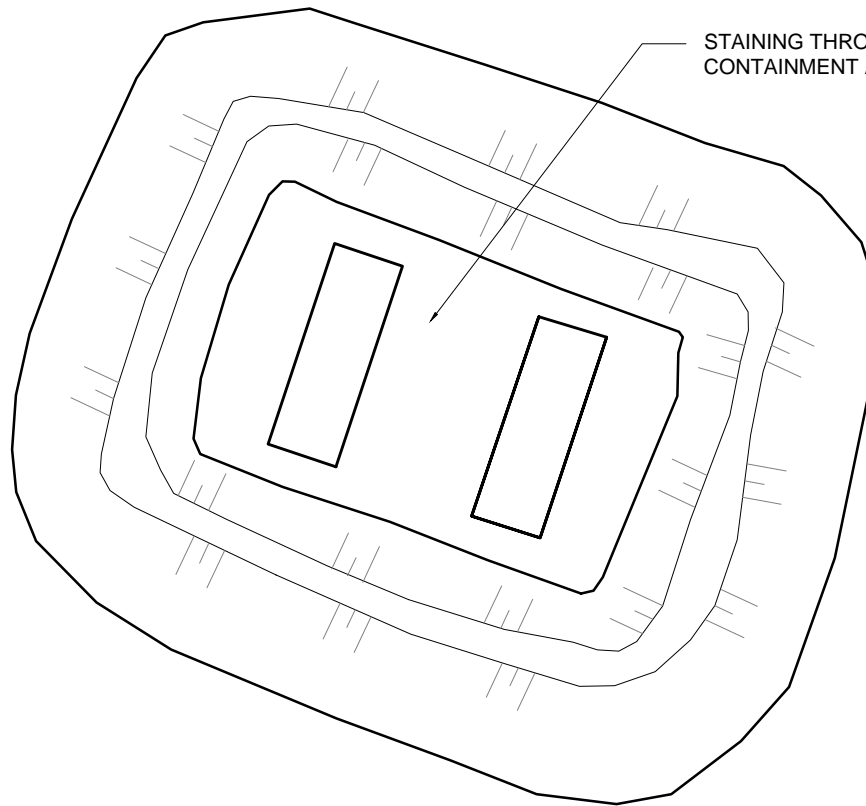
Figure I.1

STAINING THROUGHOUT
CONTAINMENT AREA

BERMS IN GOOD
CONDITION

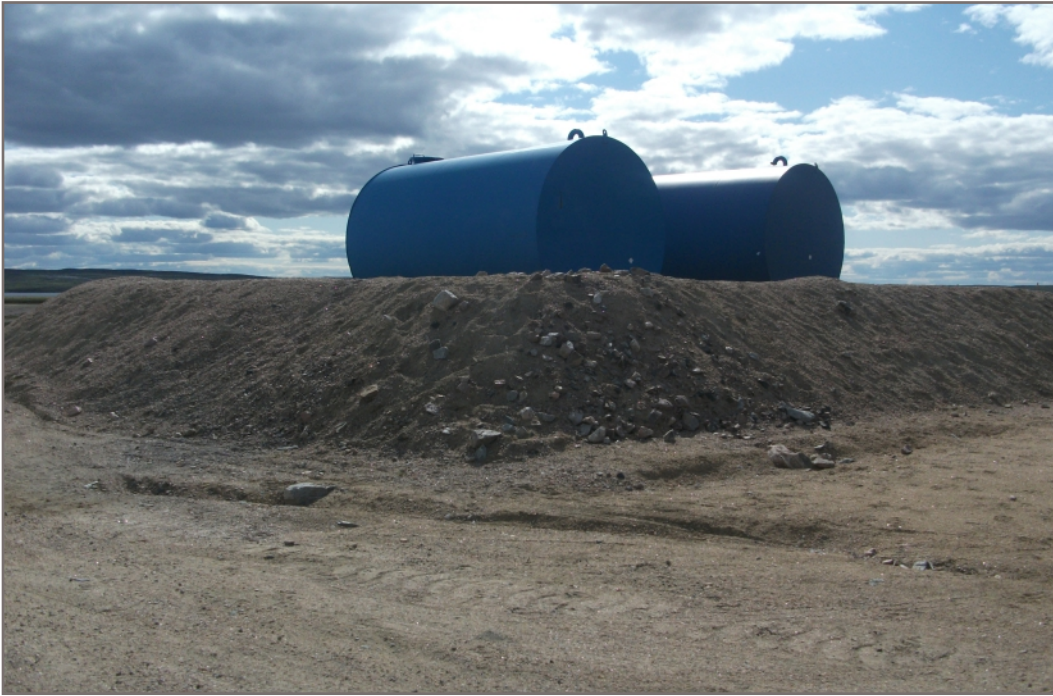
Photo I1: Airstrip tank containment area

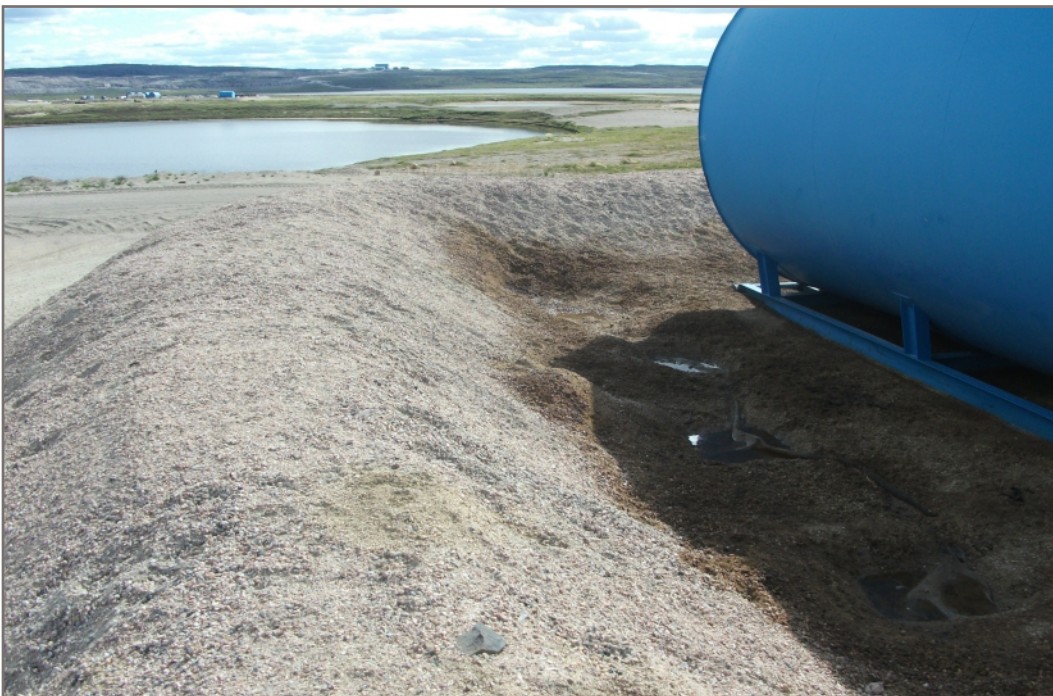
Photo I2: Staining on interior of containment area

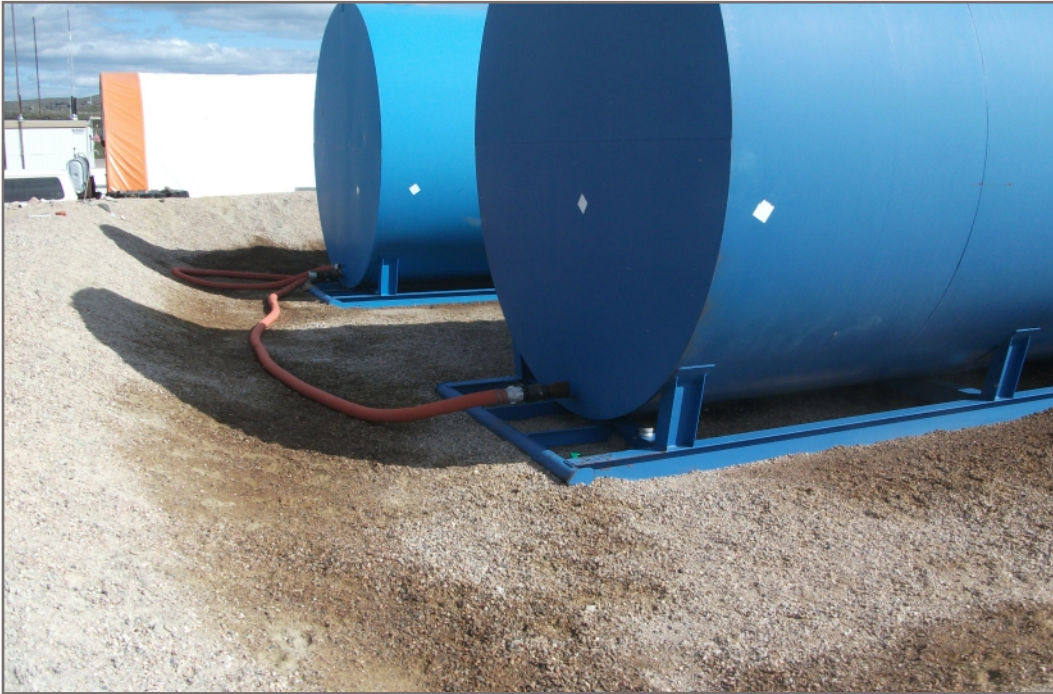
Photo I3: Staining on interior of containment area

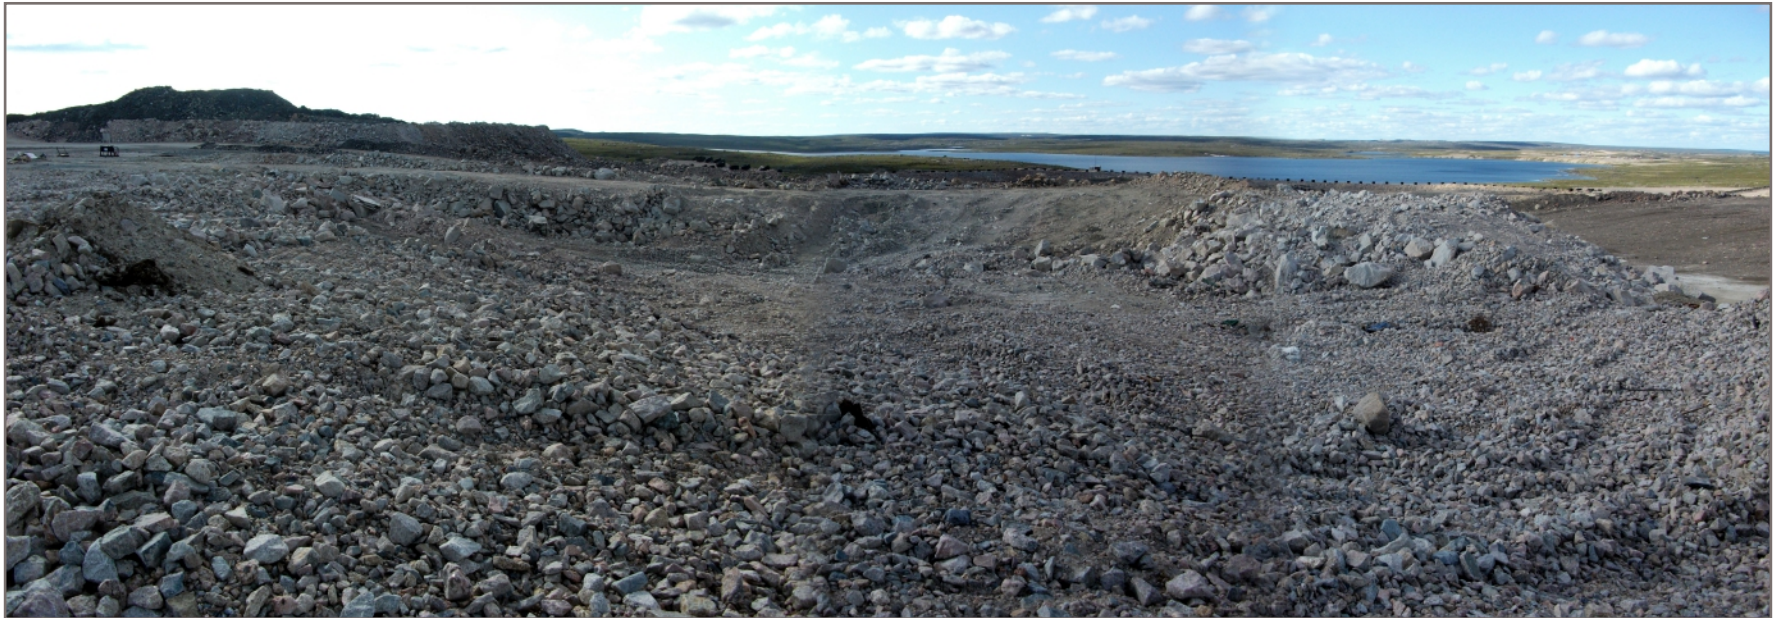
Photo J1: Landfarm area has been capped

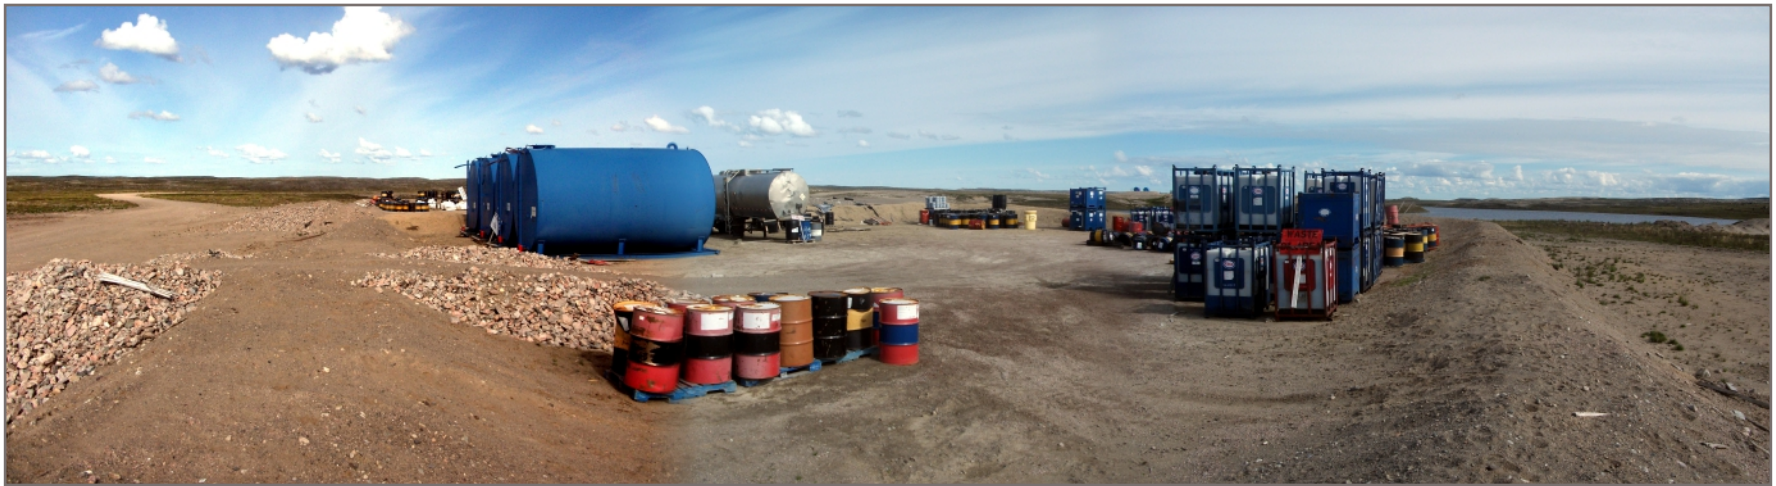
Photo K1: Hazardous waste transfer area from south corner

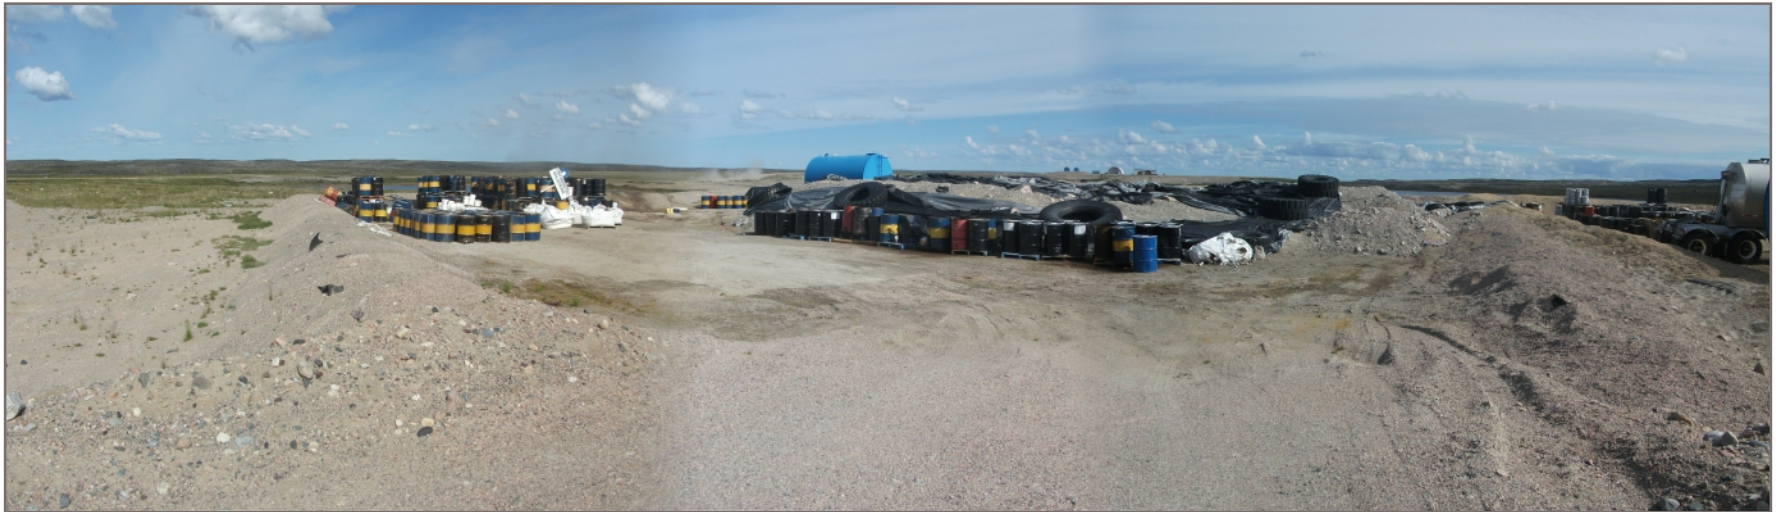
Photo K2: West cell from center berm location; note low spot in center berm in foreground of picture

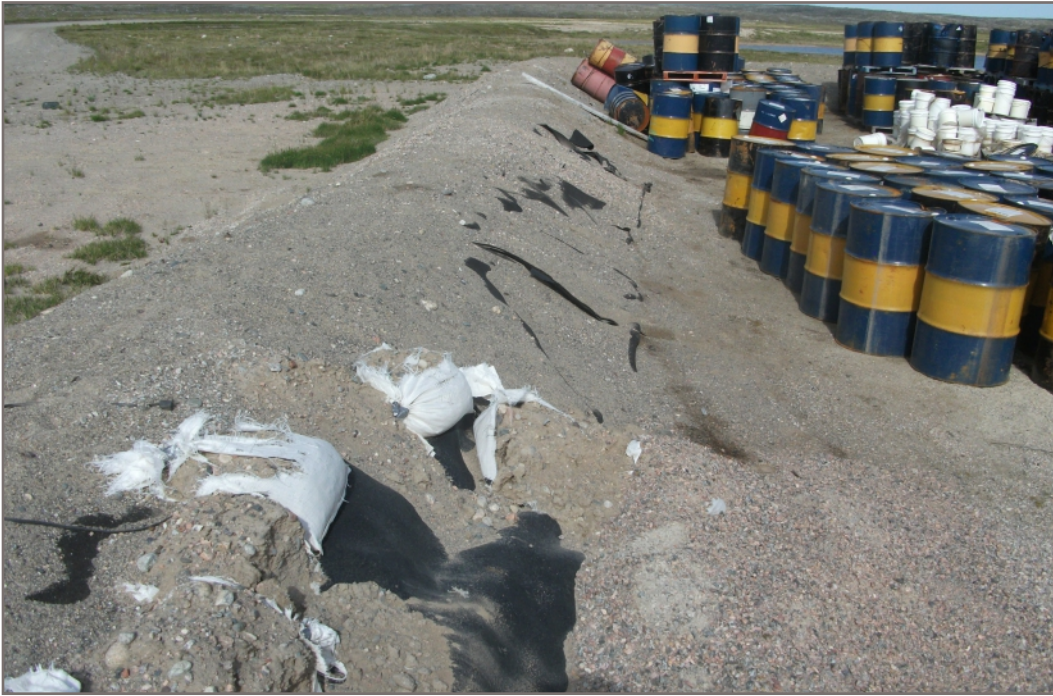
Features	Present (yes/no)	Dimensions	Extent	Description	Photographic Records
Erosion	None noted				
Cracking	None Noted				
Settlement	Center Berm		Localized	Settlement of center berm near access road	K.4
Seepage	None Noted			Shear reports water impounded in HWTa base during freethet	
Other Features	Liner Damage			Liner damage at several locations on interior berms, in both cells. Perforations noted 0.3 m above base do not provide required containment. Extent of liner damage should be evaluated and a remediation plan developed.	K.3, K.4

Photo K3: Liner damage in west cell on southwest berm

Perforations in berm do not provide required containment. Extent of liner damage should be evaluated and a remediation plan developed.
--

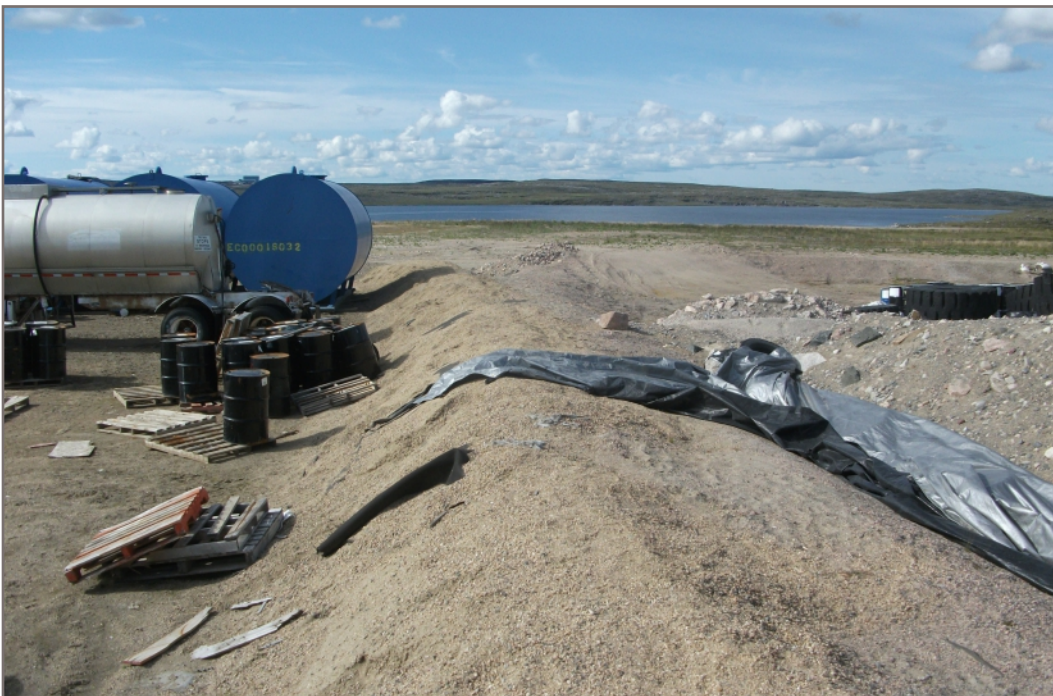
Photo K4: Exposed and damaged liner in center berm

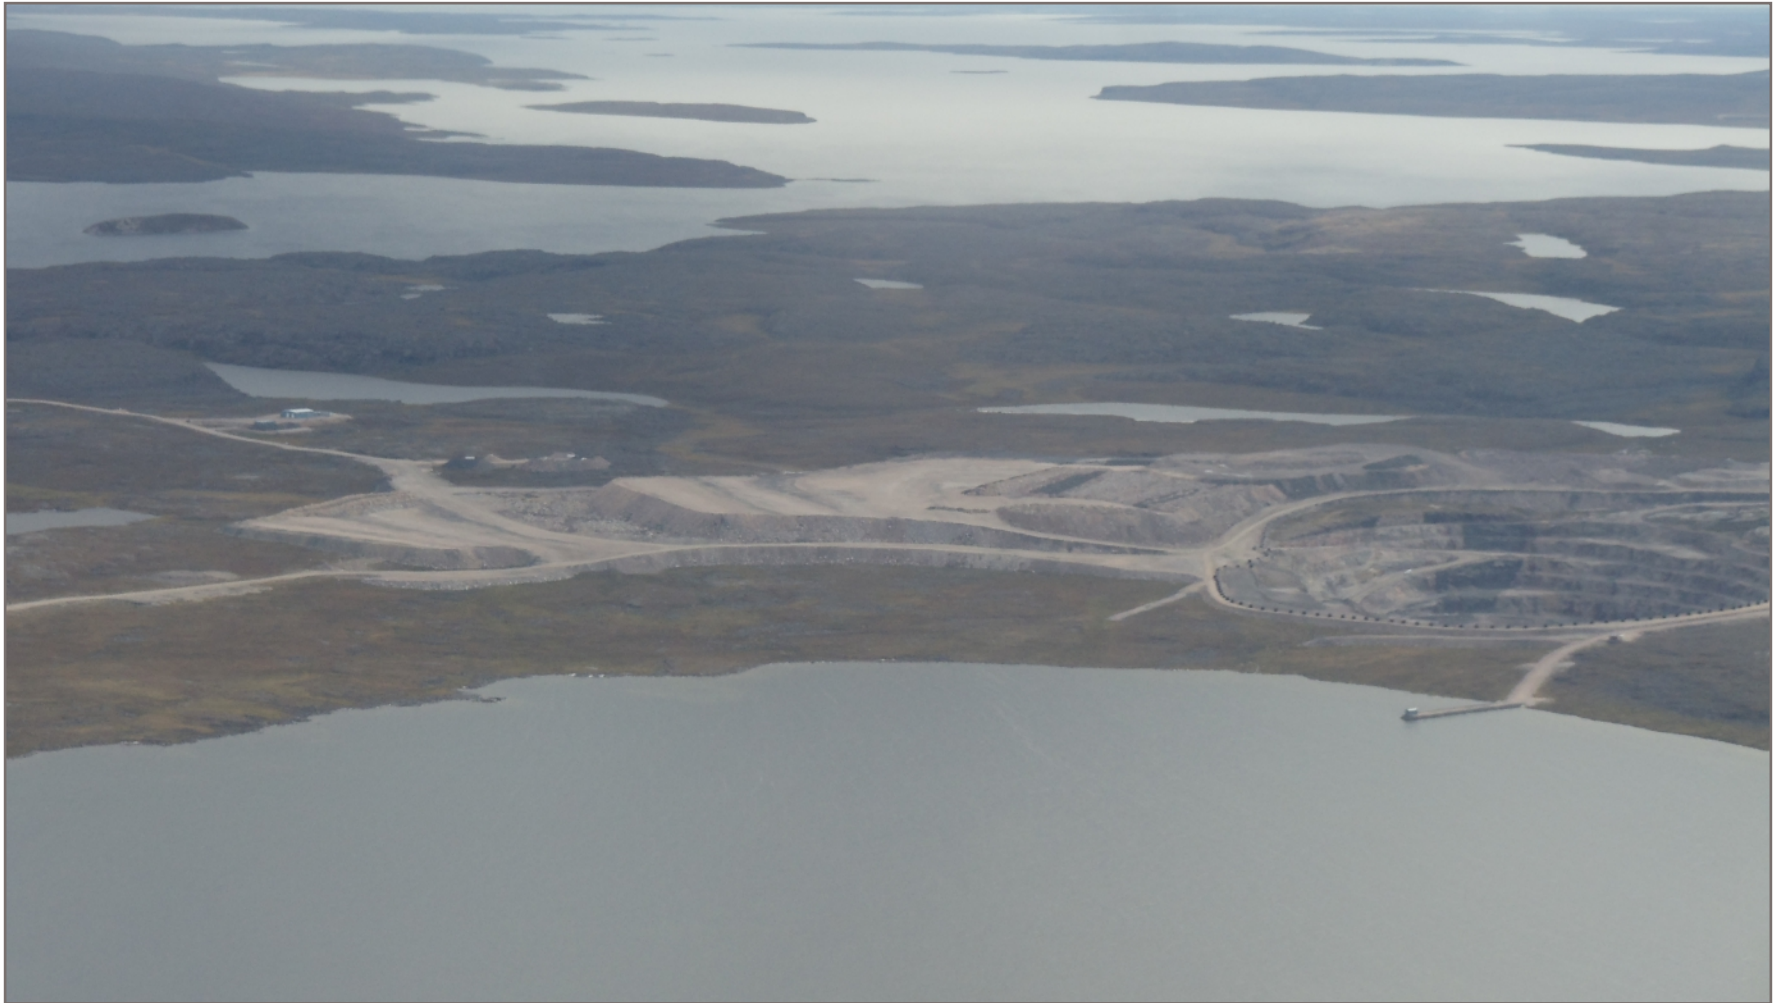
Photo L1: Waste rock dump facing southeast

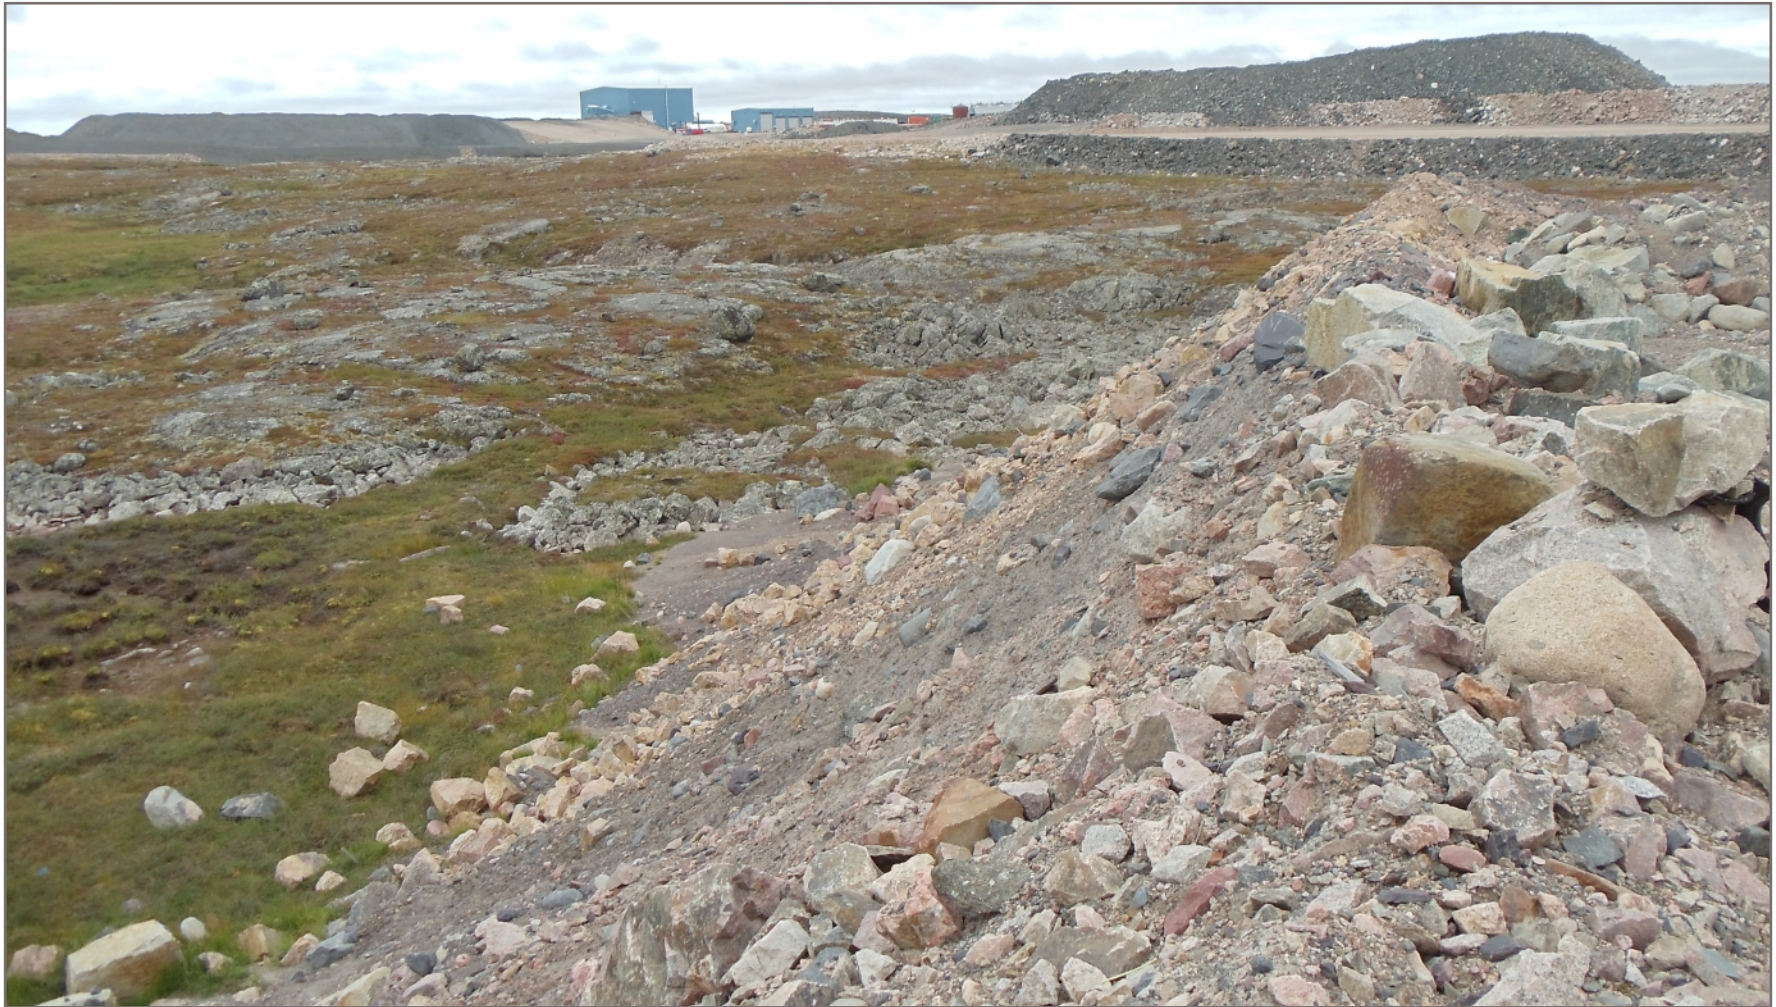
Photo L2: Till pile slope, note some sloughing of ice-rich material at toe; low grade and coarse PK stockpiles in background of photo

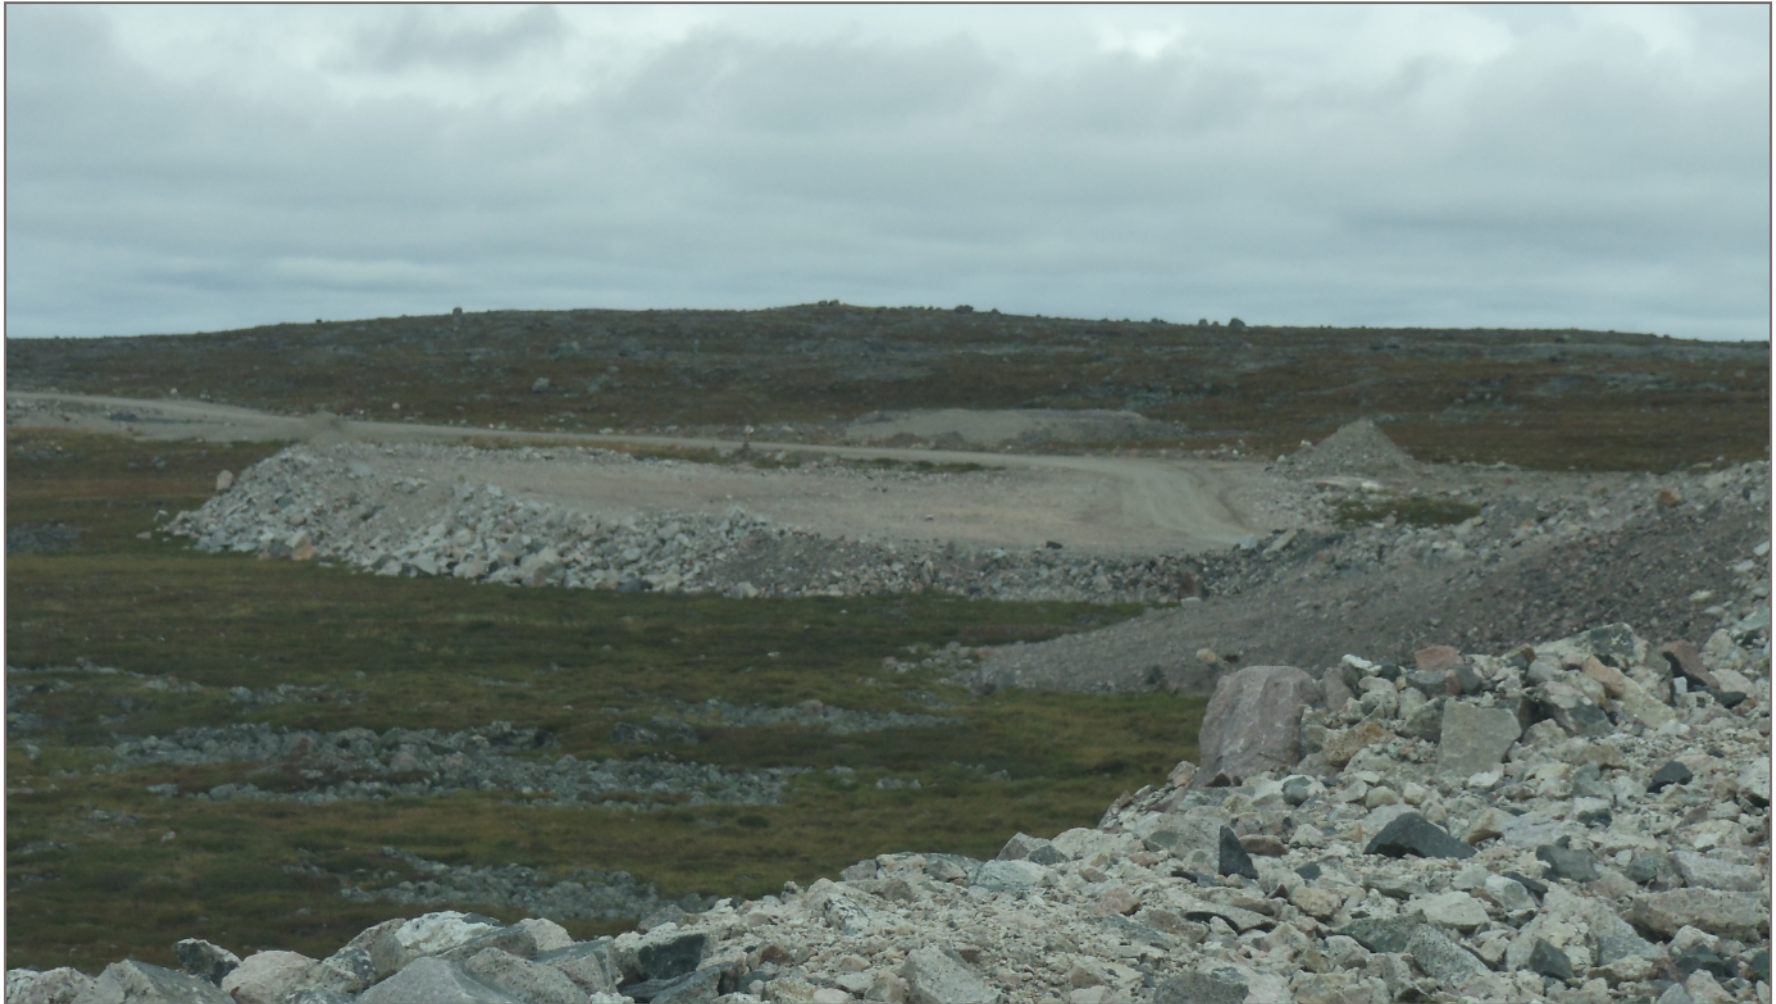
Photo L3: North portion of Waste Dump 1, no problems or issues noted

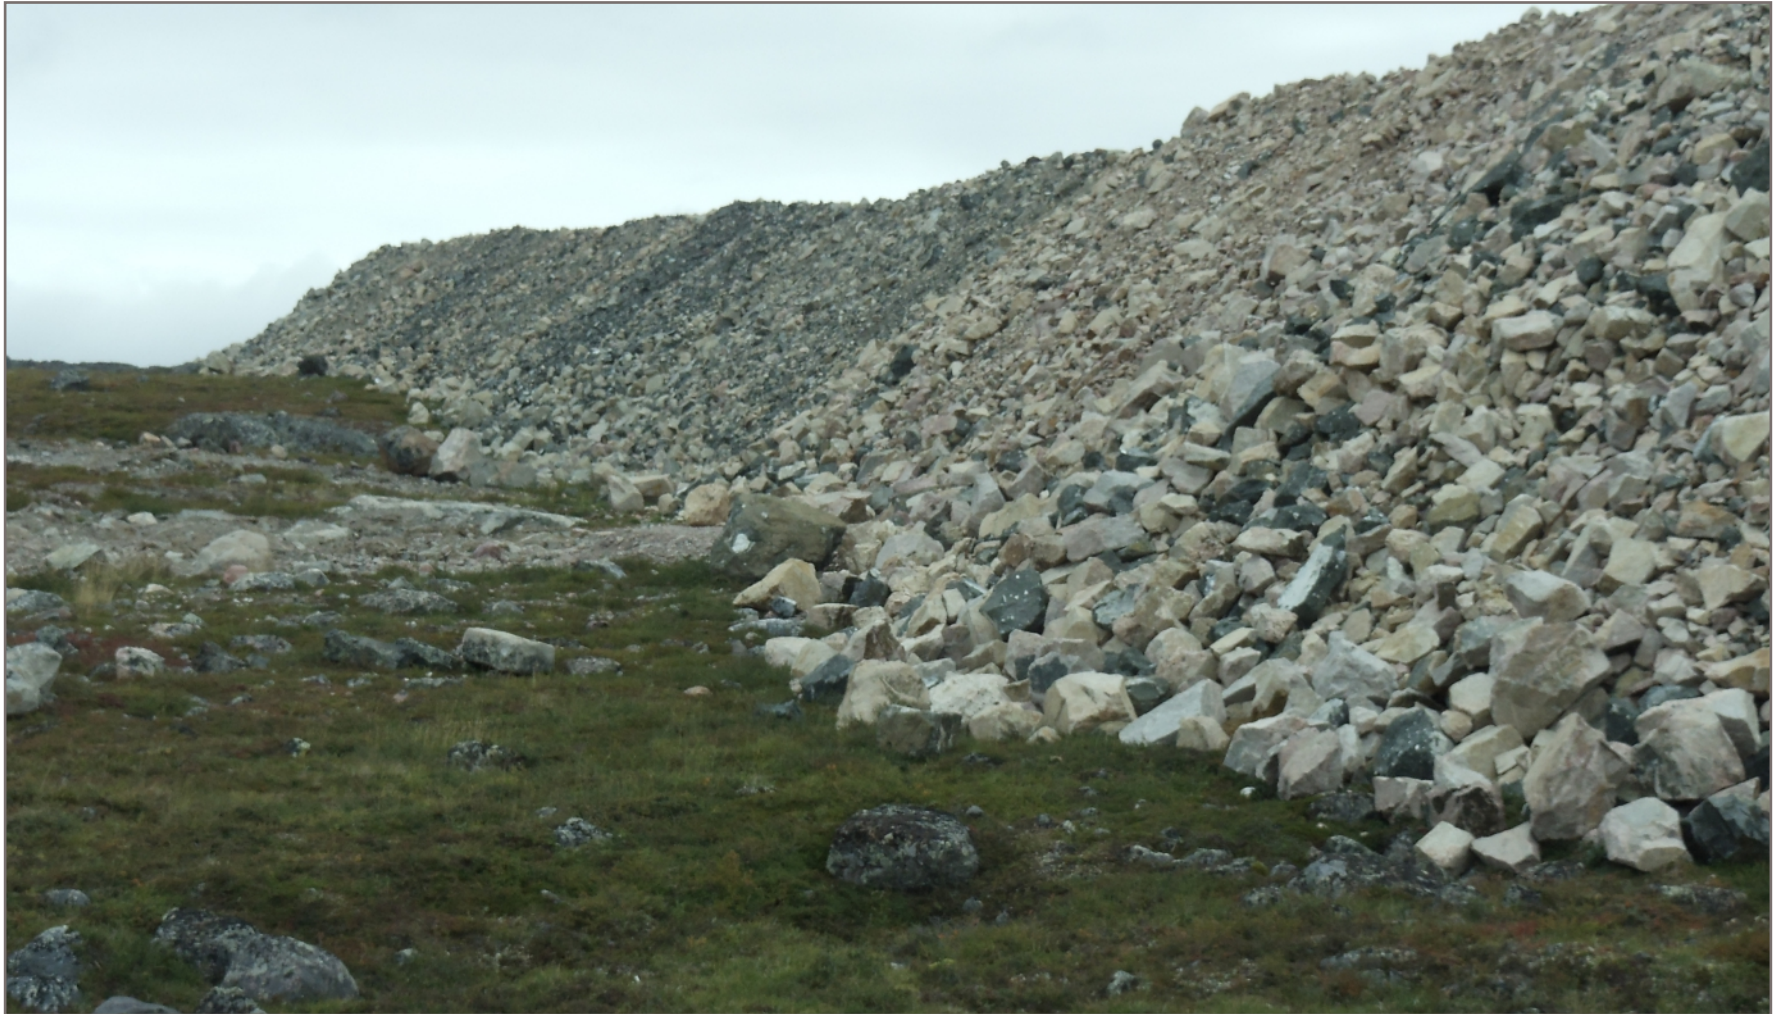
Photo L4: Waste Rock Dump 1 slope in good condition

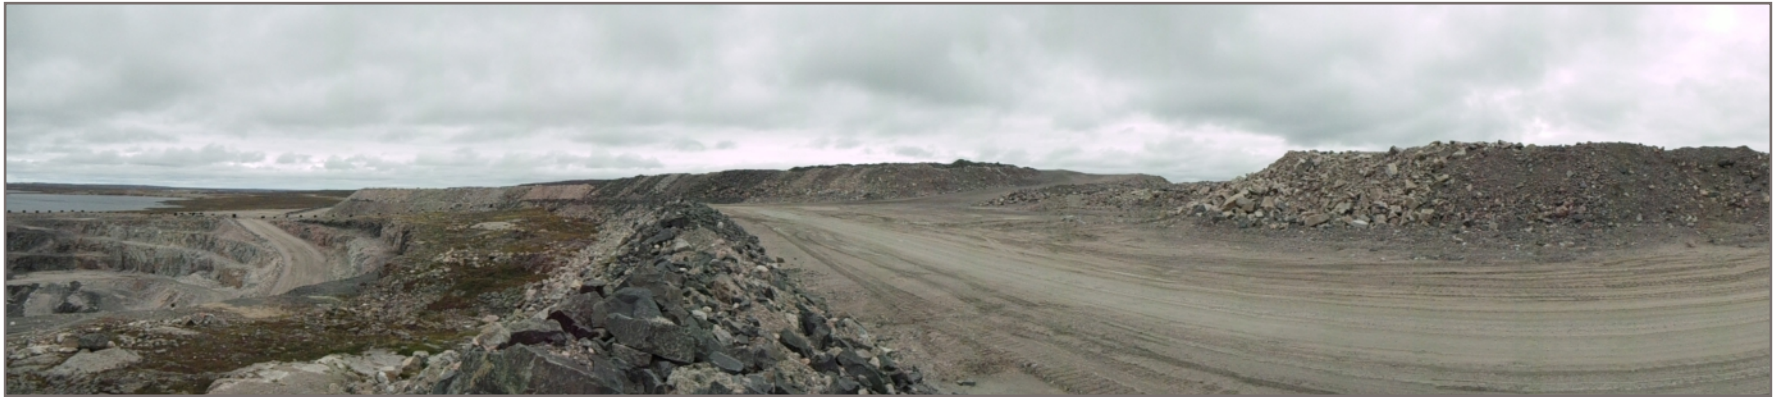
Photo L5: Waste rock dump facing north

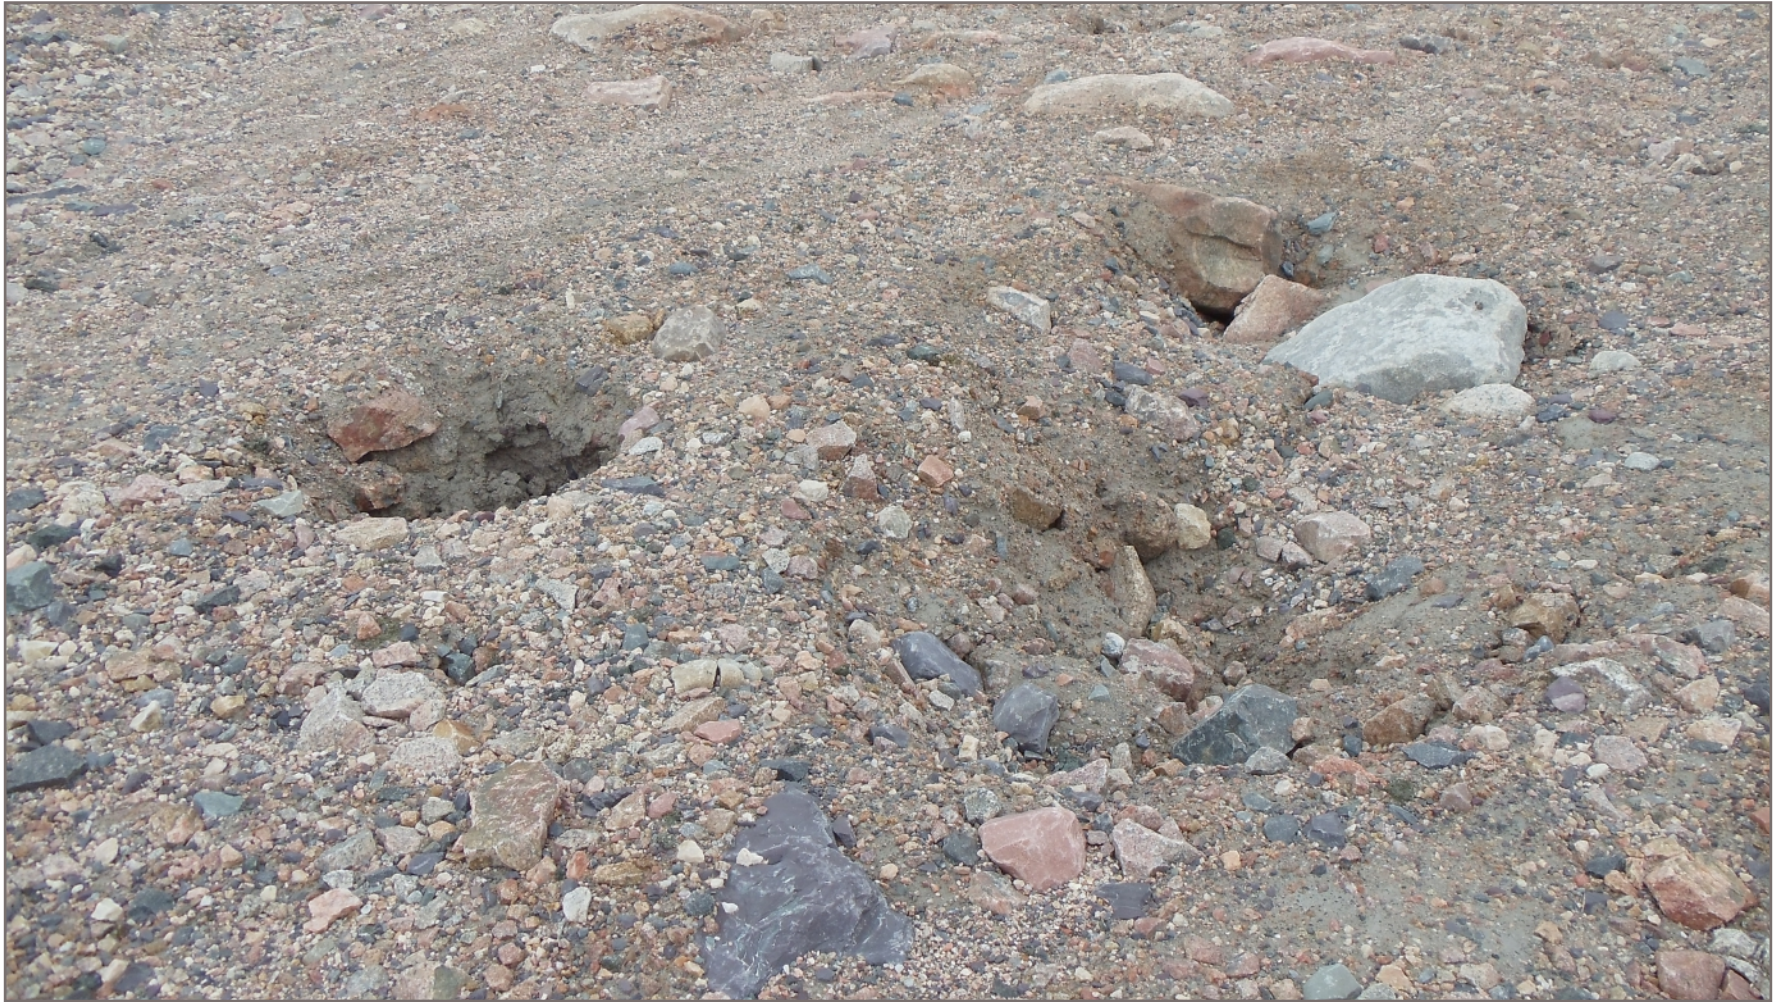
Features	Present (yes/no)	Dimensions	Extent	Description	Photographic Records
Erosion	None noted				
Cracking	None Noted				
Settlement	Waste Dump 1		Localized	Settlement of waste rock in Waste Pile #1	L.6
Seepage	None Noted				
Other Features

Photo L6: Minor settlement in waste pile 1; settlement is not a concern and does not impact waste rock pile performance

Waste rock pile is performing adequately. No remedial action is required at this time. Regular inspection should be completed by Shear personnel, particularly once active deposition in the pile resumes.
