Geotechnical Inspection Summary

Location: Jericho Diamond Mine
Facility: Divider Dyke A
Observation Date: July 15, 2011
Inspected by: Gary Koop, P.Eng.
 EBA, A Tetra Tech Company

| 2011 ANNUAL GEOTECHNICAL INSPECTION JERICHO DIAMOND MINE, NU | | | | |

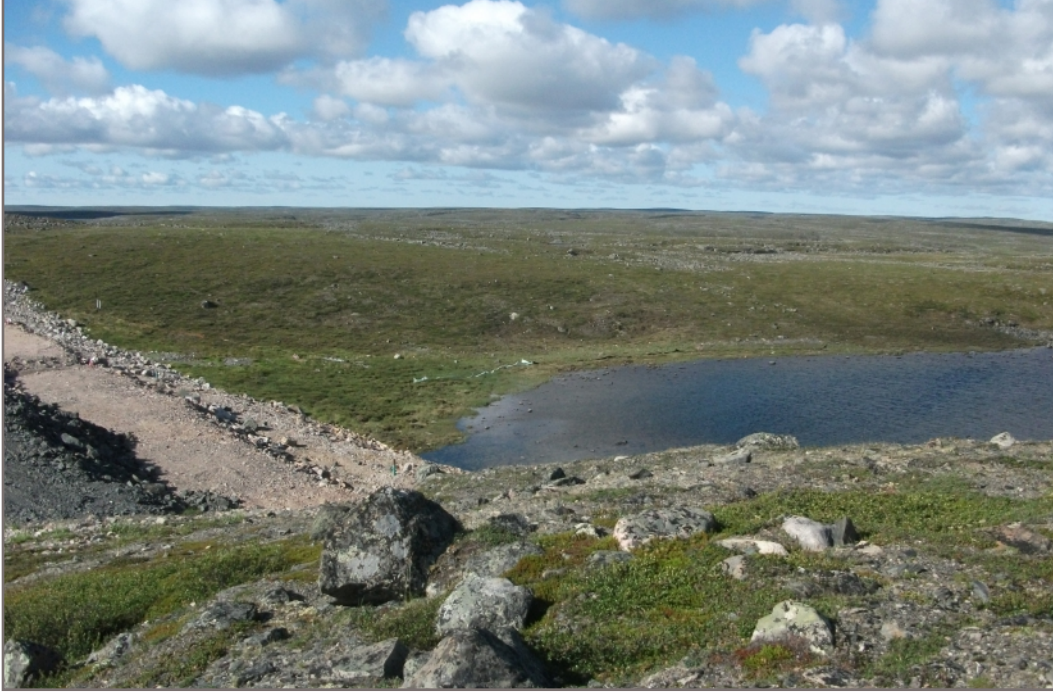
Photo B1: West Dam discharge location on downstream side of dam

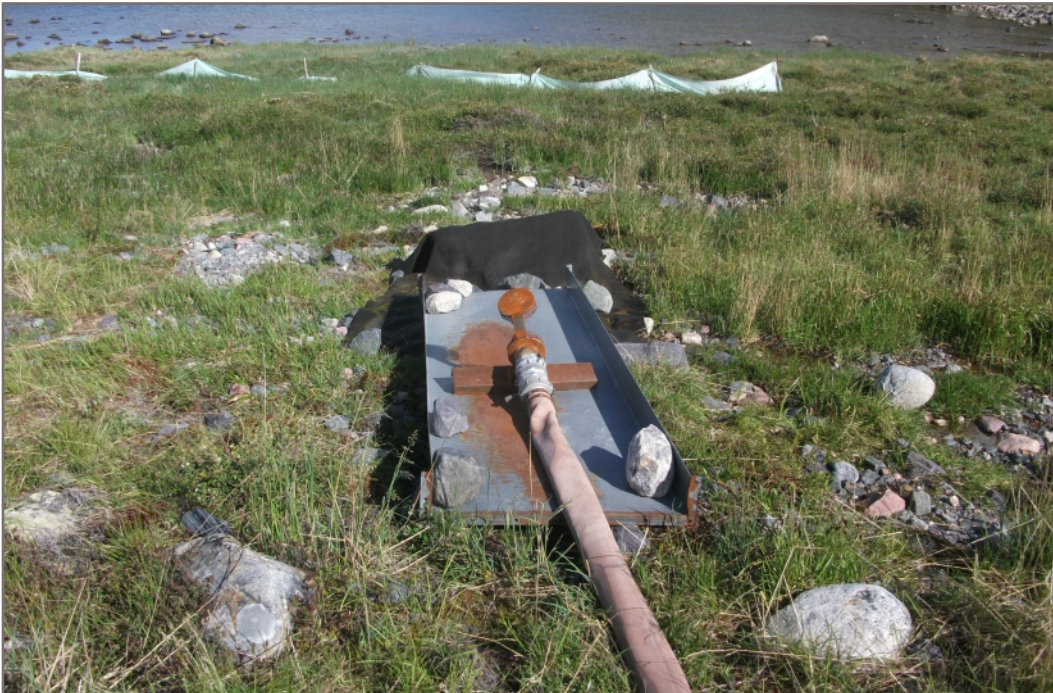
Photo B2: Energy dissipator at discharge location

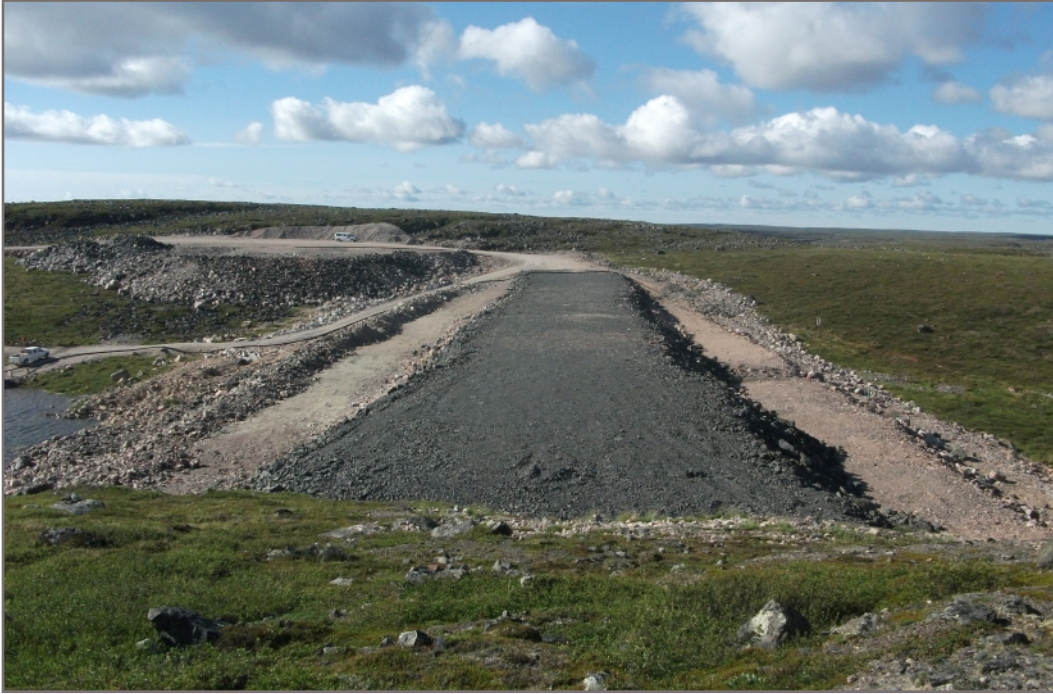
Photo B3: West dam looking south; dam crest in good condition with no problems noted

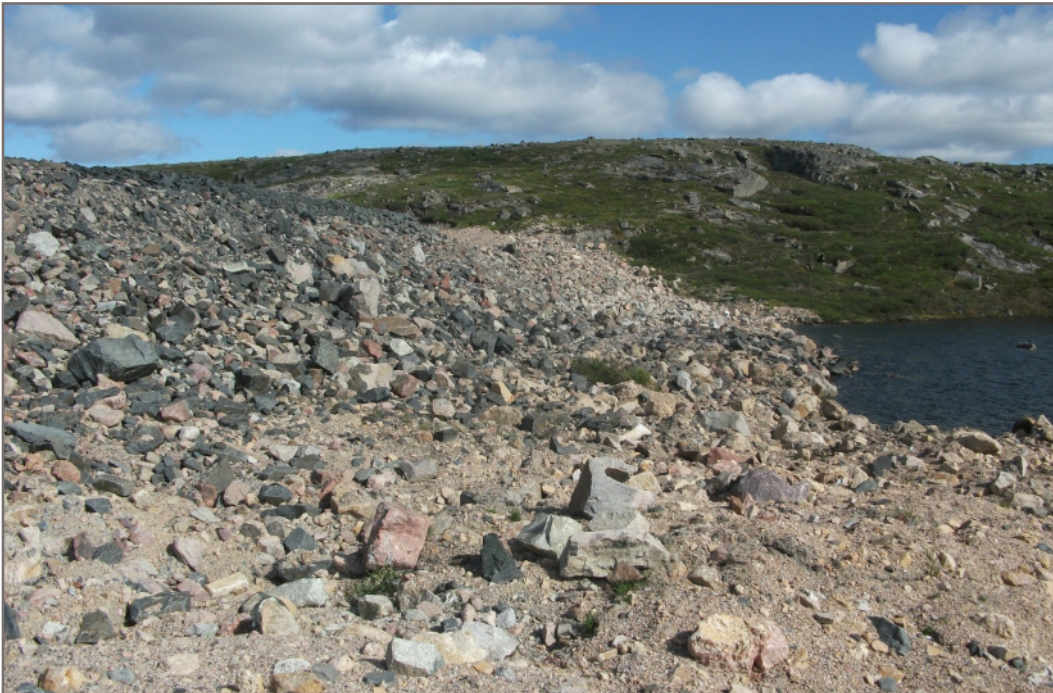
Photo B4: Upstream slope of dam in good condition

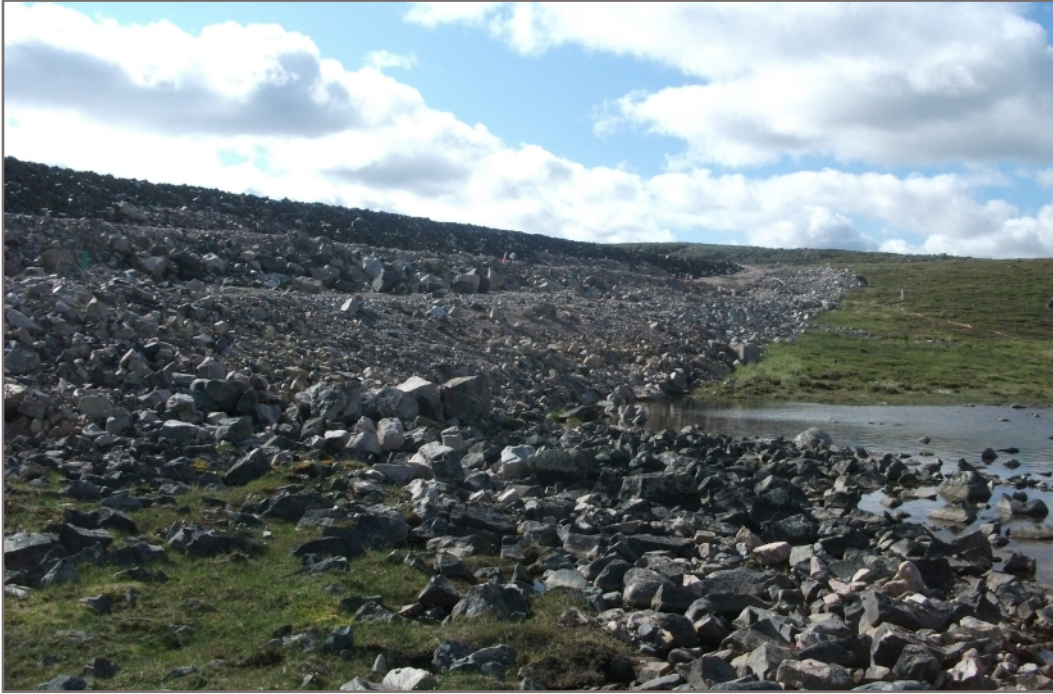
Photo B5: Downs slope of dam generally in good condition. Some settlement and tension cracking at south end of dam. Does not impact dam performance

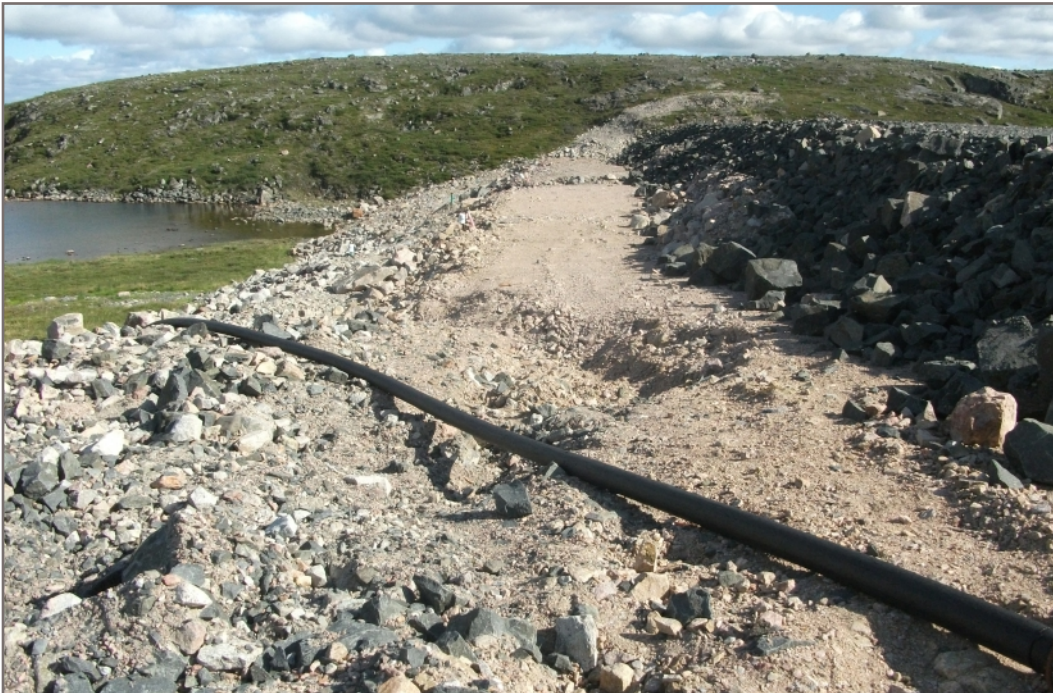
Photo B6: Settlement at south end of dam, on downstream slope; condition appears unchanged from 2009

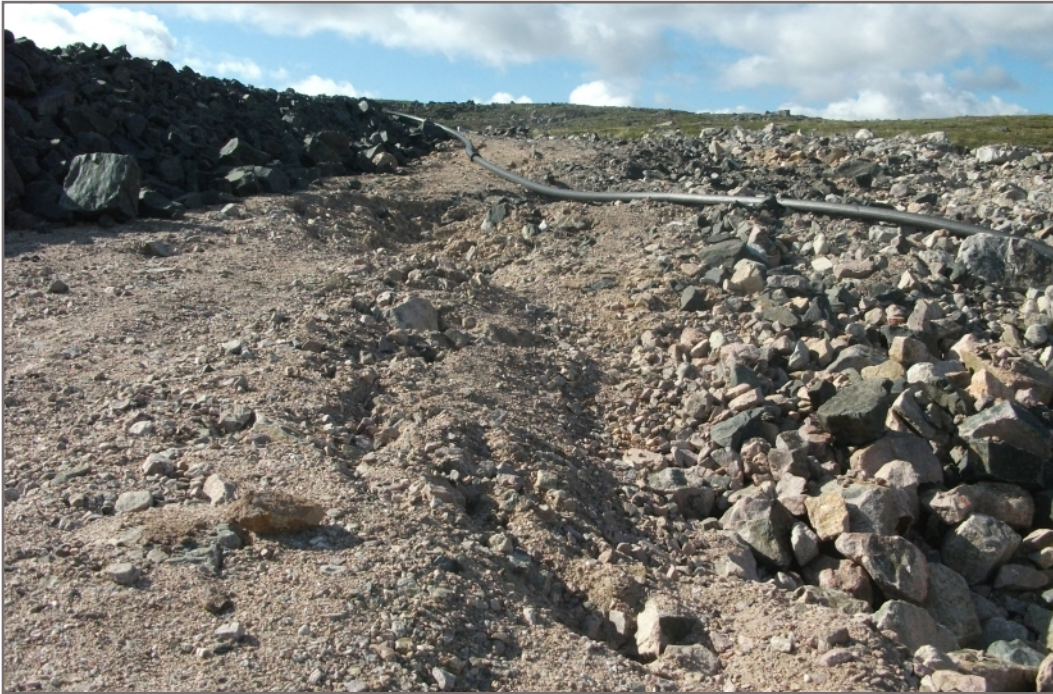
Photo B7: Tension cracking downstream of settlement area; condition appears unchanged from 2009, does not impact dam performance

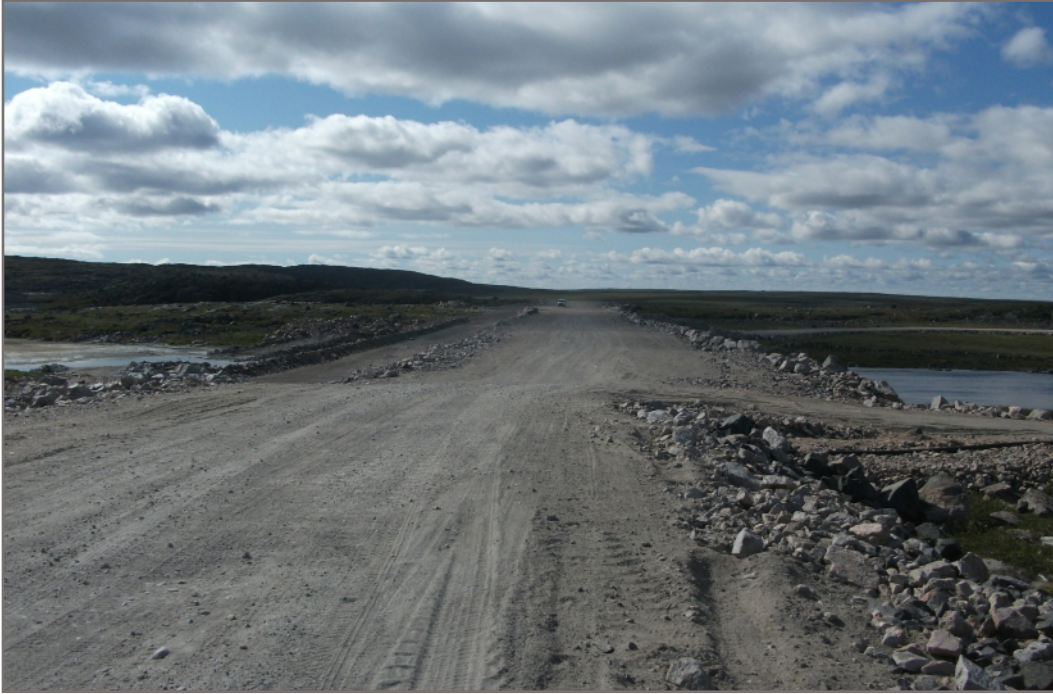
Photo C1: Divider Dyke A facing south; crest is in good condition with no problems noted

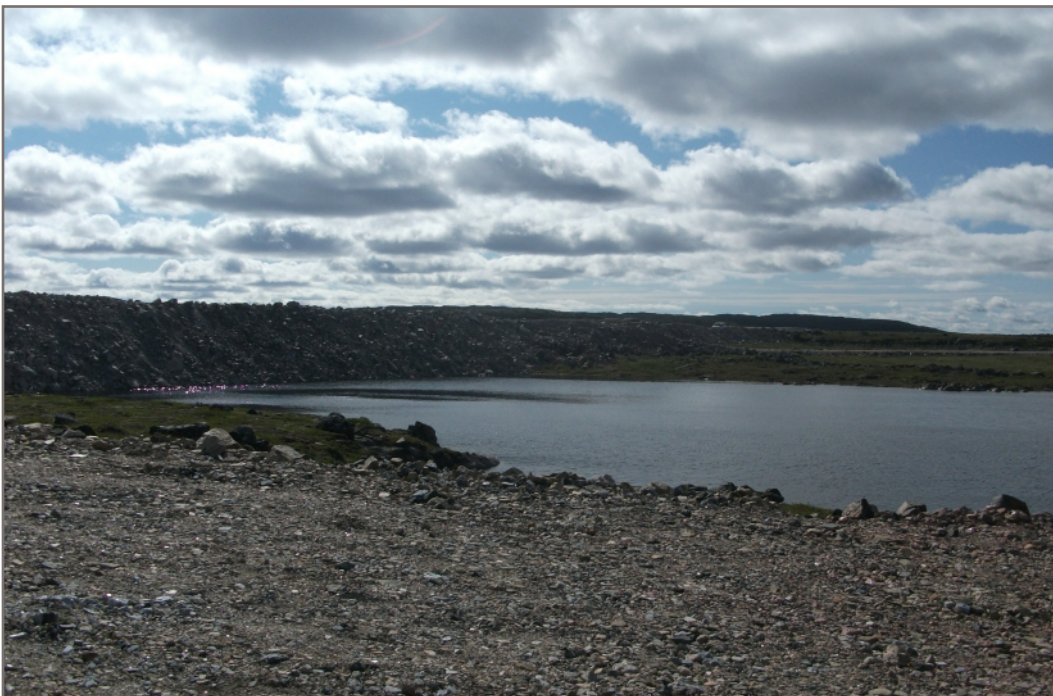
Photo C2: Downstream slope of divider is in good condition

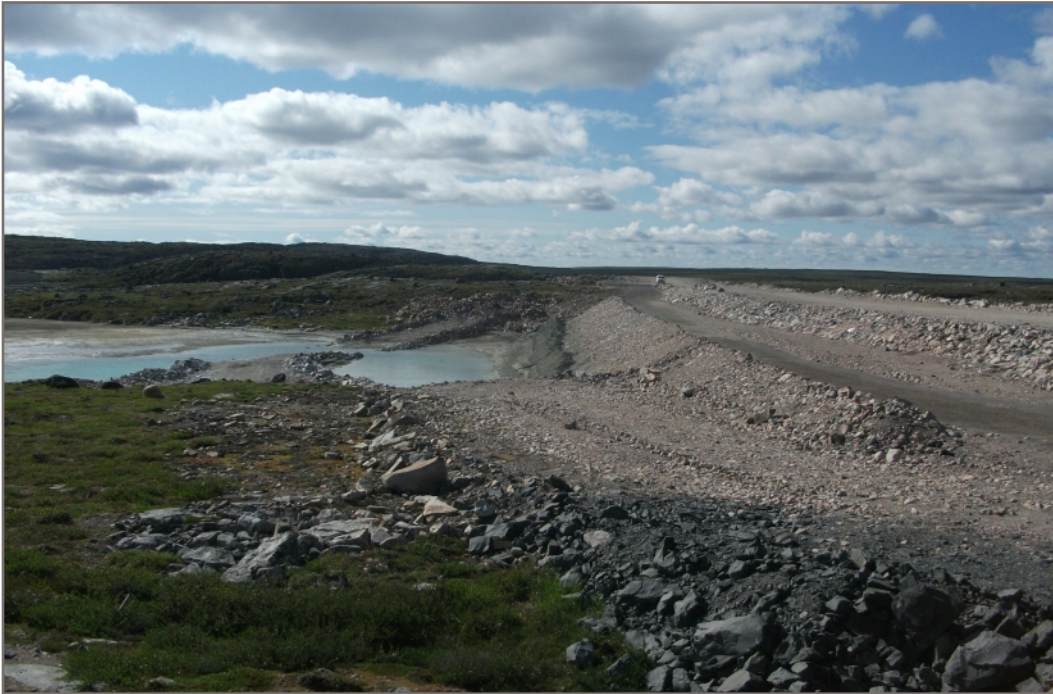
Photo C3: Upstream face of divider dyke; processed kimberlite placed on upstream slope to inhibit seepage through dyke

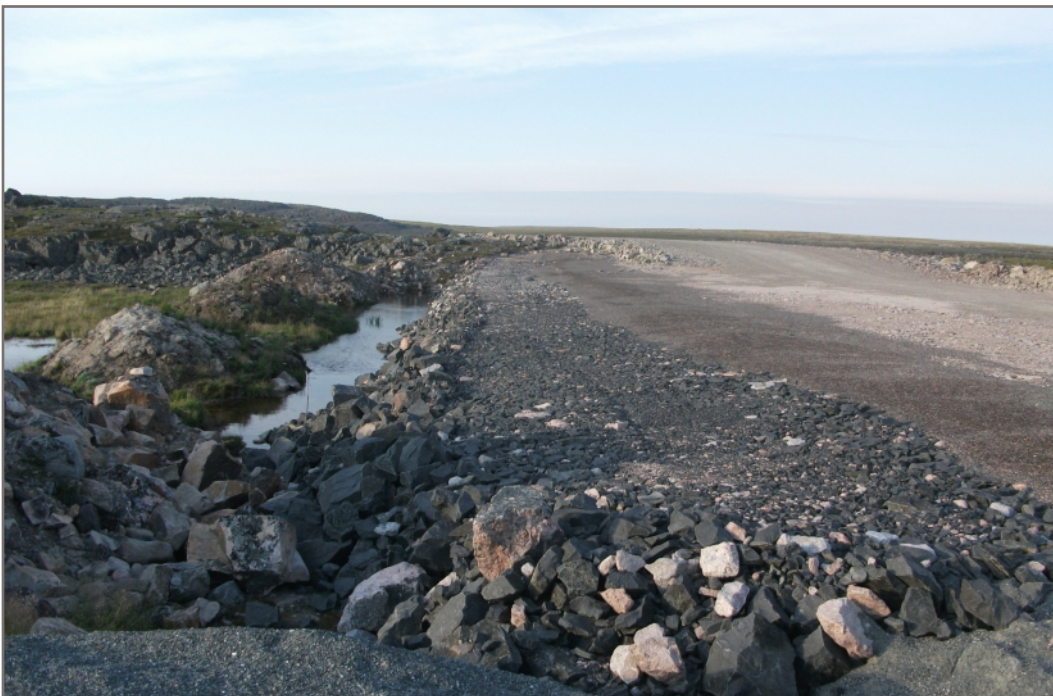
Photo C4: Upstream slope of dyke at south end of structure, no problems noted

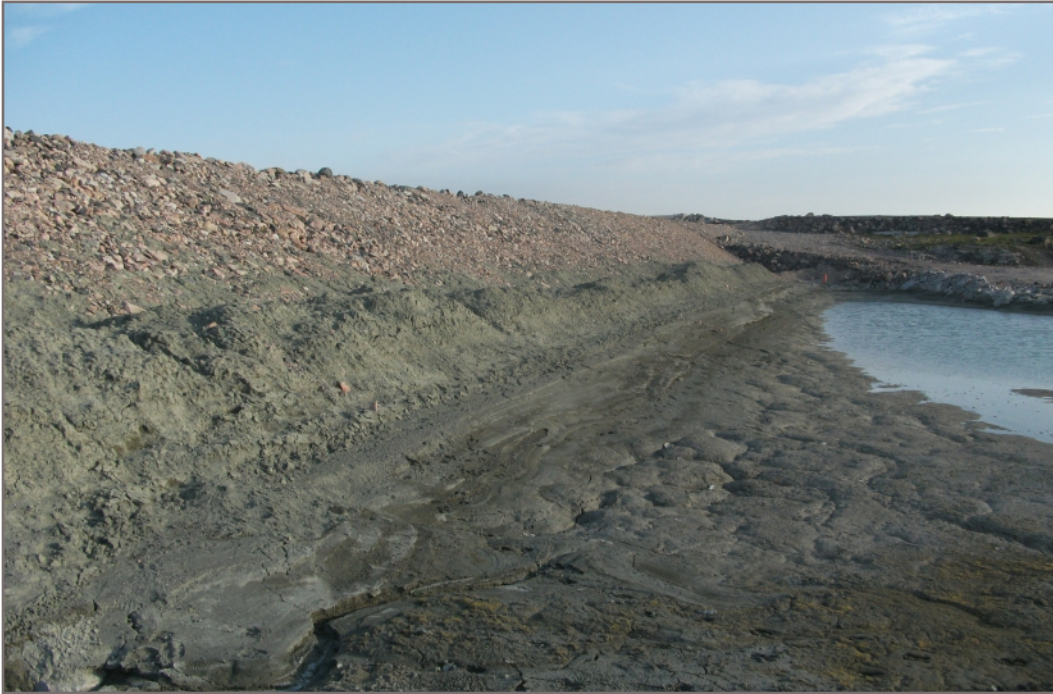
Photo C5: Processed kimberlite placed on upstream face of divider dyke

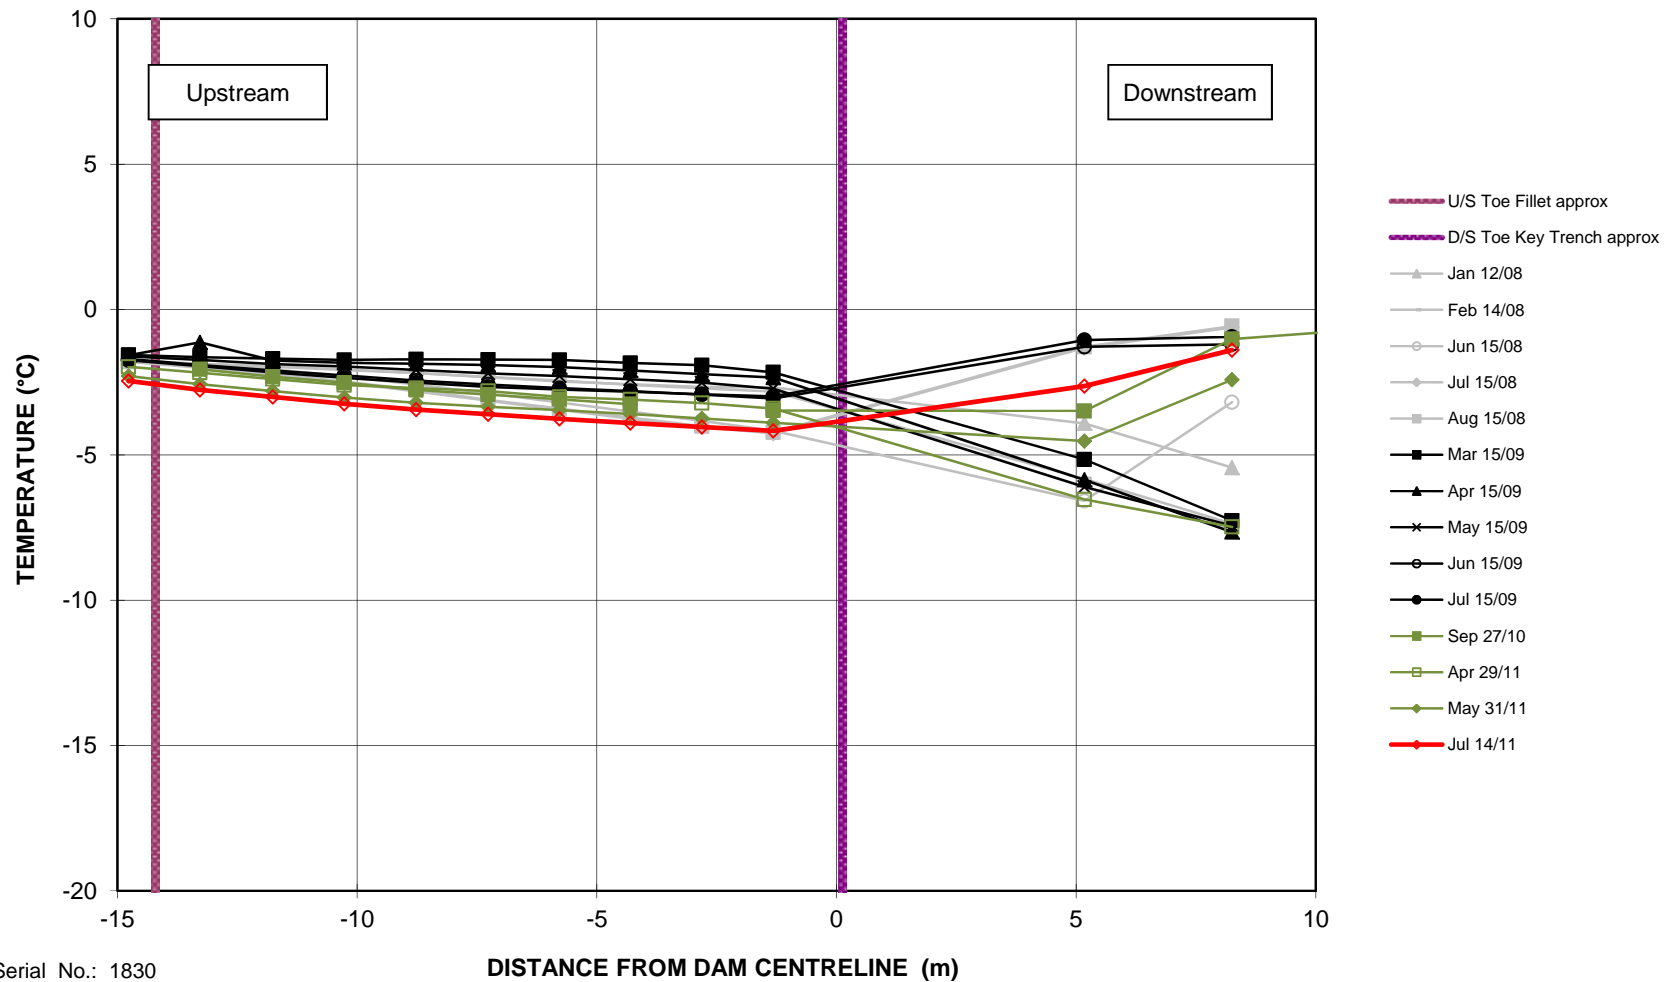
Figure D-2
Horizontal Ground Temperature Distribution
East Dam
Station 0+100, Trench Elevation 517 m

| Ground temperature measurements in attached Figures D.2 to D.5. Base of key trench approximately -2.6 to -4.9°C. Temperatures typically within 1°C of values measured in 2009. |
