## Geotechnical Inspection Summary

**Location:** Jericho Diamond Mine  
**Facility:** Southeast Dam  
**Observation Date:** July 15, 2011  
**Inspected by:** Gary Koop, P.Eng.  
 EBA, A Tetra Tech Company

2011 ANNUAL GEOTECHNICAL INSPECTION JERICHO DIAMOND MINE, NU				
SOUTHEAST DAM				
PROJECT NO. E14101140	DWN EP	CKD GDK	REV 0	Figure E.1
OFFICE EBA-EDM	DATE September, 2011

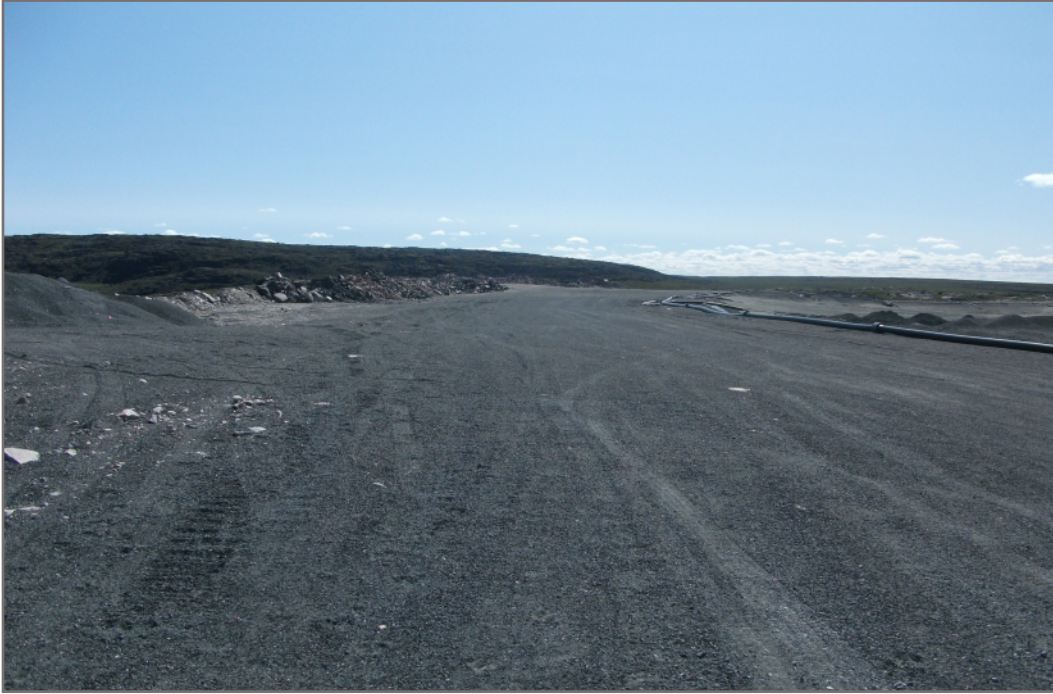
**Photo D1:** East dam facing southeast; dam crest is in good condition

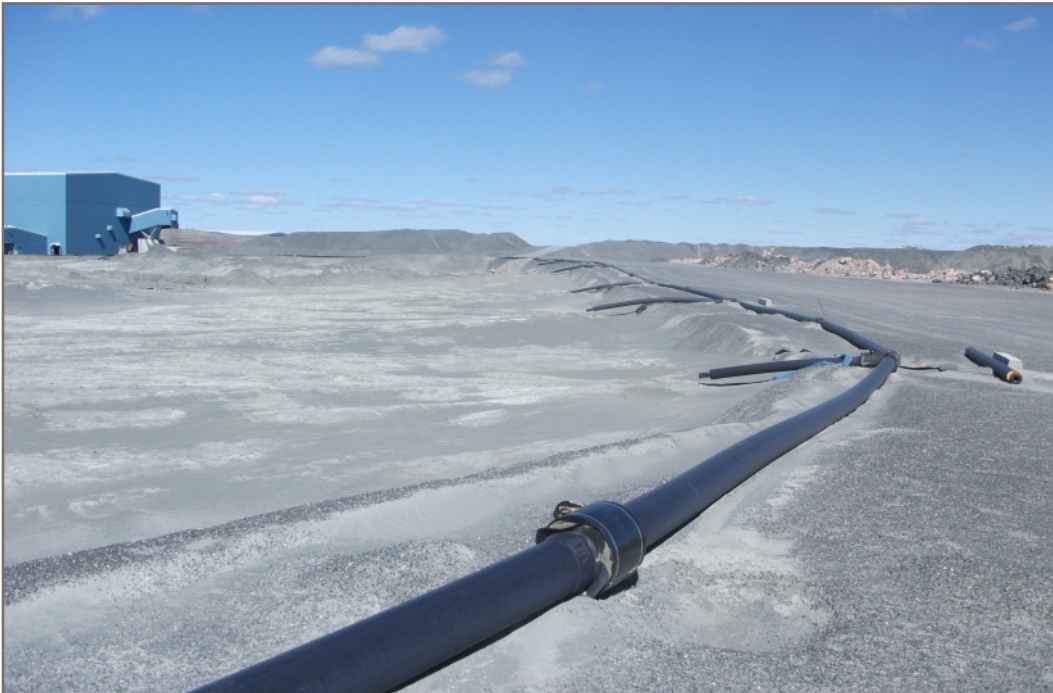
**Photo D2:** Processed kimberlite deposited on upstream face of dam

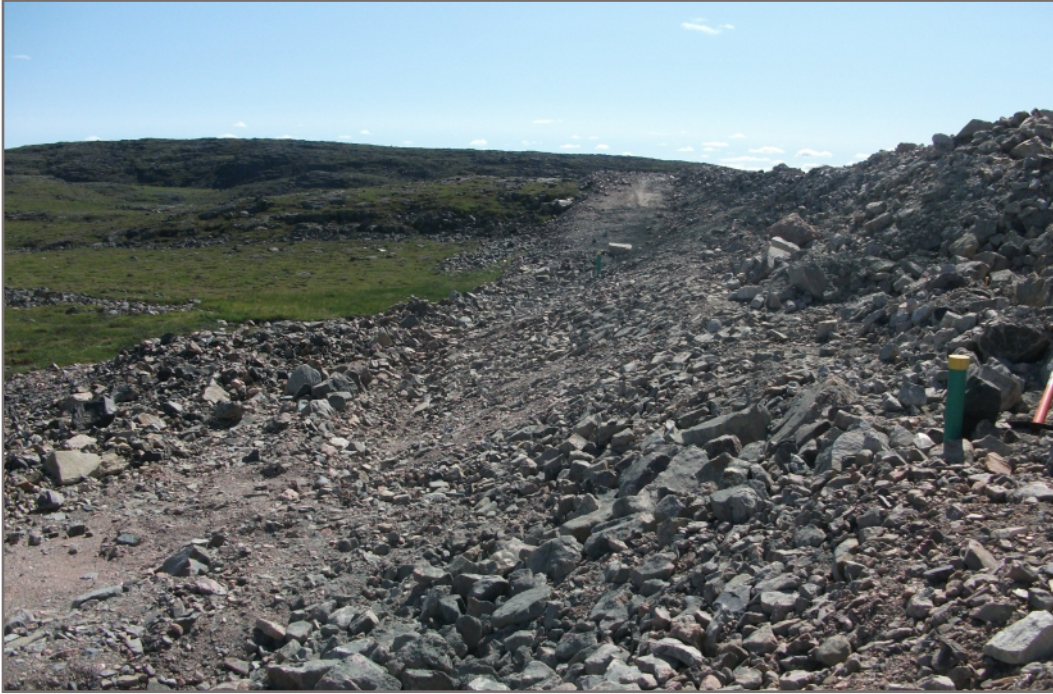
**Photo D3:** Downstream face of dam is in good condition

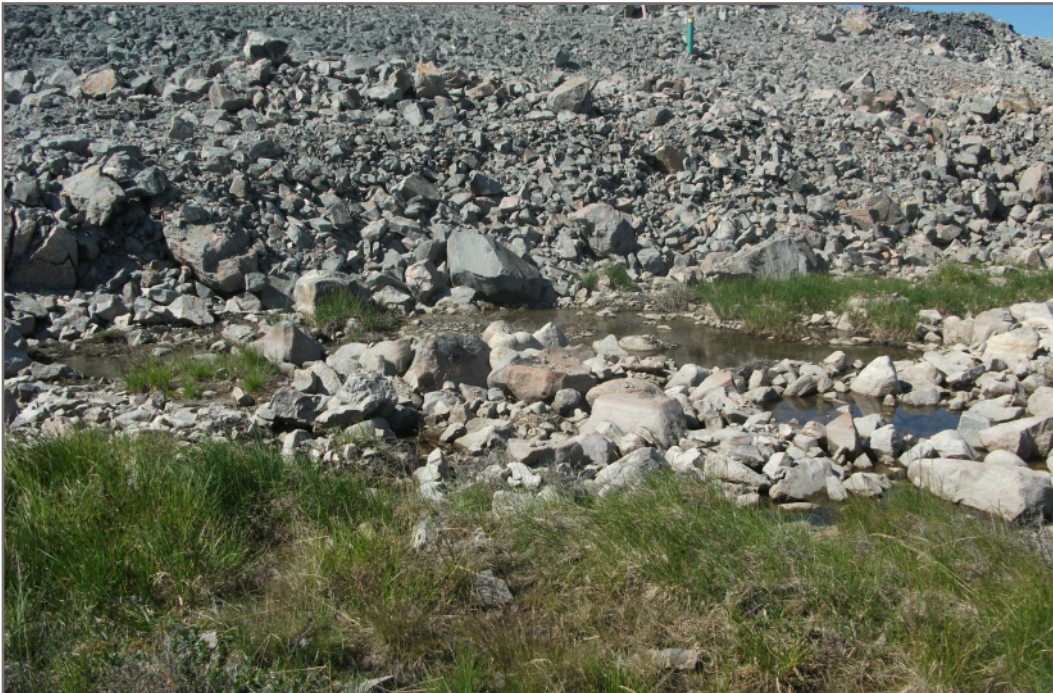
**Photo D4:** Standing water at downstream toe of dam; water is pooling in a topographic low and not seeping through dam

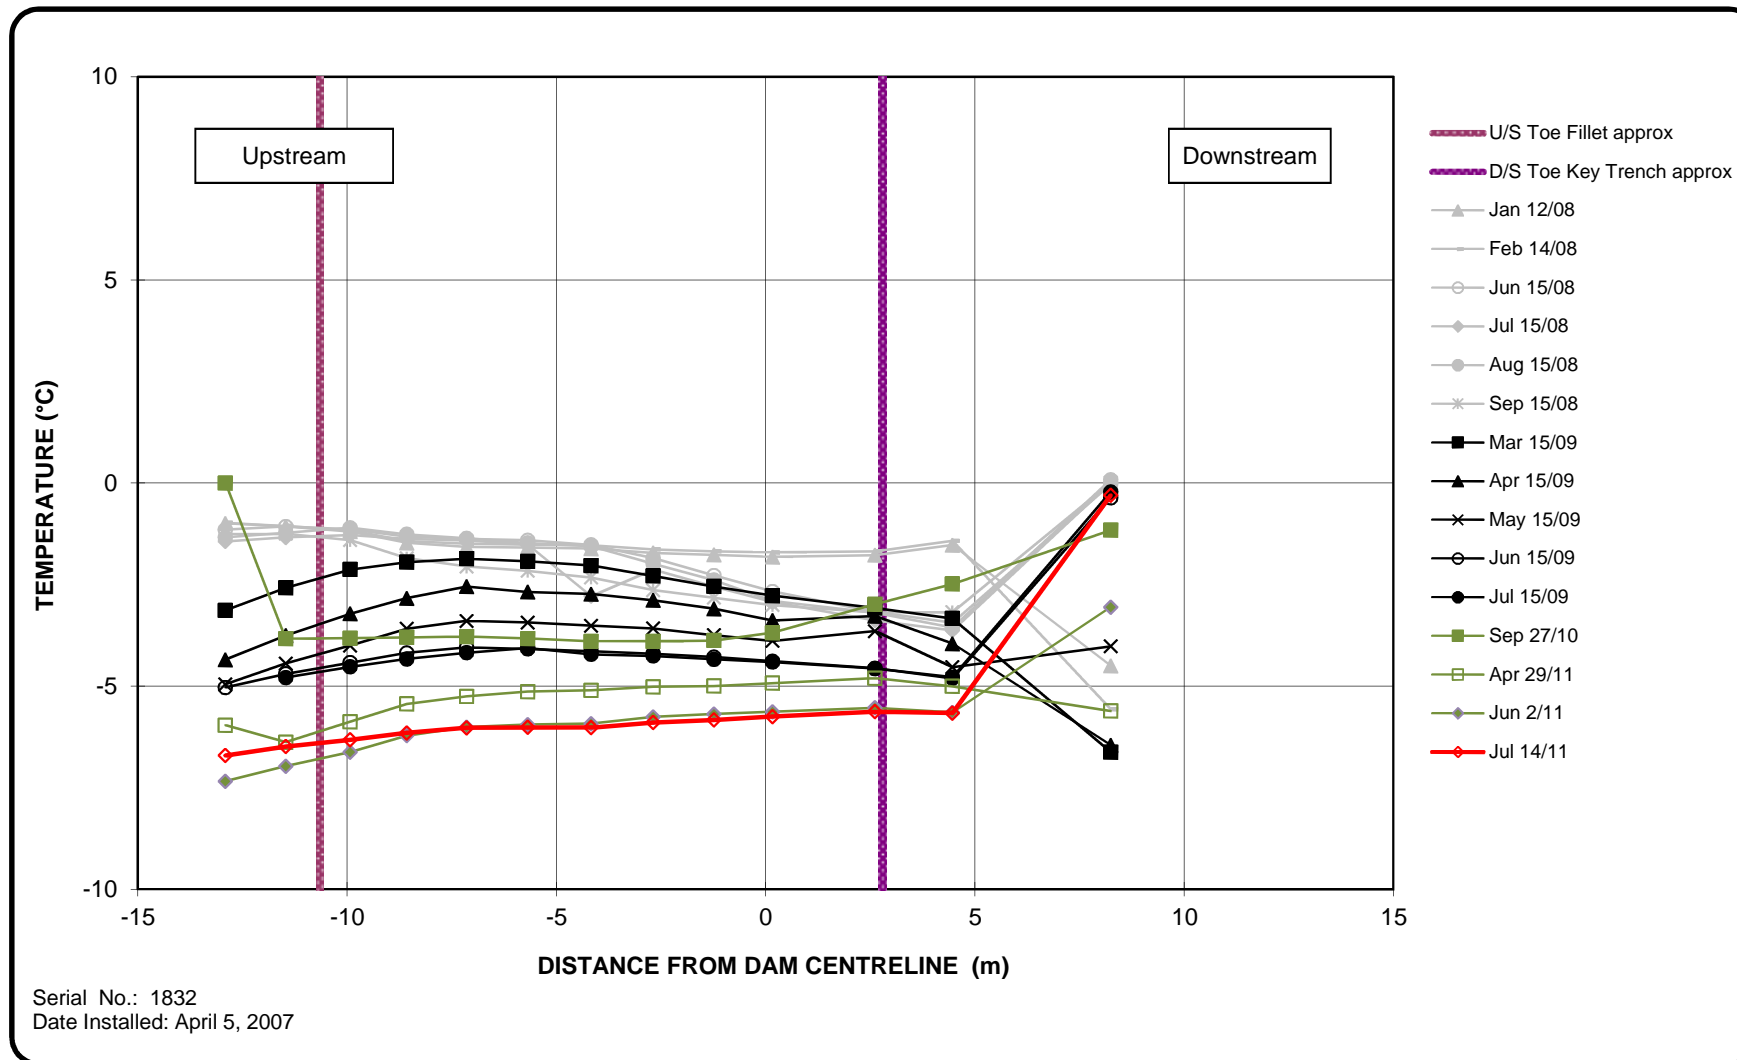
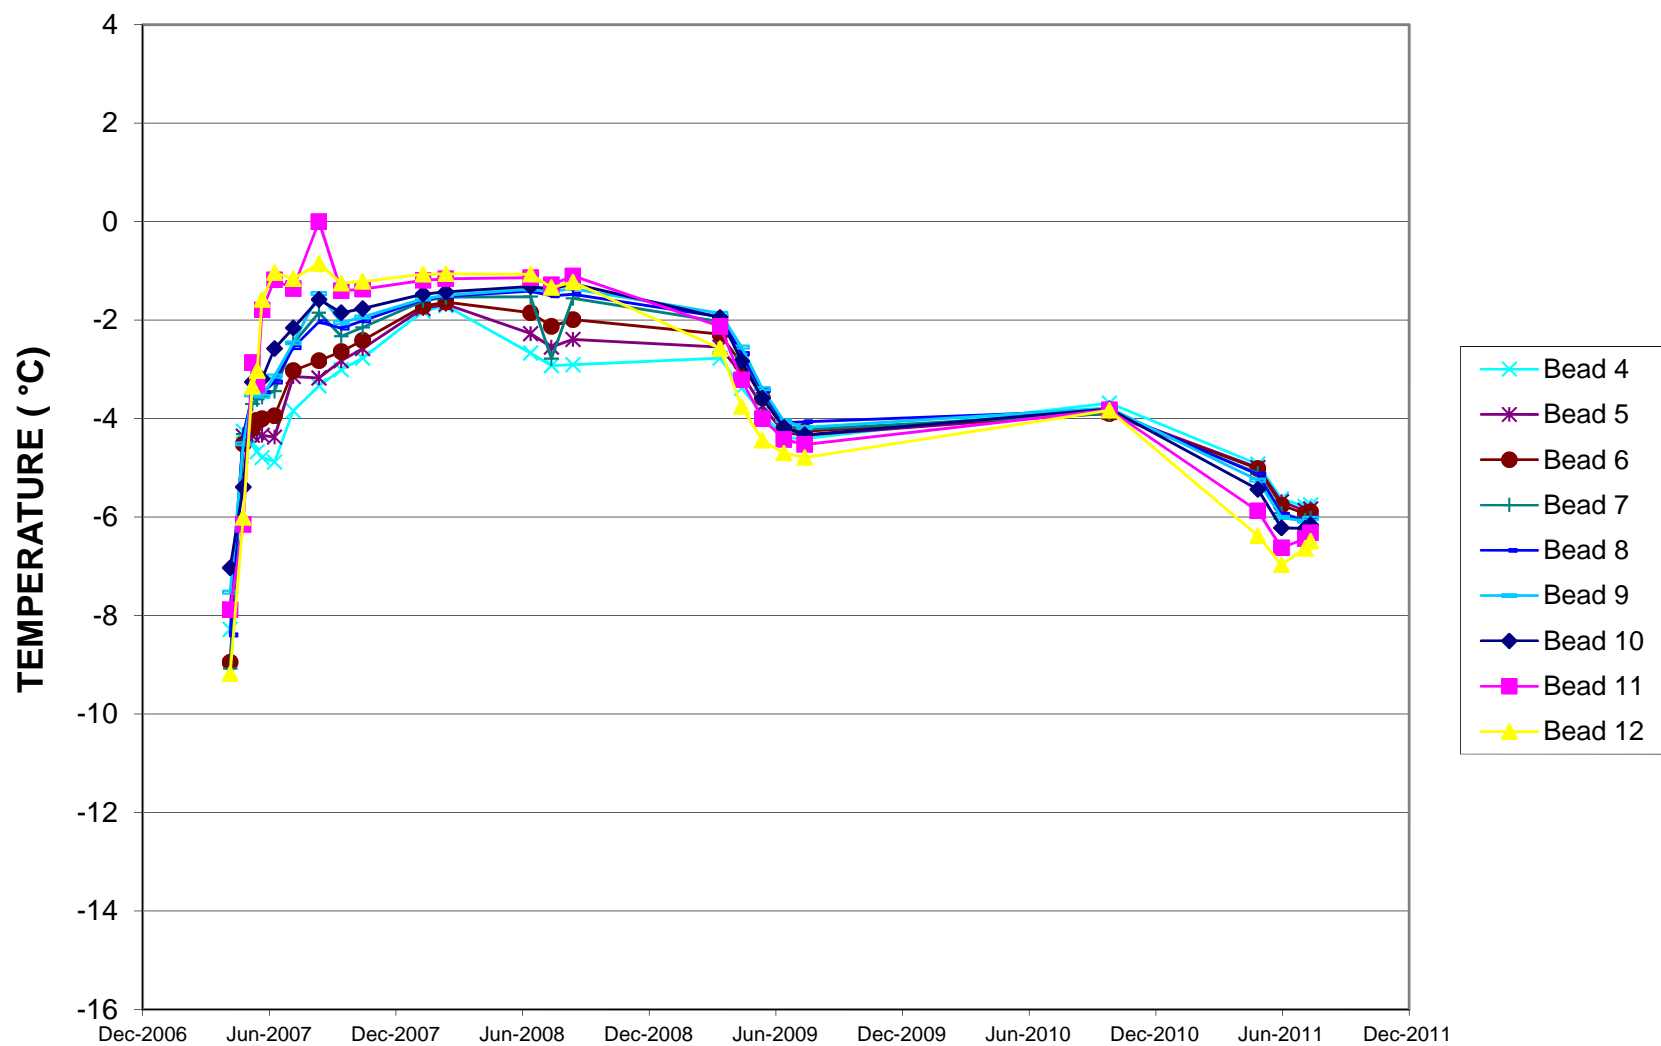
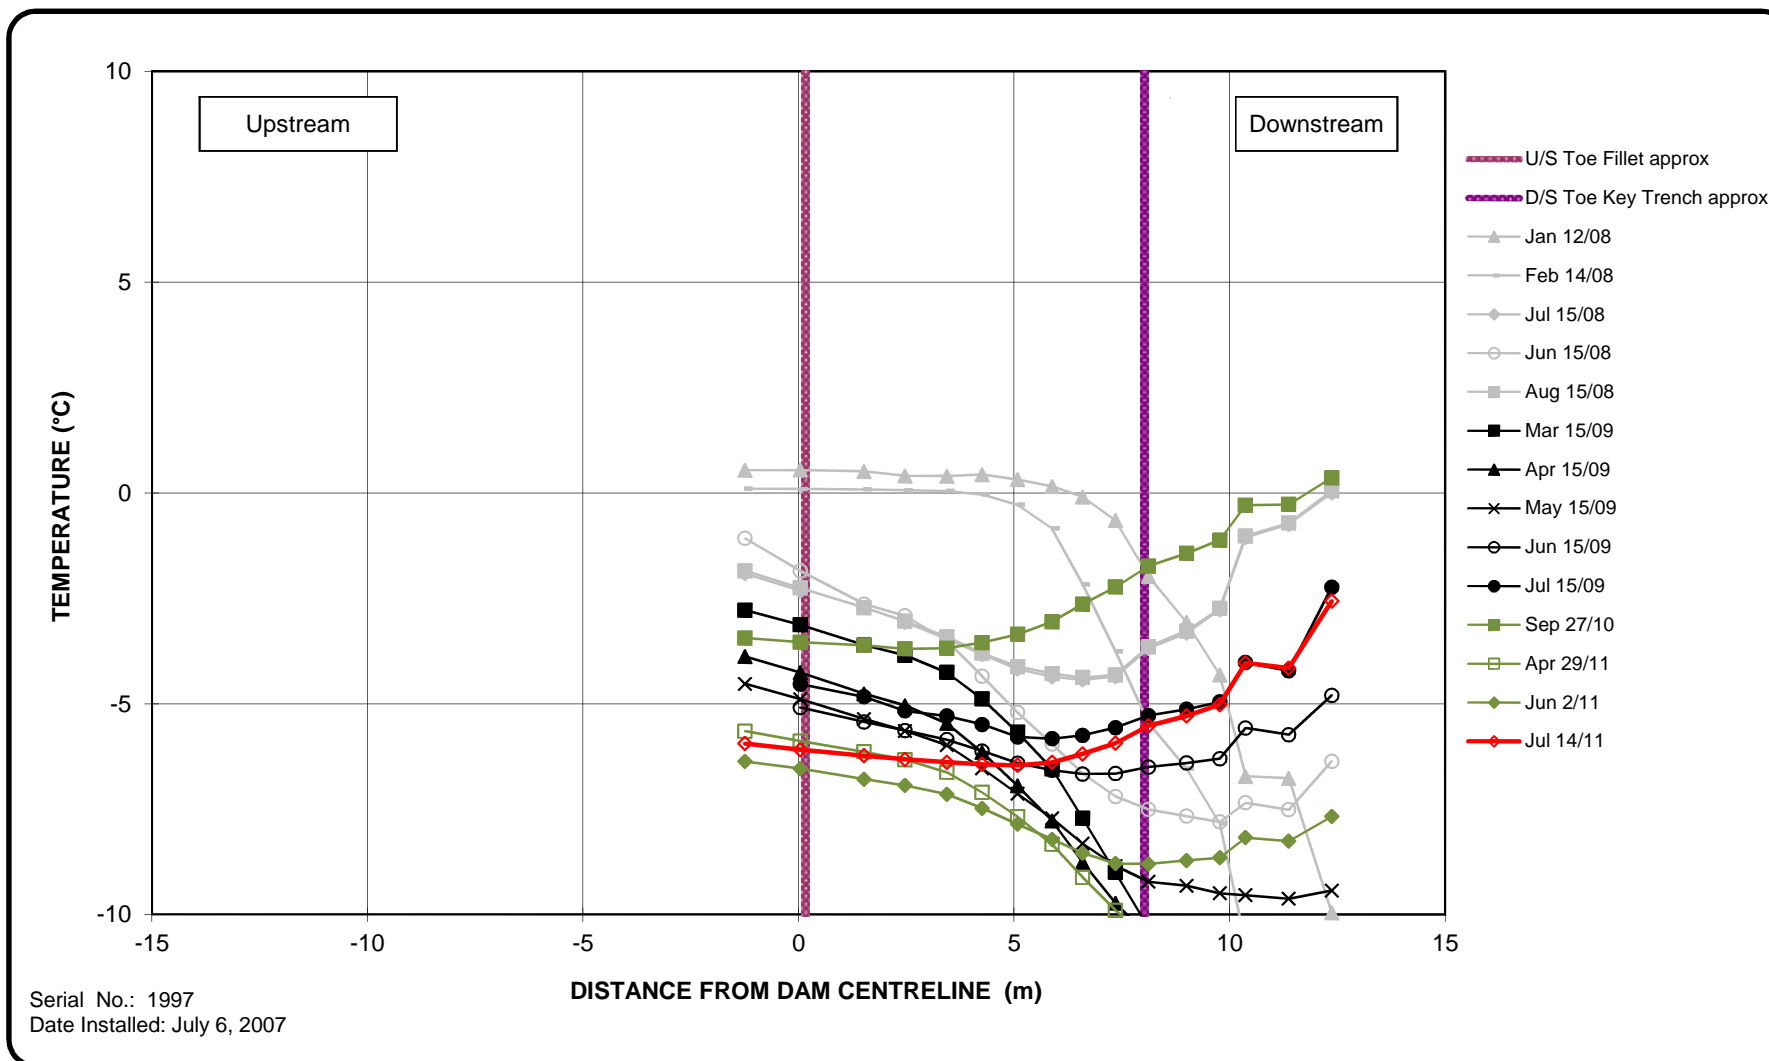
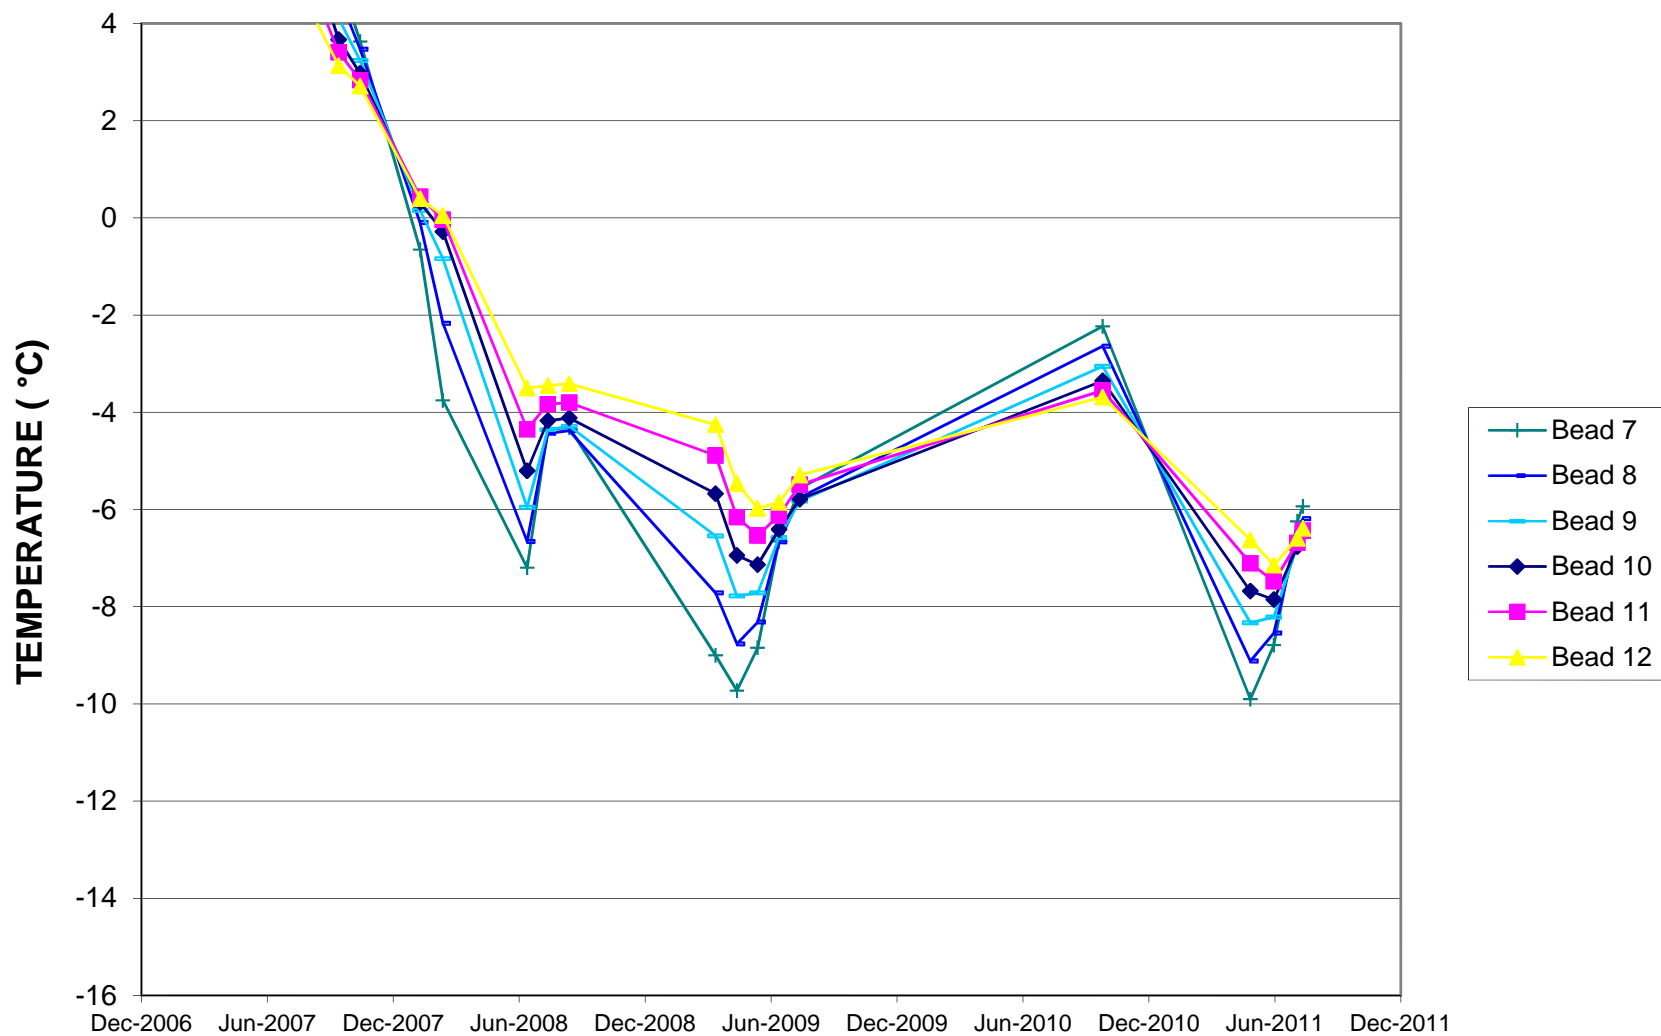
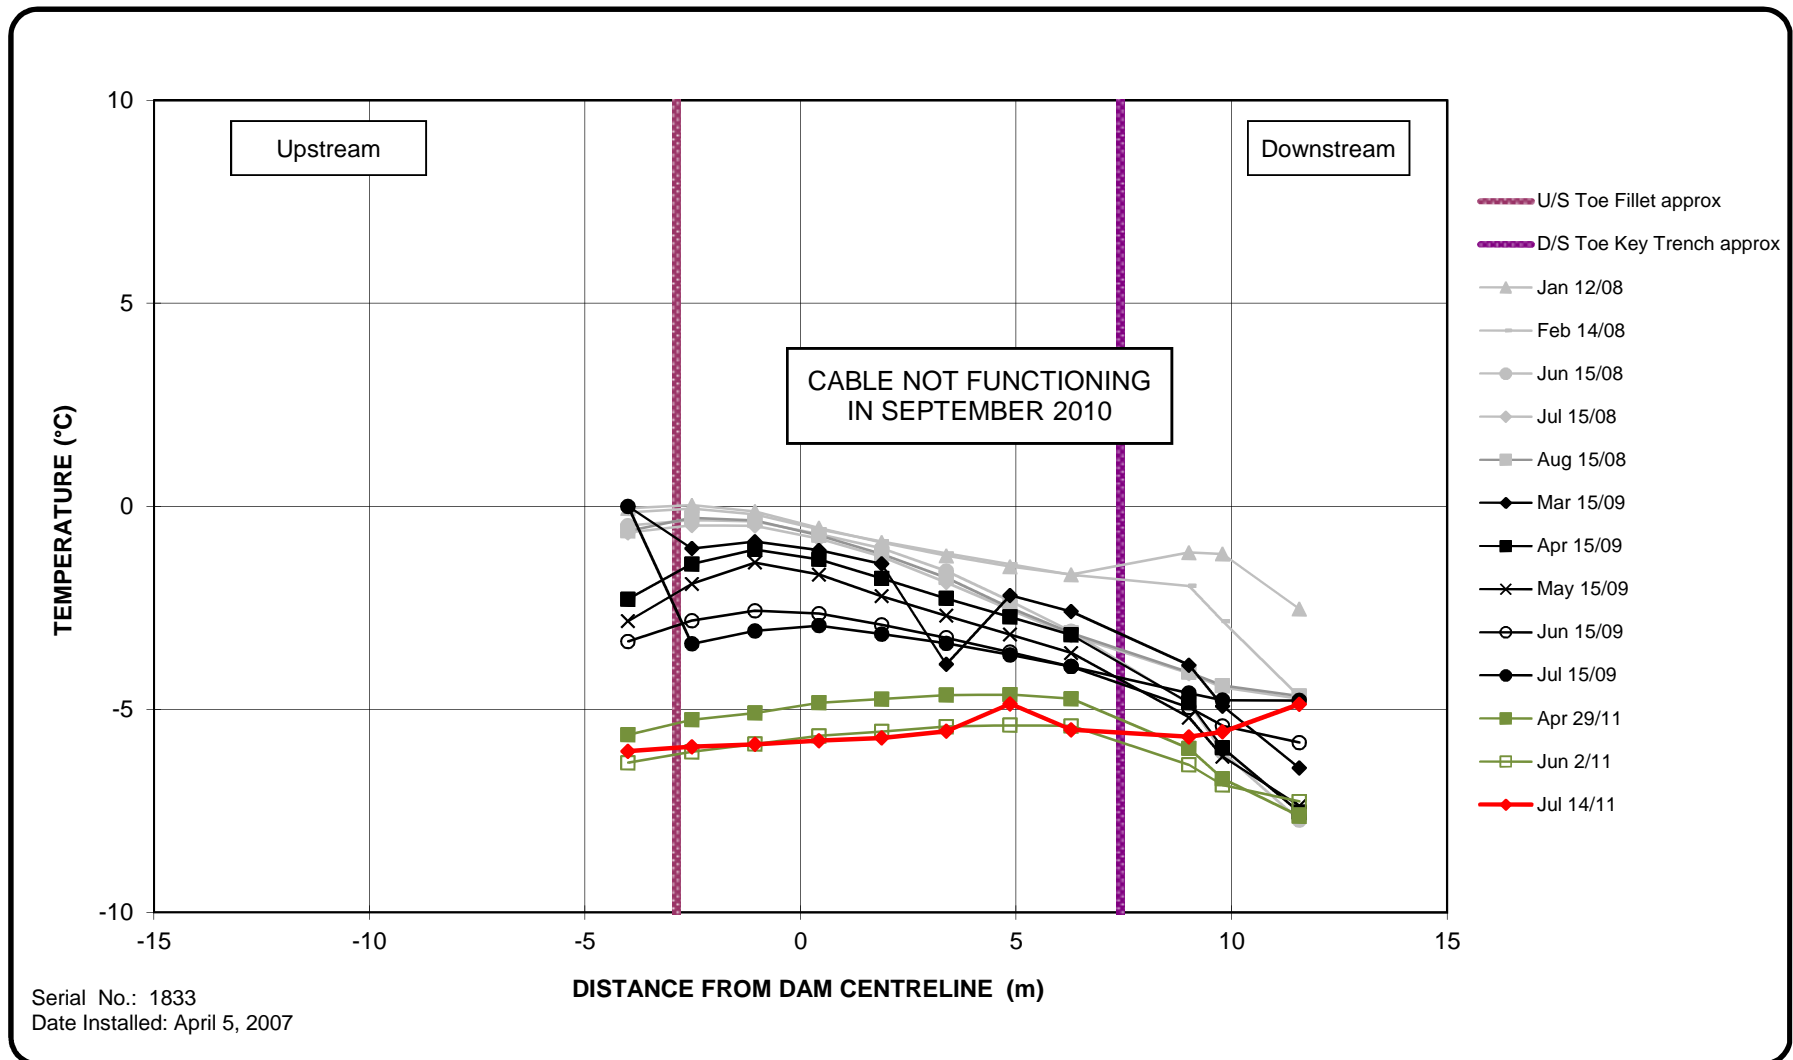
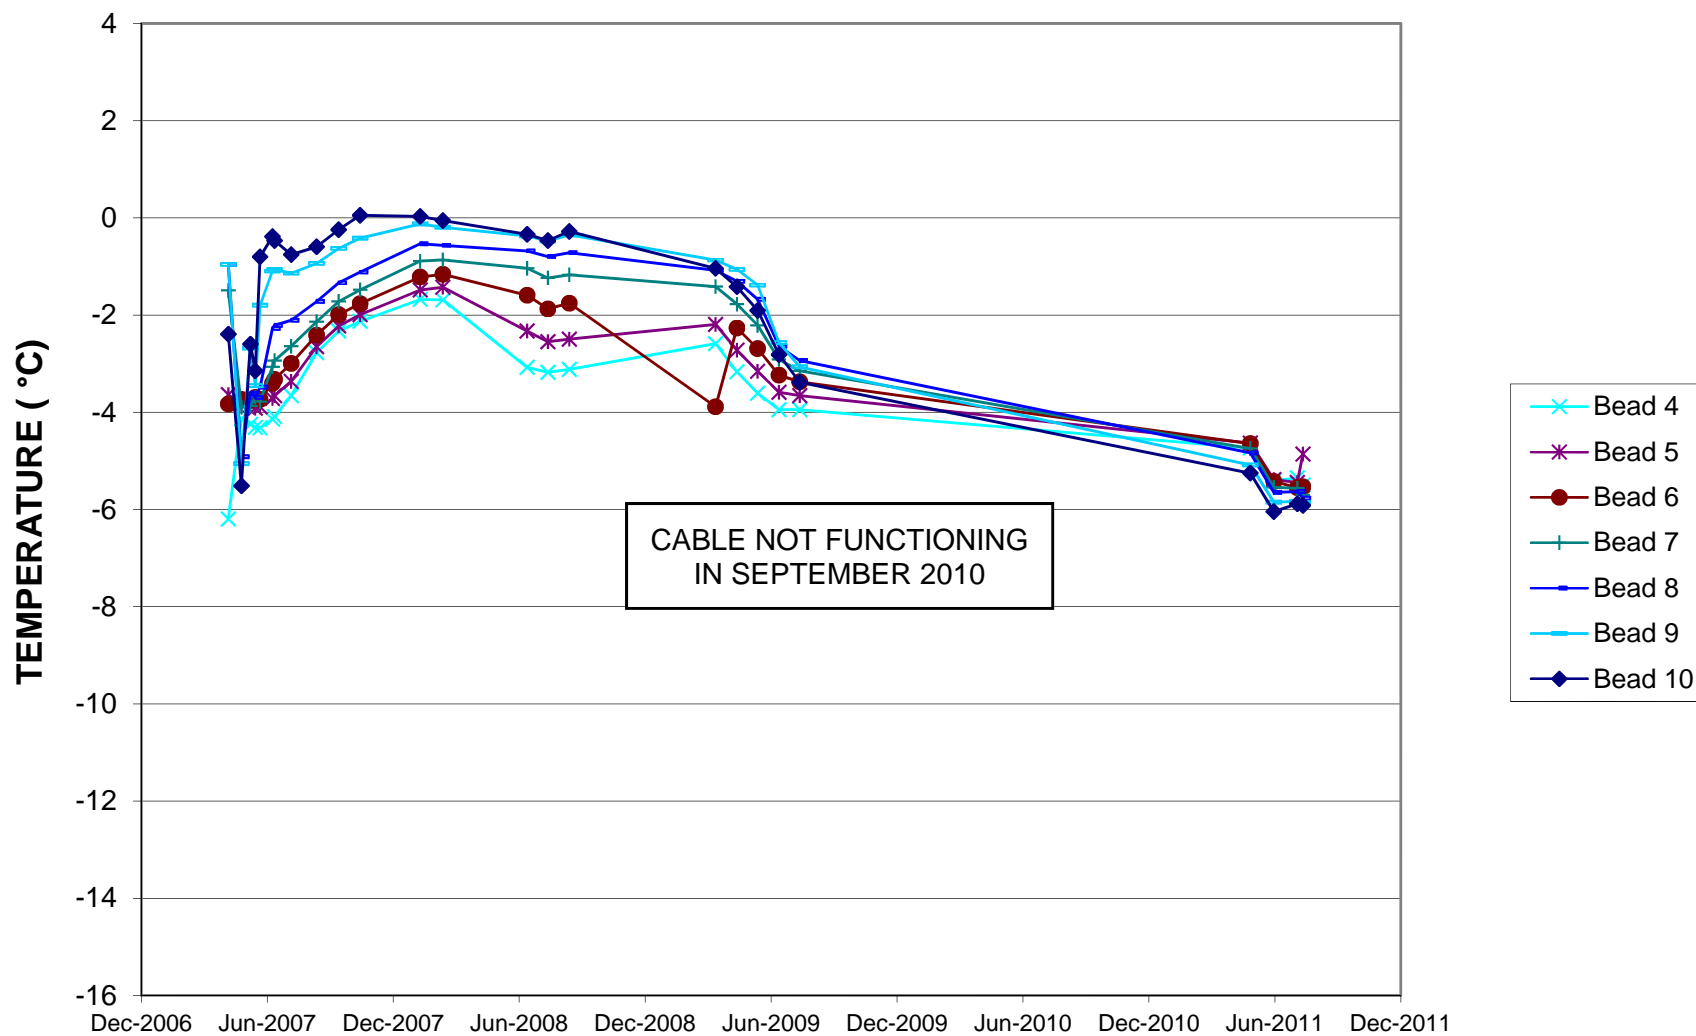
Ground temperature measurements in attached Figures E.2 to E.7. Temperatures in base of key trench range from -4.9 to -6.5 °C. This is 1 to 3°C cooler than measurements made at the same time in 2009.
---

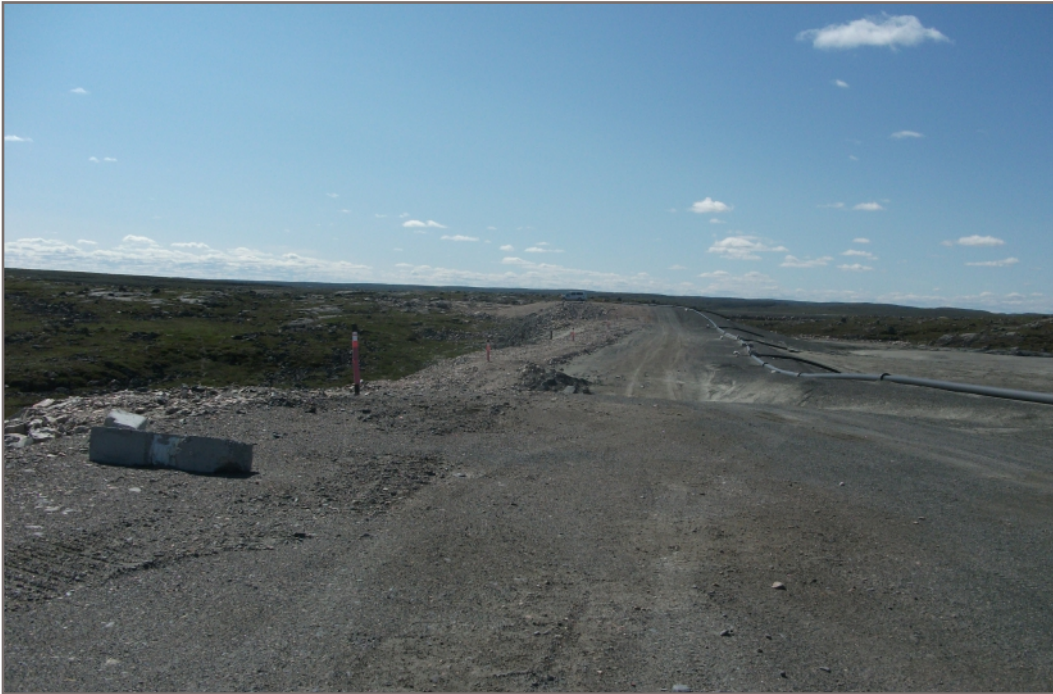
**Photo E1:** Southeast Dam crest facing southwest; crest is in good condition with no problems noted

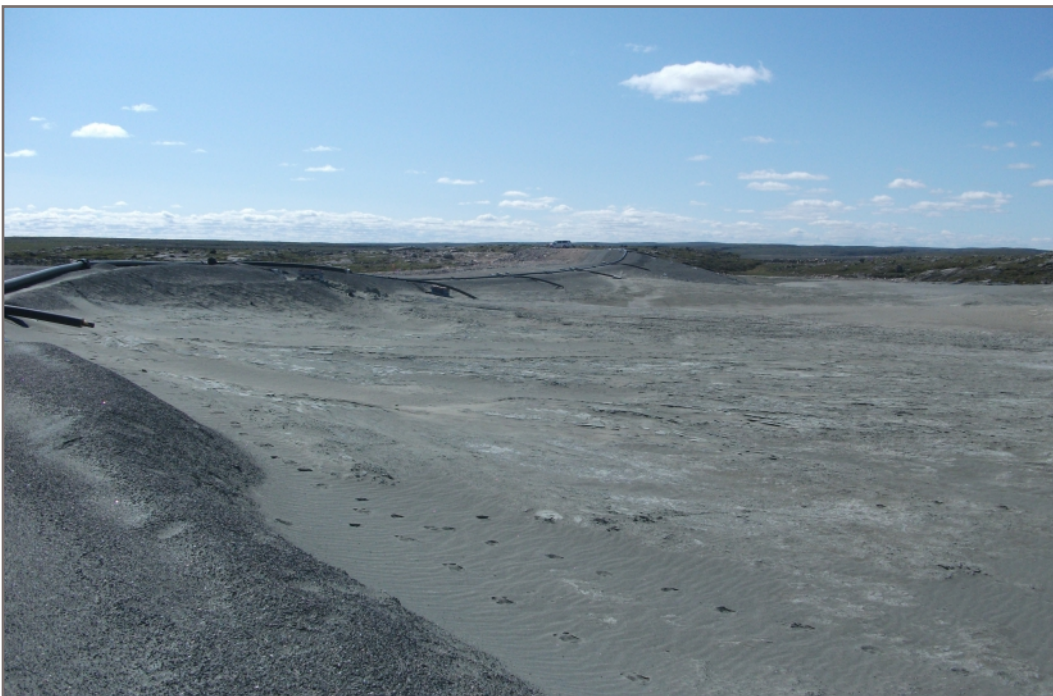
**Photo E2:** Processed kimberlite discharged on upstream face of dam

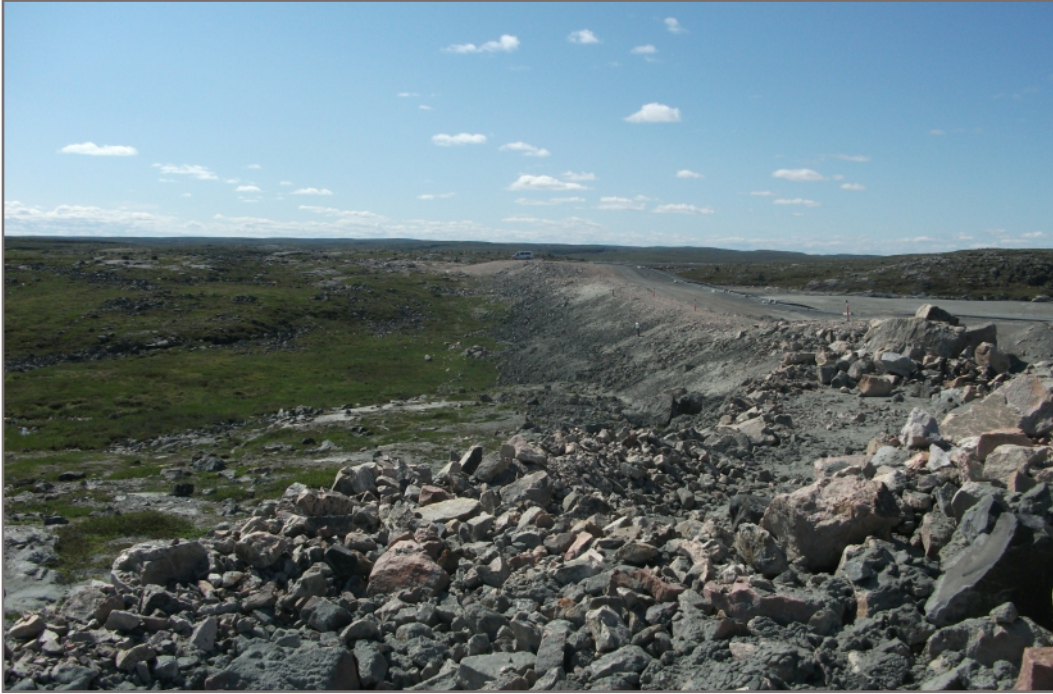
**Photo E3:** Downstream slope of dam is in good condition

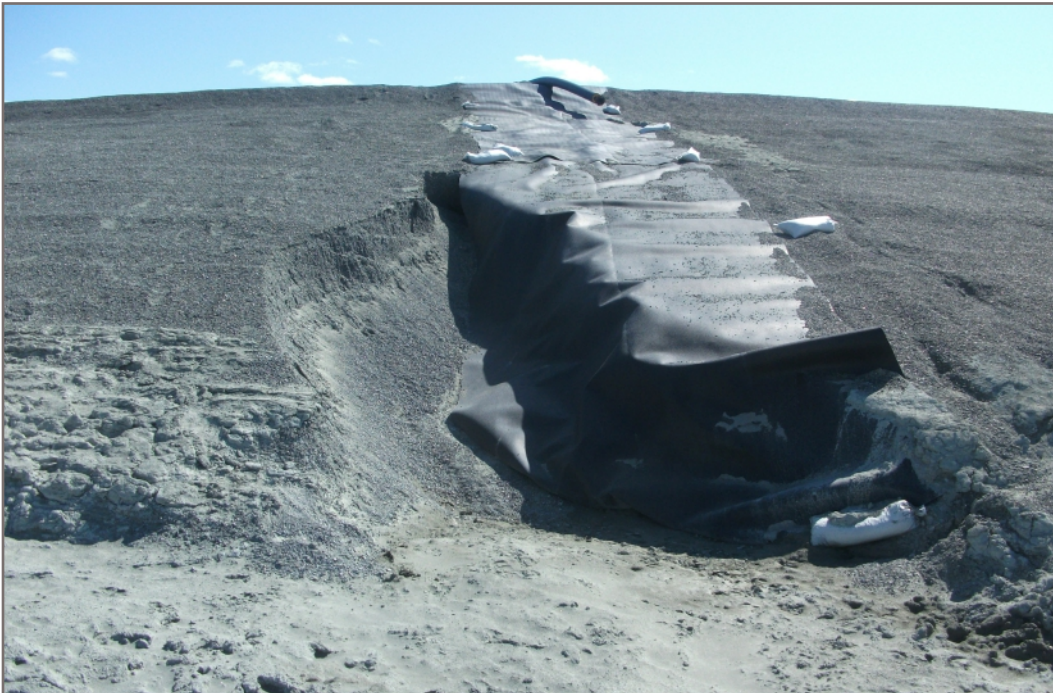
**Photo E4:** Localized erosion of processed kimberlite cover at discharge location; does not impact dam performance

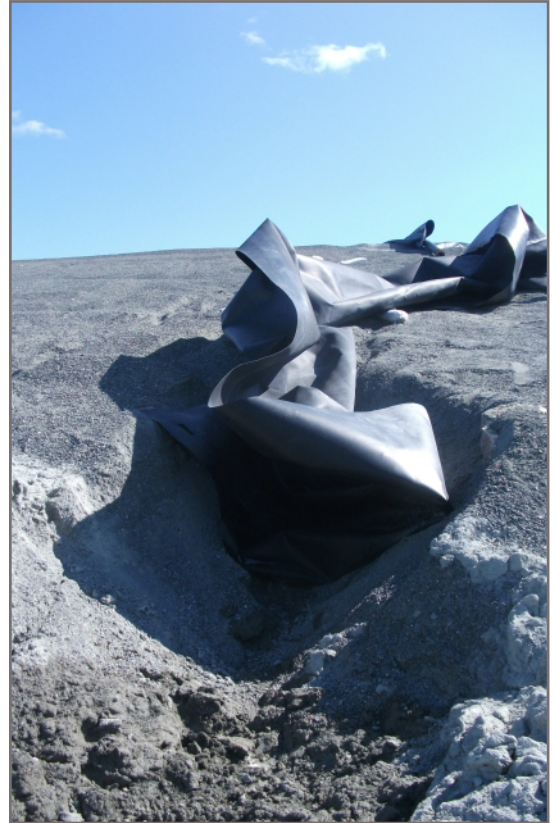
**Photo E5:** Localized erosion of processed kimberlite cover at discharge location; does not impact dam performance

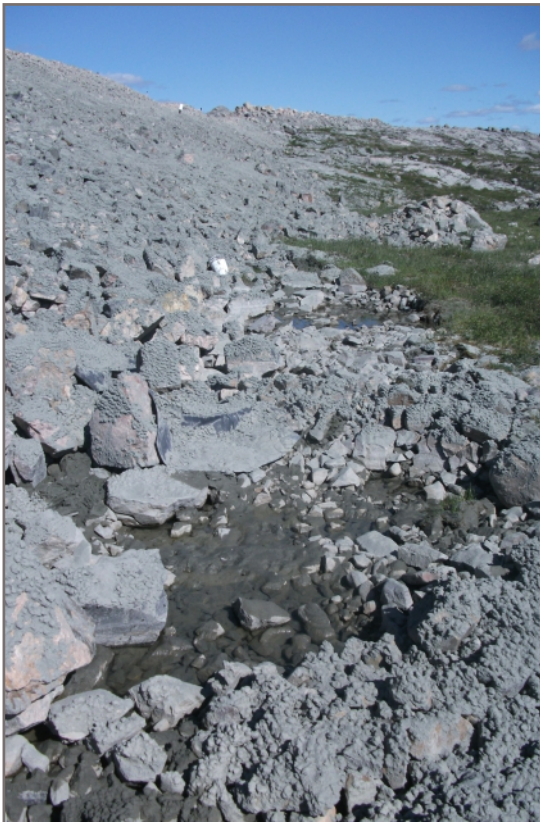
**Photo E6:** Ponded water adjacent to downstream toe; water collected in topographic lows and not seeping through dam
