2011 ANNUAL GEOTECHNICAL INSPECTION  
JERICHO DIAMOND MINE, NU

C1 DIVERSION

**Location:** Jericho Diamond Mine  
**Facility:** Tankfarm  
**Observation Date:** July 16, 2011  
**Inspected by:** Gary Koop, P.Eng.  
EBA, A Tetra Tech Company

TANK FARM

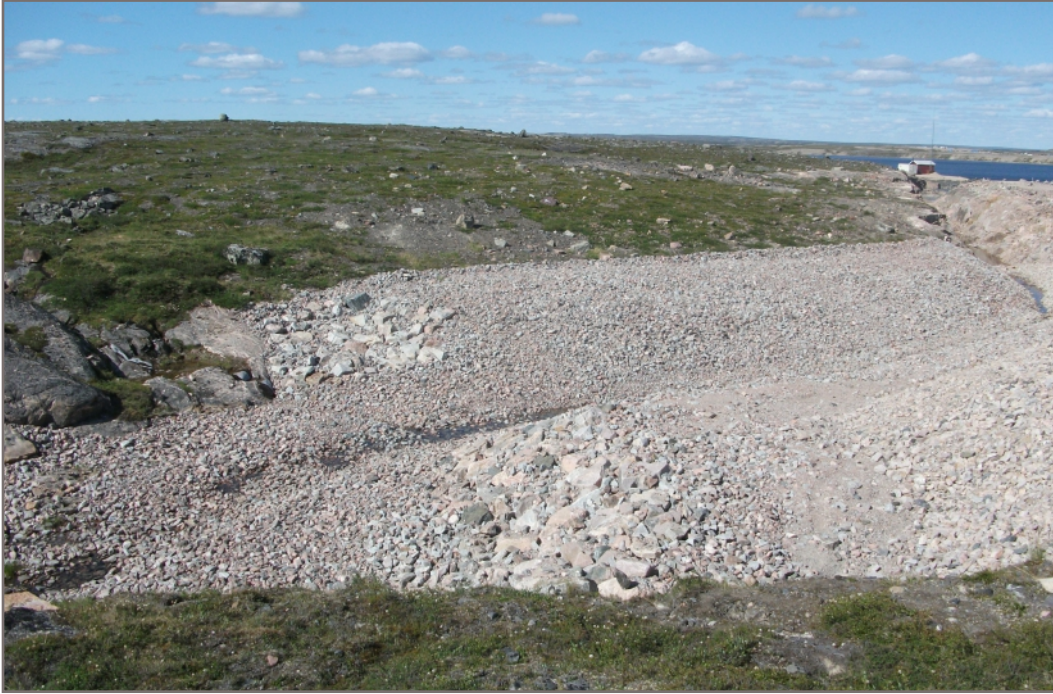
**Photo F1:** Inlet area (Reach A) of C1 Diversion

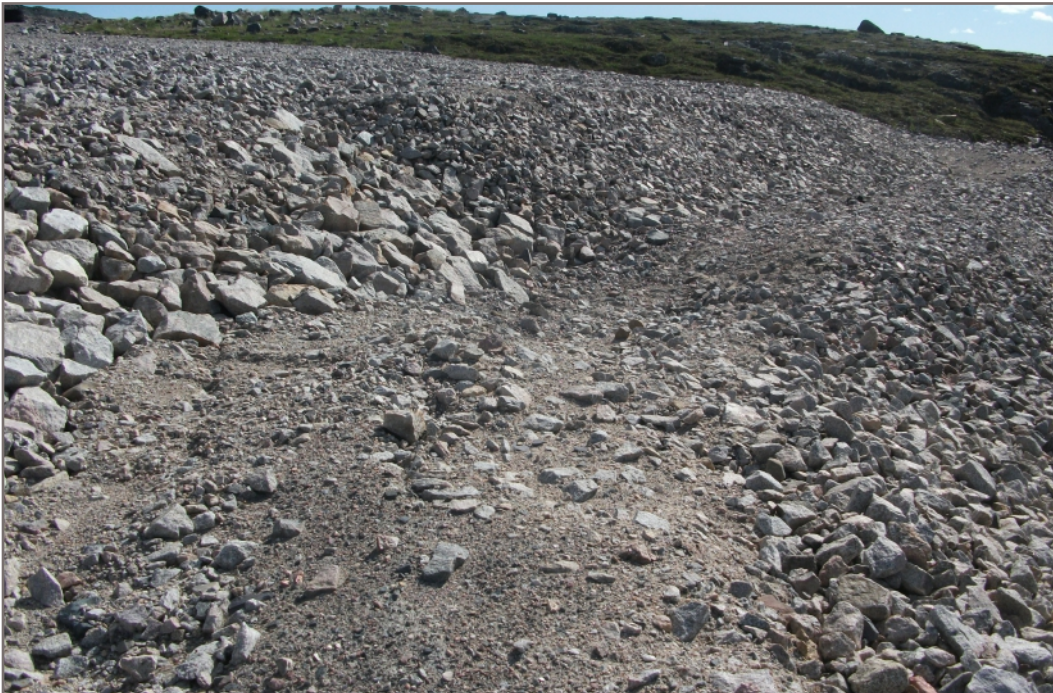
**Photo F2:** Settlement and tension cracking in inlet fill pad; area appears to have self healed from 2009 inspection

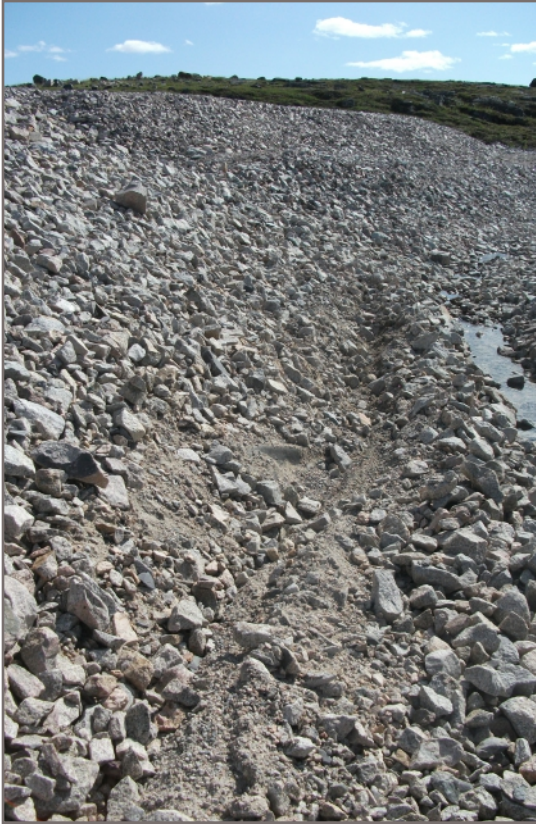
**Photo F3:** Sloughing of erosion protection at north end of Reach A

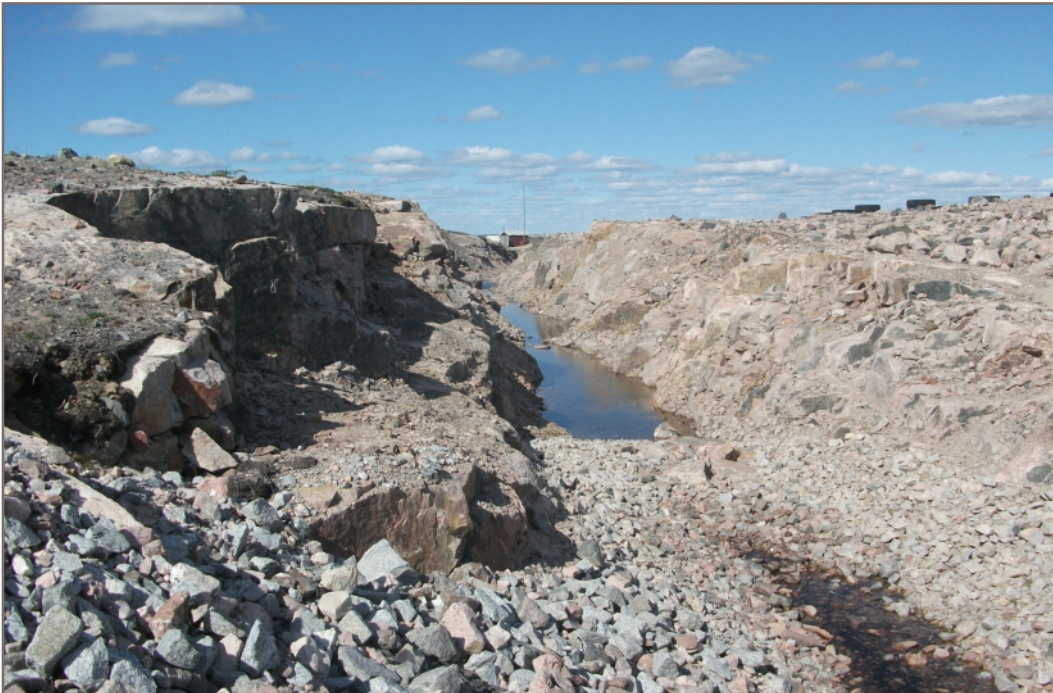
**Photo F4:** Reach A rock cut; no problems noted

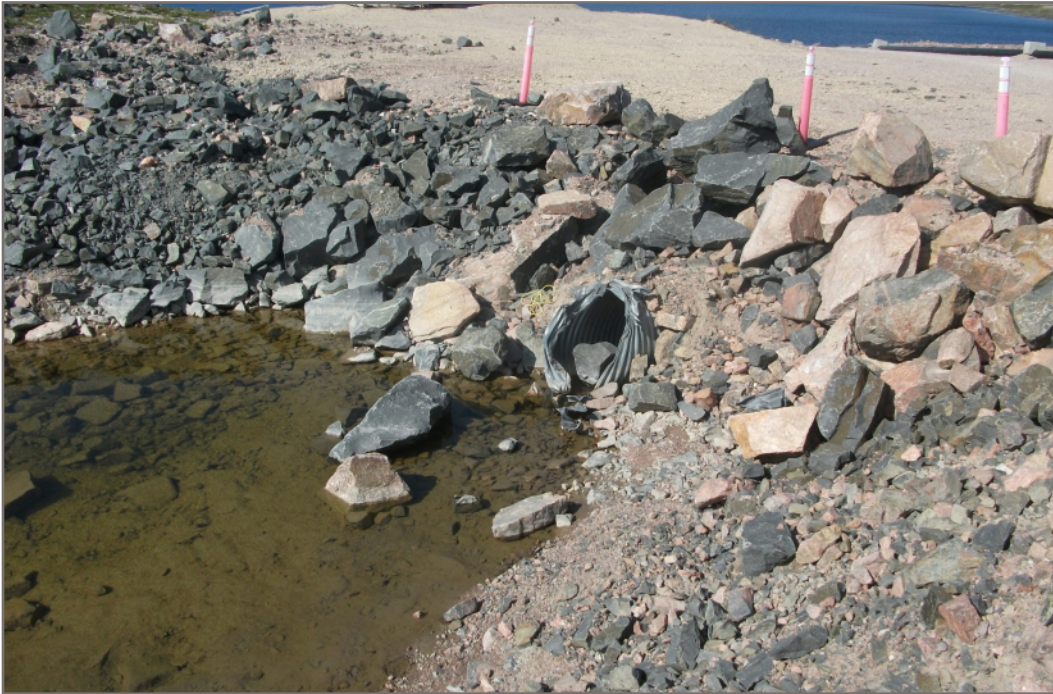
**Photo F5:** Carat Lake Road culvert inlet damaged; inlet appears to have been trimmed since 2009 to better facilitate culvert flow

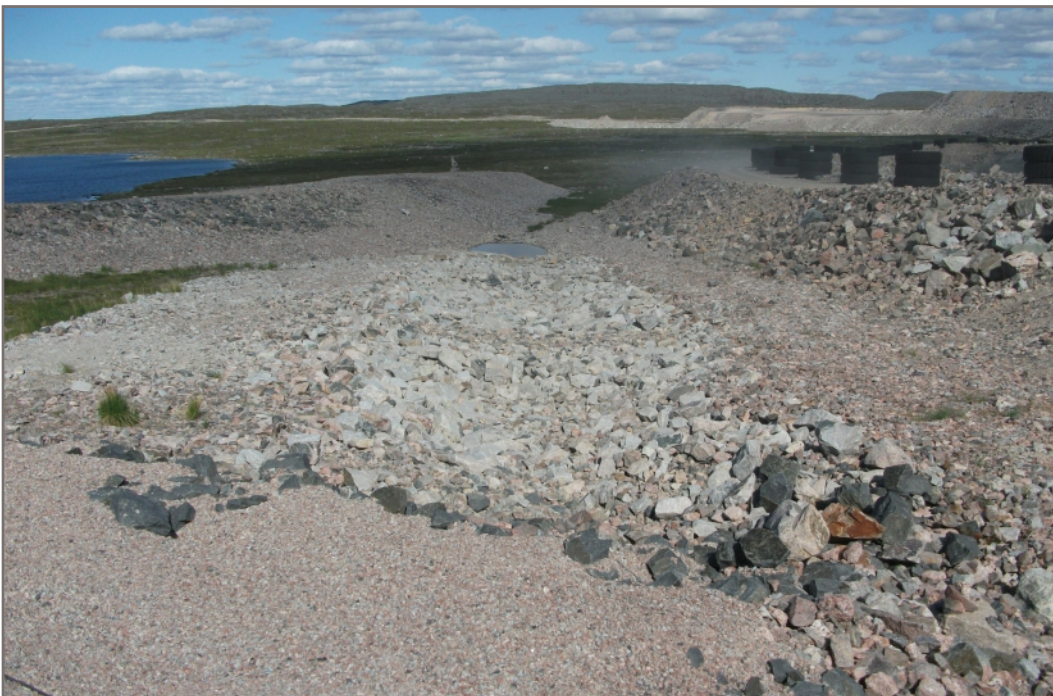
**Photo F6:** Reach B looking northeast from Carat Lake Road

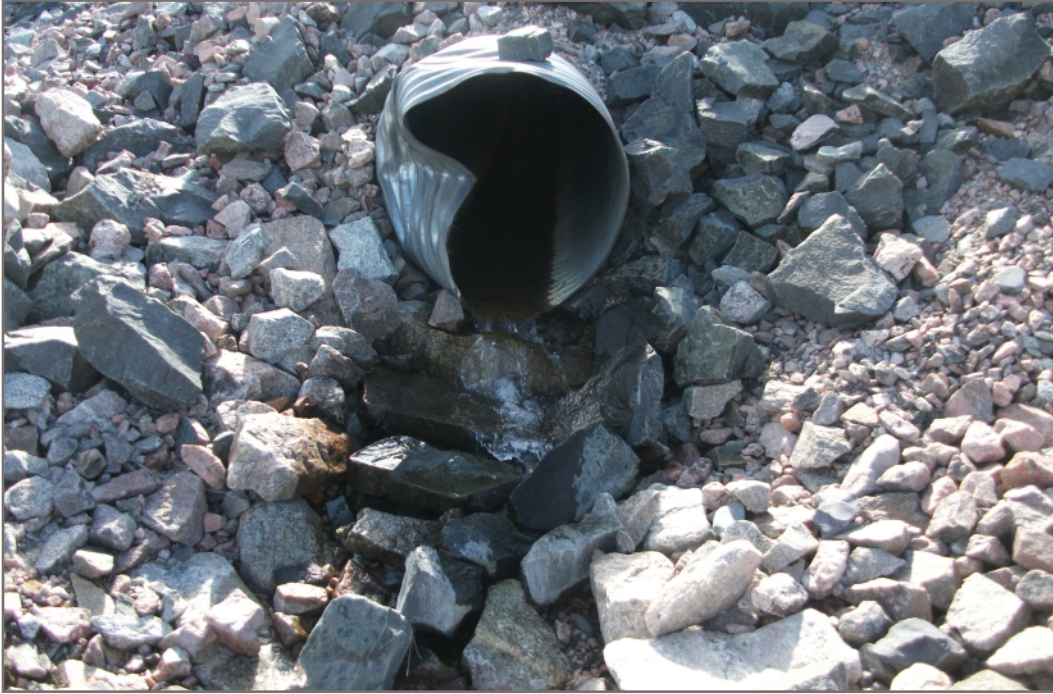
**Photo F7:** Culvert outlet; condition unchanged from 2009 inspection

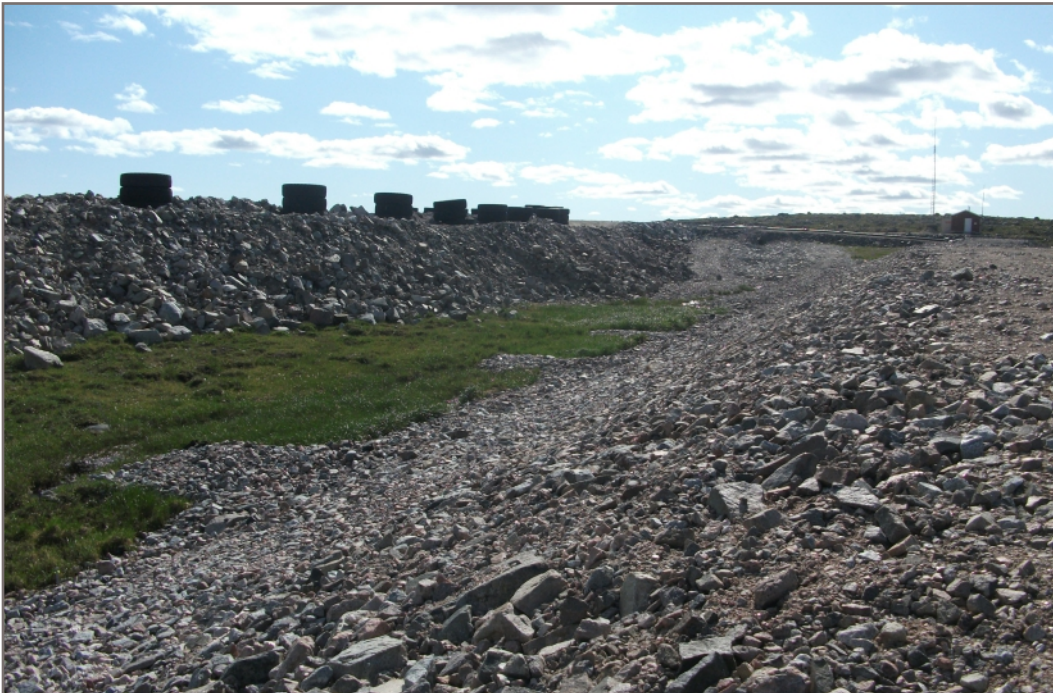
**Photo F8:** Reach C well vegetated

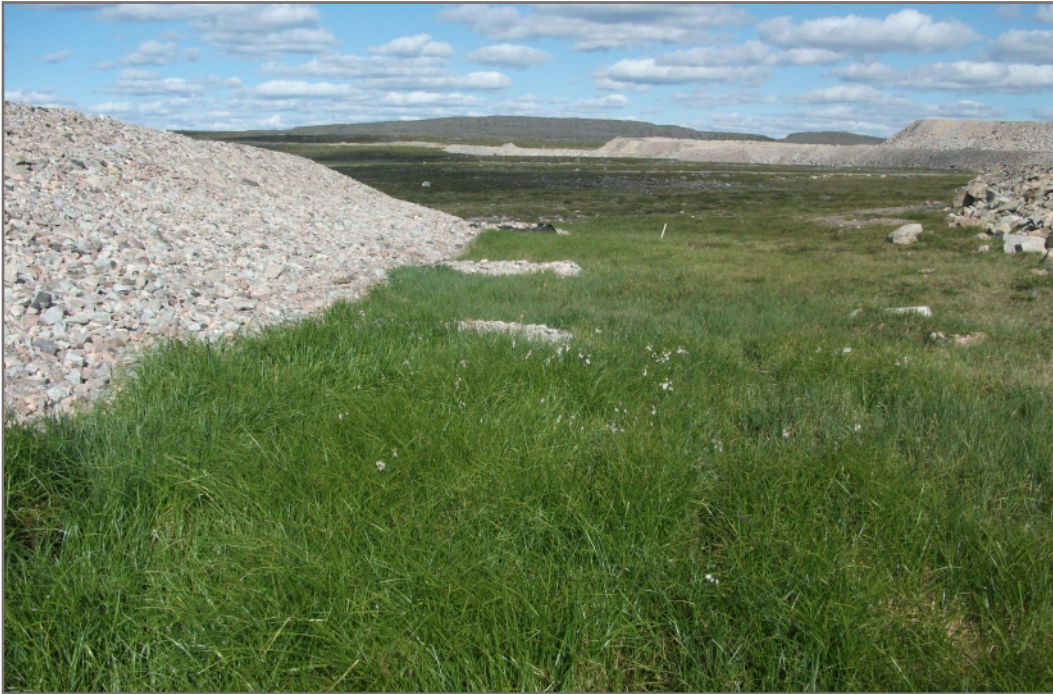
**Photo F9:** Reach C - spur with insufficient cover visible in background of photo; condition similar to 2009 inspection

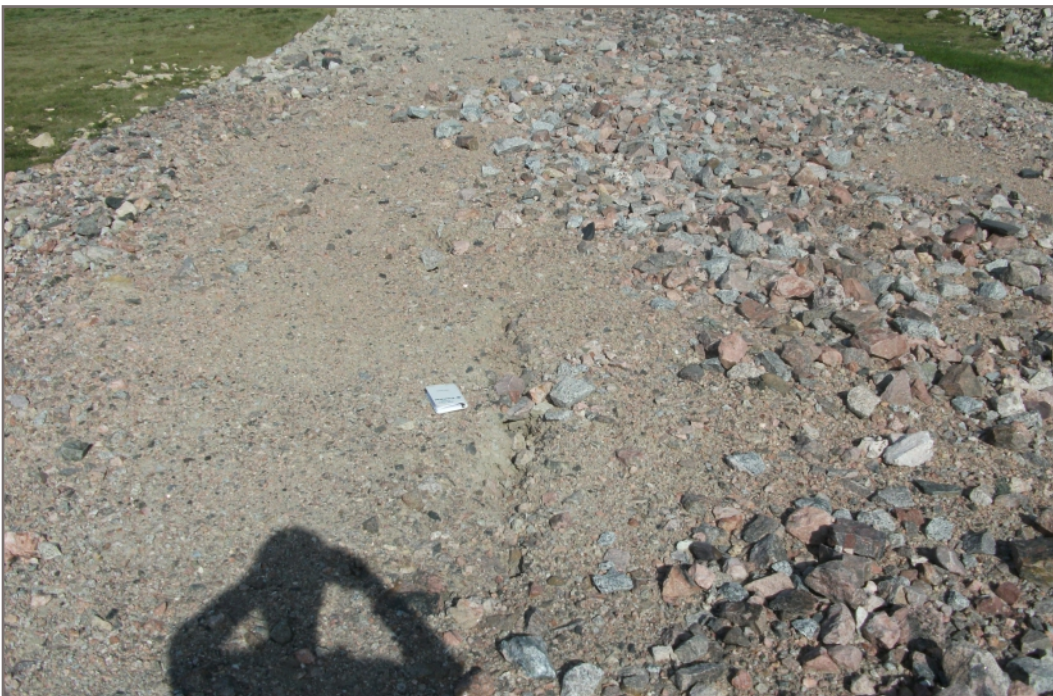
**Photo F10:** Longitudinal cracking in north berm (typical)

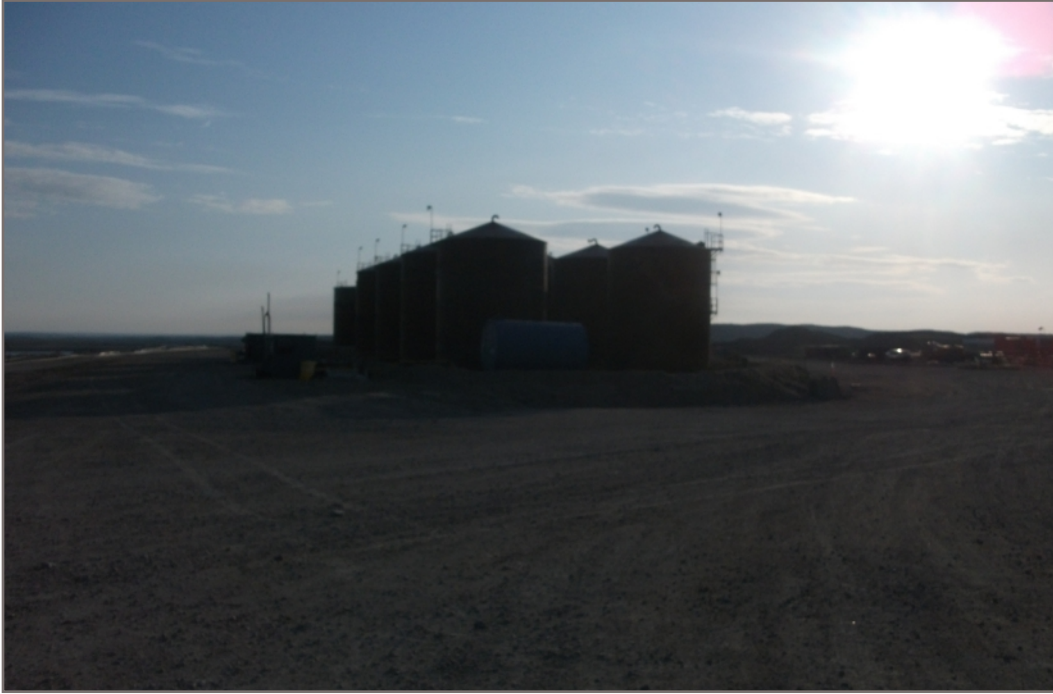
**Photo G1:** Phase 1 tankfarm

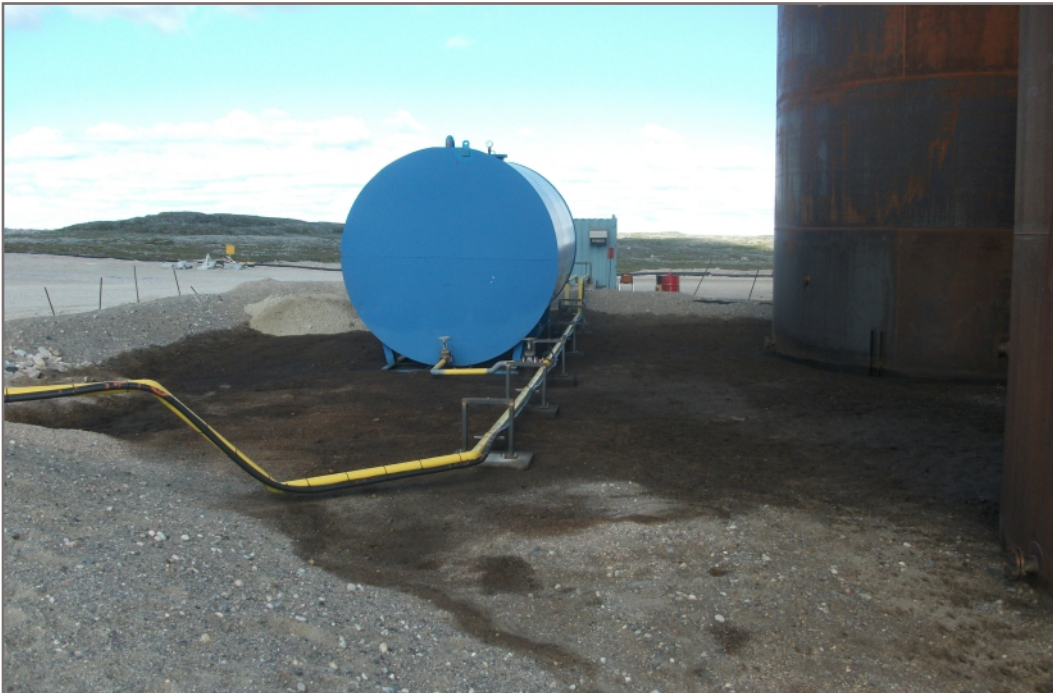
| | Stained Soil | Numerous large stain areas | Sporadic, most at valve locations | Hydrocarbon stained soil on inside surface of tankfarm base | G.2 |

**Photo G2:** Significant staining in tankfarm area

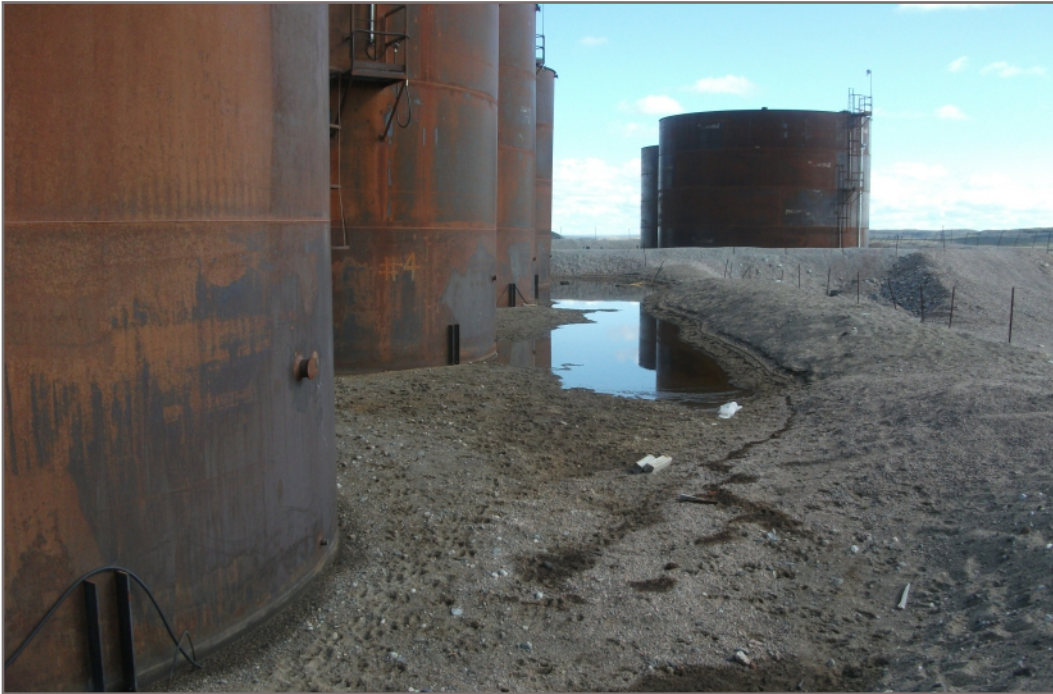
| | East Berm | no fuel in Phase 1 except for residual amount. | | Settlement in east berm appears to be greater than 0.3 m. | G.3 |
| | Ponded/Frozen Water | | Sporadic | Sections throughout Phase 1 | G.3 |

**Photo G3:** Water collected in northern portion of Phase 1 Tank Farm; low berm near tie-in with Phase 2 Tank Farm

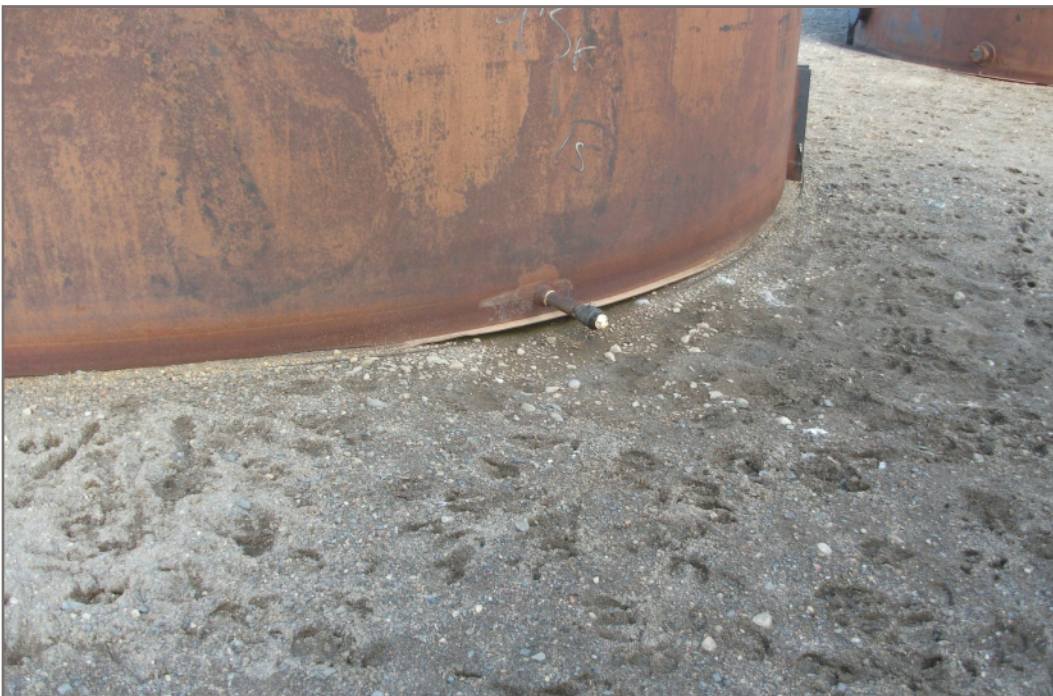
| Features | Present (yes/no) | Dimensions | Extent | Description | Photographic Records |
|---|--|---|---|--|---|
| Settlement | Settlement within Phase 1 Tankfarm<br><br>Tanks List | Uneven surface throughout tank farm Gaps up to 50 mm high under several of the tanks. Tanks in Phase 1 tilting up to 1.5°. Previous monitoring indicated settlement during the first year, settlement appeared to slow down. Has not been monitored recently. Presently | Throughout the tankfarm and berm. | Settlement apparent under tanks. New flexible pipe connections were installed in 2007 to accommodate the settlement. | G.4 |

**Photo G4:** Gap under Tank 4 approximately 50 mm

The deficiencies noted in the Tank Farm are similar to the previous inspection indicating that settlement has slowed or stopped at present. List angles of the tanks were measured by EBA but a survey of the tanks should be performed when possible.

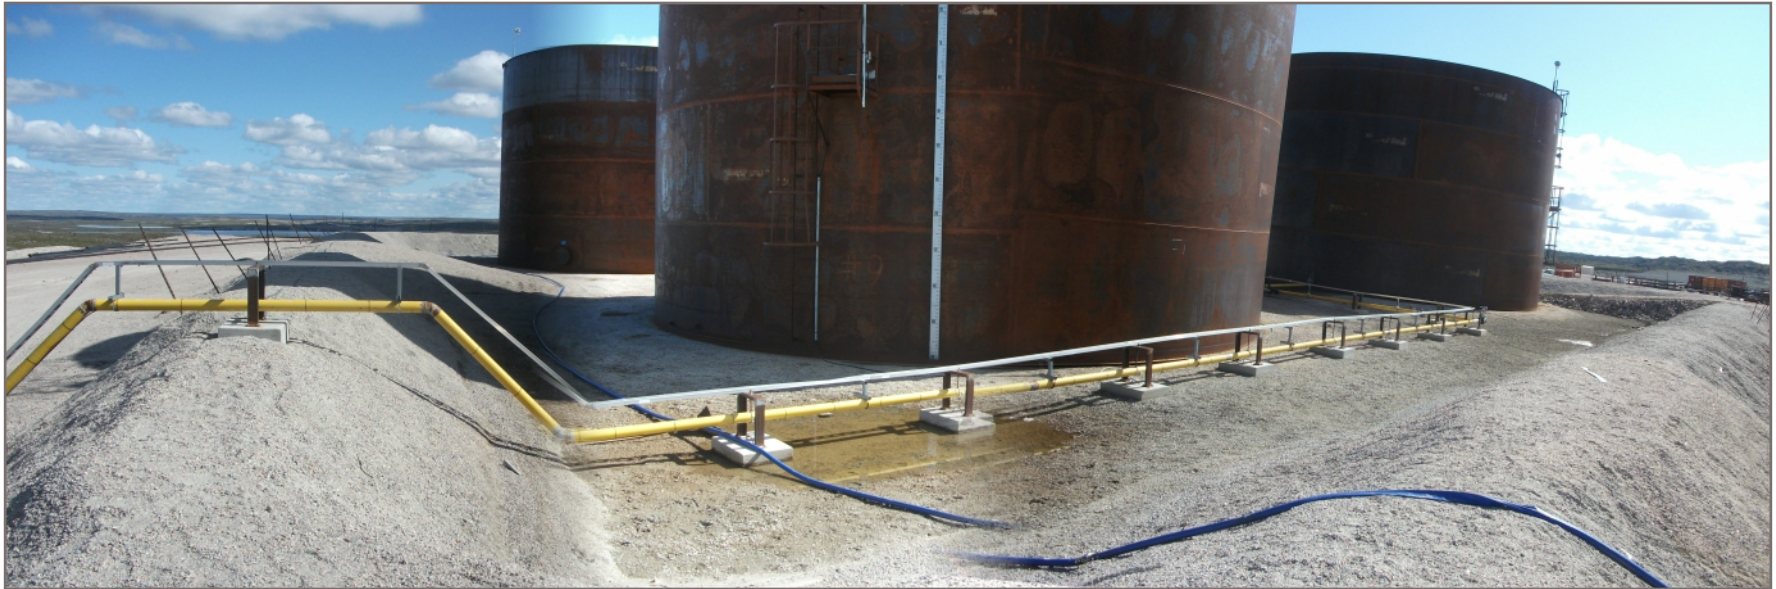
**Photo G5:** Phase 2 Tankfarm

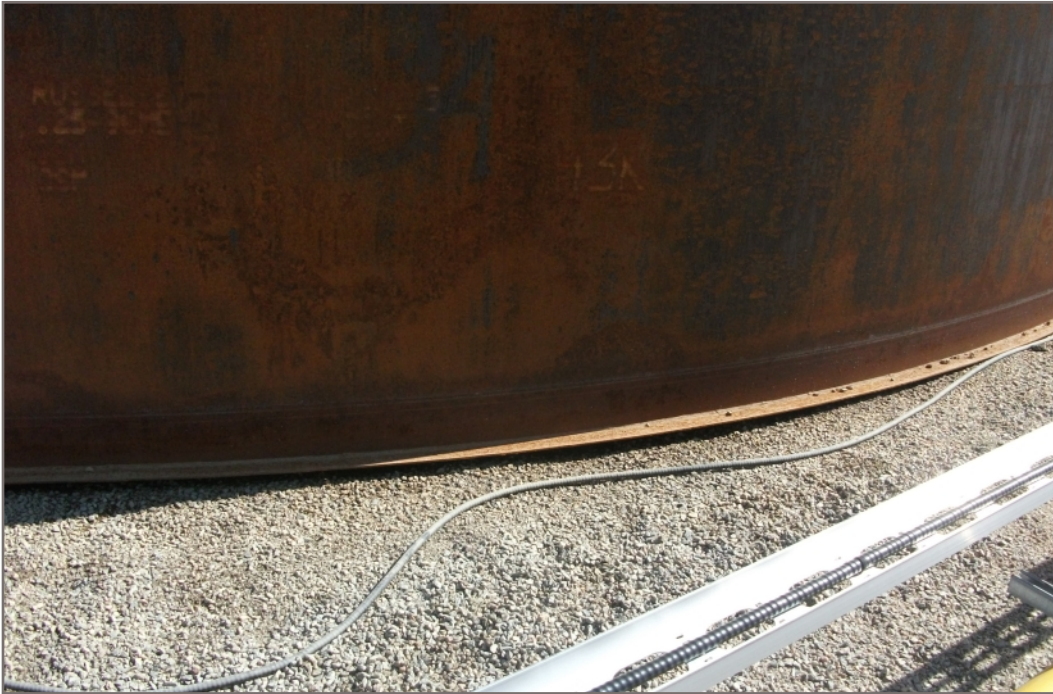
| Settlement | Settlement with Phase 2 Tankfarm | Gap under edge of Tank 9 - up to 35 mm. | Only noted on Tank 9 | Settlement has resulted in gap under edge of the tank. | G.6 |

**Photo G6:** Gap under Tank 9 approximately 50 mm

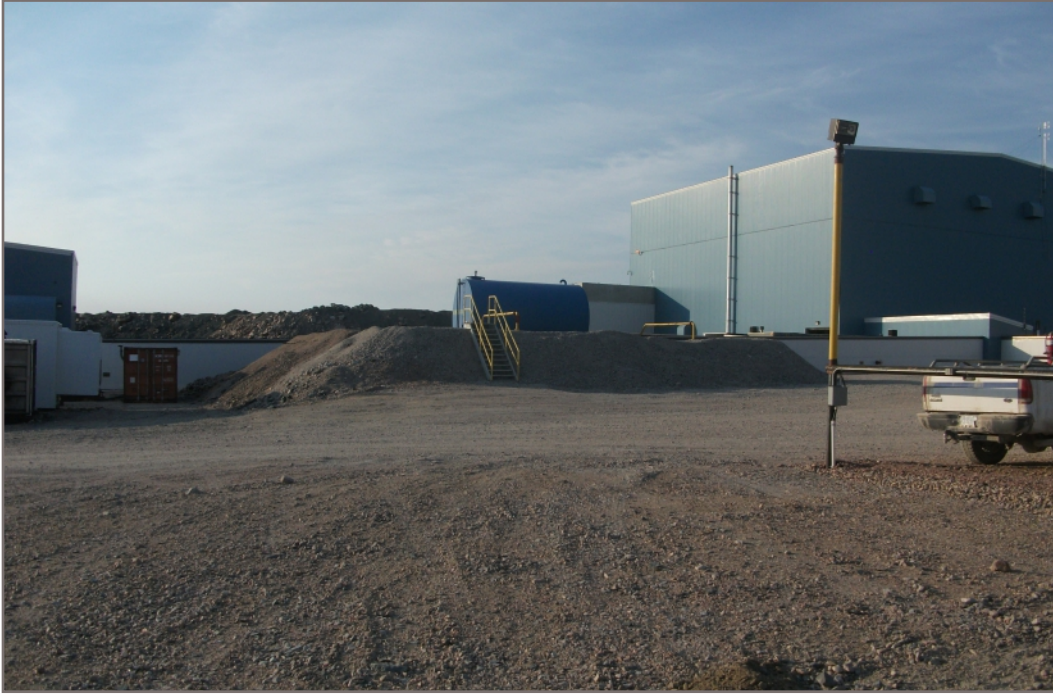
**Photo H1:** Generator tank and berm containment

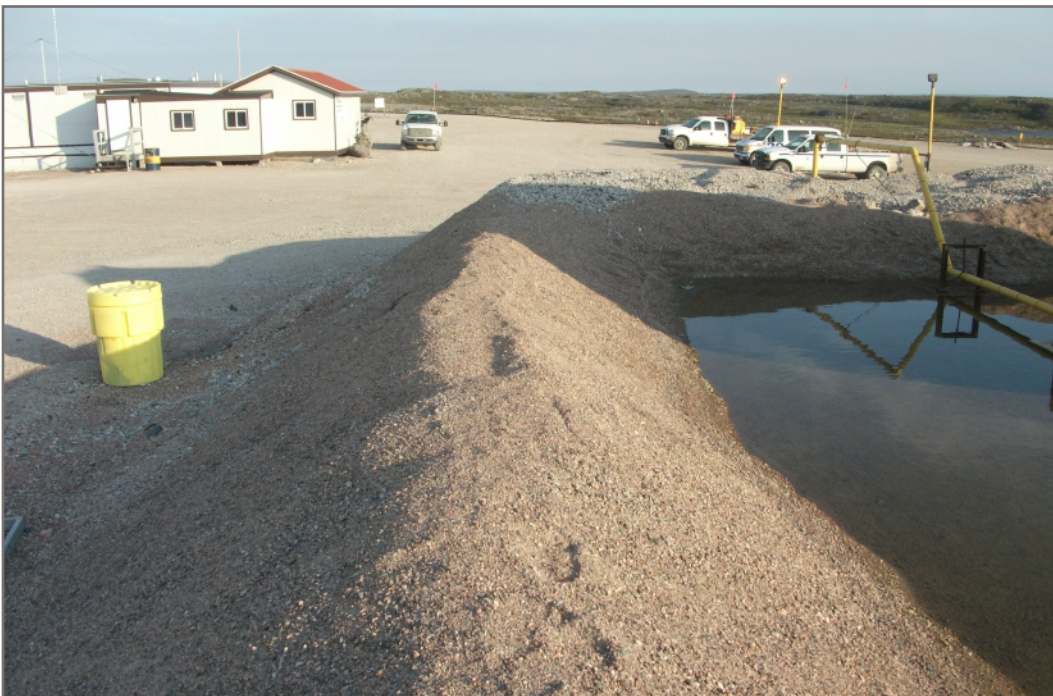
| Features | Present (yes/no) | Dimensions | Extent | Description | Photographic Records |
|---|---|--|---|---|---|
| Other Features | Low area in 20 mm crush on West berm | Berm is approximately 0.4 m low along the north berm | 5% of berm | | H.2 |
| | Ponded Water | | 100% of berm base | | H.2 |

**Photo H2:** Low spot in generator tank berm

Low spot in the 20 mm crush berm – berm supported by 150 mm crush berm. Record drawings should be reviewed to determine where the liner is located to determine if there is a low area in the liner along the north berm. If so, the containment capacity should be reviewed to determine if berm modifications are required.
