SHEAR DIAMONDS (NUNAVUT) CORP.

## 2011 ANNUAL SEEPAGE SURVEY REPORT JERICHO DIAMOND MINE, NUNAVUT

NOVEMBER 2011  
ISSUED FOR USE  
EBA FILE: E14101140

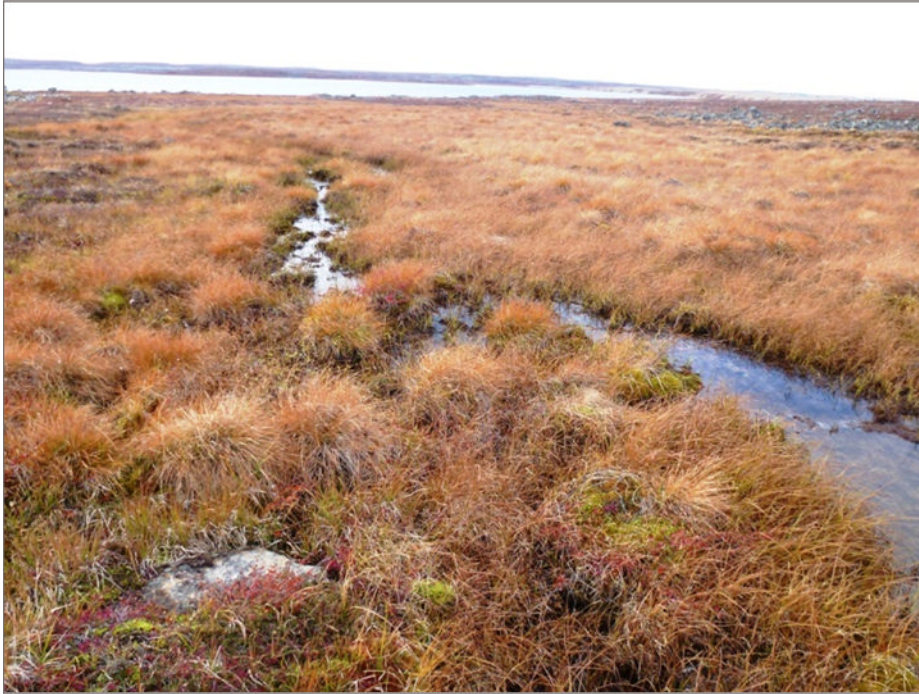
Seeps JER-SPG-01D and 02A infiltrated into the road along the pit, and may further seep into the pit or exit from the toe at the northwest side of Waste Rock Dump 1. Seeps JER-SPG-01A and 01C flowed through a vegetated area before entering Carat Lake; therefore, TSS concentrations in these two seeps are anticipated to be reduced before reaching Carat Lake.

**Photo 1:** Seep JER-SPG-1A Flowing into Carat Lake  
Western aspect  
Photo taken on September 14, 2011

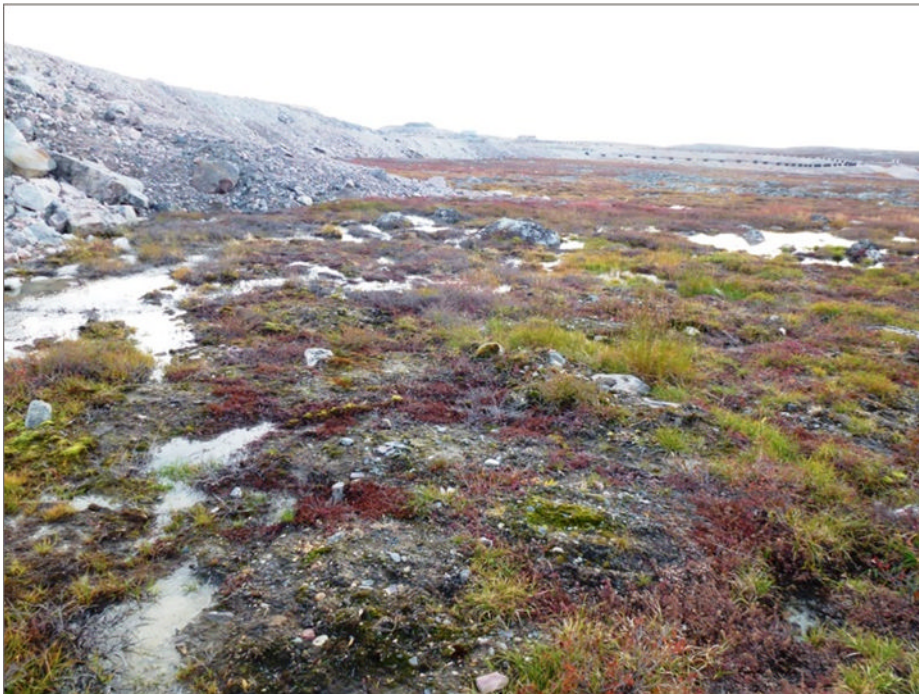
**Photo 2:** Seep JER-SPG-1B Emerging from West Side of Waste Rock Dump 1  
Southern aspect  
Photo taken on September 14, 2011

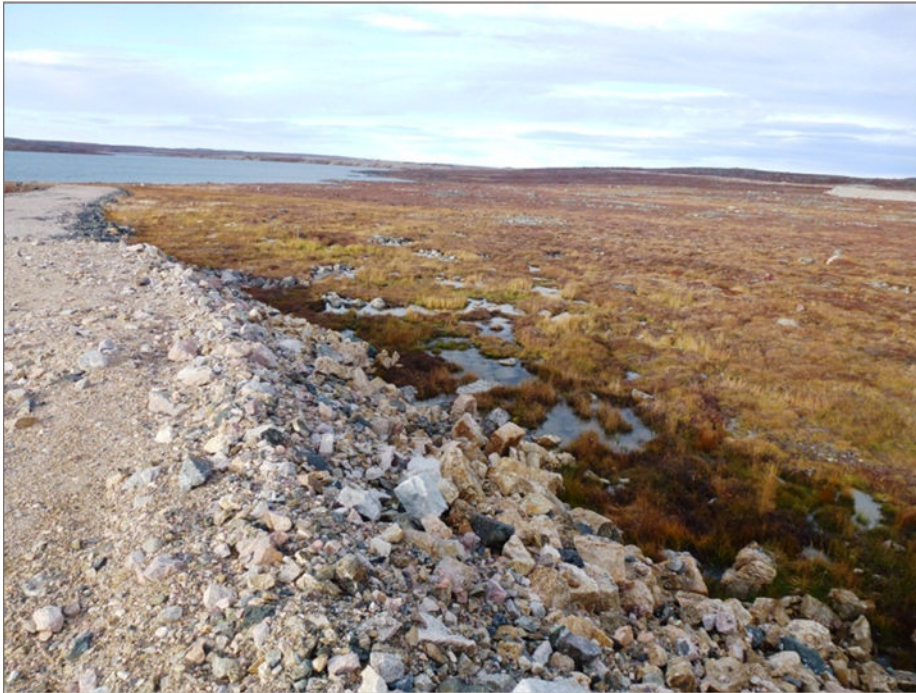
**Photo 3:** Seep JER-SPG-1C Flowing North into Carat Lake  
Northern aspect  
Photo taken on September 14, 2011

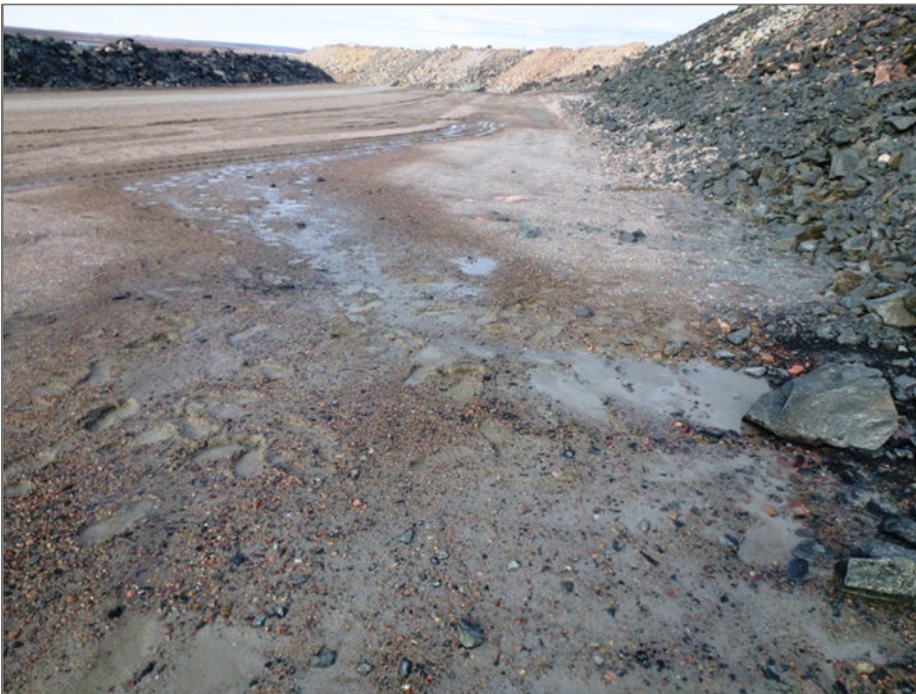
Nitrate concentrations in samples JER-SPG-01D and 02A were 125 mg/L and 58 mg/L, which exceeded the Water Licence MGC criterion of 56 mg/L. These two seeps infiltrated the road. Based on the topography of the original ground, they may further seep into the pit or exit from the toe at the northwest side of Waste Rock Dump 1.

**Photo 4:** Seep JER-SPG-01D Flowing North on Haul Road  
Northern aspect  
Photo taken on September 14, 2011

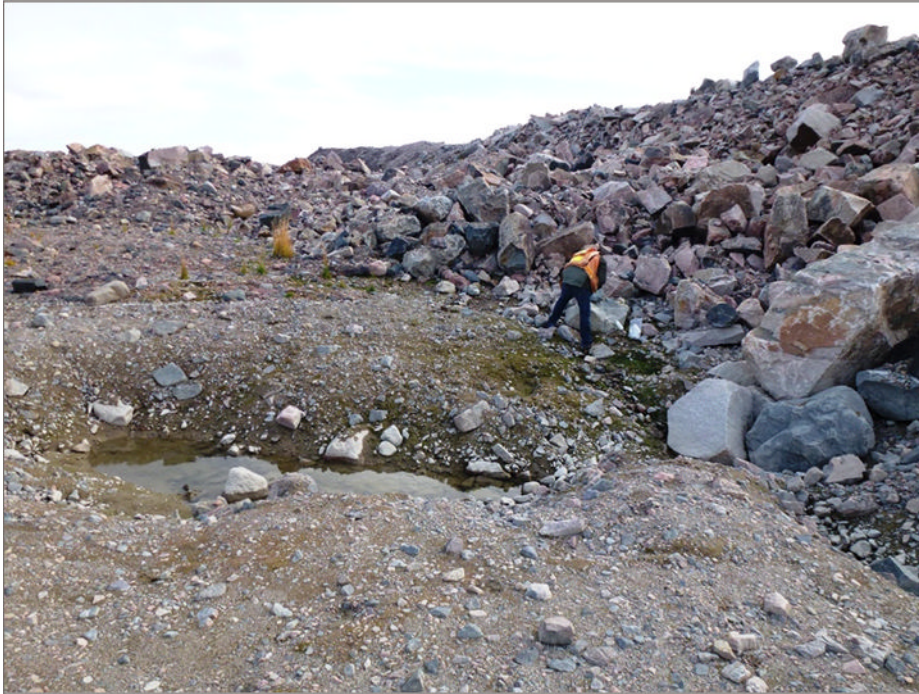
**Photo 5:** Seep JER-SPG-02A Flowing into a Small Pond on Side of Haul Road  
Southeastern aspect  
Photo taken on September 14, 2011

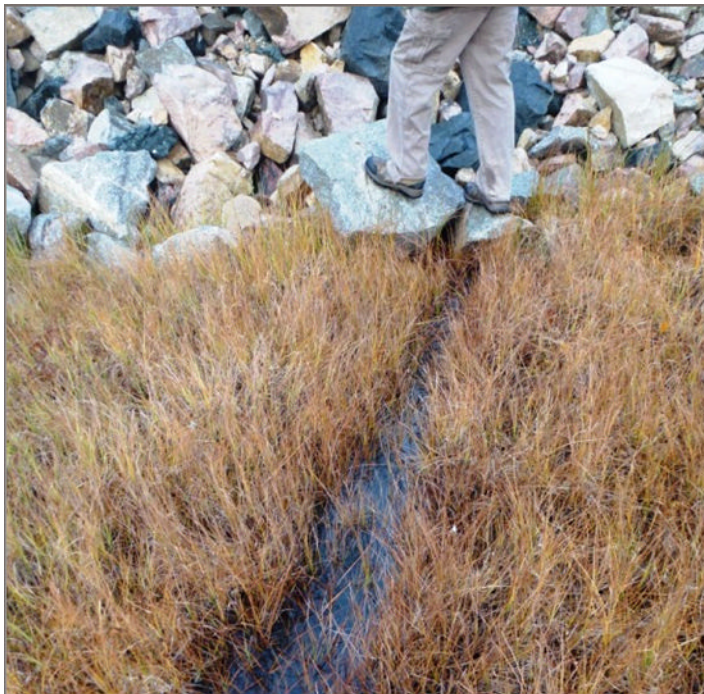
**Photo 6:** Stream JER-SPG-INFLOW01 Flowing West into Waste Rock Dump 1  
Western aspect  
Photo taken on September 15, 2011

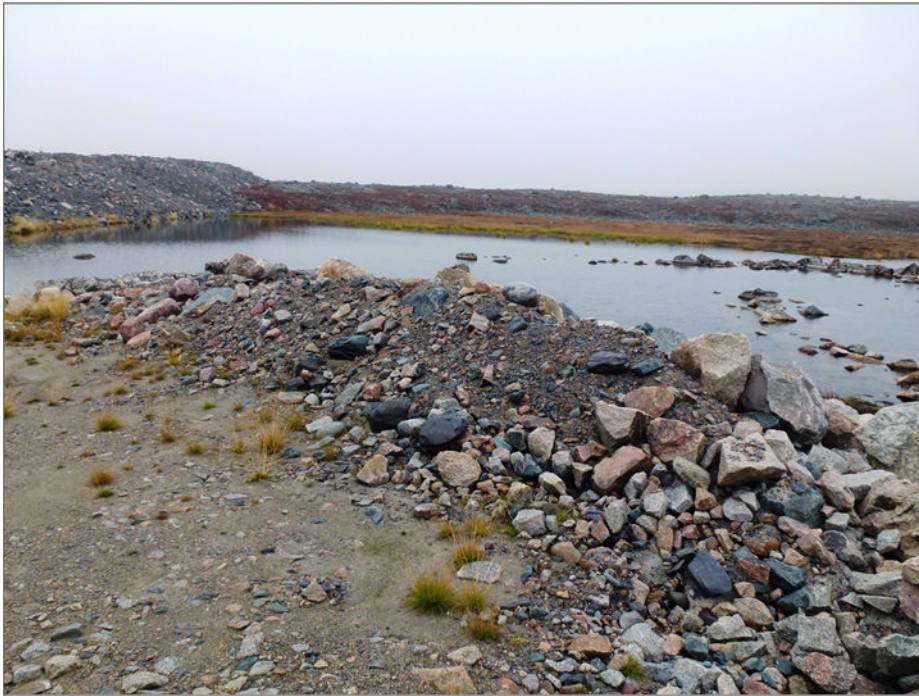
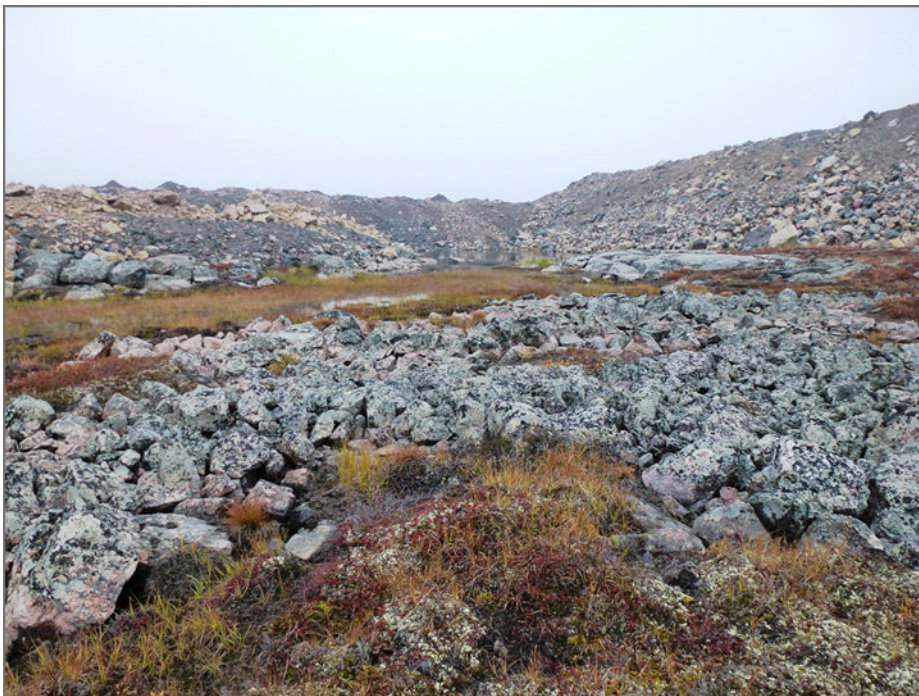
In addition, six water pondings were observed along the perimeter of the waste rock dump, of which two relatively large water pondings had accumulated at the south and east side of Waste Rock Dump 2 (see Figure 1, and Photos 7 and 8). These two pondings were isolated at the time of the survey. Based on the observed moisture at the flow path between the ponding at the south side of Waste Rock Dump 2 and Key Lake, excessive water from this pond had flowed towards Key Lake in the past.

**Photo 7:** Ponding South of Waste Rock Dump 2  
Eastern aspect  
Photo taken on September 15, 2011

**Photo 8:** Ponding East of Waste Rock Dump 2  
Northwestern aspect  
Photo taken on September 15, 2011

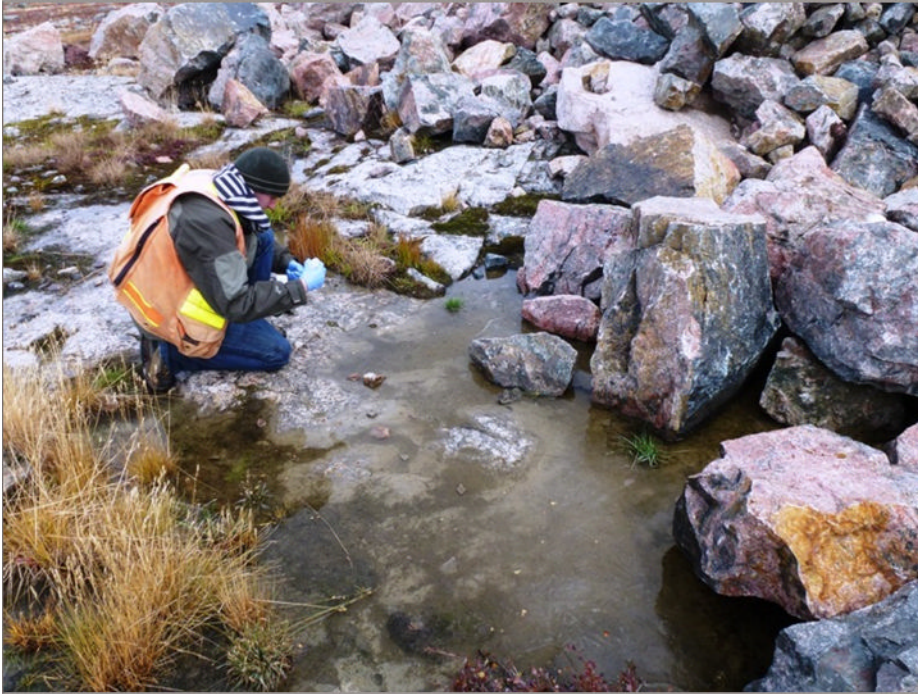
**Photo 9:** Seep JER-SPG-08A Emerging from West Side of Low Grade Ore Stockpile  
Eastern aspect  
Photo taken on September 14, 2011

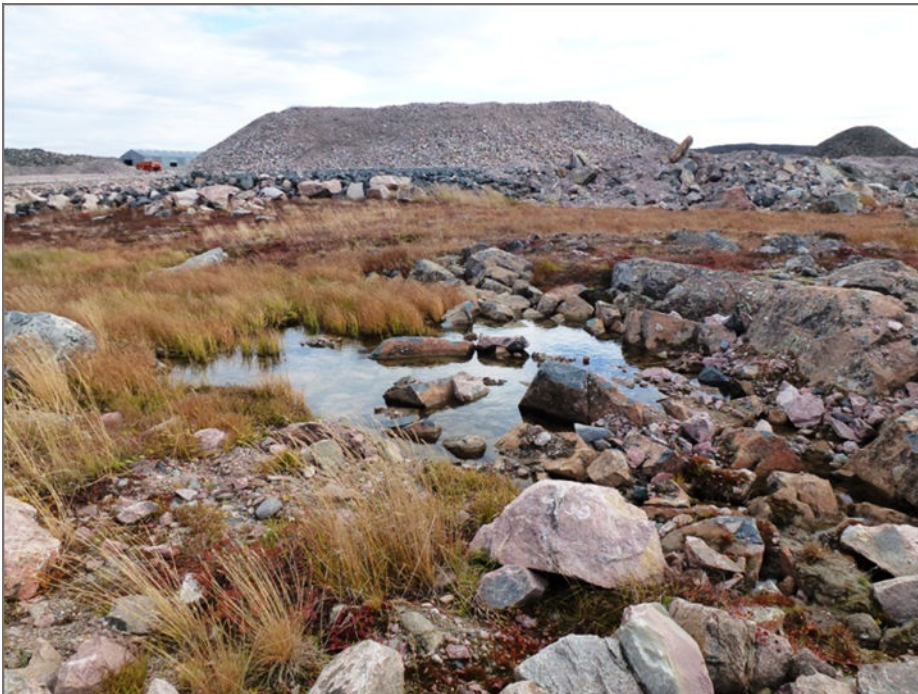
**Photo 10:** Seep JER-SPG-08B at Southwest Side of Low Grade Ore Stockpile  
Southeastern aspect  
Photo taken on September 14, 2011

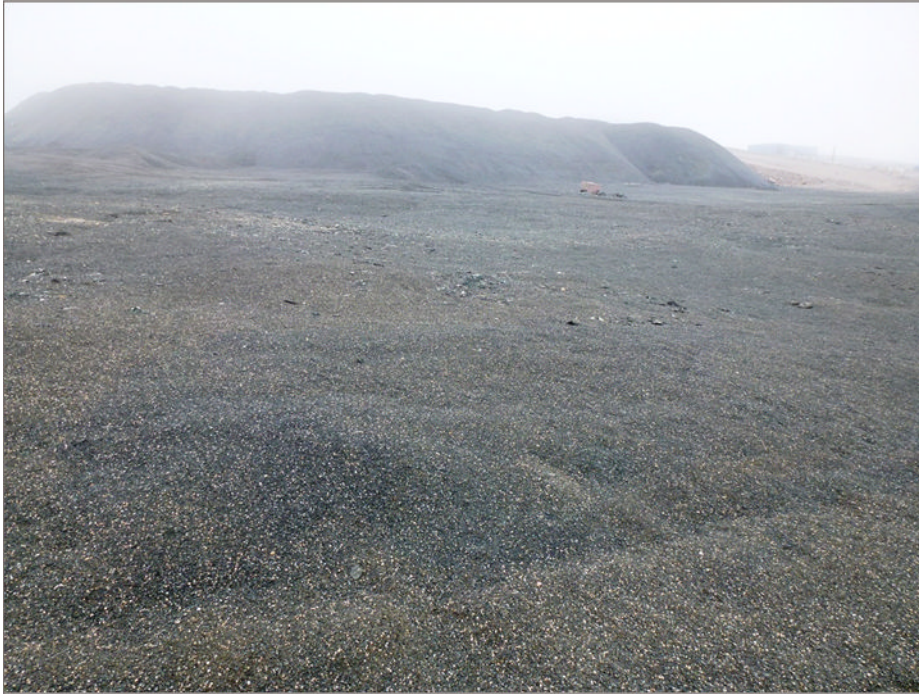
**Photo 11:** Northwest Side of Coarse PK Stockpile  
Southeastern aspect  
Photo taken on September 15, 2011

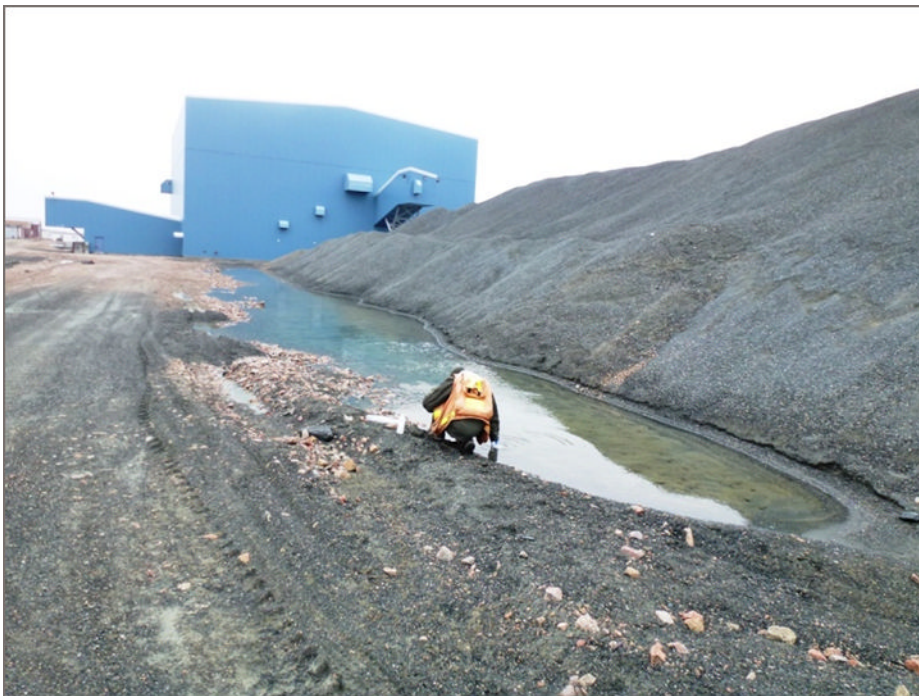
No seeps were observed the perimeters of the Ore Stockpile, CPK Stockpile or Waste Rock Pad for the Plant Site. One relatively large water ponding was found at the south side of the Ore Stockpile (see Photo 12). The ponded water is anticipated to originate from precipitation and surface runoff.

**Photo 12:** Water Ponding at South Side of Ore Stockpile  
Western aspect  
Photo taken on September 15, 2011

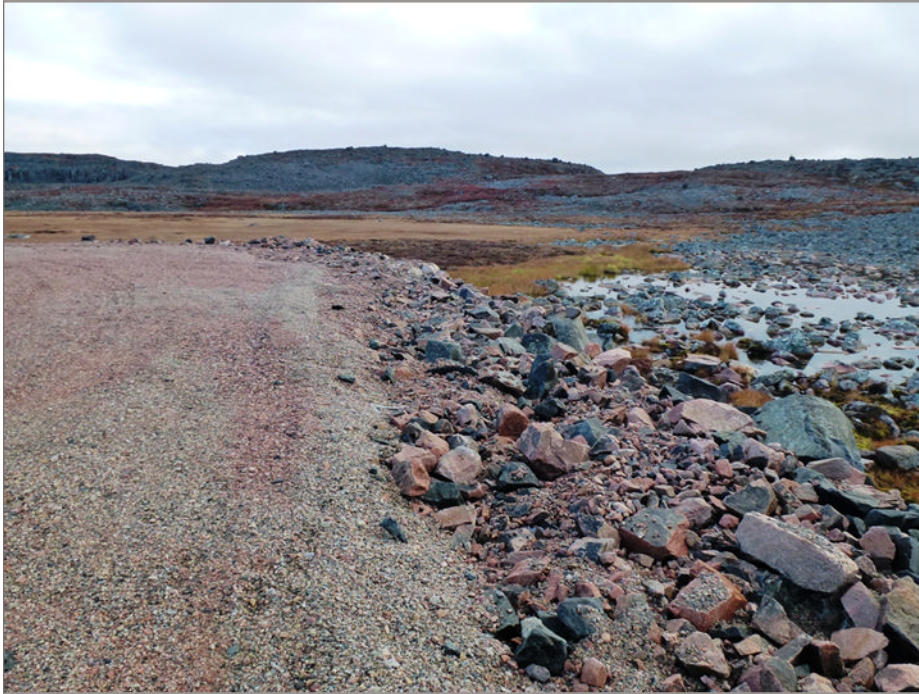
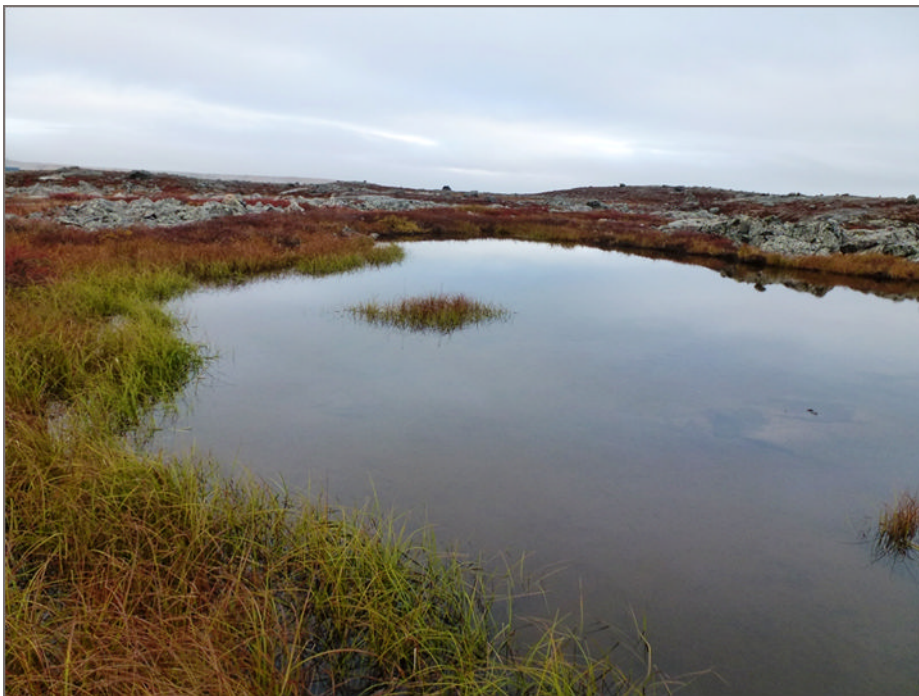
The Ammonium Nitrate Storage Pad is located in close proximity to a wetland area. Ponded water was observed at the east and west side of the pad (see Photos 13 and 14). The ponded water at the west of the pad feed into a small stream flowing in the direction to Lynne Lake. Active flowing water was observed at the time of the survey. As no ammonium nitrate was stored at the pad, no samples were collected during the site visit.

**Photo 13:** Water Ponding and Wetland at East Side of Ammonia Nitrate Storage Pad  
Northeastern aspect  
Photo taken on September 15, 2011

**Photo 14:** Water Ponding at West Side of Ammonia Nitrate Storage Pad  
Western aspect  
Photo taken on September 15, 2011

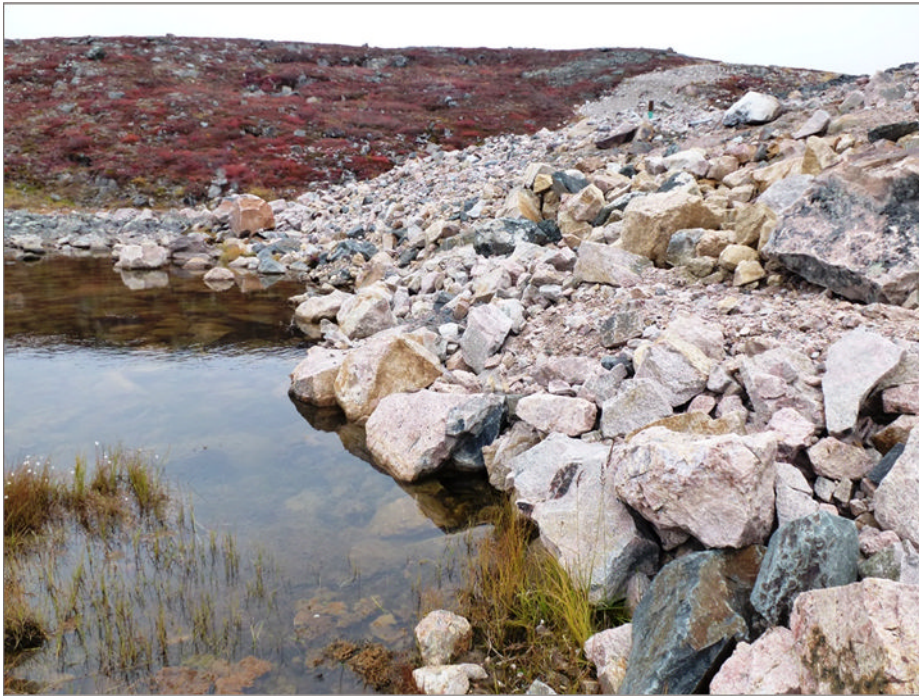
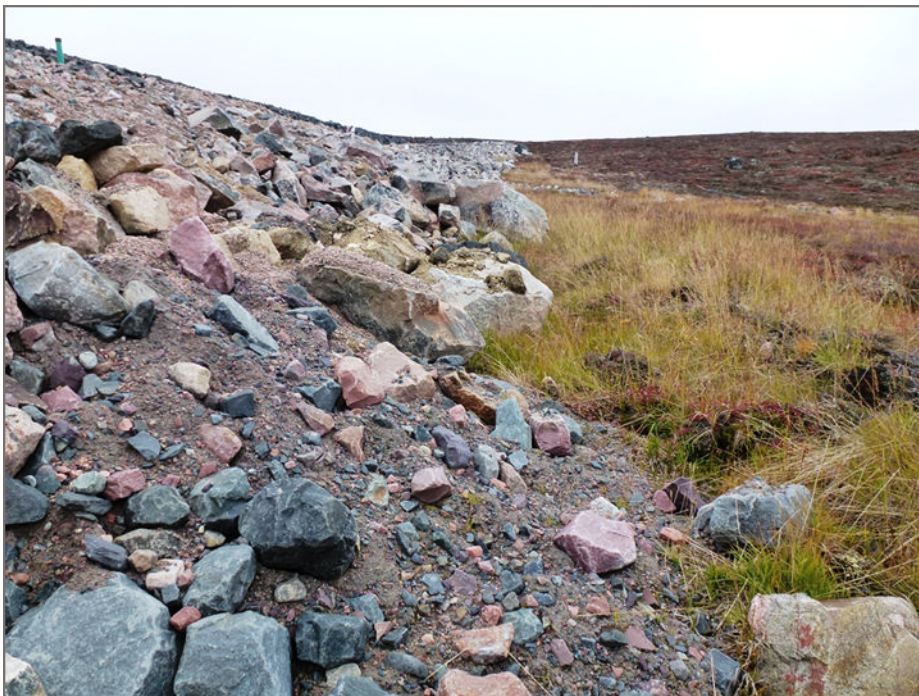
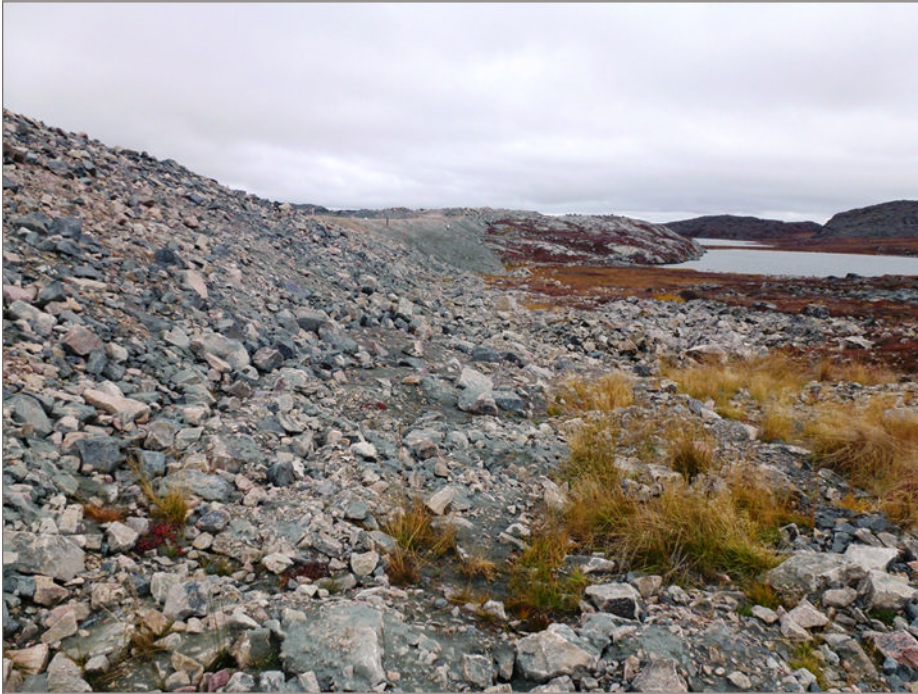
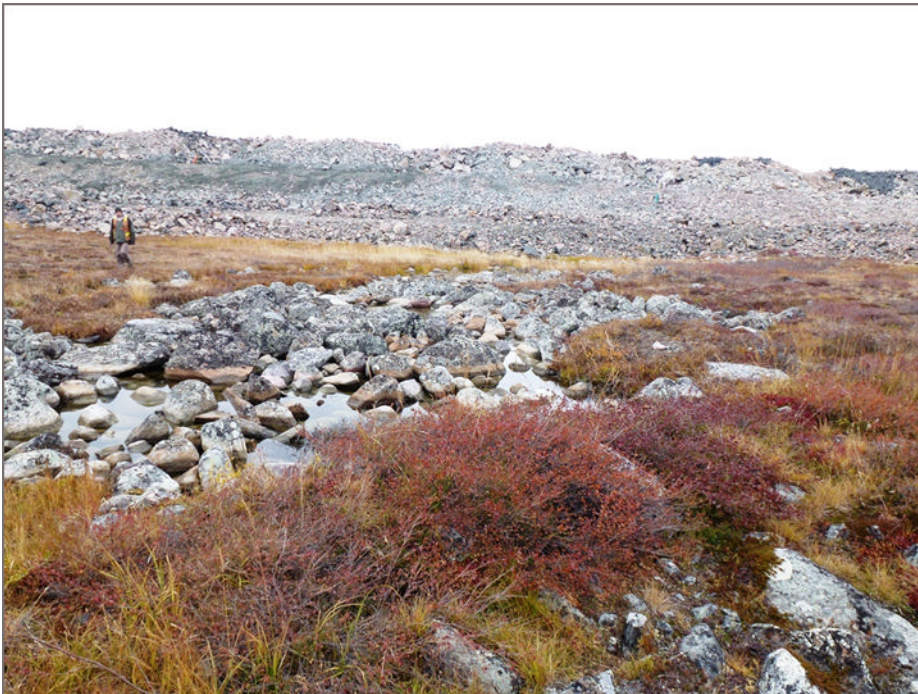
The field personnel conducted visual reconnaissance at the toe of West Dam, Southeast Dam and East Dam of the PKCA (see Photo 15 to 18). No seepage was observed at the time of the survey. This is consistent with the Annual Geotechnical Inspection conducted in July 2011 (EBA 2011a) and the routine seepage monitoring conducted by Shear's on-site personnel.

**Photo 15:** North Portion of the West Face of West Dam  
Northern aspect  
Photo taken on September 15, 2011

**Photo 16:** South Portion of the West Face of West Dam  
Southern aspect  
Photo taken on September 15, 2011

**Photo 17:** Southeast Face of Southeast Dam  
Northeastern aspect  
Photo taken on September 15, 2011

**Photo 18:** East Face of East Dam  
Western aspect  
Photo taken on September 15, 2011
