**Indian and Northern Affairs Canada  
Nunavut Field Operations  
Box 100  
Iqaluit, Nunavut  
X0A 0H0**

**Tahera Diamond Corporation/ Benachee Resources Inc.  
803-121 Richmond Street West  
Toronto, Ontario  
M5H 2k1**

**February 22, 2005**

**Re: Jericho Camp Water Licence Inspection July 15, 2004.**

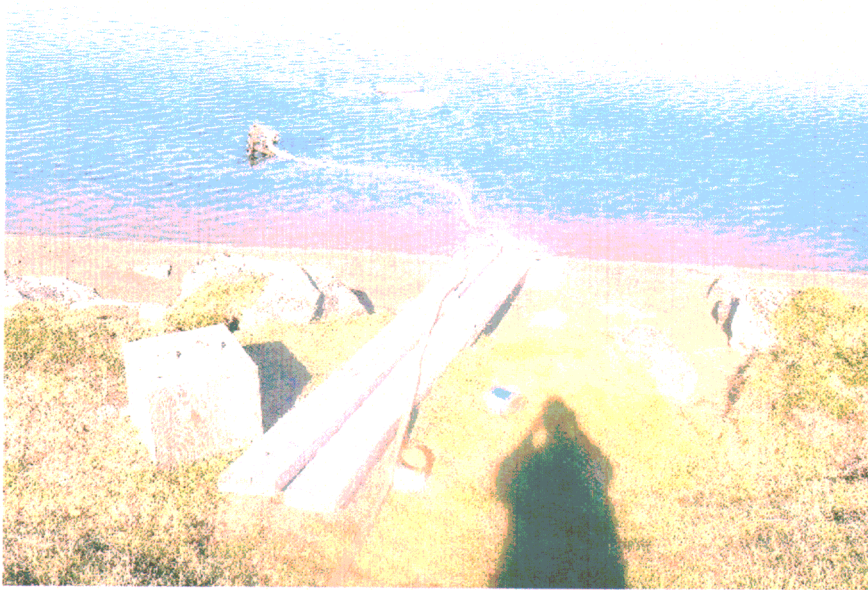
The Licencee is required to record the monthly and annual quantities of freshwater obtained from Carat Lake. Water use records were not present at the time of the Inspection and no means were in place to record the volume of water drawn from Carat Lake. An Annual Report containing information on all activities relating to the Water Licence in 2004 is required not later than March 31, 2005. The small, gasoline powered intake at Carat Lake should be equipped with a spill kit to ensure that fuel does not enter the water should a spill occur (Figure 1). The water intake and treatment plant (Figure 2) will be upgraded when the camp is moved and expanded, hopefully spill response and containment measures will be upgraded as well.

Figure 1. Freshwater intake on Carat Lake at Jericho Camp.

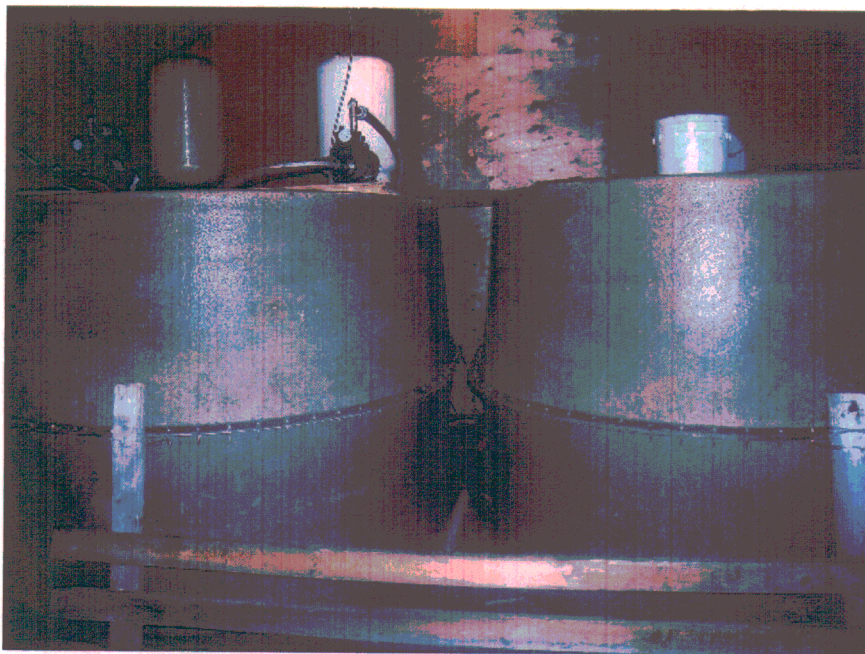
Figure 2. Freshwater tanks in the Water Treatment Plant at Jericho Camp.

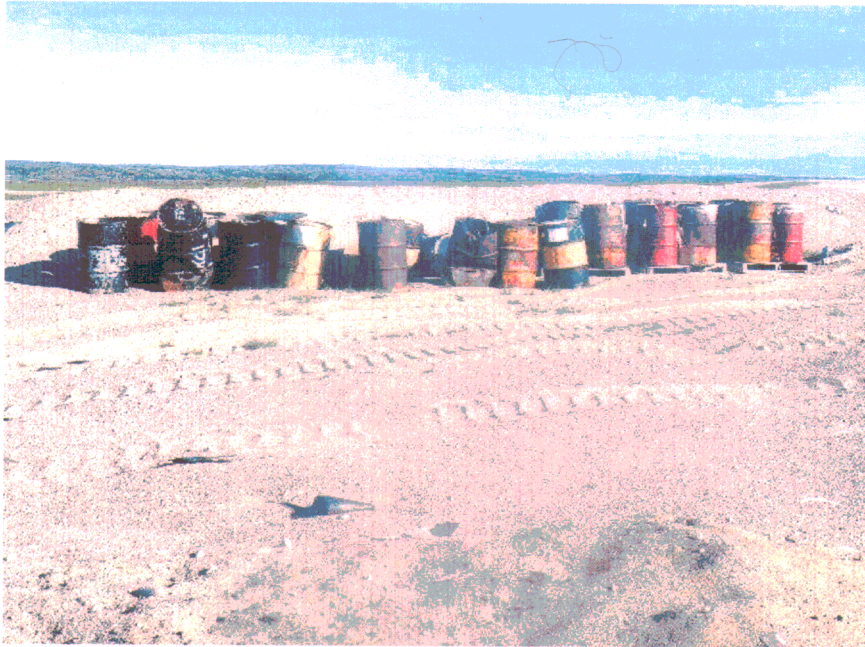
Current storage of waste fuel and oil is unacceptable. Many of the waste drums are tipped over and the partial liner currently in place would not hinder the migration of any released contaminants. Small combustibles and food waste are incinerated on site while non-burnable waste and the ash from incineration are collected and stored in a partially bermed area (Figure 3). The waste barrels should all be stored upright on pallets, in a completely bermed and lined area to prevent contaminant migration (Figure 4). Large combustible waste is currently open burned (Figure 5) with the ash placed in barrels for transport south. Waste barrels should be transported south for disposal in an appropriate licenced facility on an annual basis.

Figure 3. Waste drums in a partially bermed area at Jericho camp.

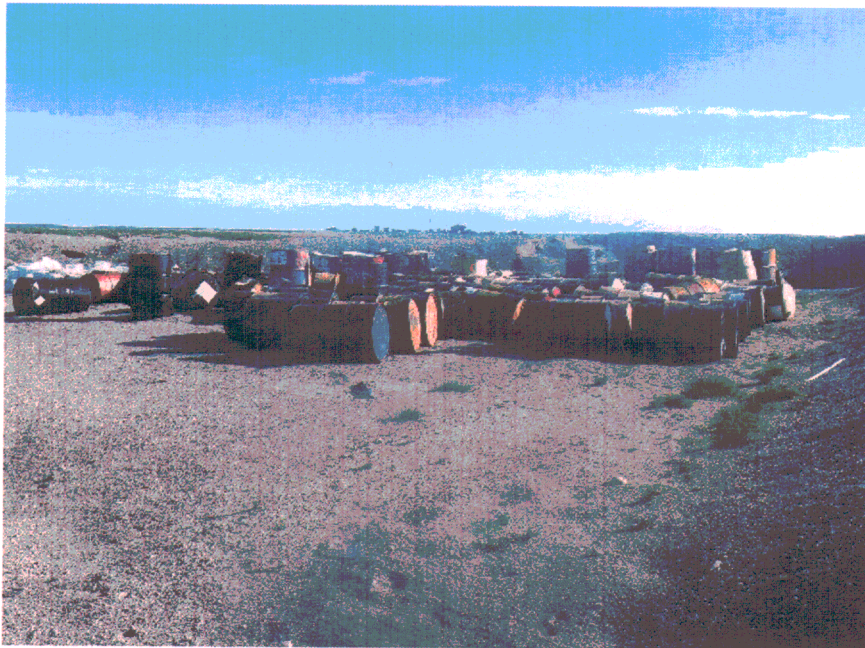
Figure 4. Ash, waste oil and non-burnable waste storage area with many barrels tipped on their side.

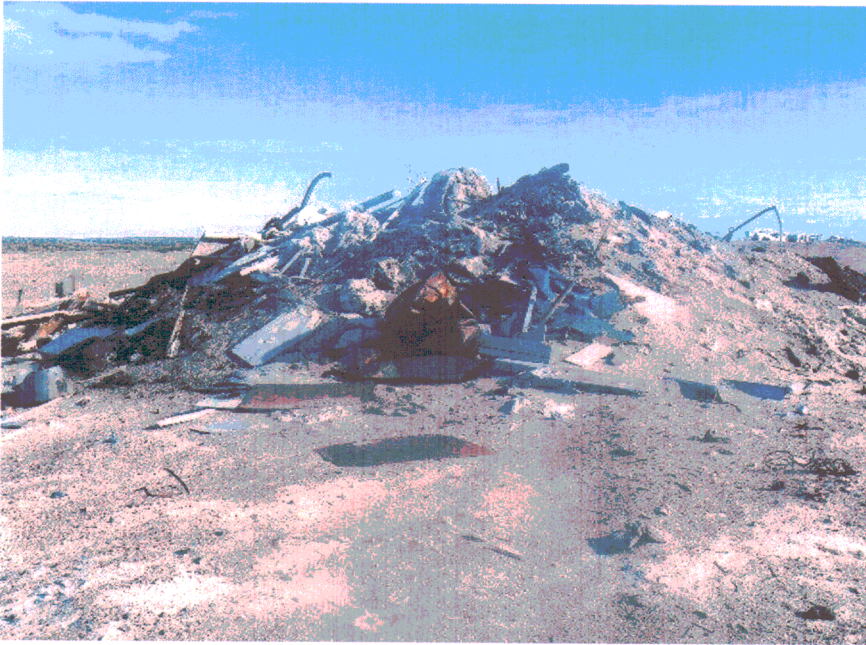
Figure 5. Ash and metal waste pushed into a pile at what appears to be an open burning site.

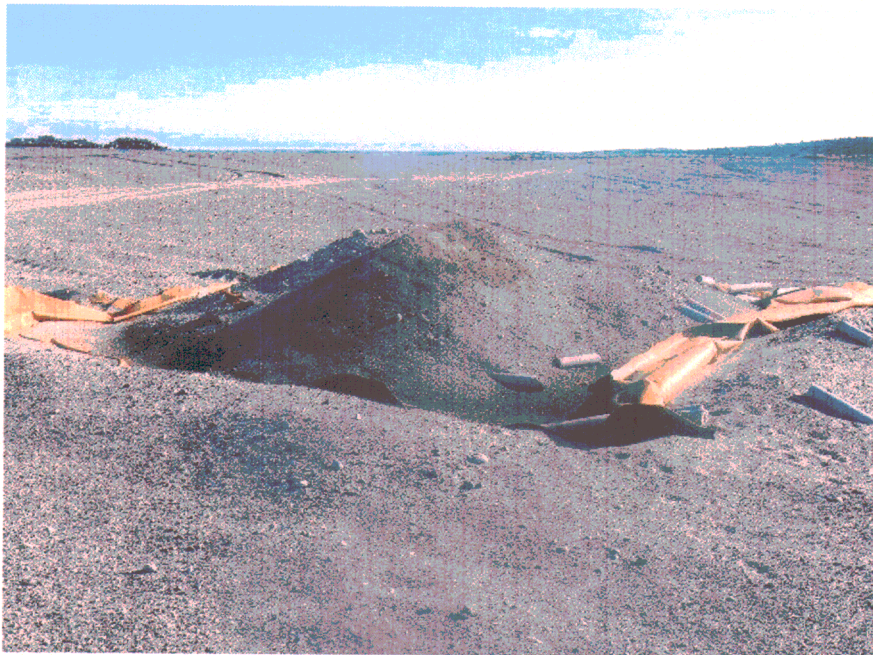
The current contaminated soil farm at Jericho camp is in an unacceptable condition. The soil farm is not properly managed or maintained. Contaminated soil is overflowing the sides of the containment tarp (Figure 6) and it does not appear that the contaminated soil it contains has ever been turned/ tilled. Furthermore, there are no measures in place to prevent spring runoff from carrying contaminants out of the soil farm. The Licencee needs to maintain the soil farm to prevent the migration of contaminants out of the site and facilitate the microbial and mechanical breakdown of contaminants through tilling of the soil. The soil it contains should be collected and placed into sealed drums and shipped south unless the condition of the soil farm is drastically improved.

Figure 6. The mismanaged contaminated soil farm at Jericho camp.

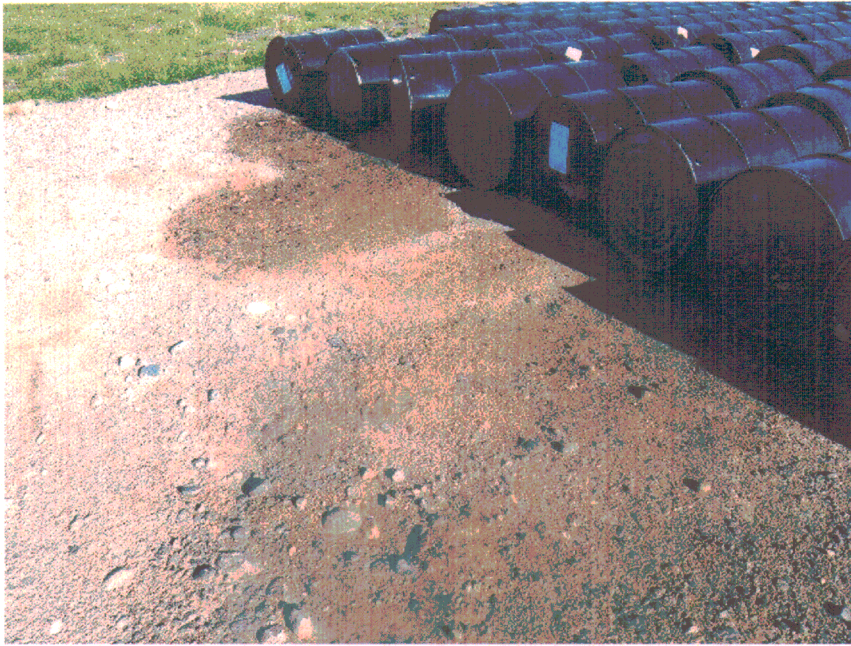
There are a number of spills at the site which have not been reported to the 24 hour Nunavut/NT Spill Line (867 920-8130) or cleaned up, a direct violation of the Nunavut Waters and Nunavut Surface Rights Tribunal Act (Figure 7). Spill reporting and clean up must be improved if Tahera/ Benachee Resources is to avoid enforcement action. A large number of p-50 fuel drums are stored on a sandy strip of land adjacent to Carat Lake. Fuel is visible leaking from a number of these drums. The elevation of this area combined with the high porosity of the soil and the proximity to Carat Lake pose a significant risk that spilled fuel could enter Carat Lake.

Figure 7. A fuel spill at Jericho camp that went unreported and was not cleaned up at the time of the Inspection.

The Licencee needs to clean up spills promptly when they occur and immediately report all spills to the 24 hour Spill Line. All spills need to be cleaned up with a follow up Spill Report to an INAC inspector within thirty days of the occurrence of the spill. The stipulations outlined in this report will be the responsibility of Benachee Resources Incorporated once a new Water Licence has been issued. All concerns identified in this report need to be dealt with prior to the next Water Licence Inspection in 2005.
