From: Jimmy Noble
To: Carl McLean
Date: 11/10/2005 4:50:26 PM
Subject: Tahera Site Inspection Oct 2005

INDUSTRIAL MUNICIPAL WATER USE INSPECTION FORM

ENVIRONMENTAL INSPECTION REPORT

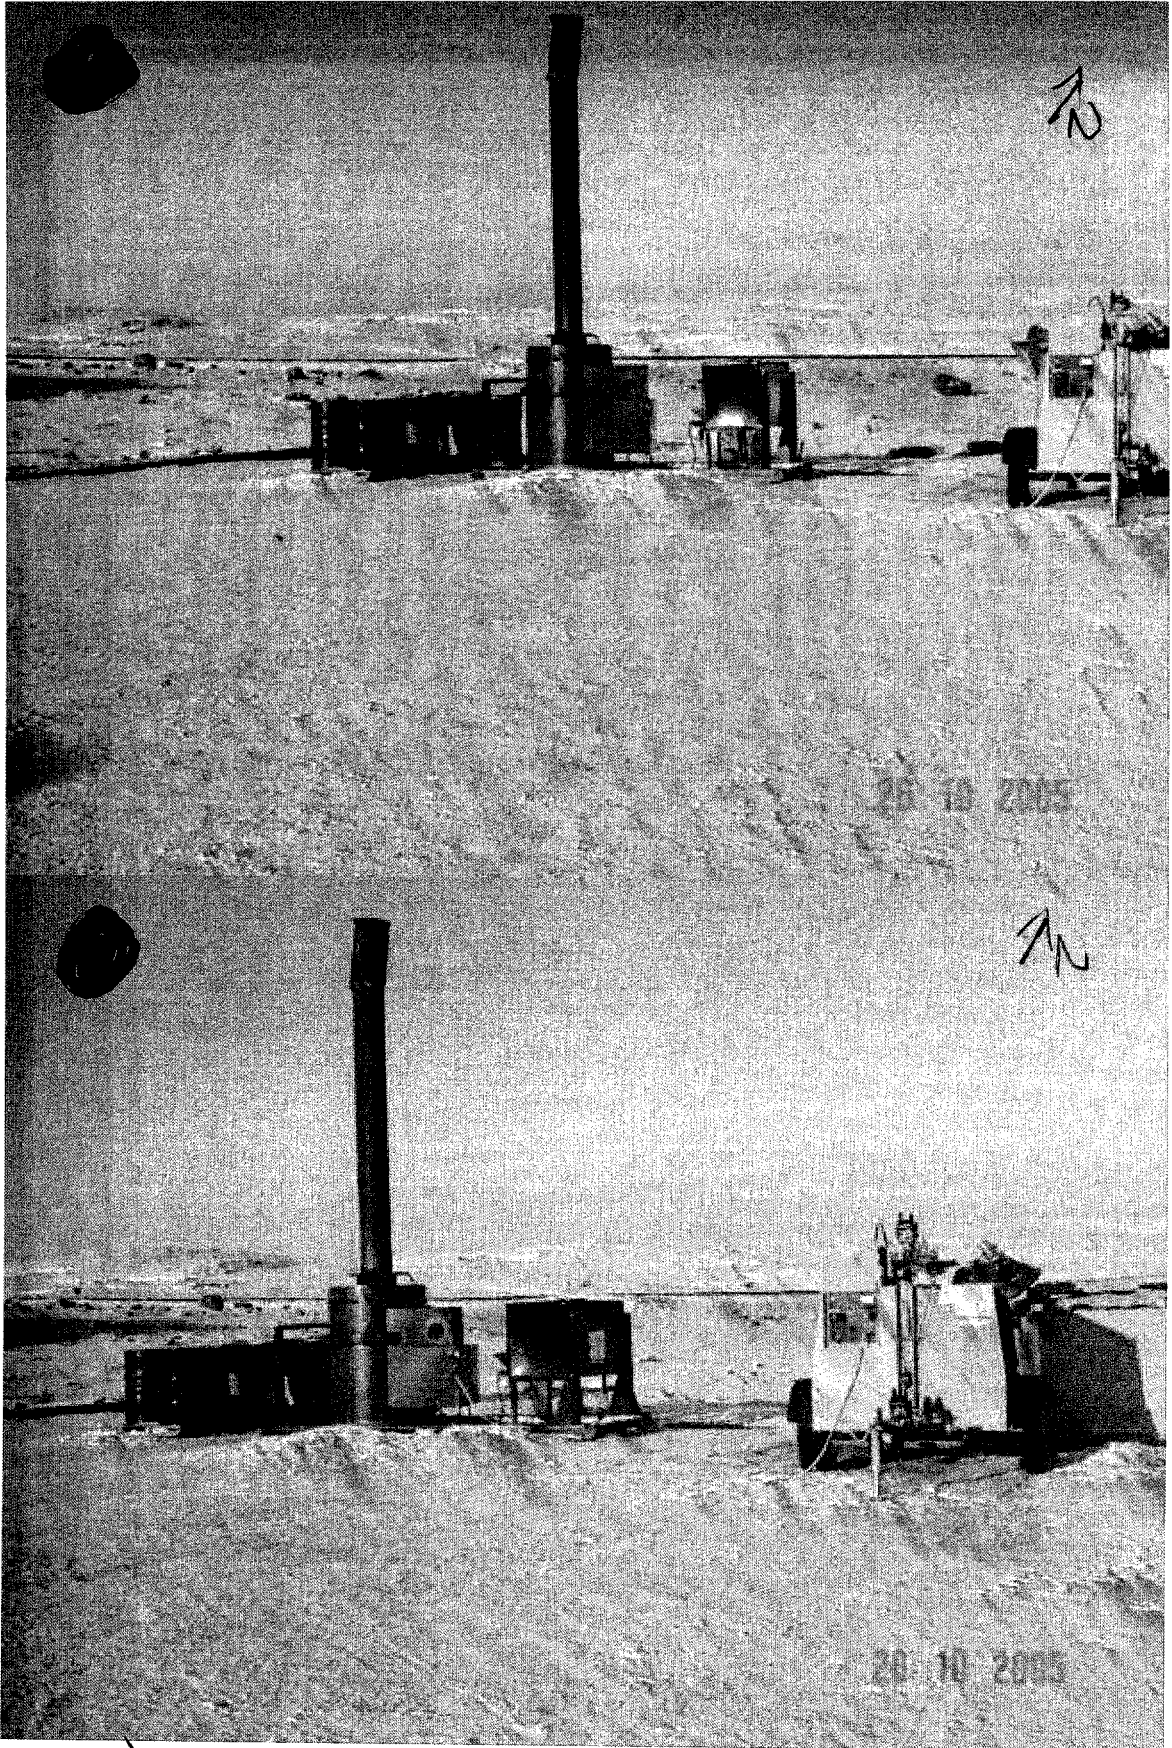
Lane Farm

1) Operational Land Farm - Inspector took note that things were being buried, such as metals / non burnable.

- It was undetermined at the time of Inspection, as to what was in place under the Water Licence or how things would be monitored with respect to having things buried or if they were allowed to cover up the debris on site.
