**TAHERA RESPONSE TO INAC CONCERNS;  
INAC REVIEW OF TYPE A WATER LICENSE ANNUAL  
REPORT AND AUGUST 2008 INAC SITE INSPECTION**

*Tahera Diamond Corporation*

Compiled by: Mike Johnson  
Director of Operations

December 8, 2008

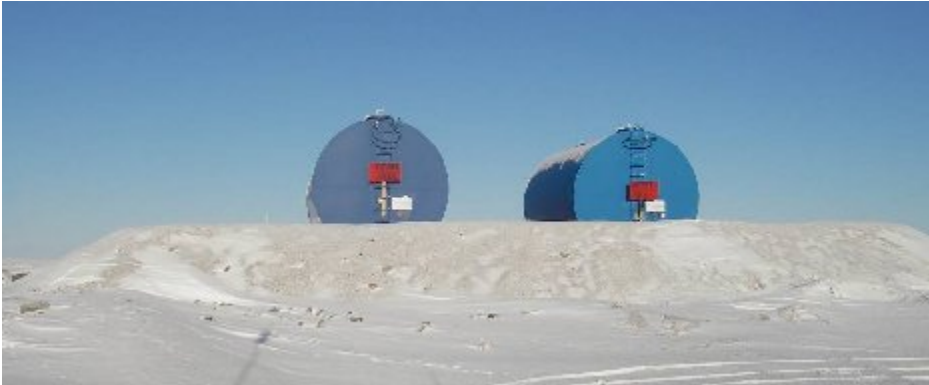
**Figure 6: Airstrip Tank Farm and signage**

jet fuel storage as they allow too much moisture to build in the tank due to improper vent design.

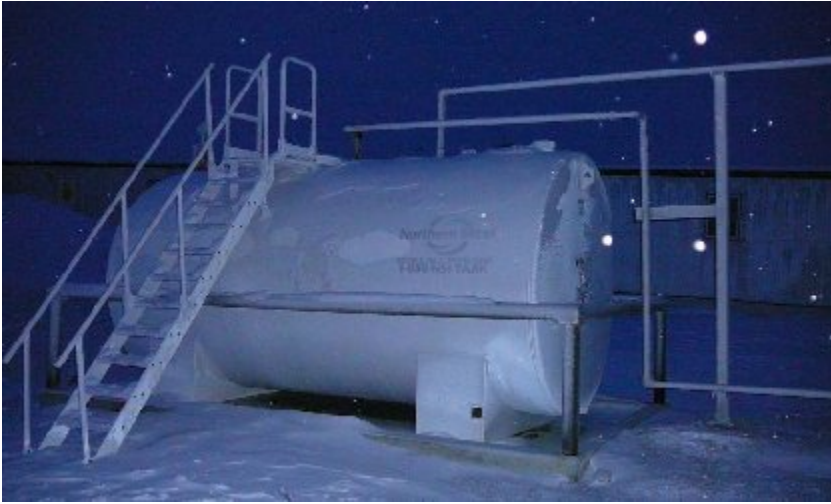
**Figure 8: Truck Shop Fuel Tank**

During a recent inspection of the double wall fuel tank which supplies the Truck Shop its primary source of fuel it was found that the concrete pad is sinking on the south side. It appears that it has settled about 12” in total. The fuel lines running from the tanks to the Truck Shop were a concern due to stress associated with the tank movement, which was

evident from a bowing in the main feed line. The lines come off the top of the fuel tank as shown in Figure 8 below. At first it was believed that a flexible connection would have to be installed on the lines.

However, after the removal of the hanger support bracket from the piping stands, the line was then able to adjust and relieve any stress from the piping. As it turns out, the supply line does have horizontal malleable 90 degree fitting in place to act as a swing joint in the event of anymore tanks or pad movement. The actual issue was that the intermediate pipe stands in between tank and shop were not allowing the required movement in the line. Removal of the pipe stand bracket is an effective solution for the tank movement stresses and therefore an additional flexible coupling is not needed.

The concrete pad was also inspected for cracks and deterioration which none were found at that time and remains in very good condition, aside from its obvious list. At this time there would not be any immediate concern of the state of the piping from the fuel tank as it has ample amount of movement available to accommodate any movement of the fuel tank. The fuel lines and concrete pad should be checked quarterly and the concrete pad repairs should be made in the summer months.

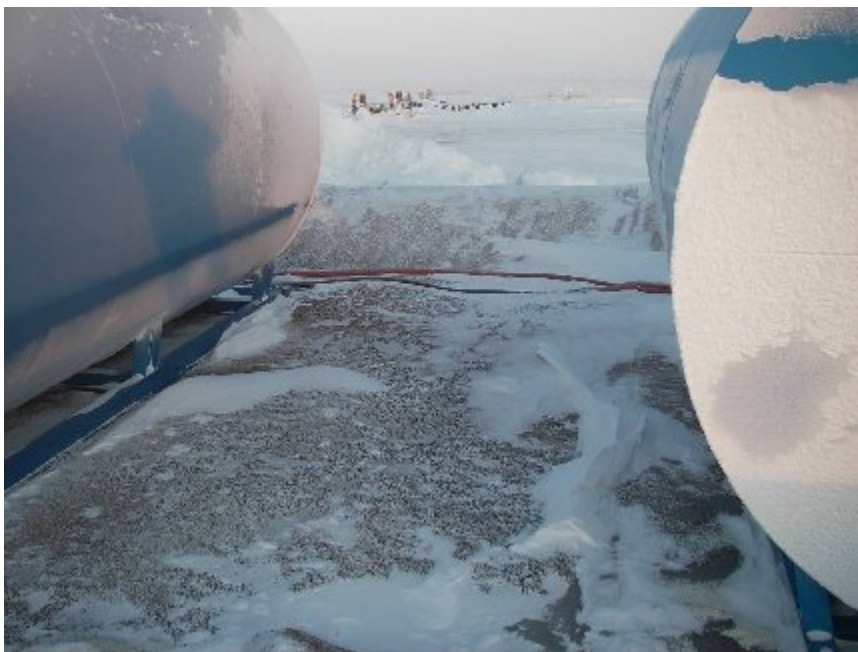
**Figure 11: Airstrip Tank Farm showing the discharge hose and contaminated secondary berm liner**

This makes the Airstrip secondary containment the most contaminated of all berms due to the small area and large amount of fuel that was discharged into the secondary containment.

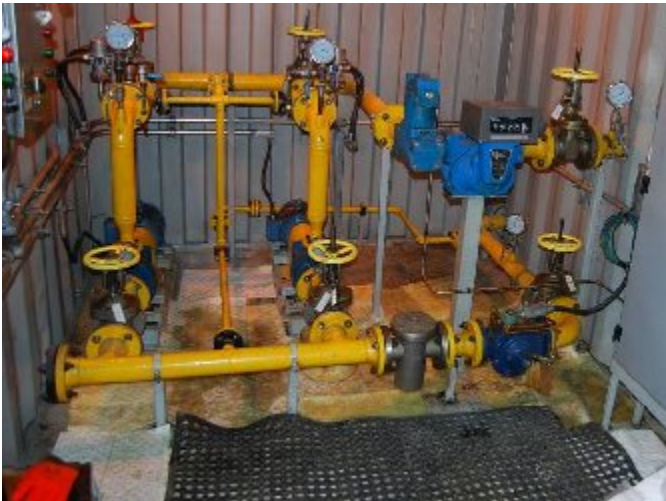
**Figure 12: August 2008 leakage from the Pumps in the Fuel transfer Pump Station**

During the inspection by INAC, drips and “loose fuel” in these areas was unacceptable. Tahera maintenance had been “fighting” with several mechanical seals and pump parts which were causing an unreasonable rate of dripping within both pump shacks (see figure 8). Although the shacks are designed to be “bathtubed”, there was some indication that spillage had at some point exceeded the containment and entered into the secondary containment berm. This was exacerbated by poor housekeeping on the part of Tahera and this cannot be allowed to happen. Although most if not all of the fuel was being contained by spill pads, the areas needed to be kept cleaner and better maintained.

Fuel staining was noted in several areas around the pump stations, including in the immediate vicinity of each pump shack. This area is contained within a lined bermed area but the cleaning of this area should be a regular part of ongoing maintenance of the site.

Since the inspection, all mechanical seals and pumps have been repaired and a regularly monthly schedule of repairs will be maintained while they are in use. As well, any contaminated soil on the fuelling berm was dug up and stored in the west cell of the Waste Transfer Area and some spill trays were installed in key areas.

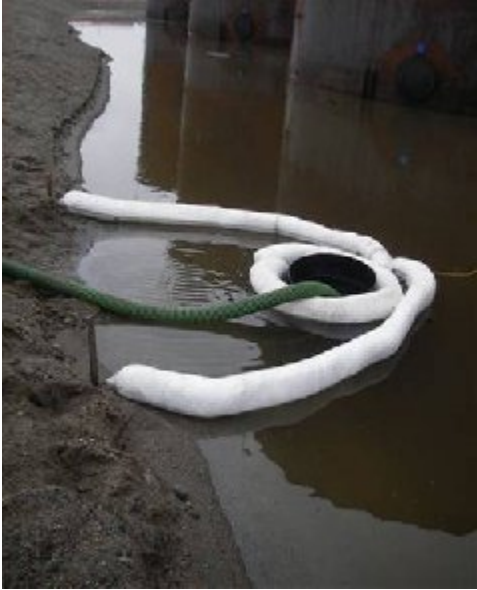
**Figure 16: Example of pooling water in the Main Tank Farm Secondary Containment (for scale, drum is full 45 gallon drum)**

When a spill happens within the containment, the aggregate and geotextile soak up the hydrocarbons, however if enough liquid (either HC or water) begin to fill the dish, a pool will form.

In order to clean up spills within the containment, a sump is dug to the liner in a low point and the fuel is drawn off from this low point. This fuel may or may not be contaminated with water, fine gravel, dust or organics. The fuel is stored in a bulk container in the Waste Transfer Area. If the fuel is sufficiently clean, it may then be used to fire a boiler or incinerator. If not, it is stored for off-site hazardous waste disposal. However, as the remaining fuel is removed and reduced in volume until it can no longer pool effectively, this method no longer works. At that point, absorbent pads are used to soak up fuel wherever possible.

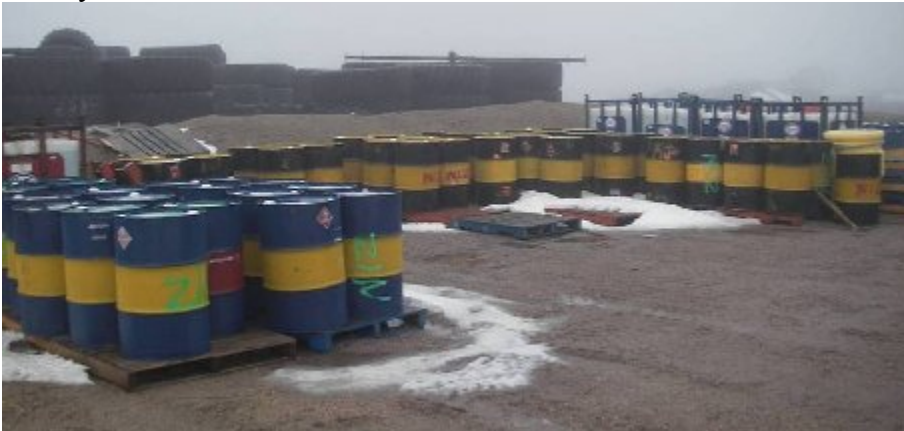
**Figure 17 : Organized Drums within the Waste Transfer Area Secondary Containment**

Under the current C&M operations, all drums have been organized by product and labelled. A strict inventory is tracked and checked monthly and the site is inspected weekly.
