**Re: Response to June 2011 Inspection Report of the Jericho Diamond Mine Property, 2AM-JER0411 – Shear Diamonds Ltd.**

We have received and reviewed your letter and inspection report, dated July 4, 2011, for Water Licence 2AM-JER0411, Jericho Diamond Mine and offer the following in response.

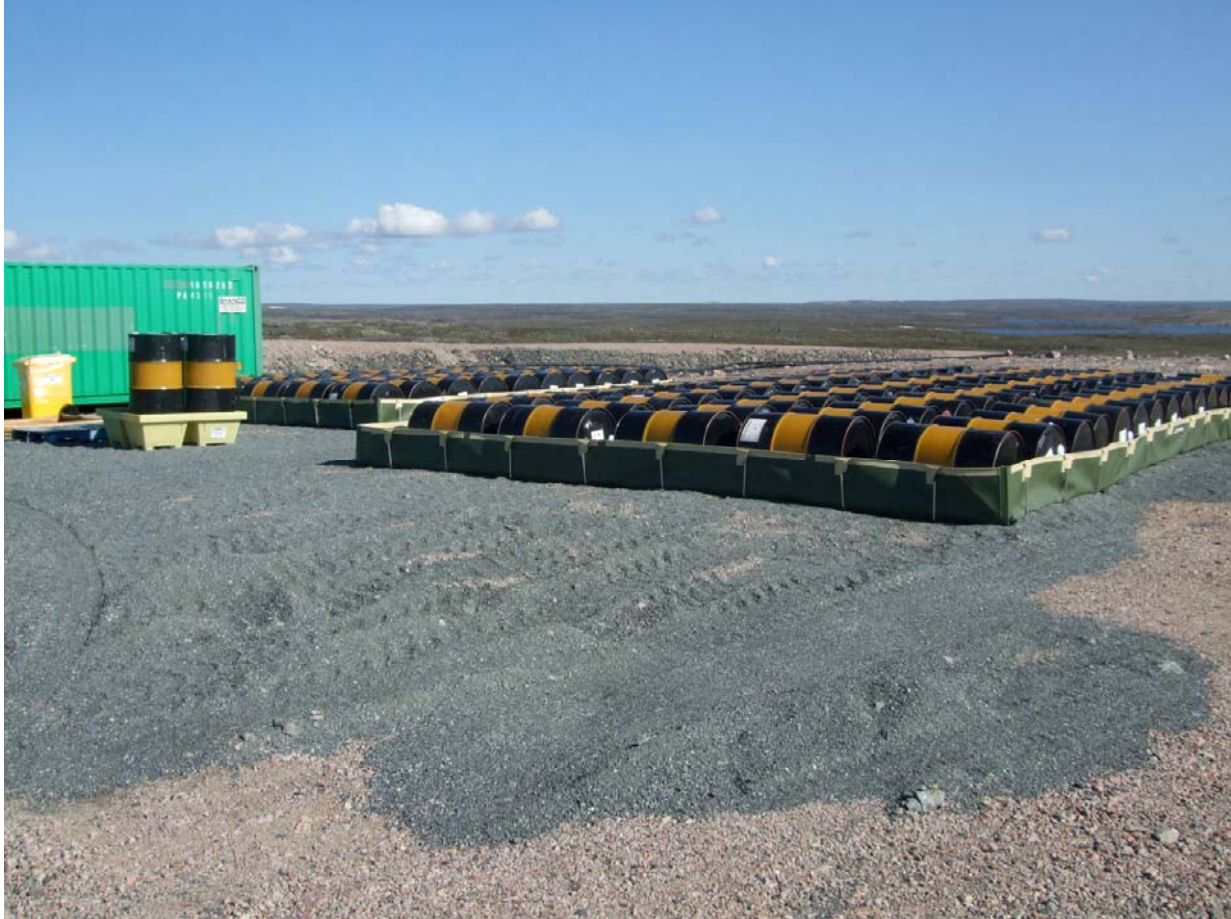
## Secondary Containment Berms Installed at Site for Drummed Fuel

The secondary containment berms were installed on June 16, 2011. Fuel drums were placed within the secondary containment berms with bungs in the 3:00 and 9:00 position on June 18<sup>th</sup> and 19<sup>th</sup>. Inspections of all fuel containment structures are conducted daily.

All drummed fuel is now stored in secondary containment.
