## 2AM-JER1119 Inspection July 4, 2012

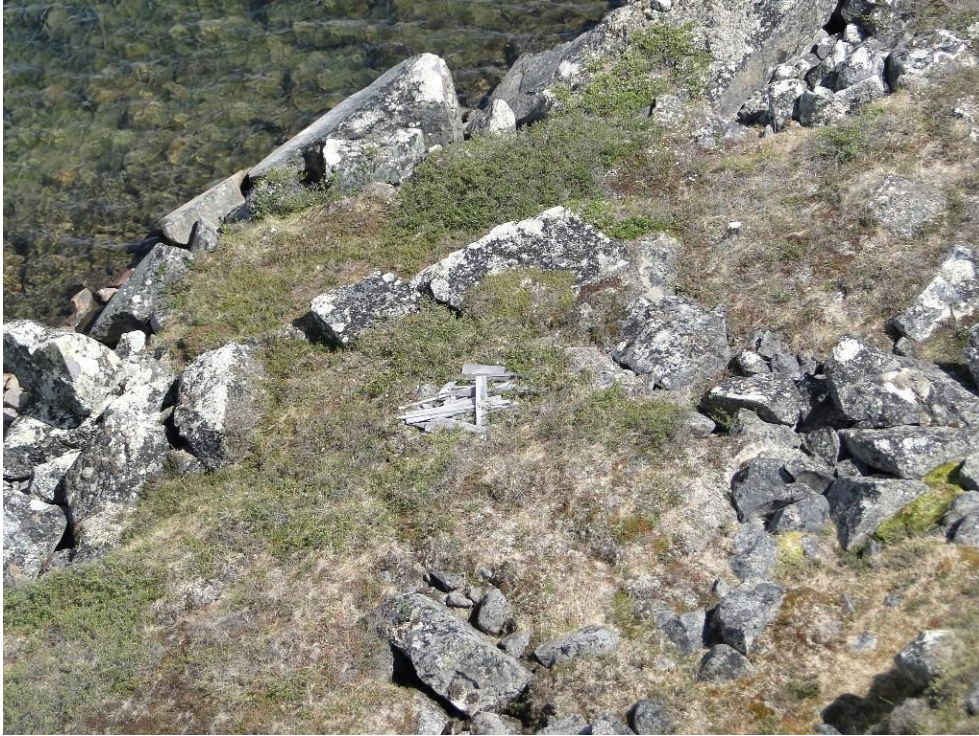
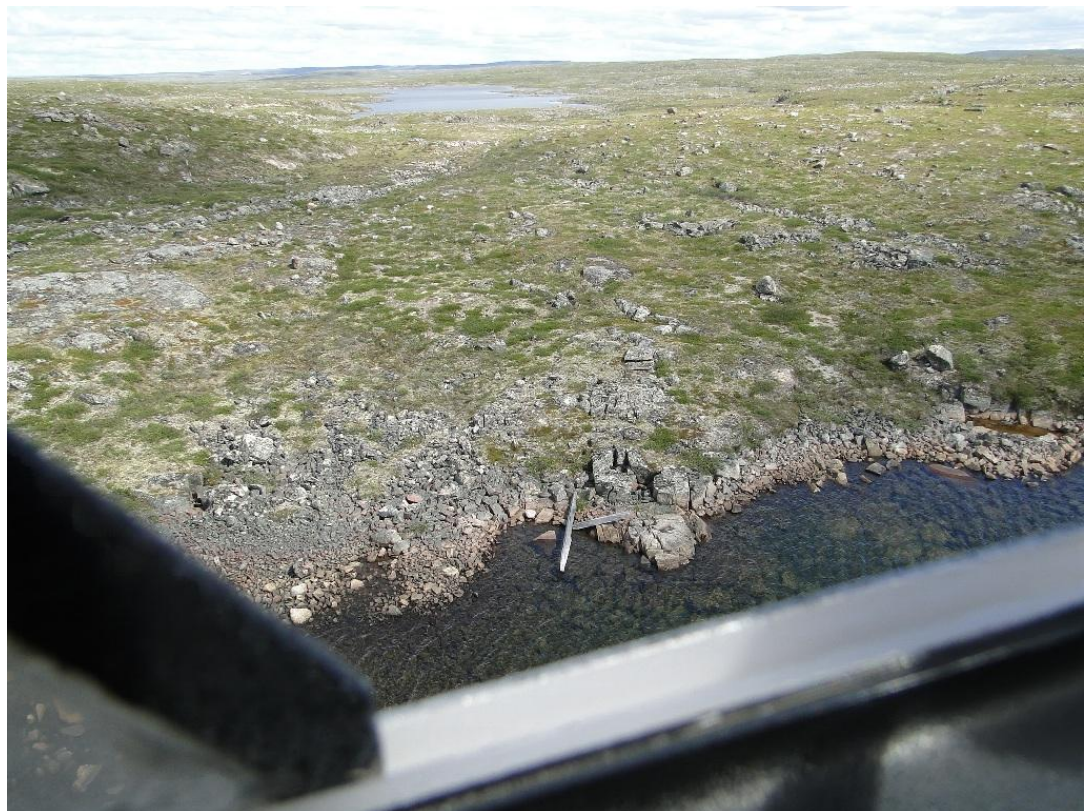
Figure 2. Examples of debris left from drill program at JD-03

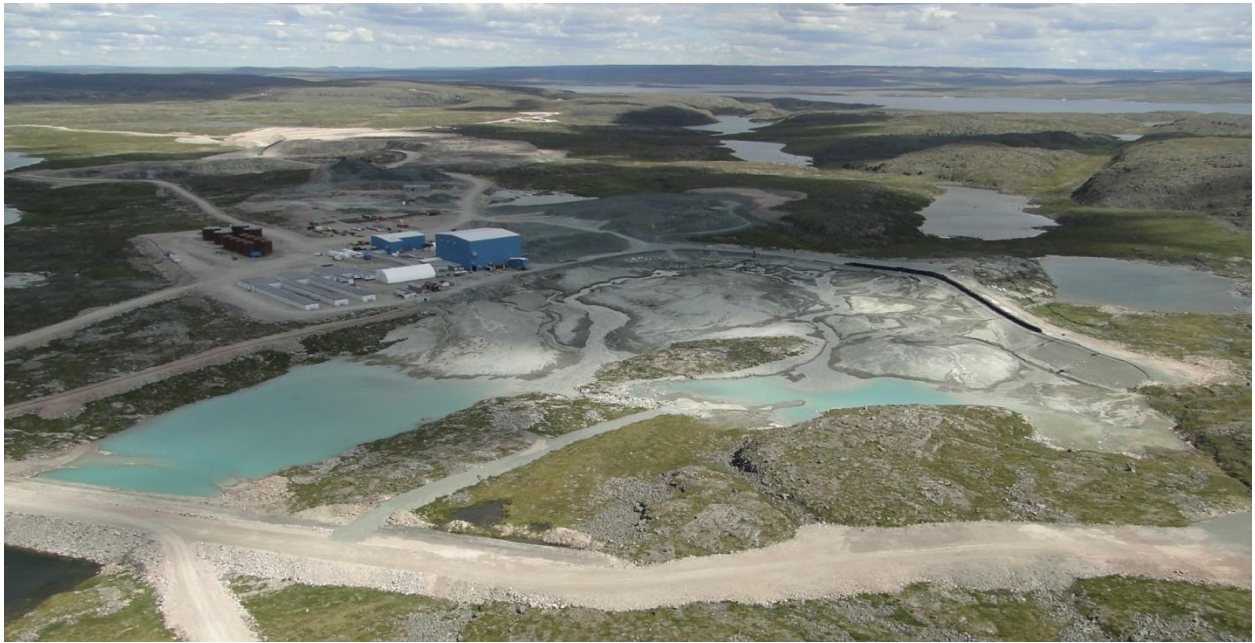
Figure 3. PKCA from above

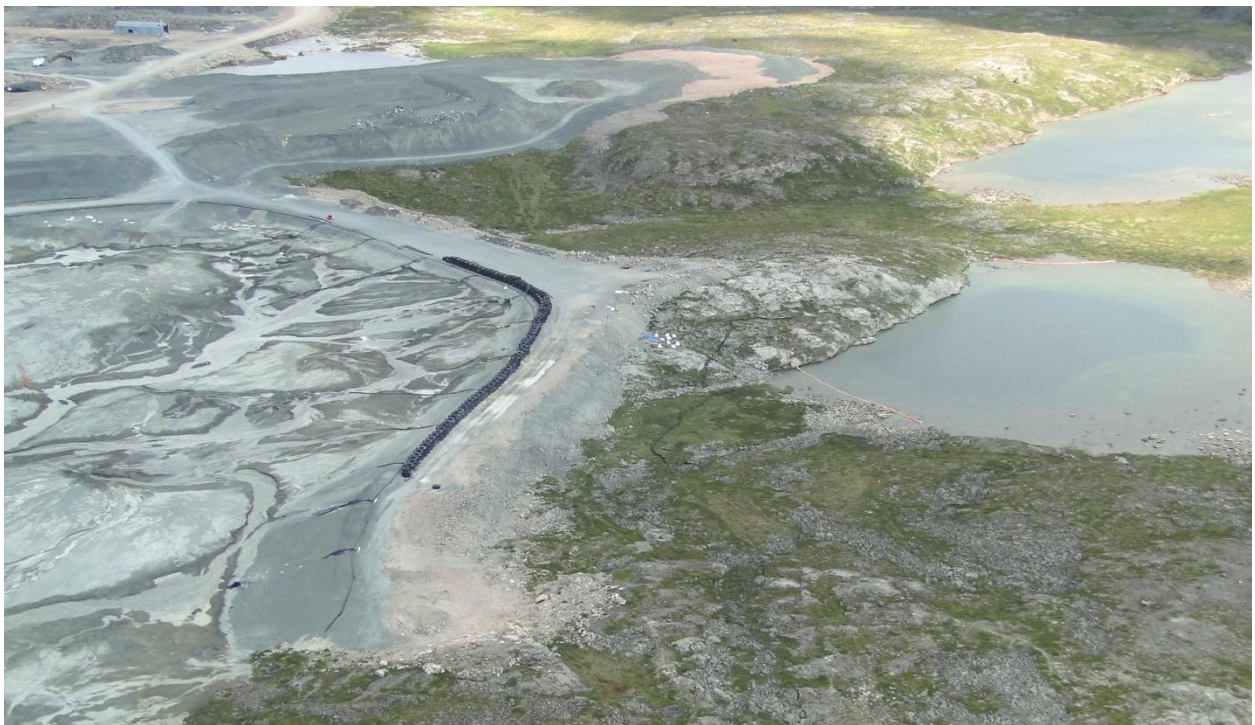
Figure 4. FPK blown towards SE pond. Note silt fences and berms in water to reduce transport of sediments.

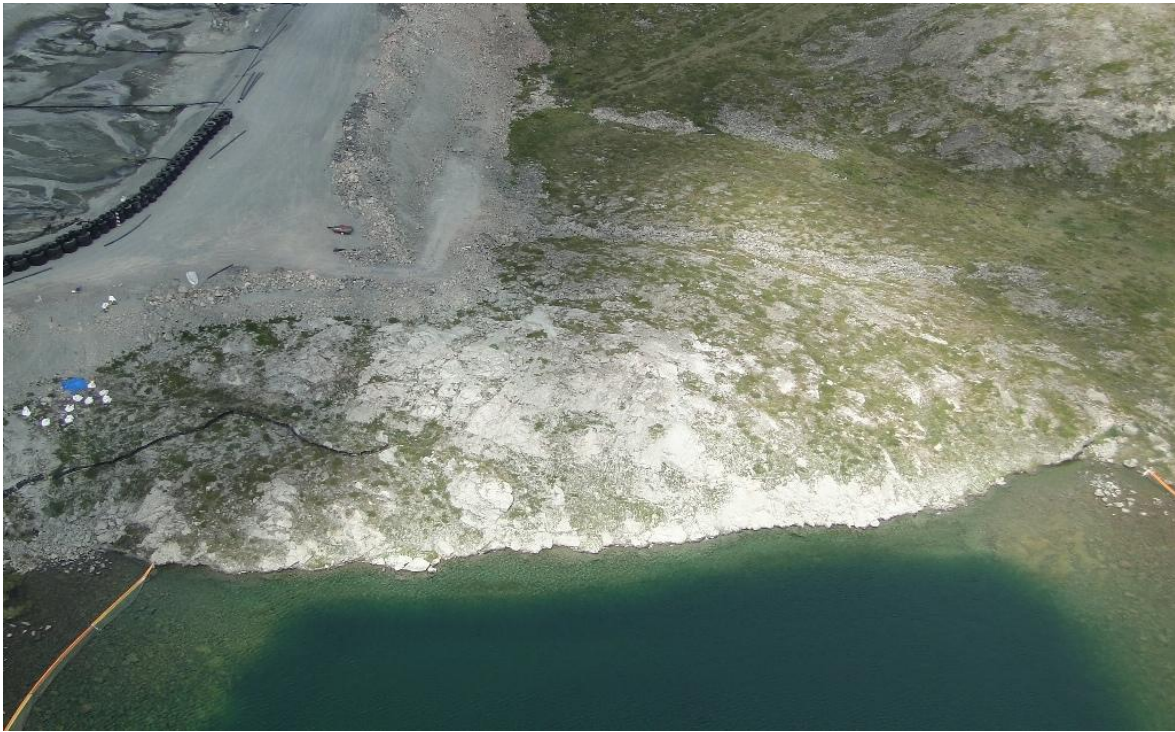
Figure 5. FPK on slope of SE pond.

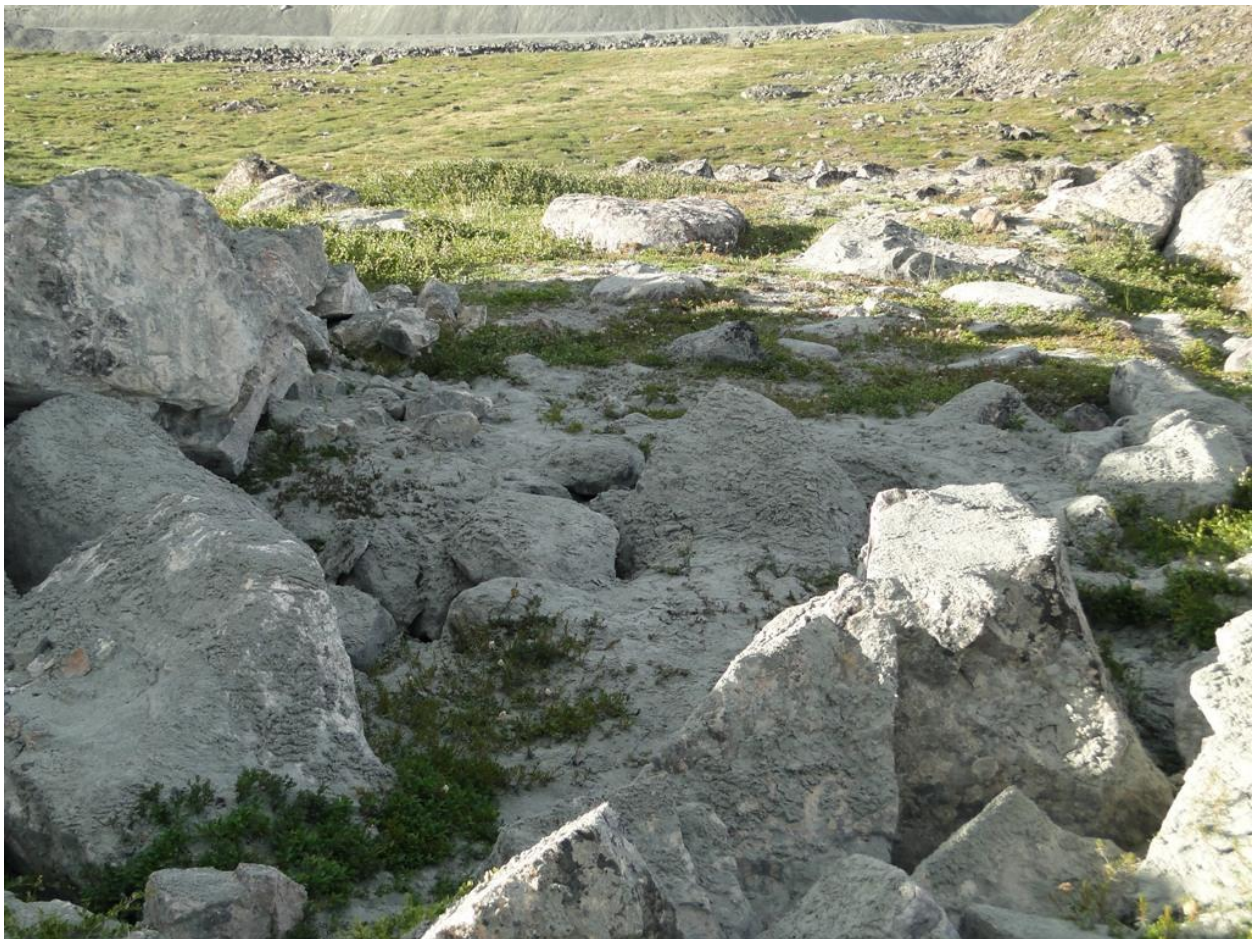
Figure 6. Closeup of FPK on vegetation

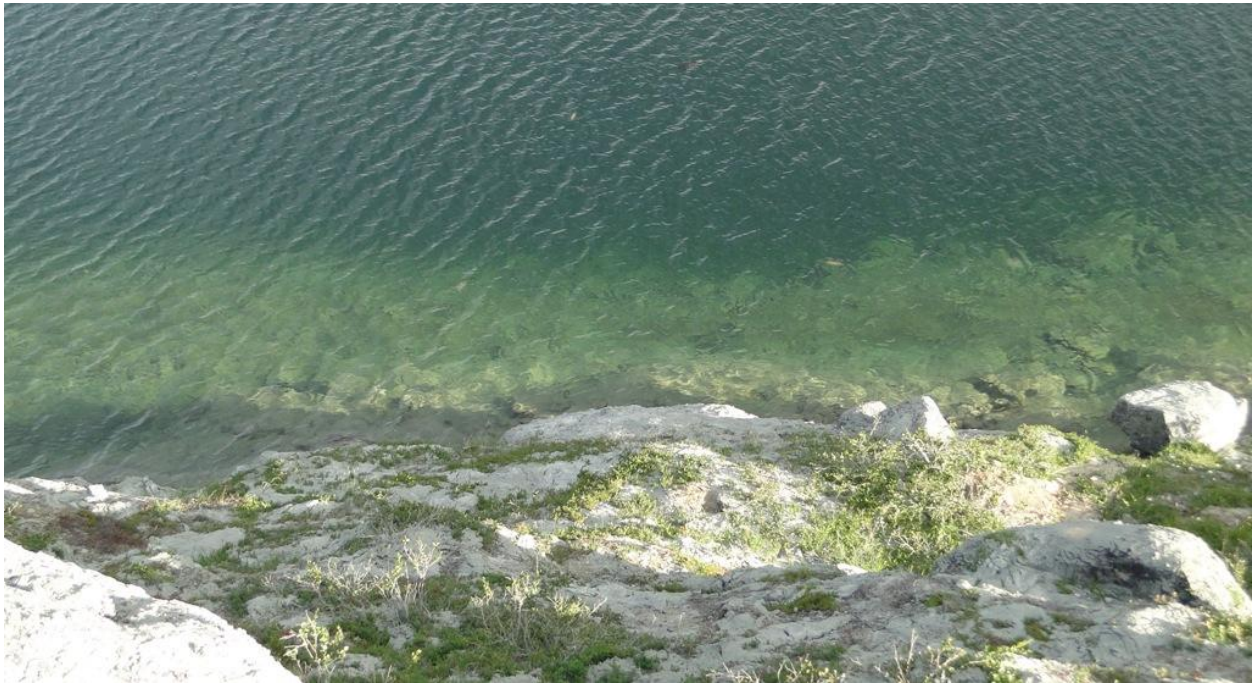
Figure 7. FPK sediment visible in pond.

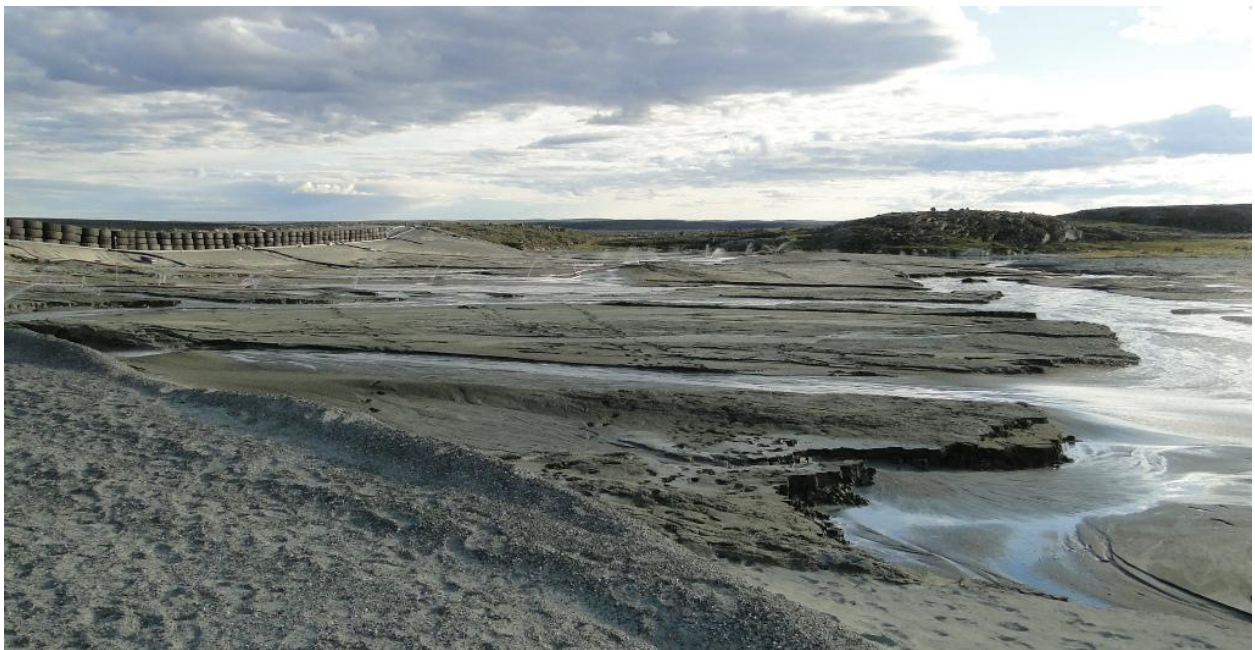
Figure 8. PKCA with new mitigation measures: Tire berm on up-wind side, sprinklers cycling water from Cell B/C to wet the FPK.

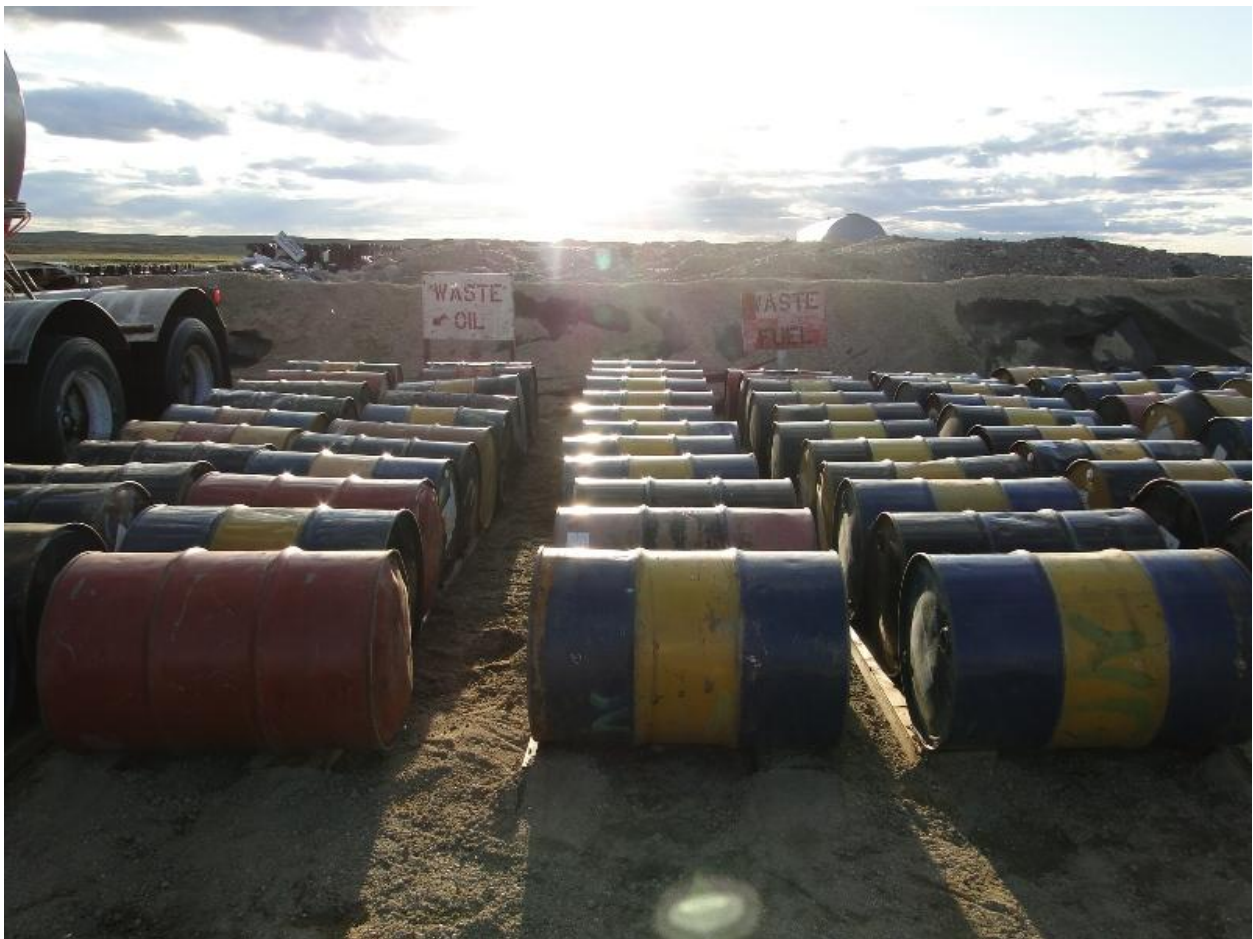
Figure 11. Signage is present and waste is well-sorted.

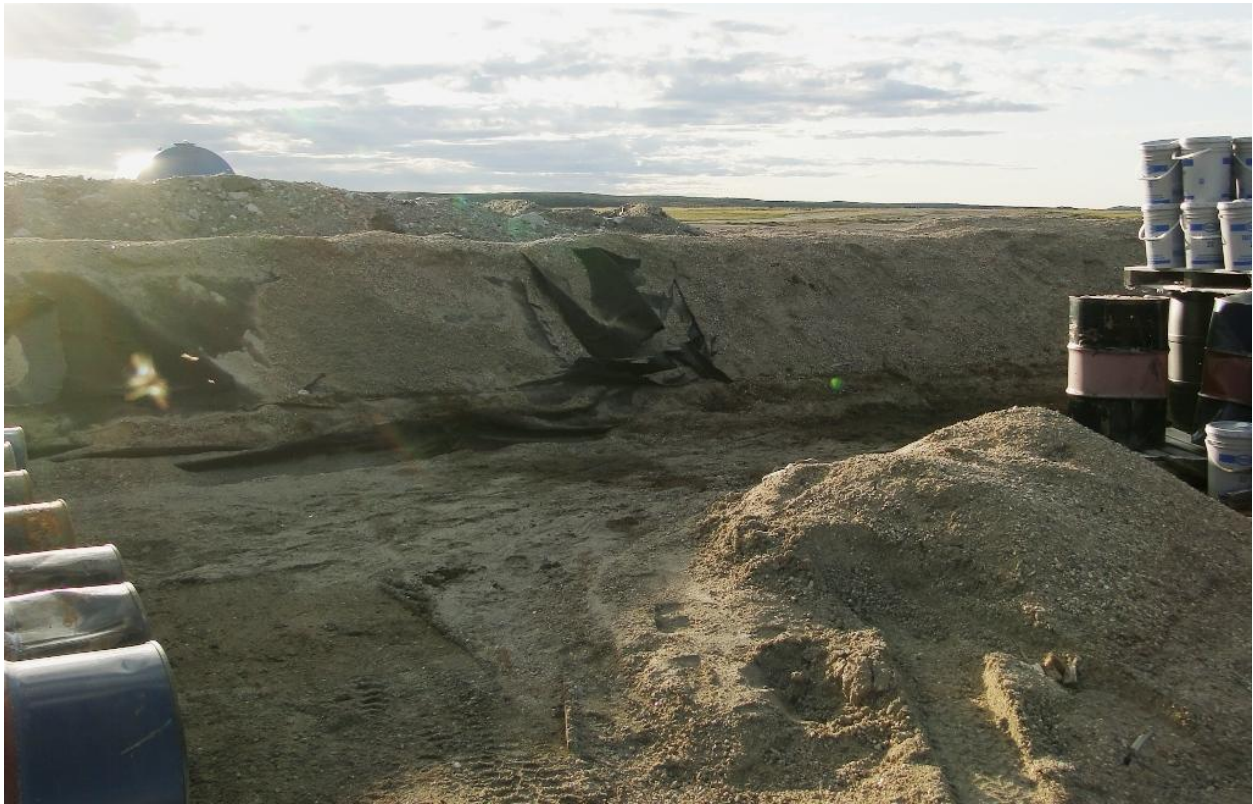
Figure 12. Liner of HWTa is exposed and integrity in doubt (scheduled for replacement this year).

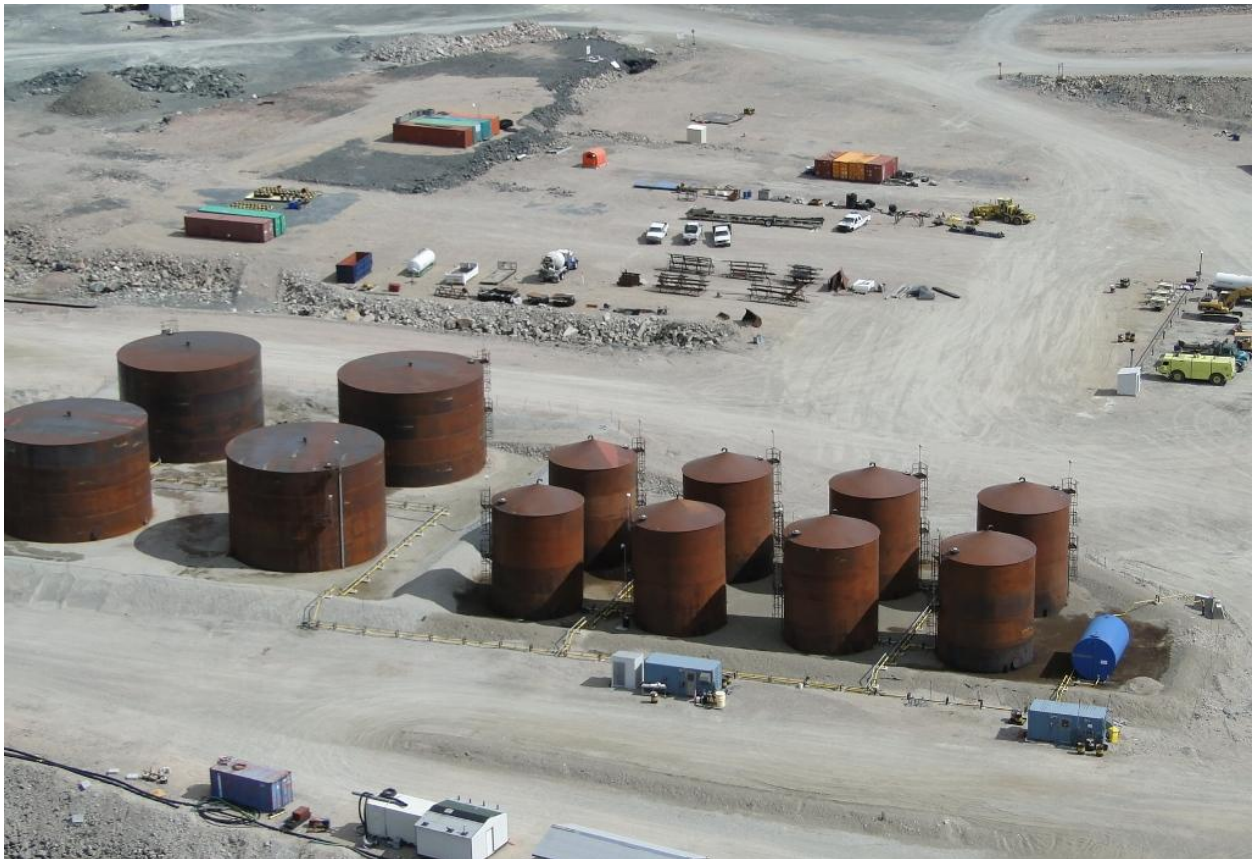
Figure 13. Legacy and contemporary contamination is present in many of the existing berms. This creates the need to constantly manage contaminated water.

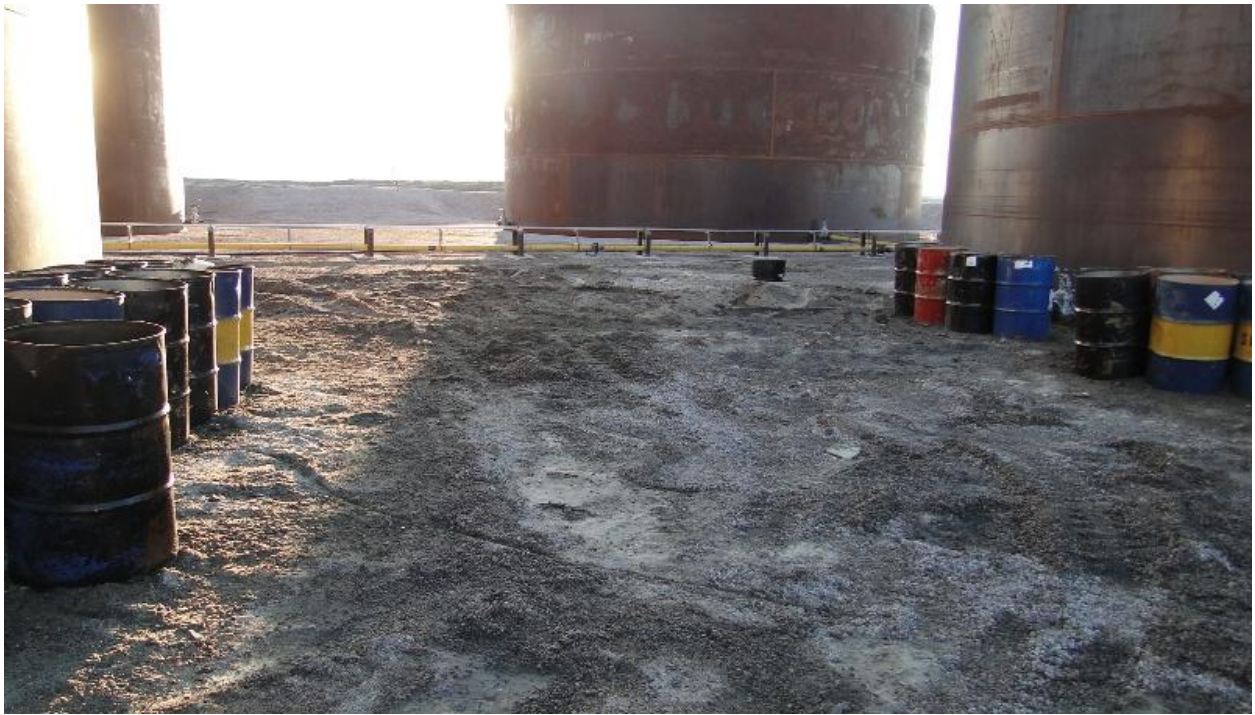
Figure 14. Contaminated material and barrels of contaminated water from oil spill (12-121).

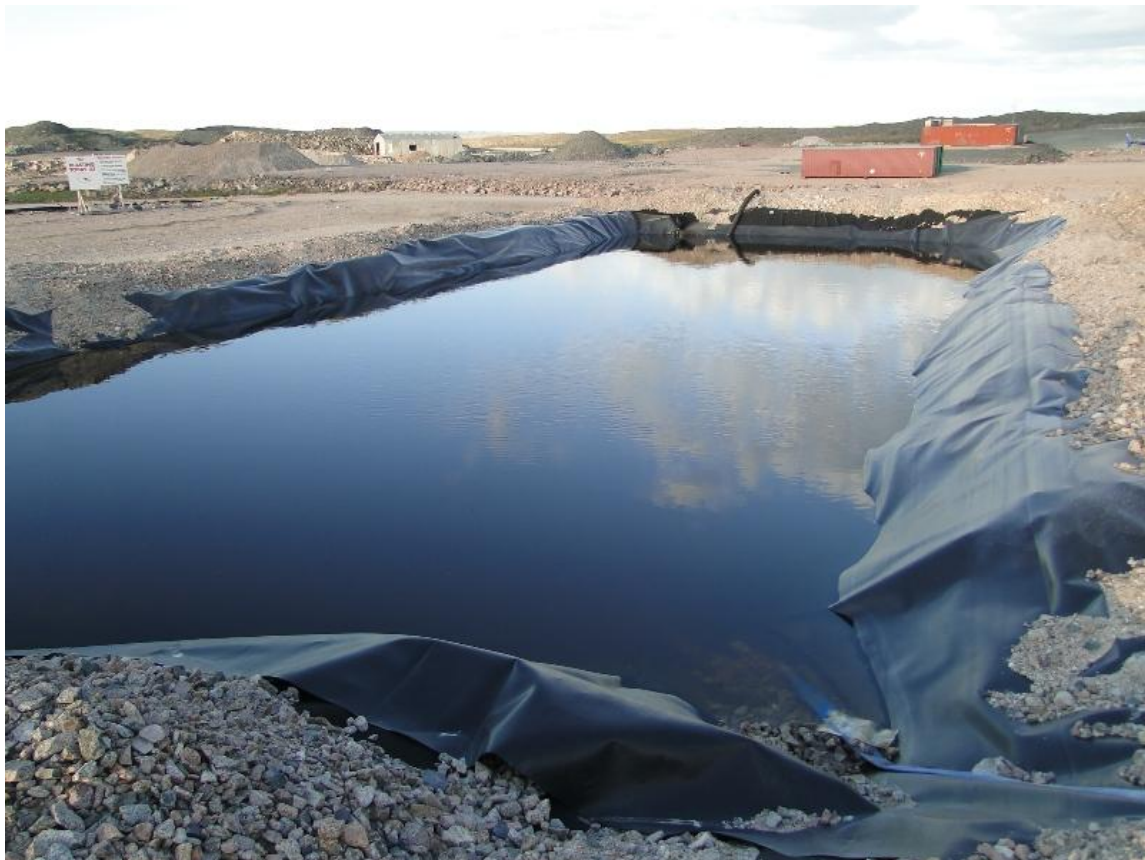
Figure 17. Water treated by the Oztek unit which now meets discharge criteria.

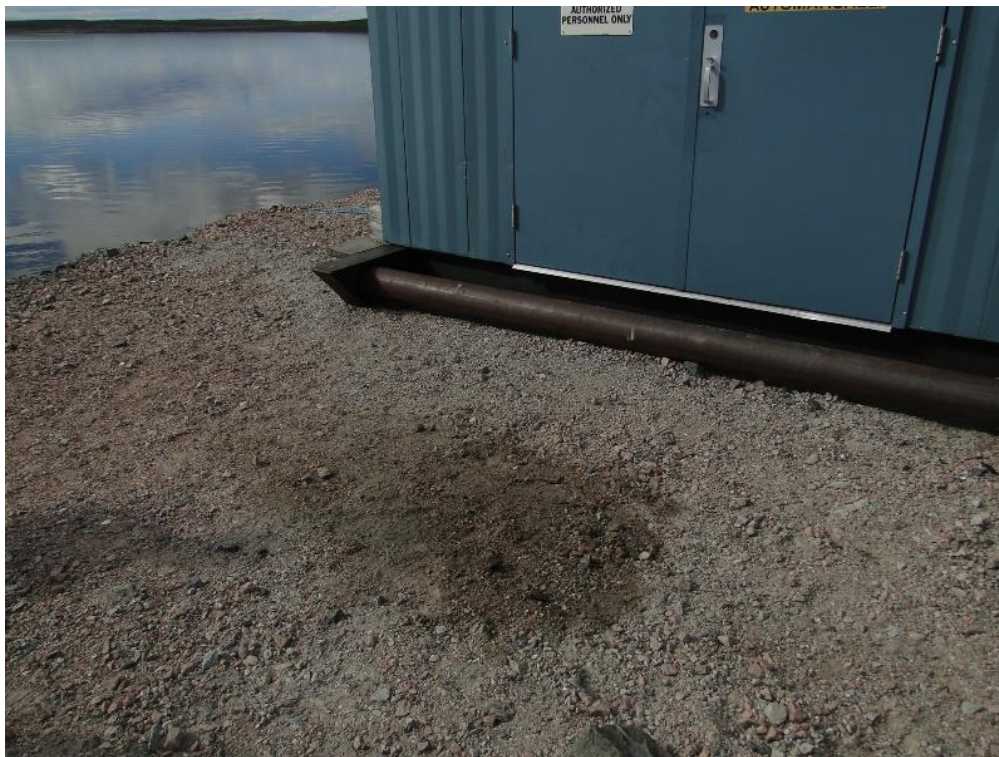
Figure 18. Unreported spill outside Water Pumphouse

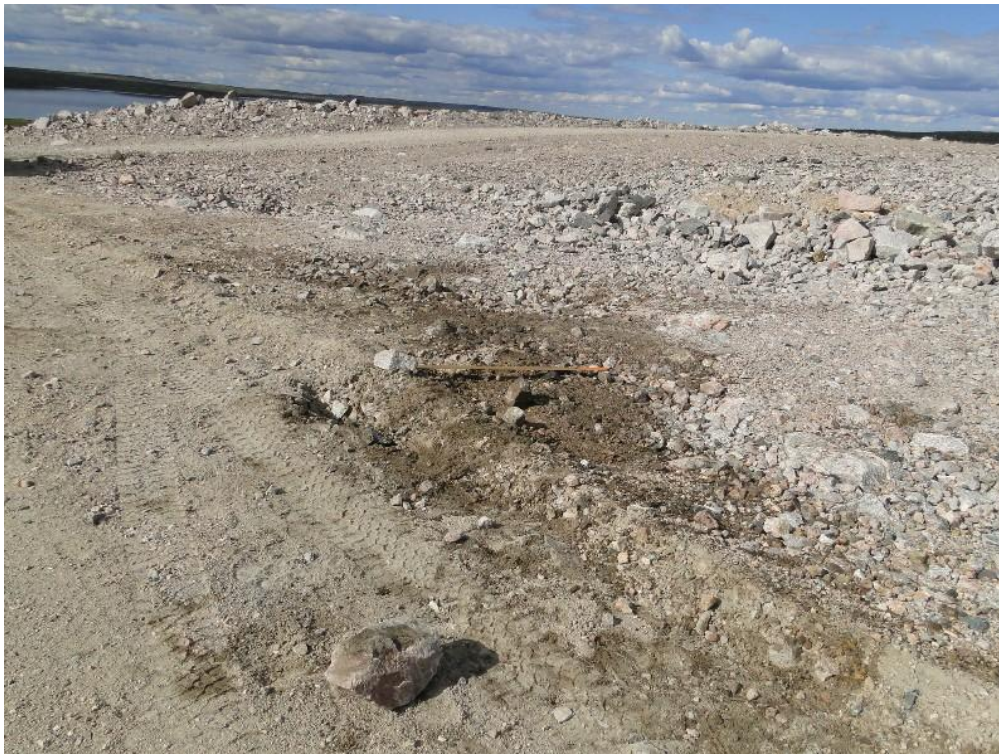
Figure 19. Remains of Spill 12-121 still visible

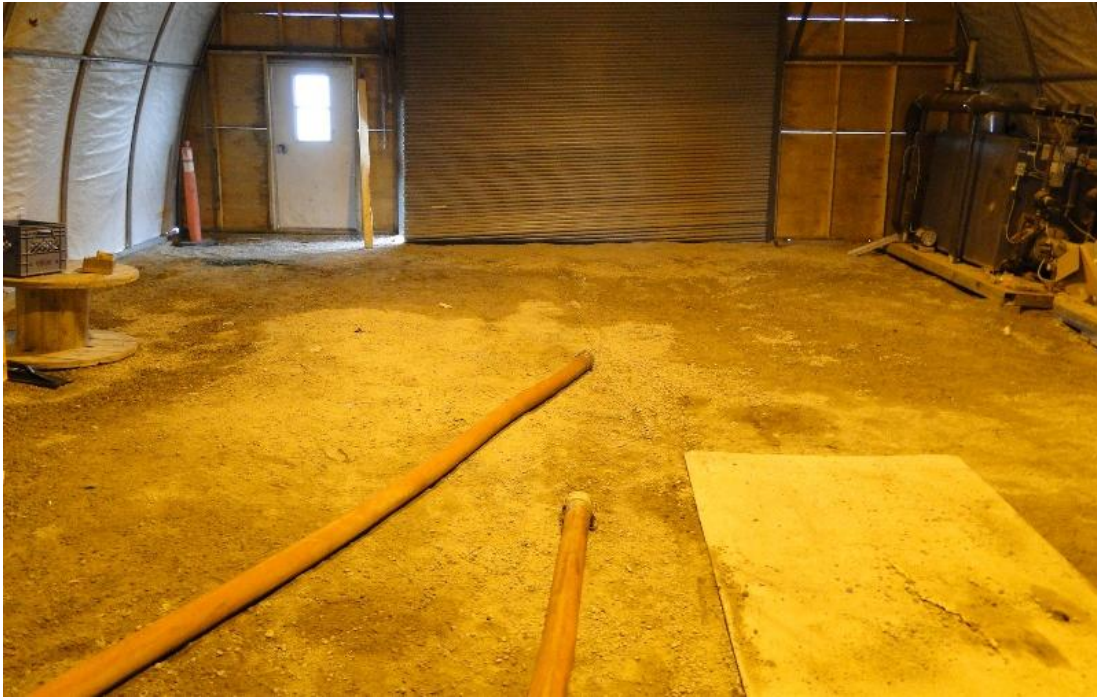
Figure 21. Garage at Airport - legacy contamination in unlined shop

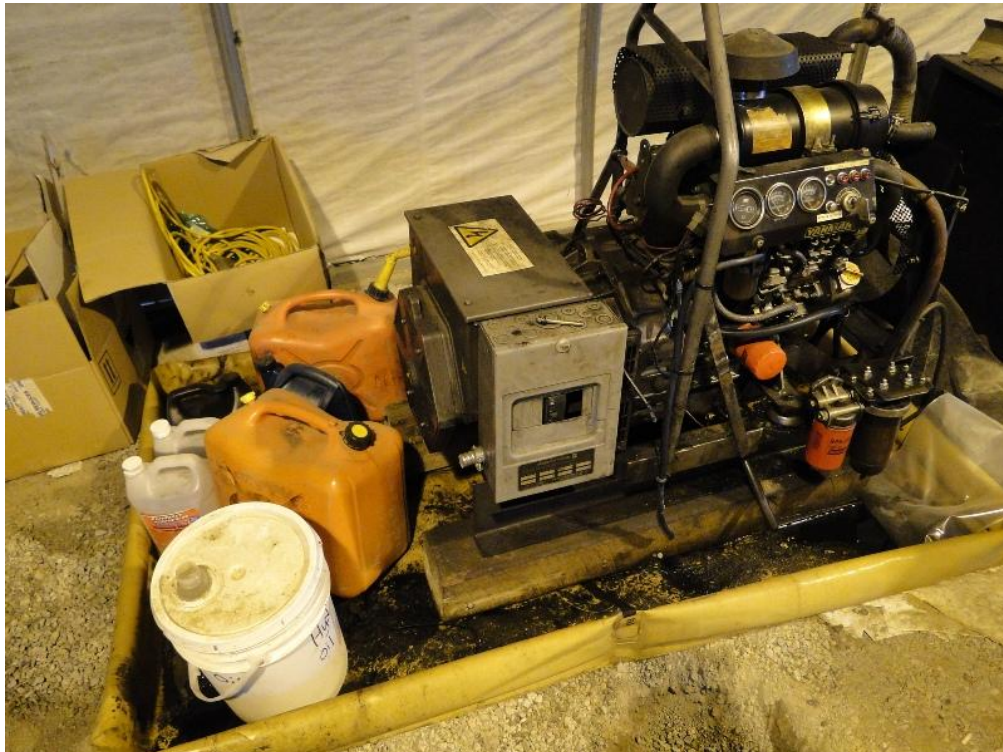
Figure 20. Further contamination is being mitigated by use of containment

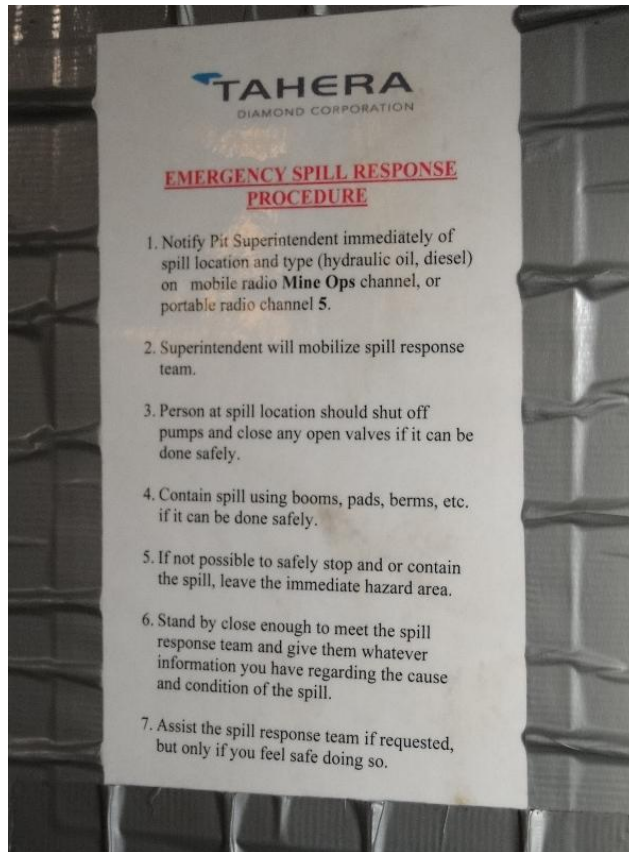
Figure 22. Spill procedures posted at Fuel Transfer Area

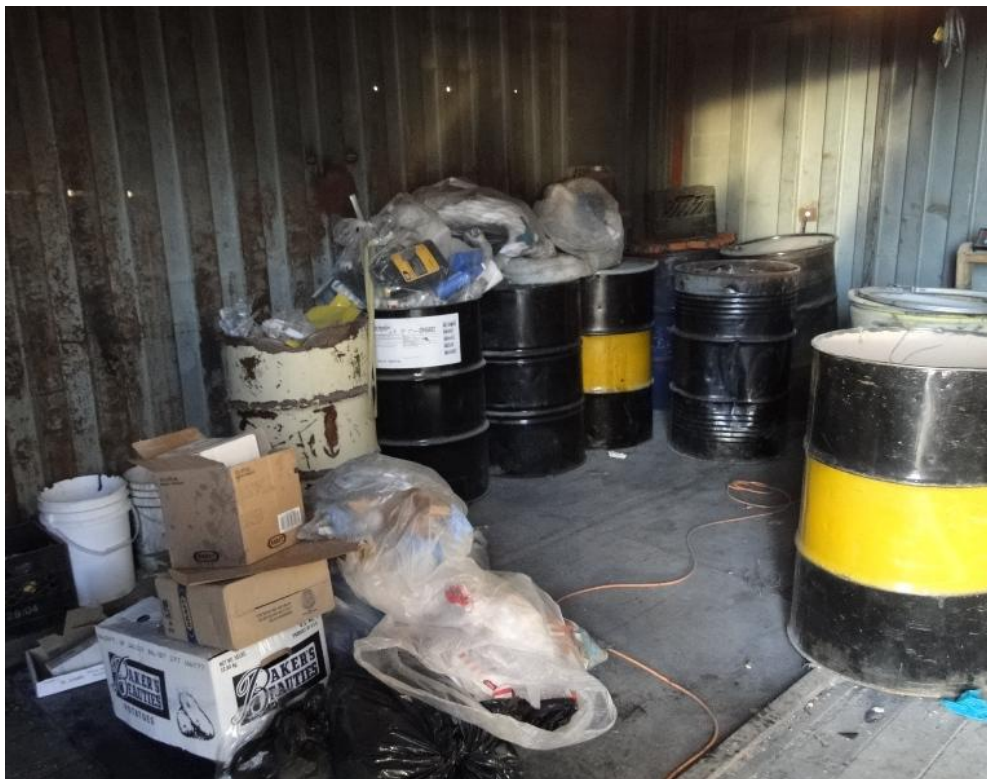
Figure 23. Waste is sorted prior to incineration
