## Inspection Photos: 2AM-JER1119 September 13<sup>th</sup>, 2012

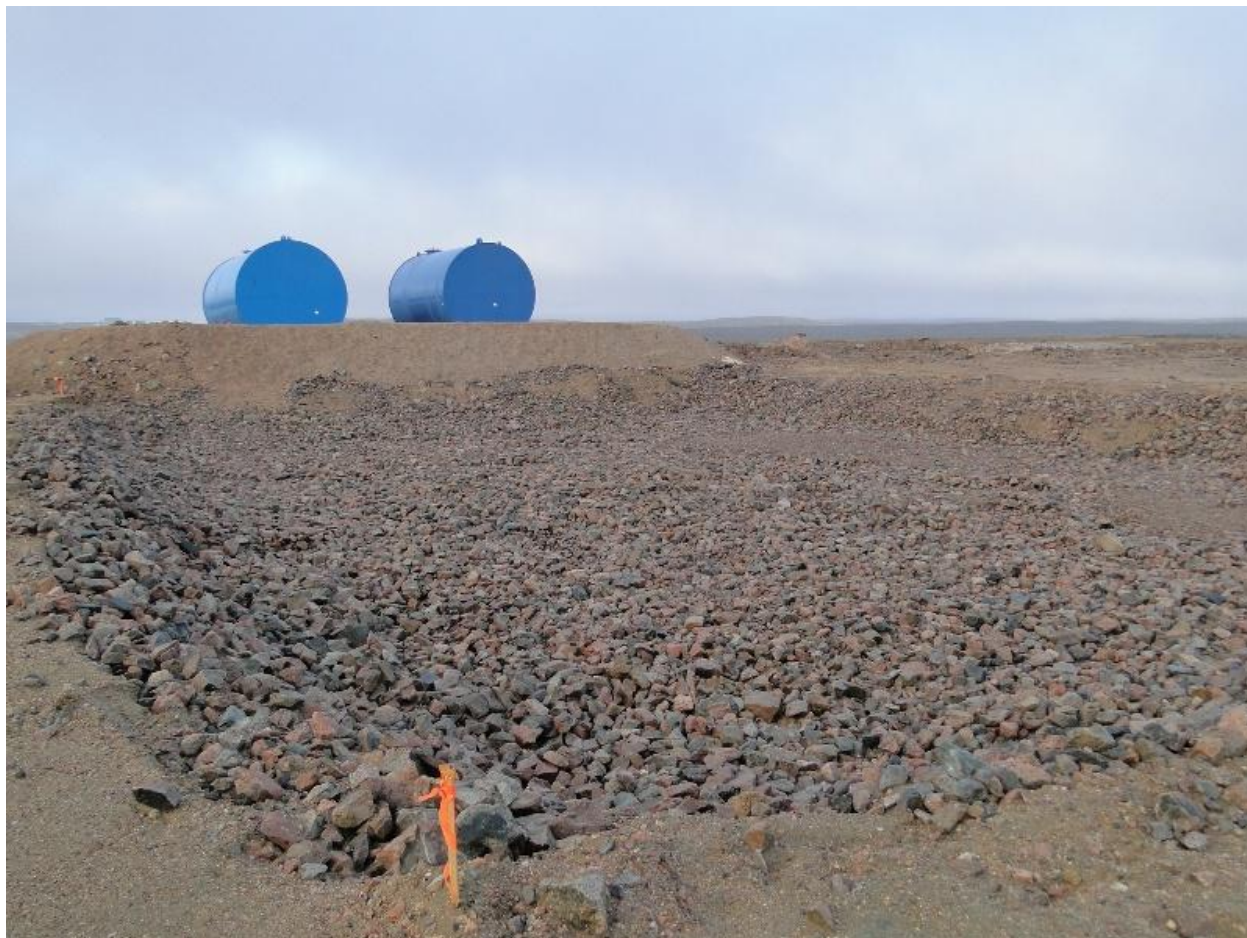
Figure 1. Preparing to install liner at the airstrip.

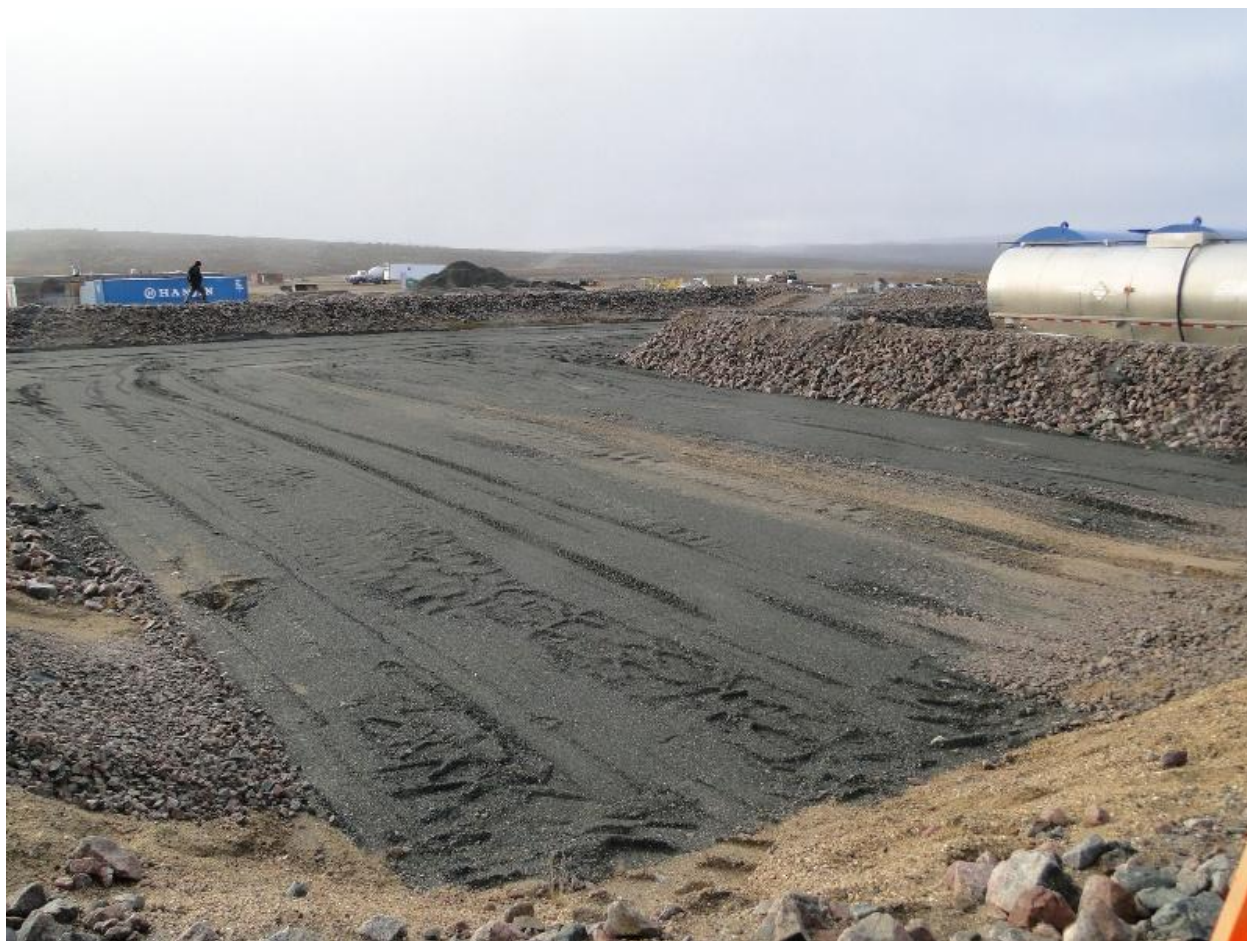
Figure 2. East cell of HWTa, ready for the new liner.

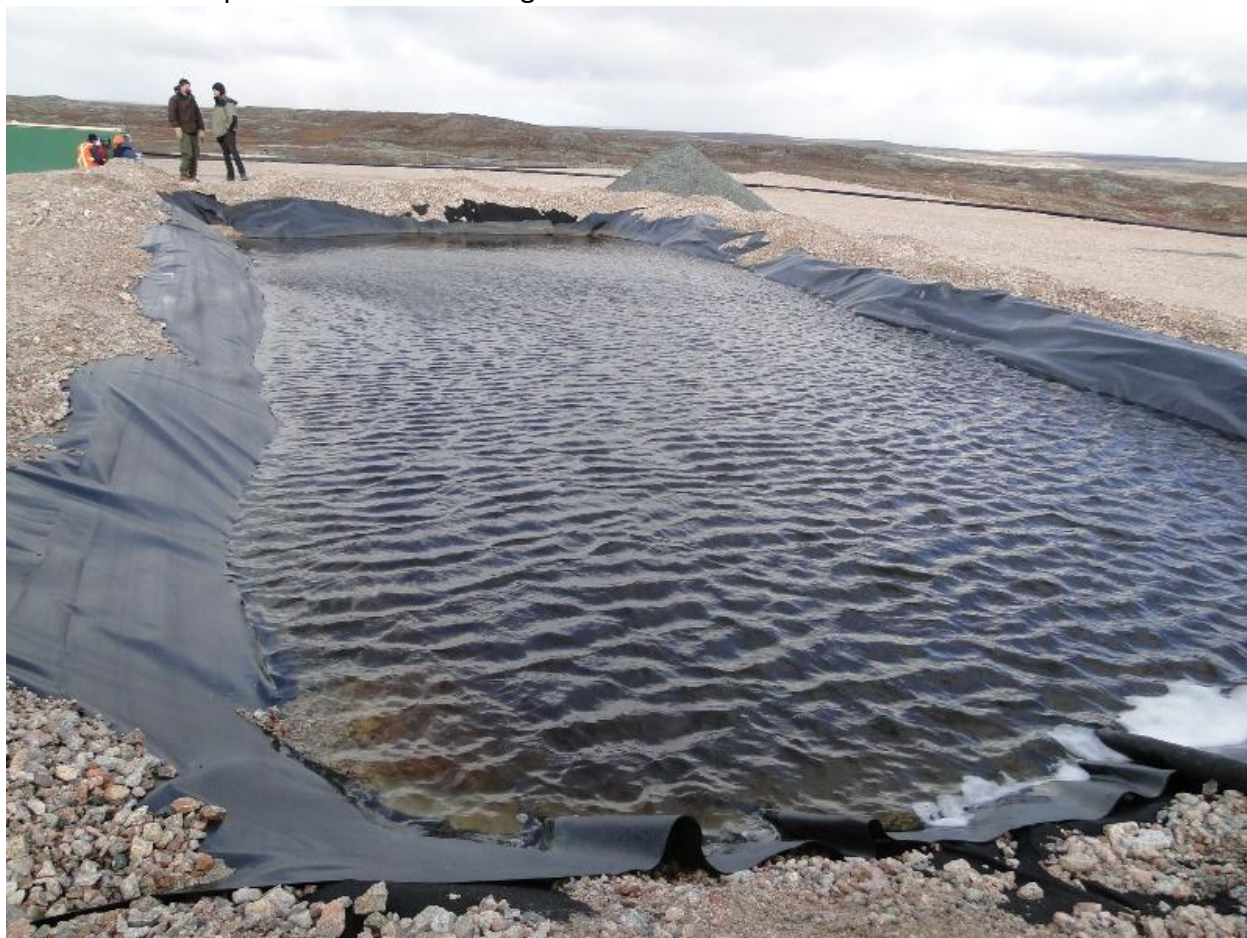
Figure 3. Oztek berm should be pumped out to protect the liner.

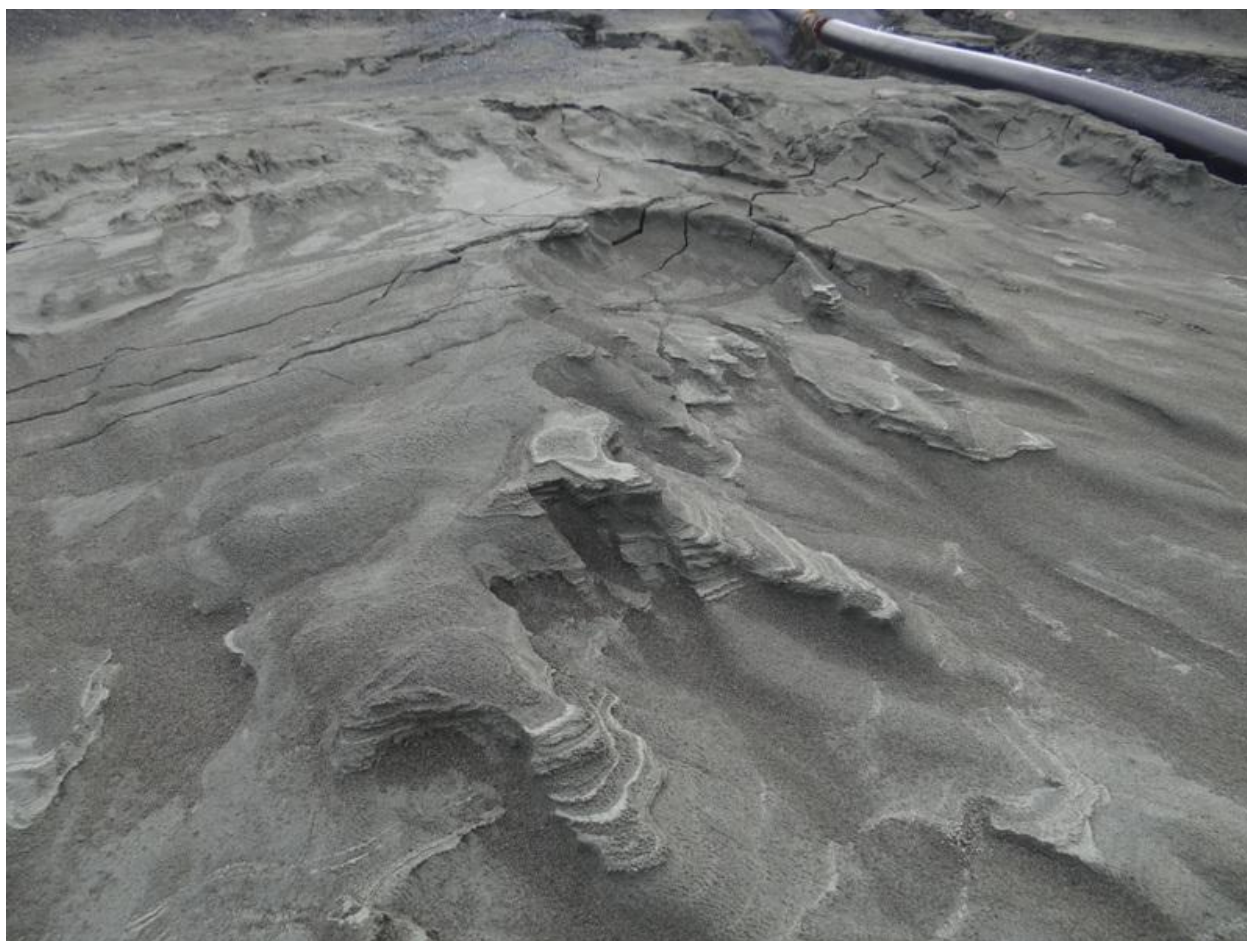
Figure 4. FPK in PKCA - drying out prior to freeze-up.

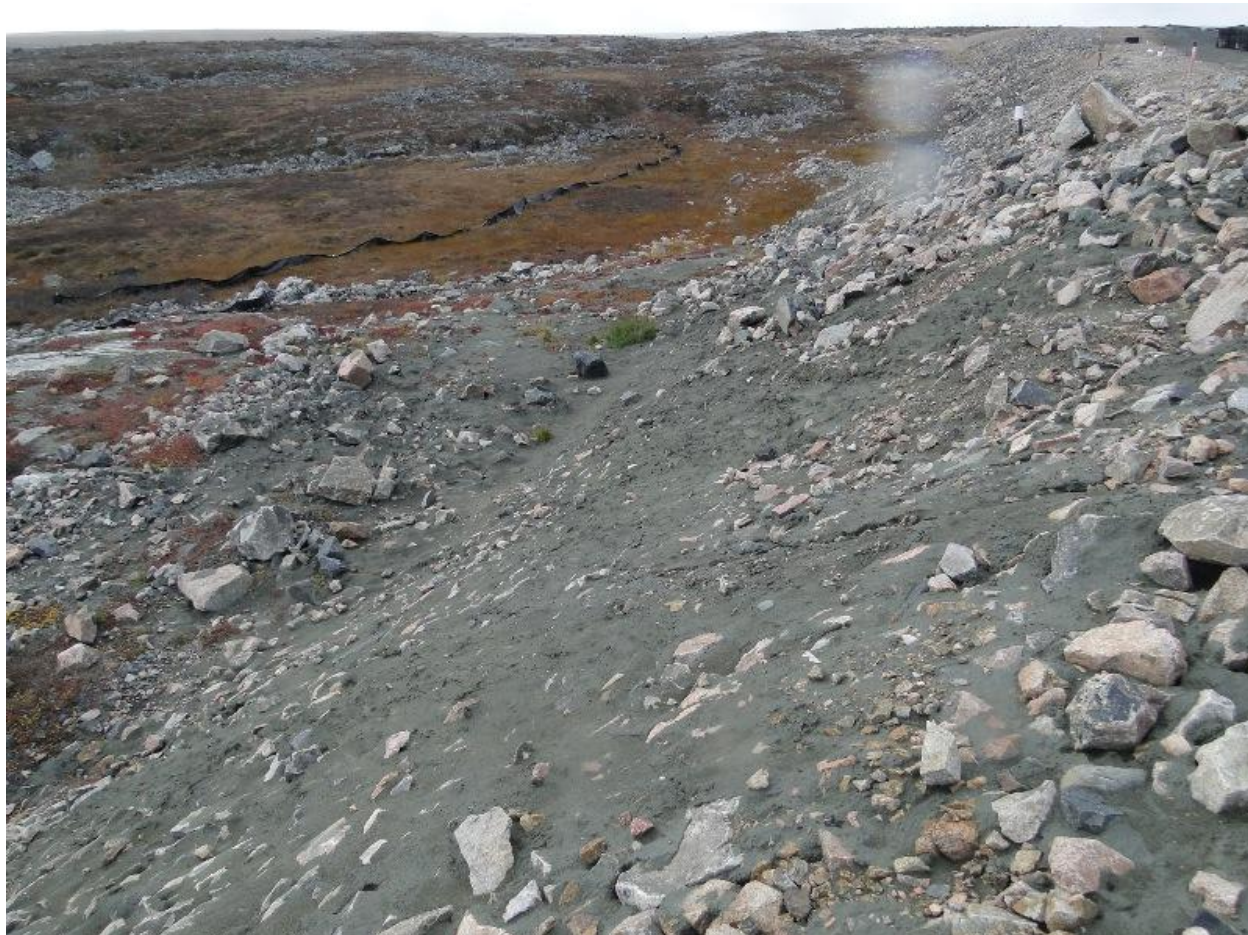
Figure 5. FPK from last winter still remains on the outside slope of the SE dam.

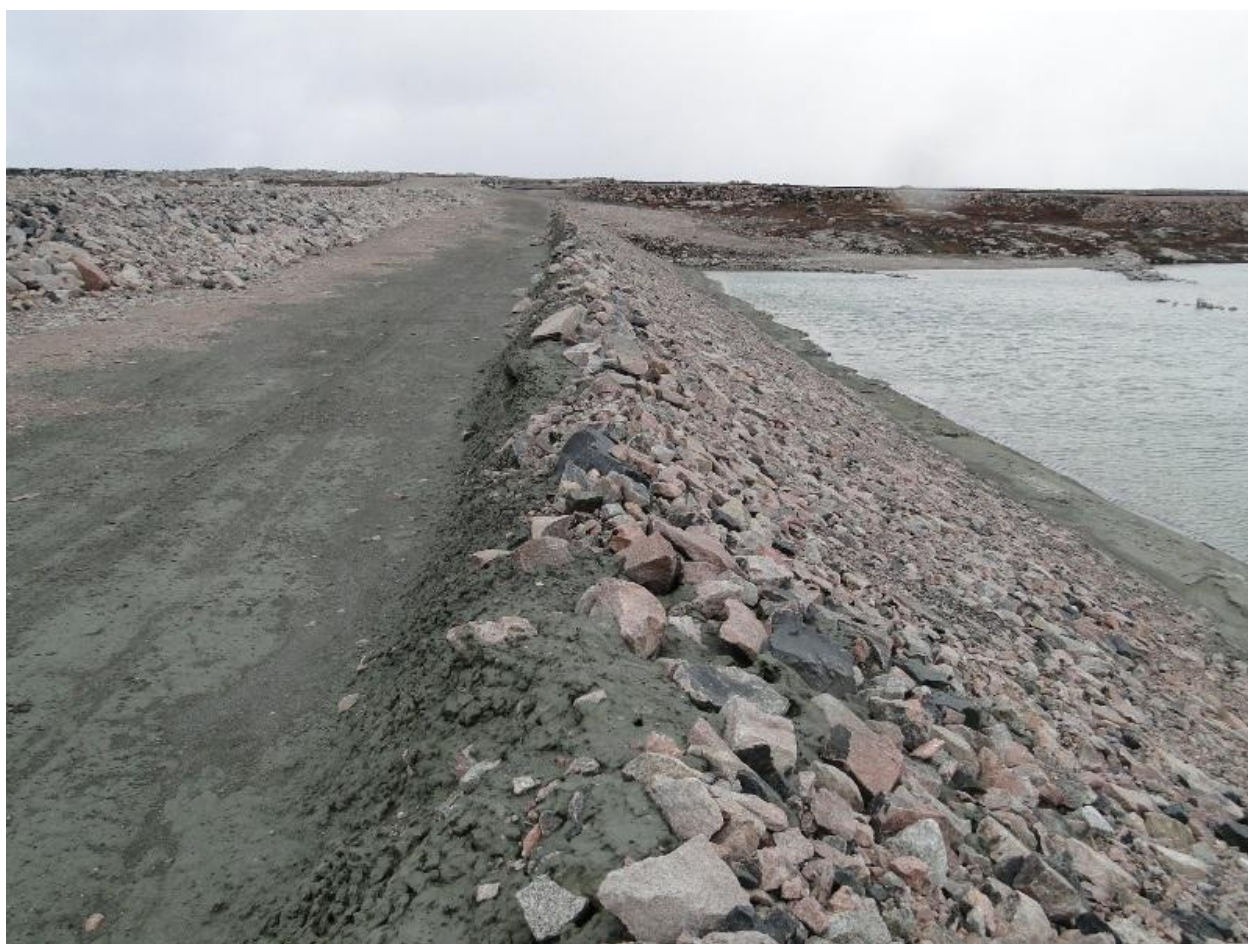
Figure 6. FPK pushing through east wall of Divider Dyke A.

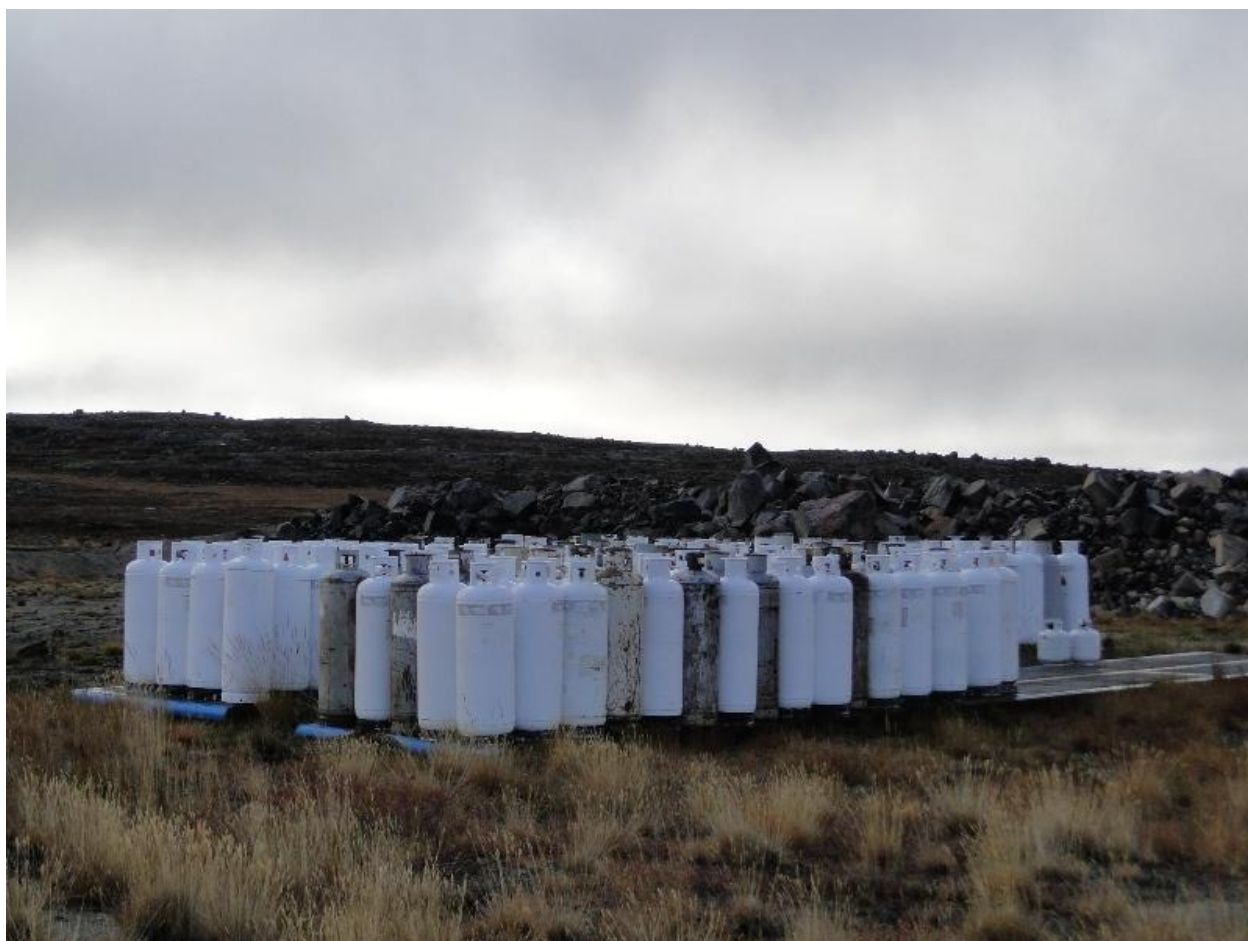
Figure 7. Stockpile of propane tanks; some found to still have propane.

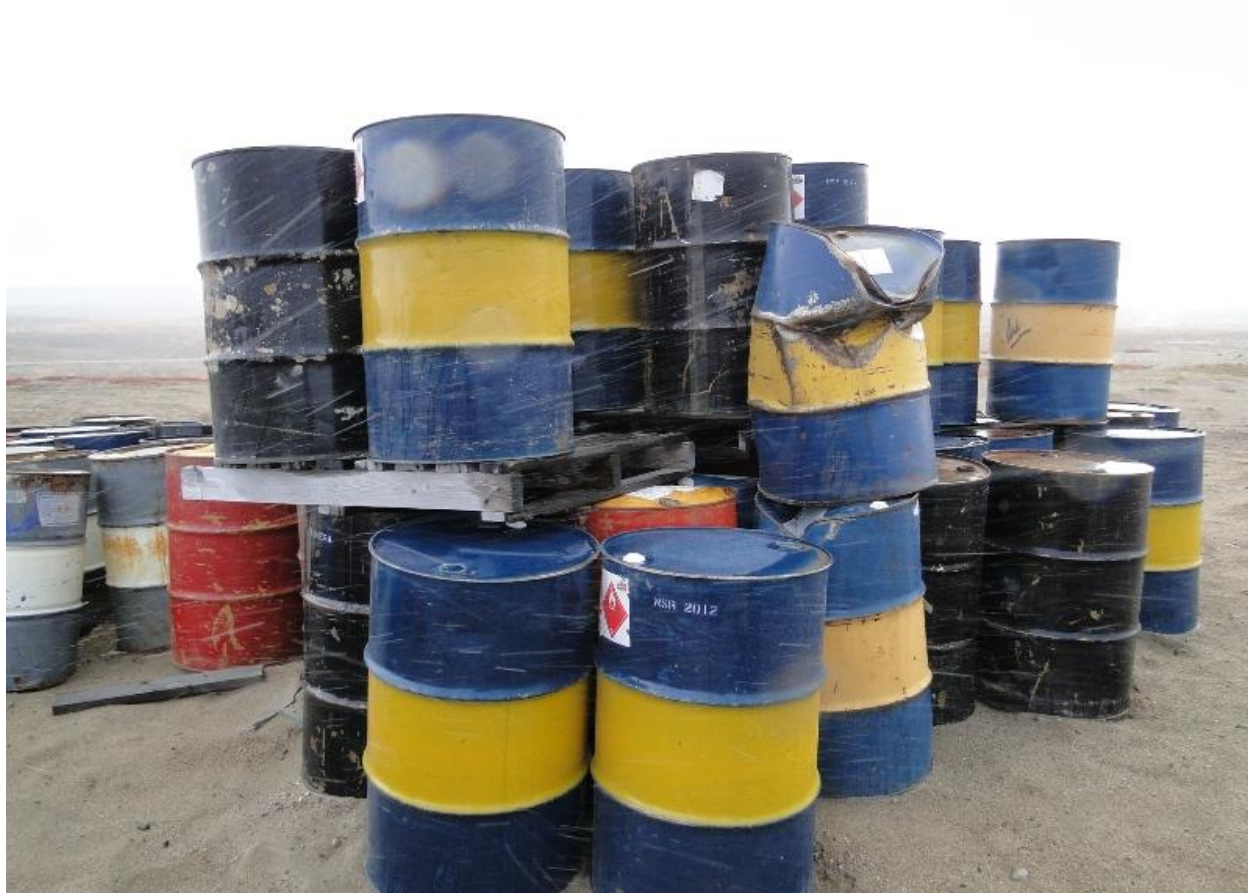
Figure 8. Barrels in laydown area, not all empty.

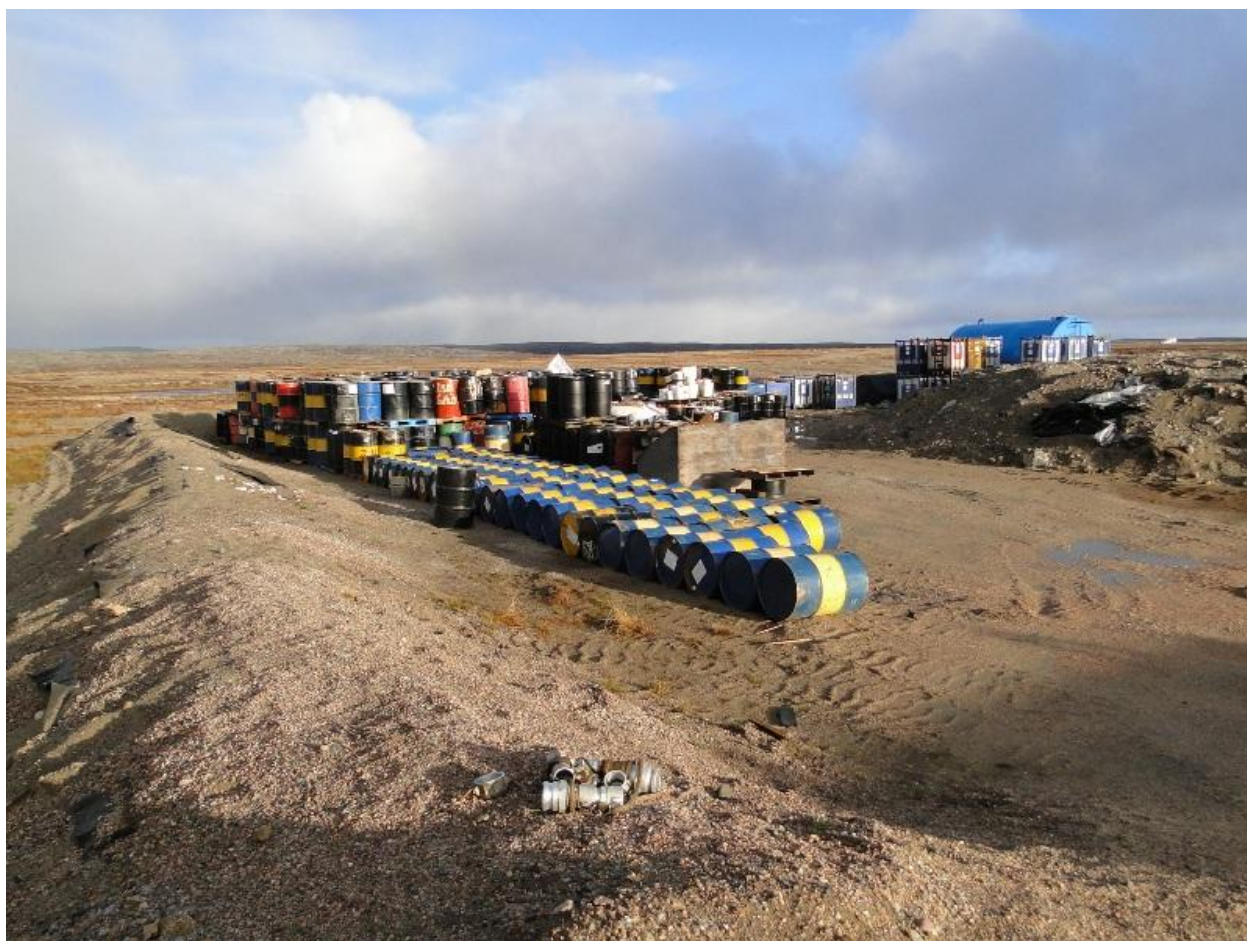
Figure 9. HWTa - barrels of old fuel should be upright to reduce likelihood of leaking.

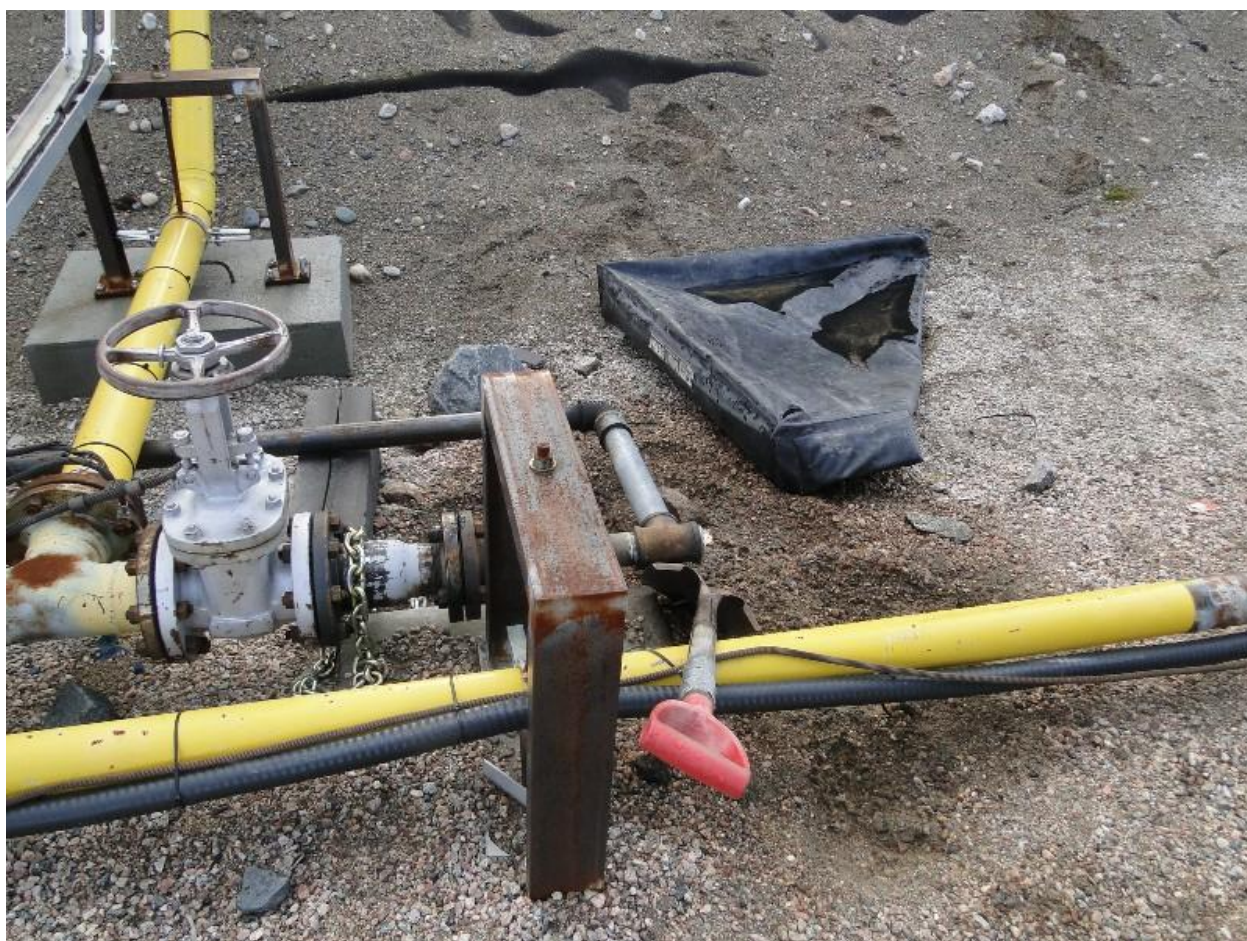
Figure 10. Leakage occurred behind the FTA; contaminated materials not picked up.

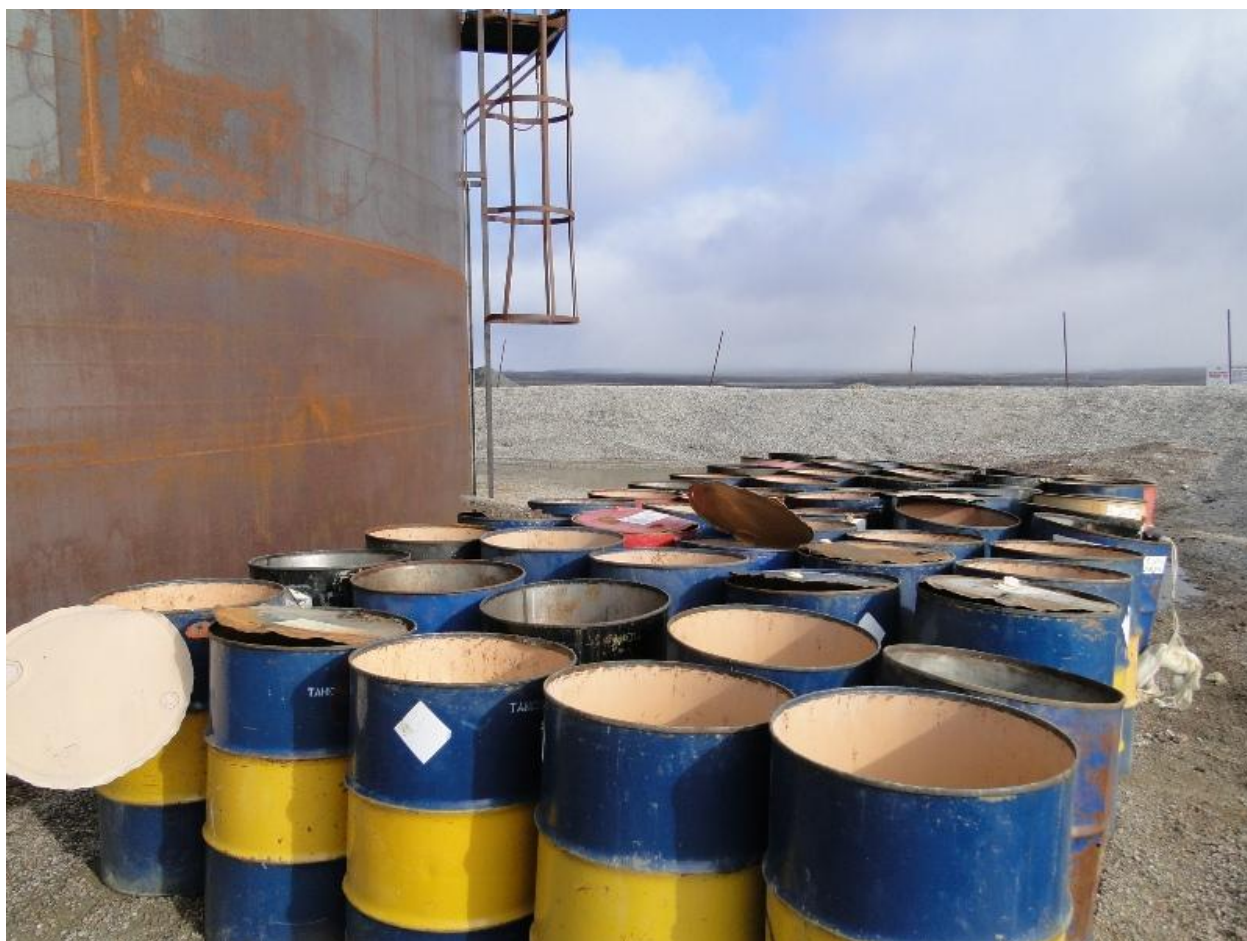
Figure 11. Barrels of oil-contaminated water from Spill 12-121.

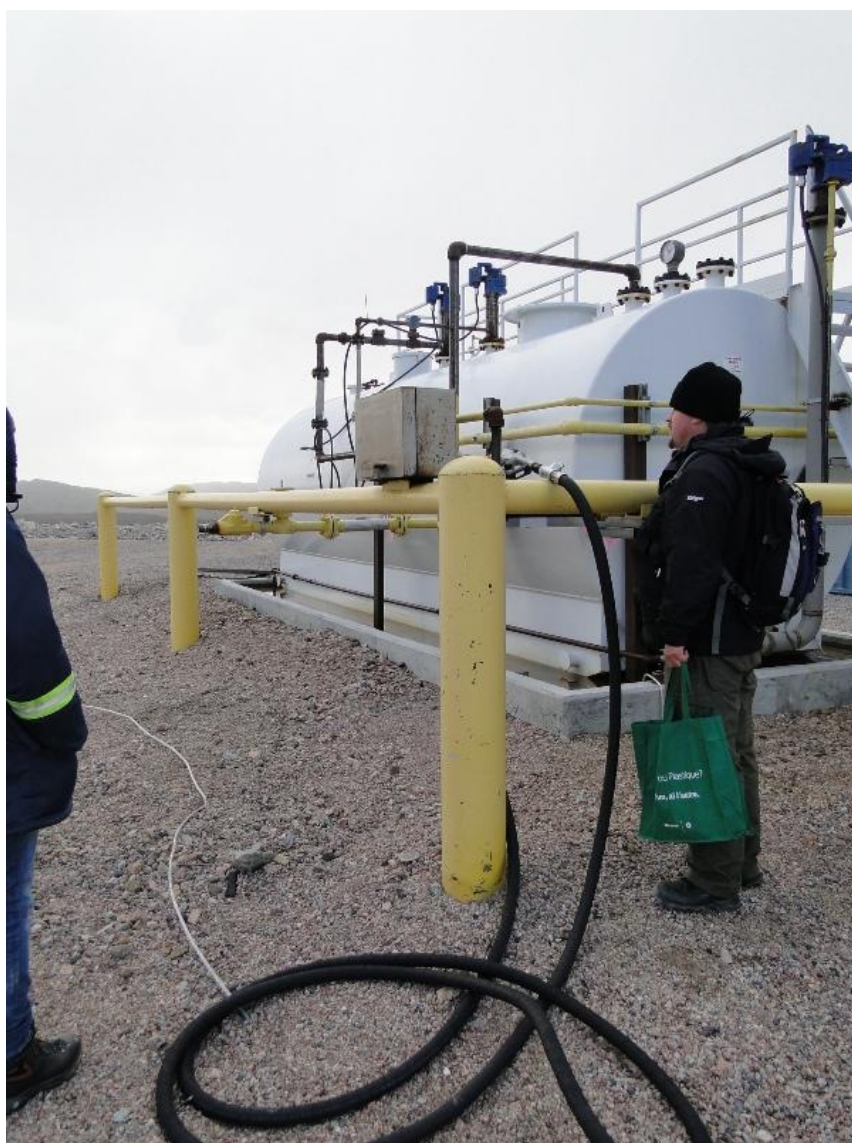
Figure 12. Fuel tank at Emulsion Plant - hose in 'on' position, berm 1/2 full of water.

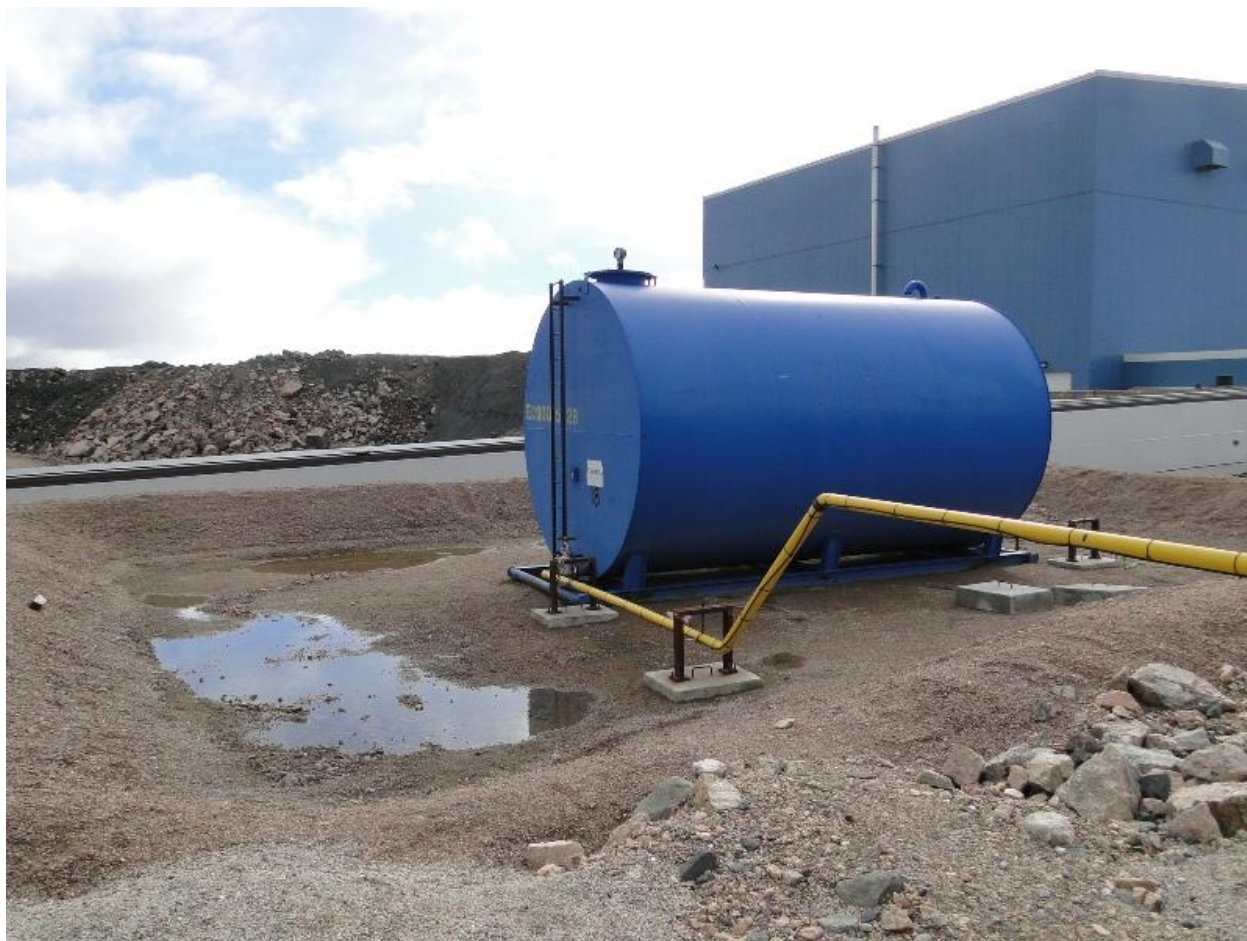
Figure 13. Tanks not locked out.

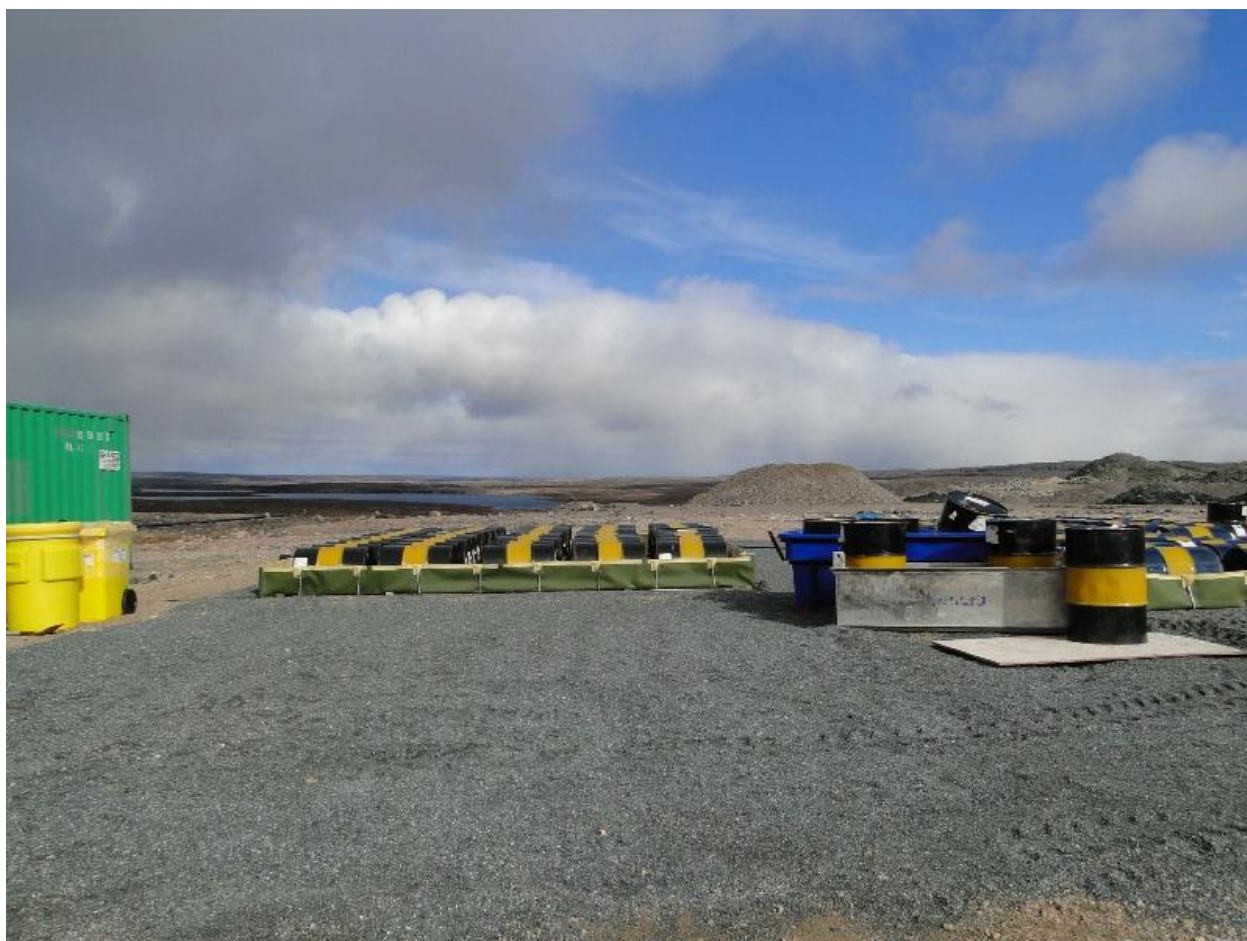
Figure 14. Barrelled fuel berms, upon arrival.

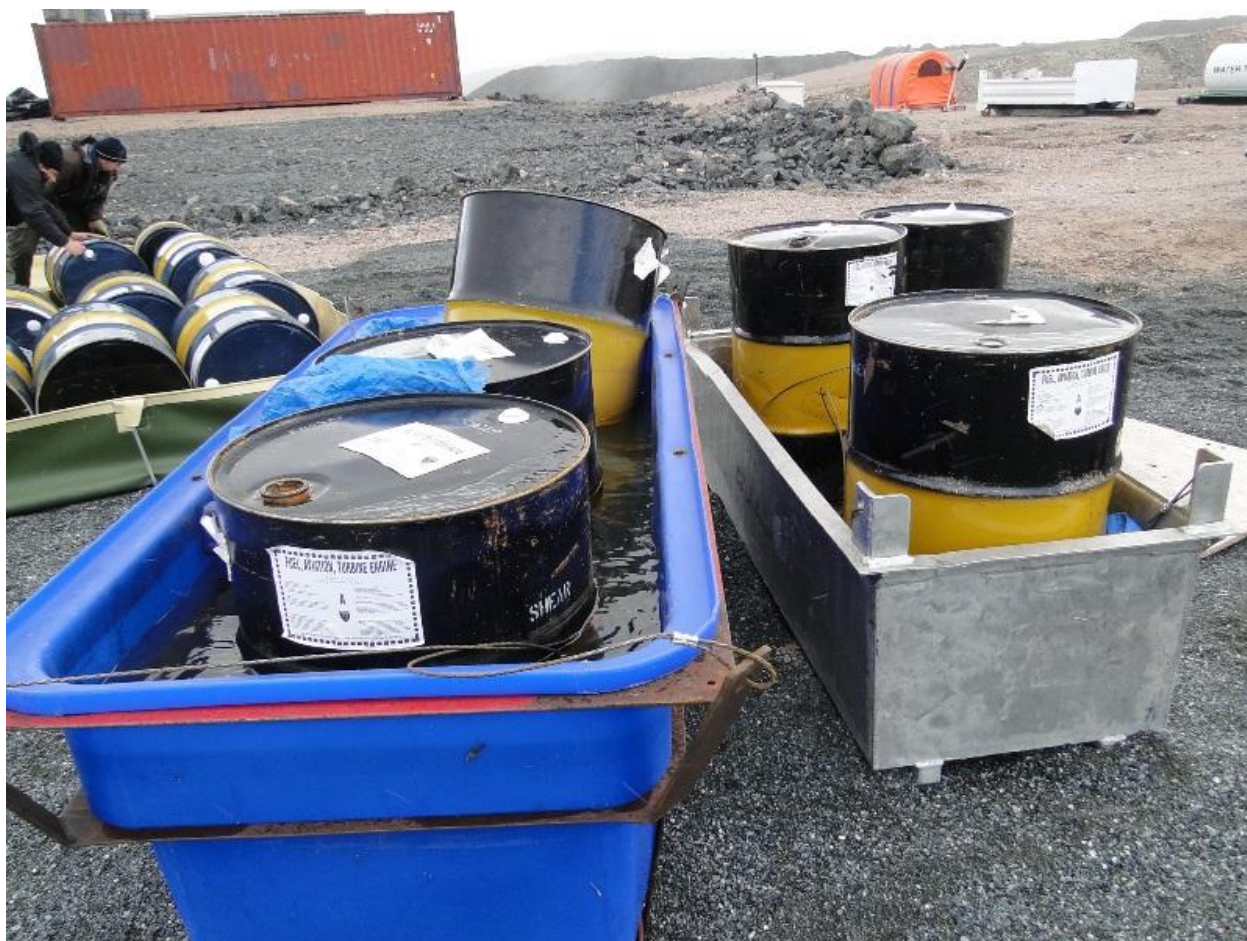
Figure 15. Container full of water.

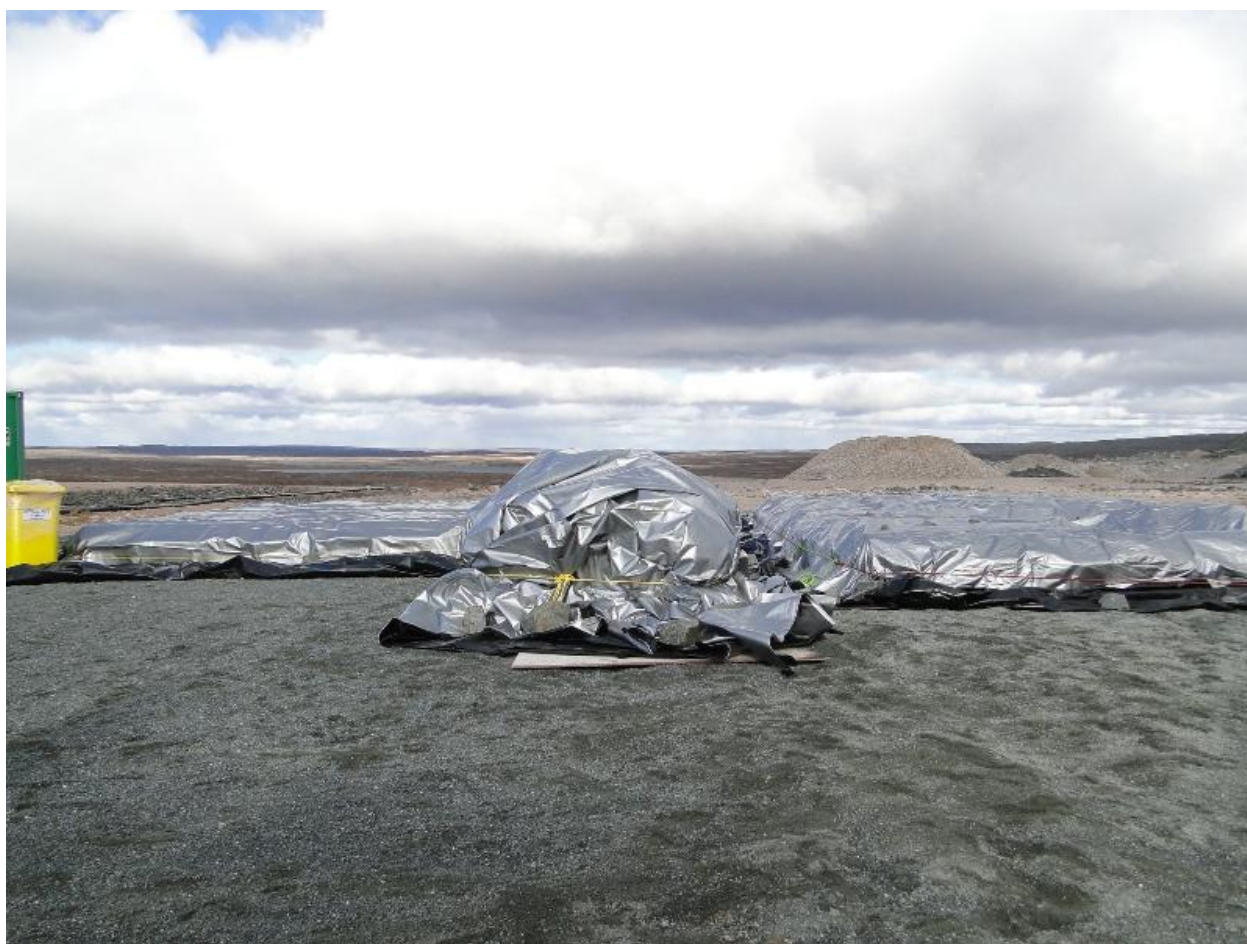
Figure 16. Berms covered over prior to departure on the 13th.

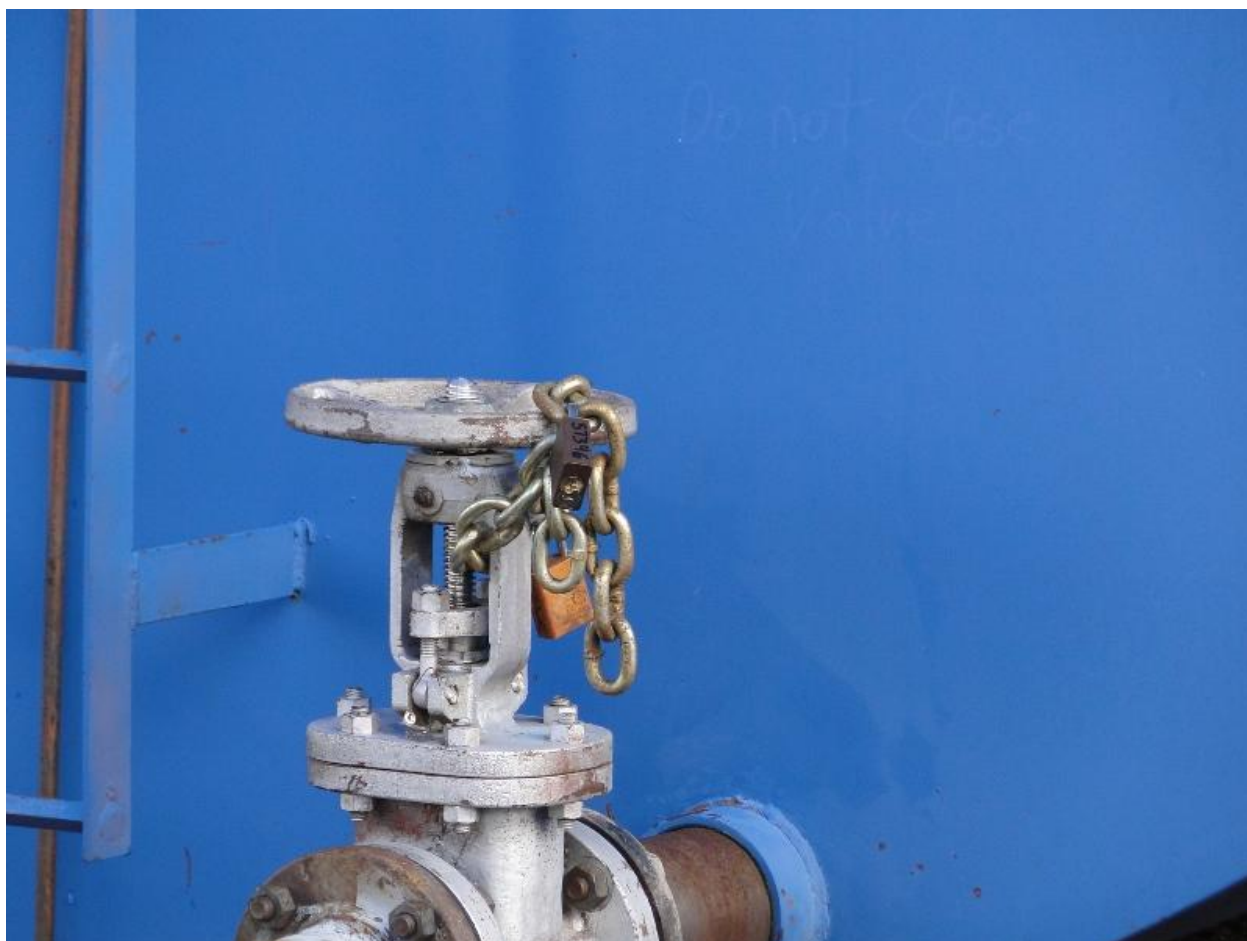
Figure 17. Tanks were locked prior to departure on the 13<sup>th</sup>.

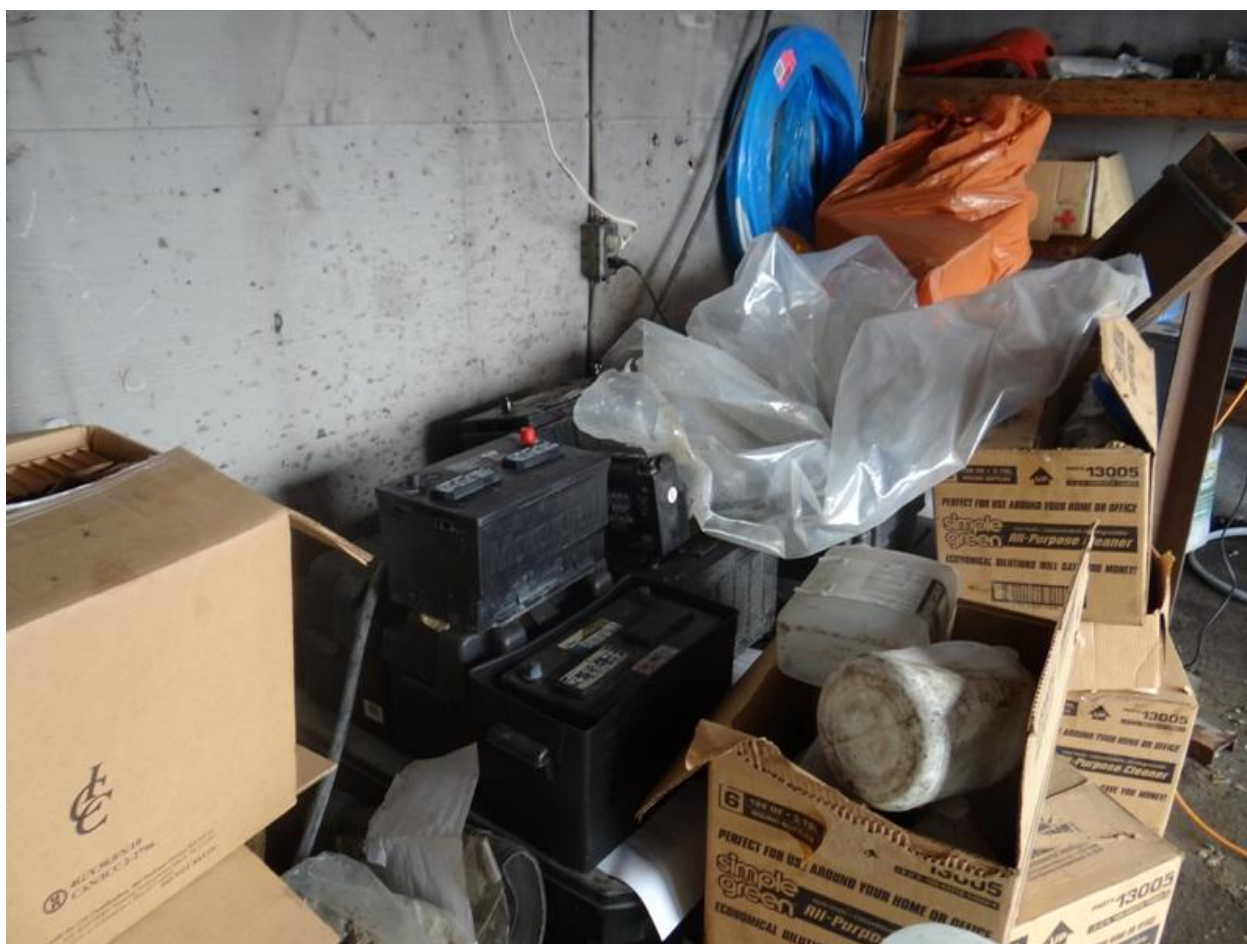
Figure 18. Chemical and battery storage at the airstrip is needed.

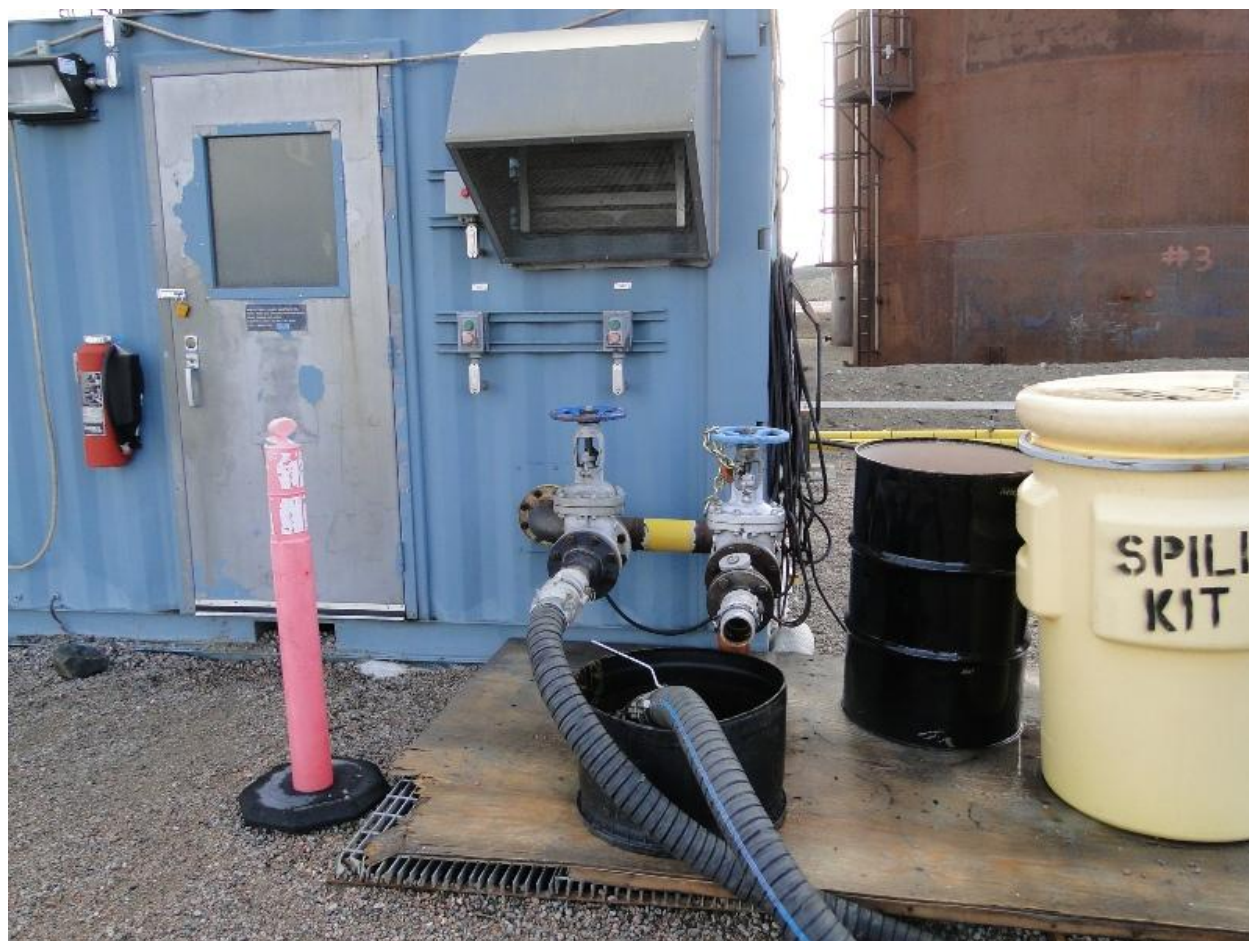
Figure 19. Hoses still contain fuel.
